DEPARTMENT OF ENVIRONMENTAL QUALITY
AIR QUALITY DIVISION
ACTIVITY REPORT: On-site Inspection

FACILITY: General Shale Brick, Inc. - DBA Michigan Brick		SRN / ID: A6497
LOCATION: 3820 E. Serr Rd., CORUNNA		DISTRICT: Lansing
CITY: CORUNNA		COUNTY: SHIAWASSEE
CONTACT: Jerry Greger , Plant Manager		ACTIVITY DATE: 04/13/2023
STAFF: Michelle Luplow	COMPLIANCE STATUS: Non Compliance	SOURCE CLASS: MAJOR
SUBJECT: Onsite compliance inspection to determine compliance with MI-ROP-A6497-2015 and MI-ROP-A6497-2022a.		
RESOLVED COMPLAINTS:

Inspected by: Michelle Luplow

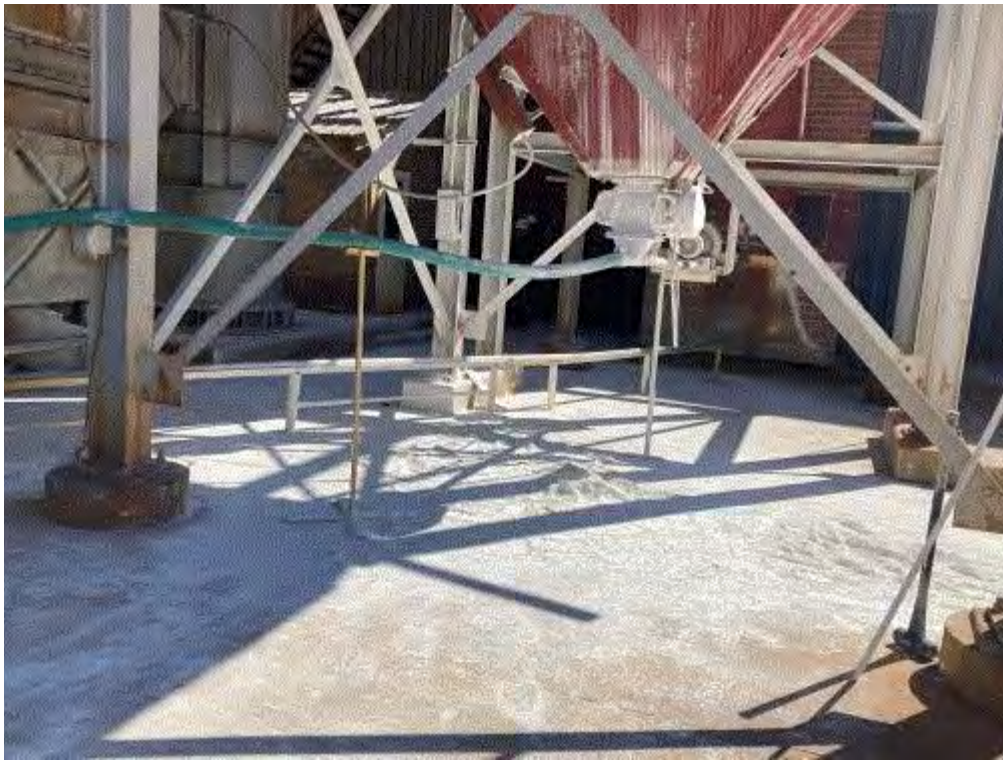
Image 2(Lime) : Lime noted on ground near baghouse. This is the result of baghouse changeout.

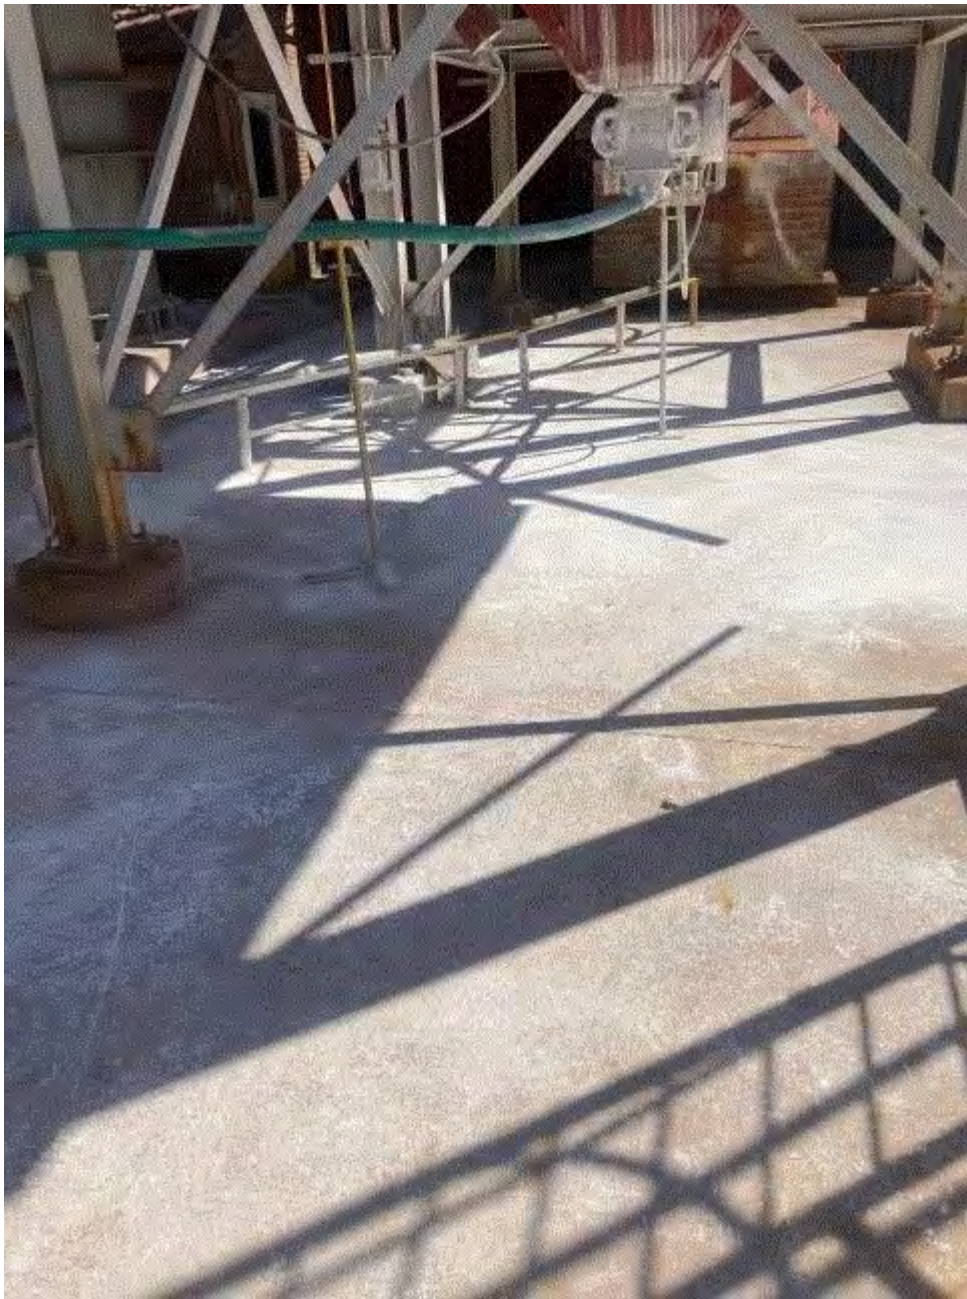
The Fugitive Dust Control Plan also requires that all paved roadways and paved areas of the plant yard be swept between dust control applications, as needed, and any spillage on roads shall be cleaned up immediately. During this inspection I noted piles of spillage pushed off to the sides of the paved plant yard near the buildings and other process equipment. I pointed this out to B. Stevens onsite, and to J. Greger during a followup call on May 19, 2023. I noted that it is required by the Fugitive Dust Plan that all piles be routinely cleaned up. J. Greger acknowledged this issue and stated it would be taken care of.

Image 3(Lime Cleanup) : Photo was taken and sent to AQD on 4/19/23 indicating that lime has been swept up, post-baghouse change. Onsite in May, AQD confirmed residual white appearance from lime cannot be re-entrained into air. Appears to be bound to the concrete's surface.

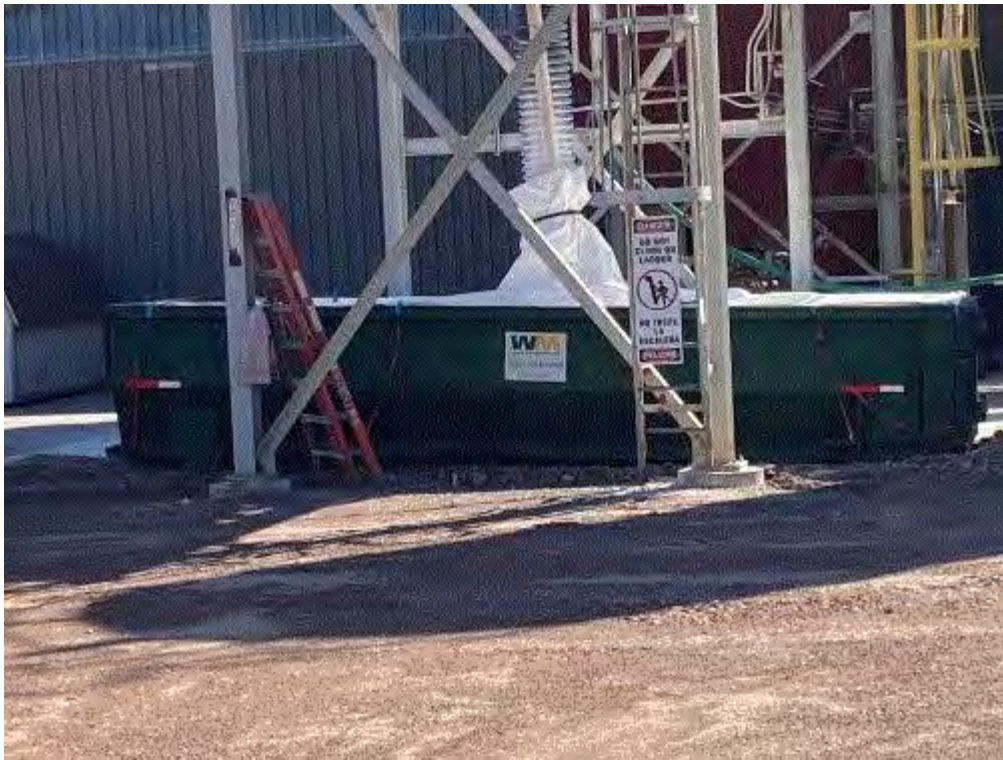
During the inspection, I noted that Michigan Brick had set up a new system to collect the waste lime used in the baghouse. Prior to the summer of 2022, Michigan Brick had the waste lime disposed of by utilizing a landfill's waste hauling truck to pneumatically pull the waste lime from the silo and into the truck. In the summer of 2022, Michigan Brick no longer had access to this waste hauling truck and therefore dropped a 12" pipe into waste bin, which then gets picked up by a local landfill company. The waste bin is lined with a plastic-type liner. The 12" pipe is inserted into the liner and waste lime can then be loaded from the silo into the waste bin. This process was not operating during the inspection; however, I did not that residual lime was coating the outside of this 12" pipe, an indicator that when lime is being transferred, lime dust is escaping the process.

Image 4(Waste Lime Bin) : System implemented to collect waste lime from storage silo.

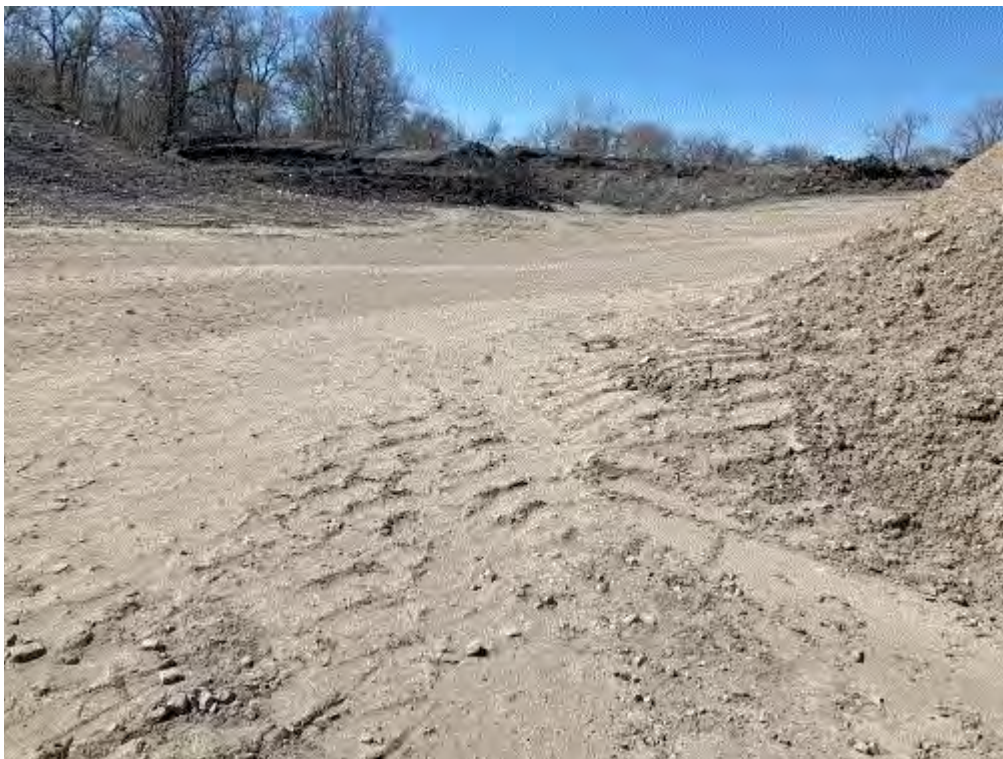
Based on the condition of the unpaved roads and yard during the inspection, it appears that Michigan Brick is maintaining most of these areas according to their Fugitive Dust Control Plan, with the exception of the haul road from the quarry to the storage piles. J. Greger noted they would work to maintain this dust as well as clean up with material piles around the paved areas of the plant to ensure compliance with the Fugitive Dust Control Plan. It is my professional judgment that a review of their dust suppressant application records was not necessary at this time; however, failure to address the fugitive dust from the haul roads and material spillage clean up may result in a violation notice in the future.

Opacity from EUTRUCKTRAFFIC operations is limited to 5% opacity, based on a 6-minute average. As previously stated in this report, it was observed that the opacity from the truck traffic on the haul road from the shale quarry to the storage pile was greater than 5%. A Method 9 was not conducted, but rather I requested that dust control be applied as soon as possible to address the exceedance. B. Stevens agreed to this, and the issue was corrected, as demonstrated by the photo sent by J. Greger on 4/19/23.

Image 5(Dry haul road) : Dry haul road resulted in fugitive dust from truck traffic during inspection.

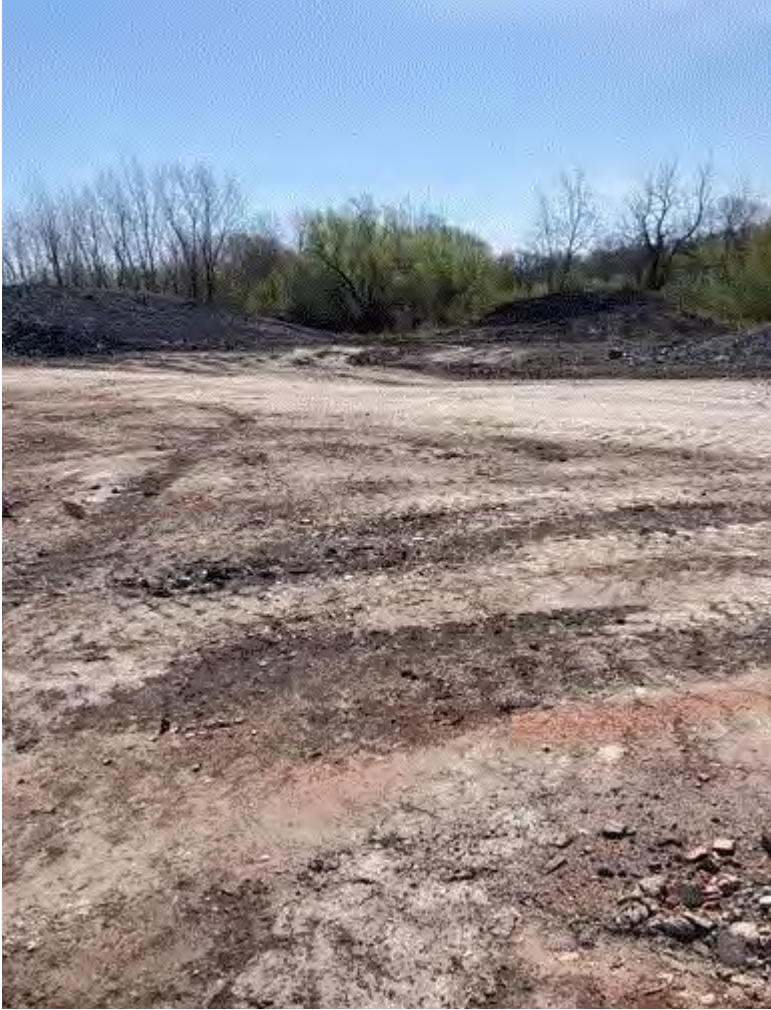
I observed 30+ commercial and personal vehicles onsite during the inspection; none of this traffic resulted in fugitive dust emissions from the unpaved portions of the plant yard (i.e. near process equipment, office, and site entryway); however, I did note fugitive dust in excess of the 5% opacity standard for truck traffic throughout the westernmost area of the plant yard where shale is stockpiled. See attached photo for dry haul road conditions. B. Stevens said this road is used strictly by Great Lakes Fusion who mines and stockpiles the shale and that he would ask Great Lakes Fusion to apply water to control the dust. I explained to B. Stevens that Michigan Brick has a responsibility to maintain the unpaved roads, regardless of who is using the roads. On April 19, 2023, J. Greger sent a photo of the watered haul road. Based on the photo, the unpaved haul road appears to have been maintained by water.

Image 6(Haul controlled) : Photo taken by Michigan Brick on 4/19/23. Photo used to demonstrate water was applied to the haul road to minimize fugitive dust from truck traffic.

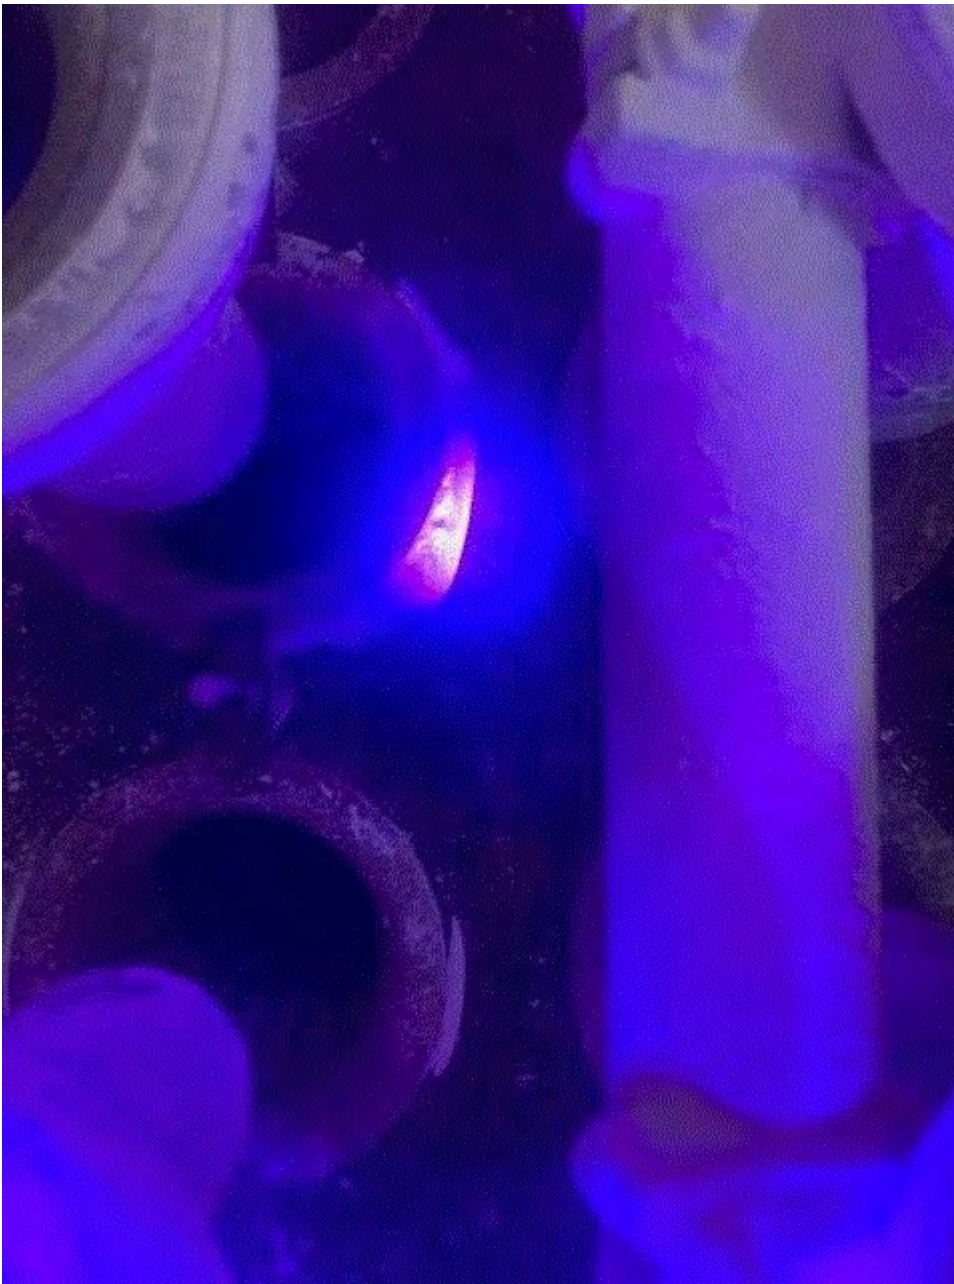
Building a proper dust cake on the new bag was likely not the reason why opacity was seen exhausting from the stack on April 13, 2023, because on May 9, 2023, during the stack test on EUKILN01, I again noted opacity from the kiln stack. During the stack test, B. Stevens, J. Greger and I discussed the opacity concern. B. Stevens said that during the April 12 opacity event, they ran UV tracer through the baghouse to determine the issue, while they noted one of the bags missing, B. Stevens also noted, based on the UV light test, that there were places where the bags connect to the baghouse floor that particulate was escaping through (at the seals) and said that the bags are bolted down as tight as they can be, but particulate is still escaping through the gaps between the floor and bag. J. Greger sent me a photo of UV light at one of these gaps (see attached).

Operating the baghouse while leaks in the seals and loose clamps were present from April 12, when the issue was noticed through May 17, 2023 when the caulk was applied is a violation of Rule 910: an air-cleaning device shall be installed, maintained and operated in a satisfactory manner. The baghouse was not being maintained and operated in a satisfactory manner from April 12 – May 17, 2023.

Image 7(Trace Baghouse) : UV Trace Light indicates leaks around the seal of a bag contained within KILN01's baghouse.

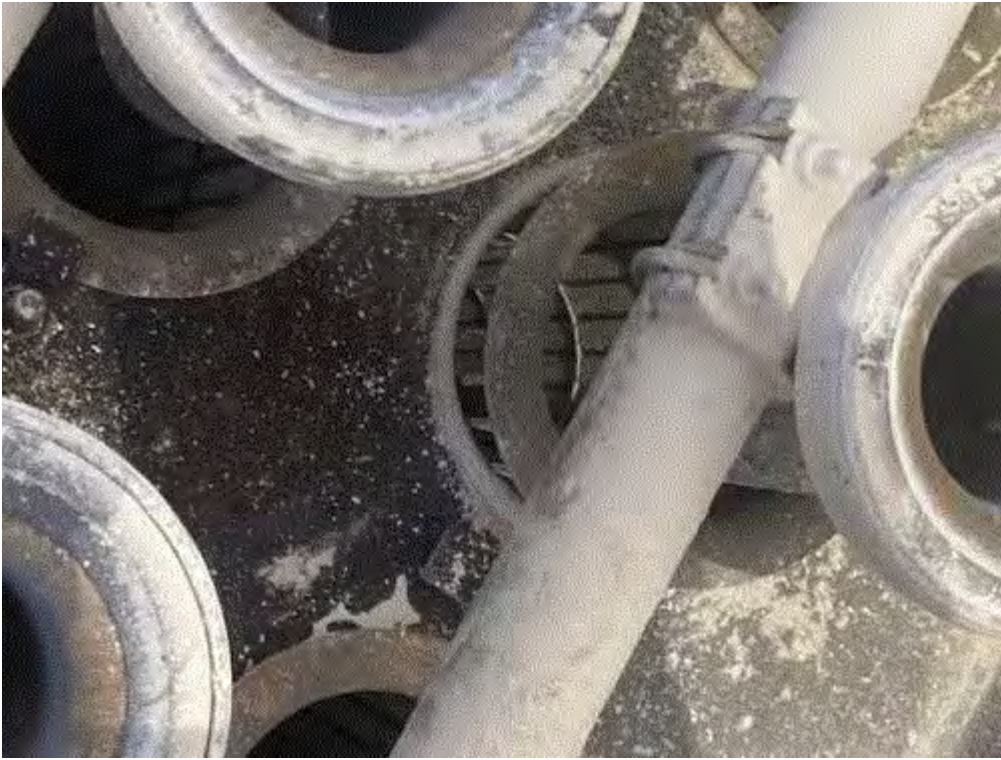
Michigan Brick continued to operate the kiln and its baghouse with the leaks at the seals, between the bags and baghouse floor from the date they noted the leaks (April 12) through Wednesday, May 17, 2023. On May 17, 2023, J. Greger informed me that a special, high-heat resistant caulk, endorsed by the Gortex bags representative, was used to seal the leaking spots in the baghouse seals on May 17. He noted that they did find some of the tighteners at the top that clamp down the bags were also loose.

Image 8(Unsealed bags) : Photo credit: Michigan Brick. Photo before sealer was applied to bag seals.

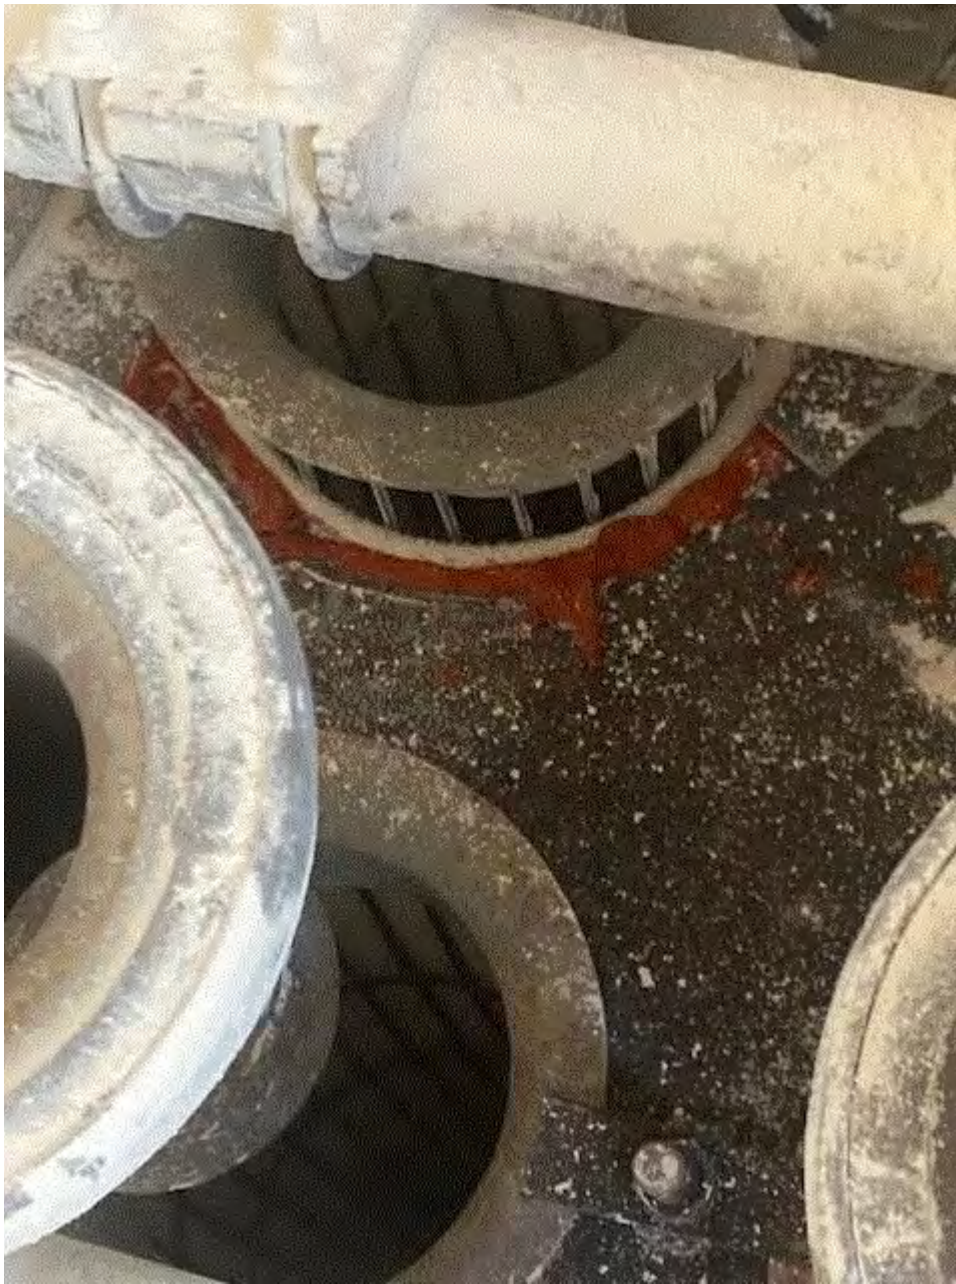
Image 9(Caulked Bag) : Photo Credit: Michigan Brick. Photo shows caulk has been applied at seal of bag cage.

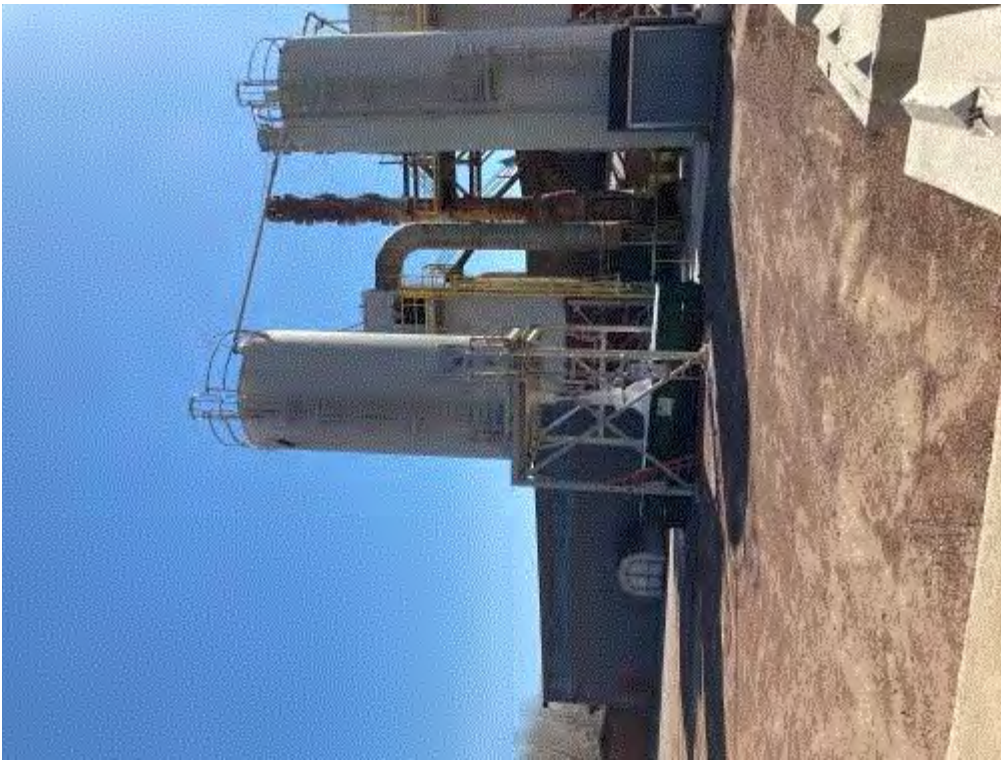
B. Stevens stated that the clip came off one of the baghouse bags, which rubbed on the ring which resulted in the ring cutting through the bag and detaching the bag from the baghouse structure. Particulate was released from the stack as the result of the missing bag. The new bag was installed at approximately 9 a.m. on the day of the inspection, April 13, 2023 (I arrived onsite at 9:45 a.m.). The kiln resumed firing bricks at 10:30/11:00 on April 13. I observed some opacity from the stack after the bag was replaced; however, I attributed the opacity to possibly the need for the bag to build a dust cake to control the dust properly.

Image 10(Facility) : Note opacity present above lime storage tower (white cylinder) from EUKILN01's stack (right side of photo).

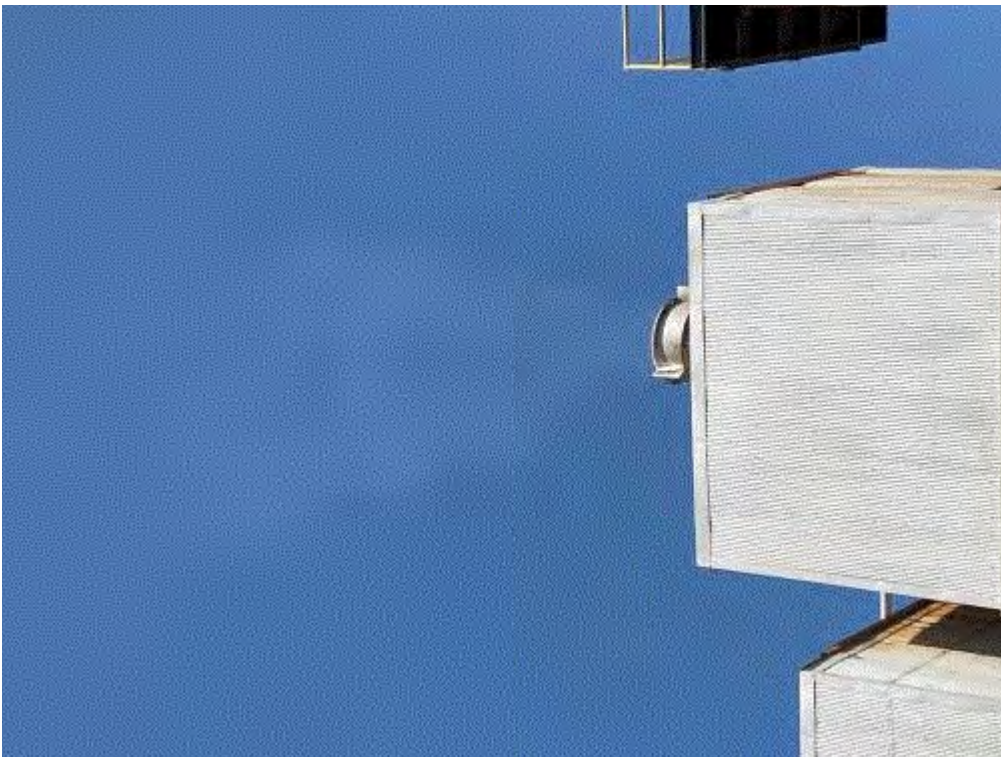
Image 11(Opacity) : Opacity seen from EUKILN01's stack on 5/9/23 during stack test.
