DEPARTMENT OF ENVIRONMENTAL QUALITY
AIR QUALITY DIVISION
ACTIVITY REPORT: Scheduled Inspection

| FACILITY: Gestamp Washtenaw, LLC | | SRN / ID: B2062 |
| SUBJECT: Unannounced compliance inspection of a new stamping plant with E-Coat line. | | |

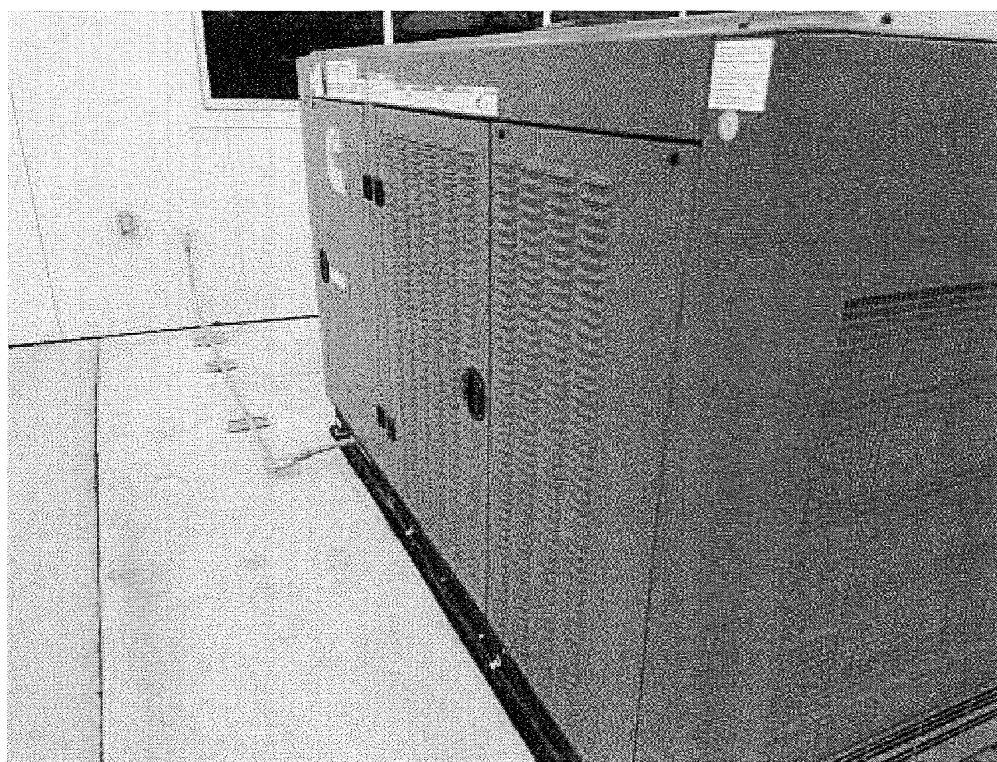
Next, we looked at the 2 new natural gas fired emergency generators. One was being used as backup power for office computers while the other was to maintain the temperature of the paint in the event of a loss of power. Basically, neither one had been used yet. It appears that they did have the ability to display the hours of usage and produce maintenance information so appeared to be in compliance with NSPS JJJJ. See attached photos.

Image 3(Emergency generator) : Emergency generator for E-coat tanks to maintain temperature in the event of a power failure.

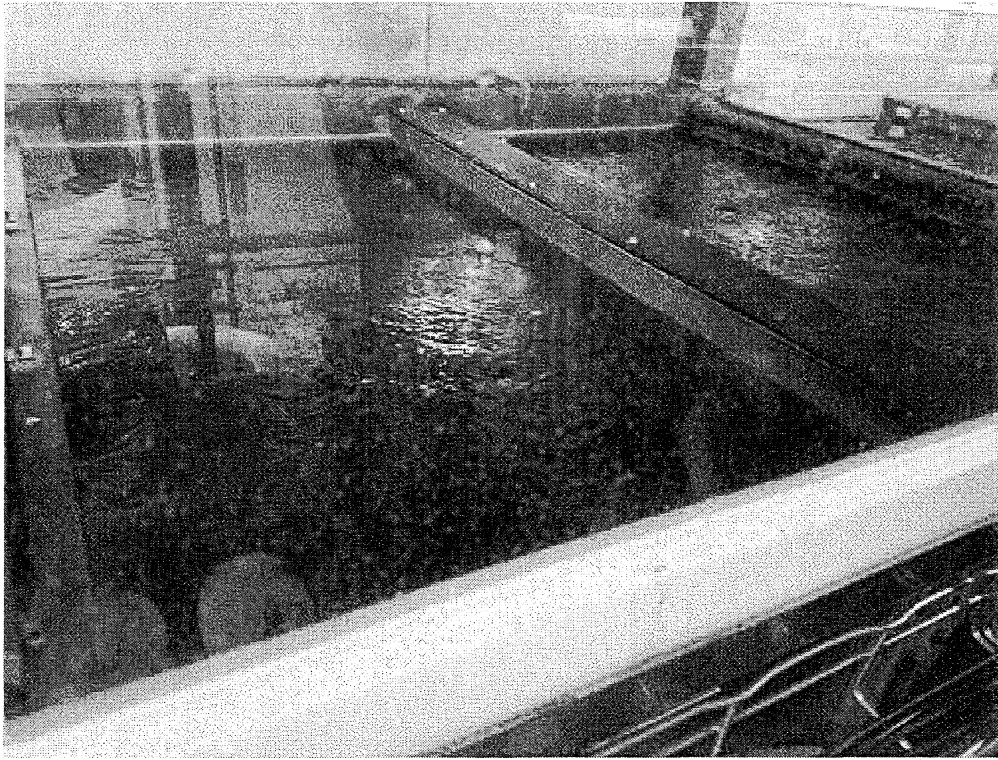
Part of the E-coat line contains an acid tank that is split into 2 by a ventilation bar going across it. The fumes from a sulfuric/phosphoric acid mixture in the acid tank are collected with linear horizontal hoods which duct emissions to the scrubber. See attached photos.

Image 4(Acid tank) : Acid tank

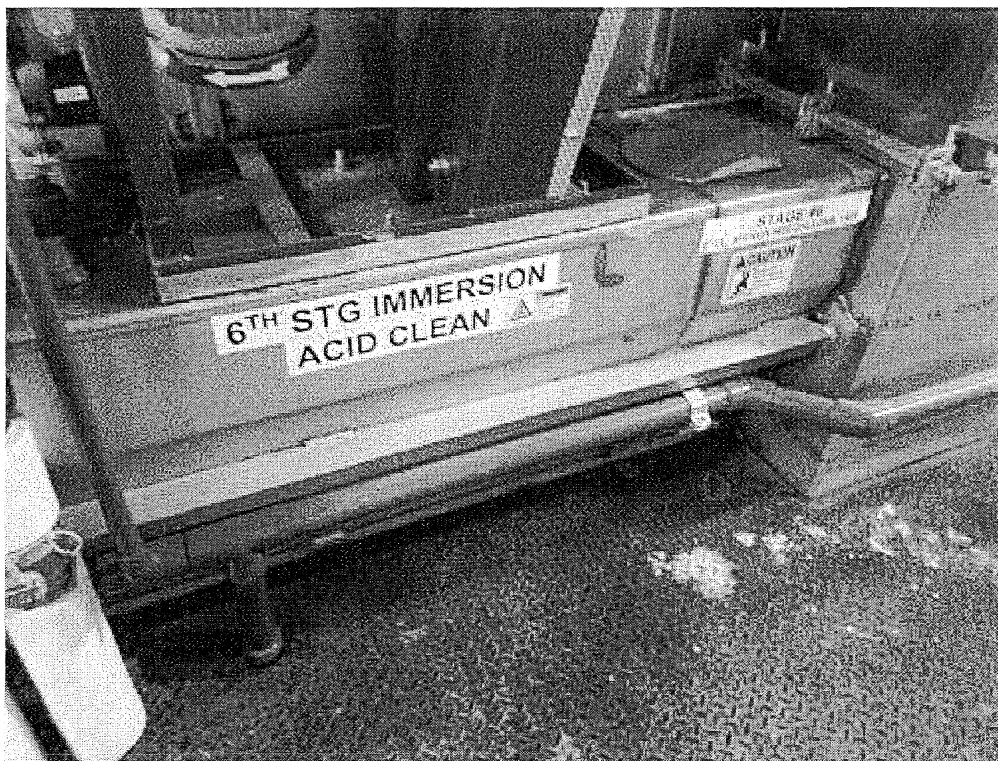
Image 5(Acid tank label) : Acid tank label

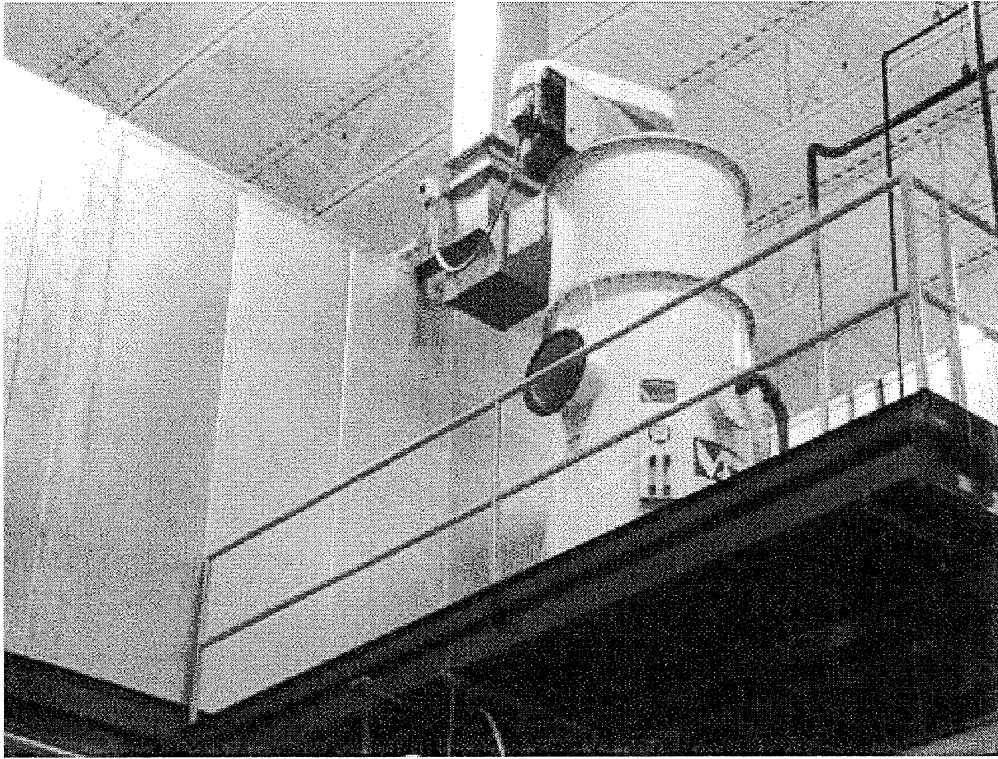
The packed bed scrubber and dryer were located above the fully enclosed E-coat line. The scrubber was not easily accessible as a safety harness would be needed to reach it so it wasn't looked at closely. See attached photo. It did appear to be new and was equipped with the required pressure drop device. Duct work from the dryer, the E-Coat line and scrubber appeared to be in excellent condition.

Image 6(Wet scrubber) : Wed scrubber next to oven.

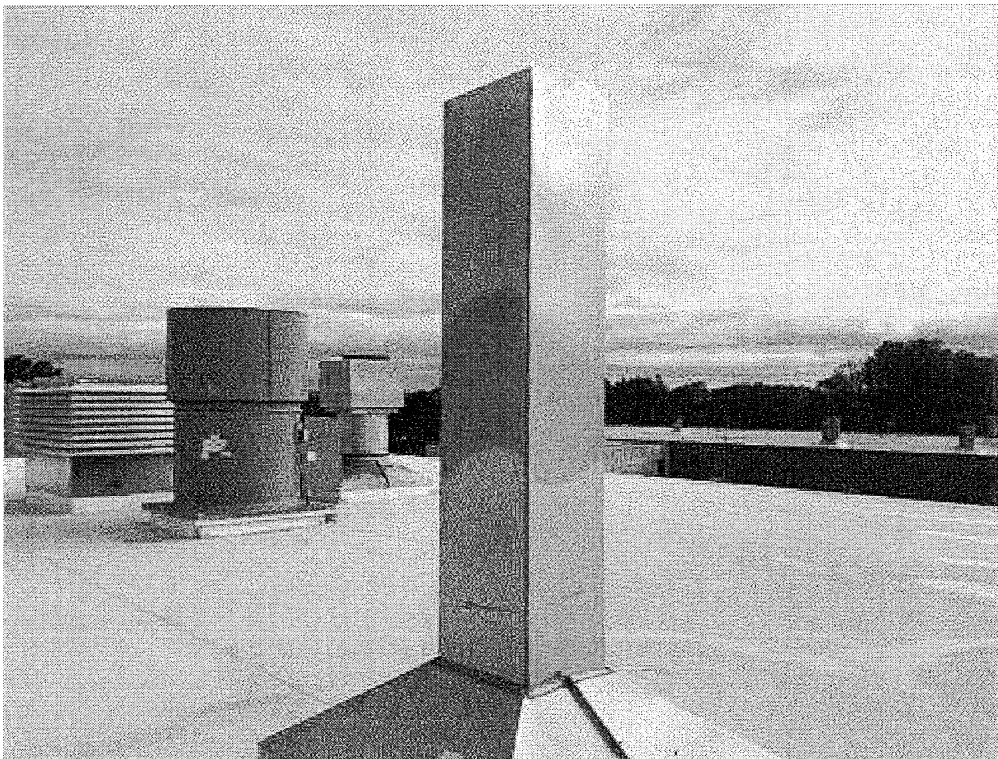
Next, we visited the roof of the E-Coat line to verify required stack heights. See attached photos. The roof and ventilation equipment appeared to be in good shape. It was noted that the intake make-up air vent was very close to the discharge of the oven stack. The roof was verified to be 42 feet high. (See Attachment (1)). Visually, it appeared all that the stacks met the PTI stack height requirements. However, that SV-WATERHEATER had a rain cap on it and so emissions from the 2 MM natural gas fired boiler were not being discharged unobstructed vertically upwards as the PTI required.

Image 7(Roof stacks) : Roof stacks. Oven stack next to air intake stack.

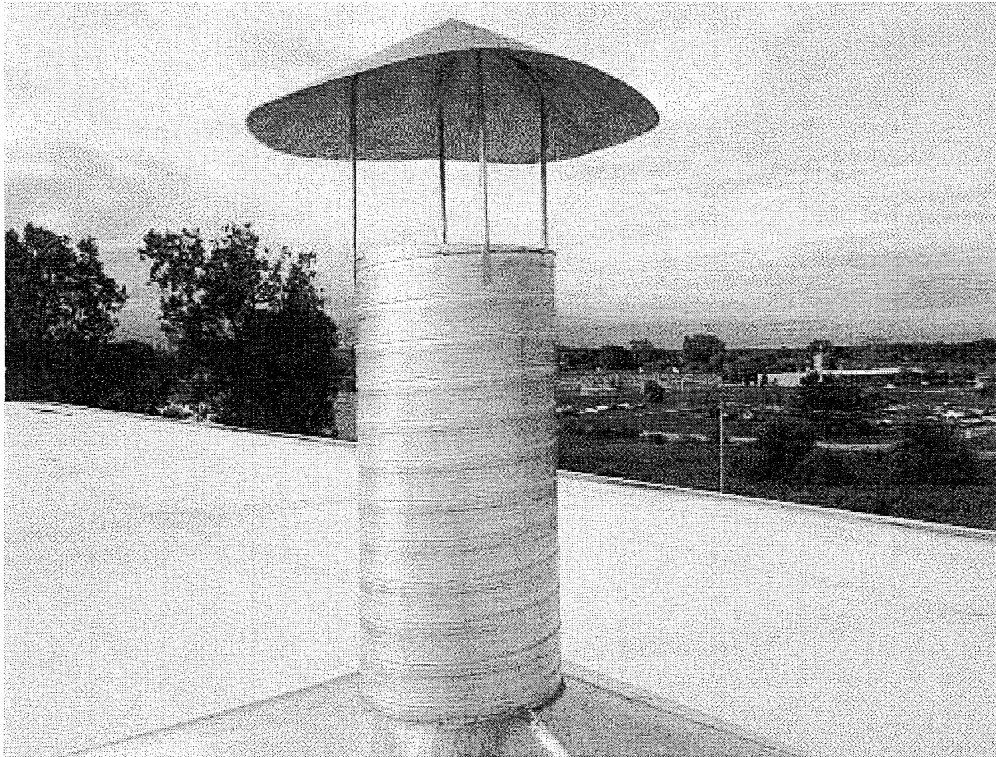
I held a brief post-inspection meeting with SF and CJ. I indicated to them that I would contact Frank Keller later in the day to get the required records for him. My only finding was the presence of a rain cap on the natural gas fired boiler stack. I noted that this was a rather dubious permit requirement requiring no rain cap for emissions from a small natural gas fired boiler that could be resolved informally and would discuss resolution with Frank as well. I thanked the 2 gentlemen for their time and cooperation, and I departed the facility at approximately 10:25 am.

Image 8(Rain cap) : Rain cap on natural gas boiler stack.

Note: Follow-up email from the Company on October 16, 2018 outlined that the rain cap had been removed and provided pictures to document it.
