DEPARTMENT OF ENVIRONMENTAL QUALITY AIR QUALITY DIVISION ACTIVITY REPORT: On-site Inspection

FACILITY: CONSUMERS CONCRETE		SRN / ID: B6241
LOCATION: 58356 CR 671, PAW PAW		DISTRICT: Kalamazoo
CITY: PAW PAW CONTACT:		COUNTY: VAN BUREN ACTIVITY DATE: 06/03/2021

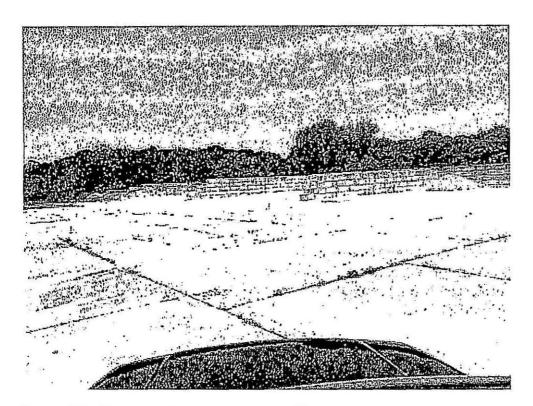
Image 1(1): Empty and near-empty aggregate bins

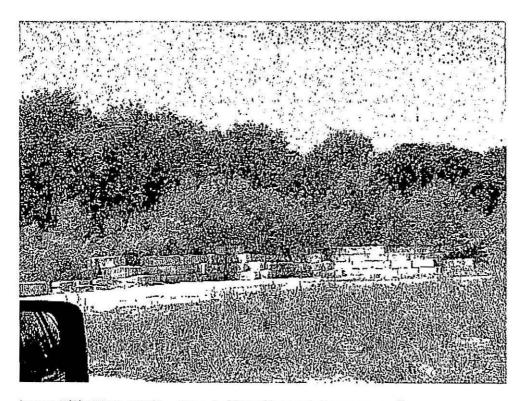
Image 2(2): More empty aggregate bins with vegetation overgrowth.

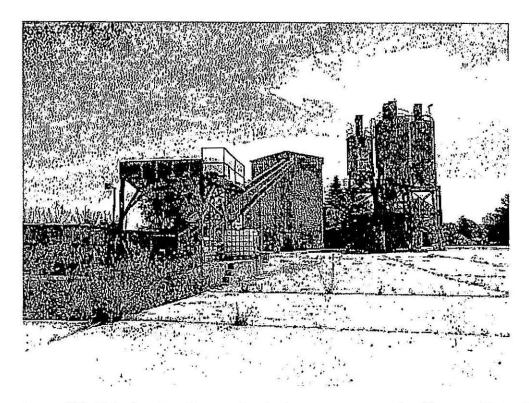
<u>Image 3(3)</u>: This plant is seldom used and only processes concrete with no crushing activities.
