DEPARTMENT OF ENVIRONMENTAL QUALITY
AIR QUALITY DIVISION
ACTIVITY REPORT: Self Initiated Inspection

FACILITY: Continental Dairy Facilities, LLC	SRN / ID: B7038
LOCATION: 999 WEST RANDALL STREET, COOPERSVILLE	DISTRICT: Grand Rapids
CITY: COOPERSVILLE	COUNTY: OTTAWA
CONTACT: Derrick Scheidel , EH&S Supervisor	ACTIVITY DATE: 09/23/2015
STAFF: April Lazzaro	COMPLIANCE STATUS: Compliance
SUBJECT: Unannounced, scheduled follow-up inspection.	SOURCE CLASS: SM OPT OUT
RESOLVED COMPLAINTS:

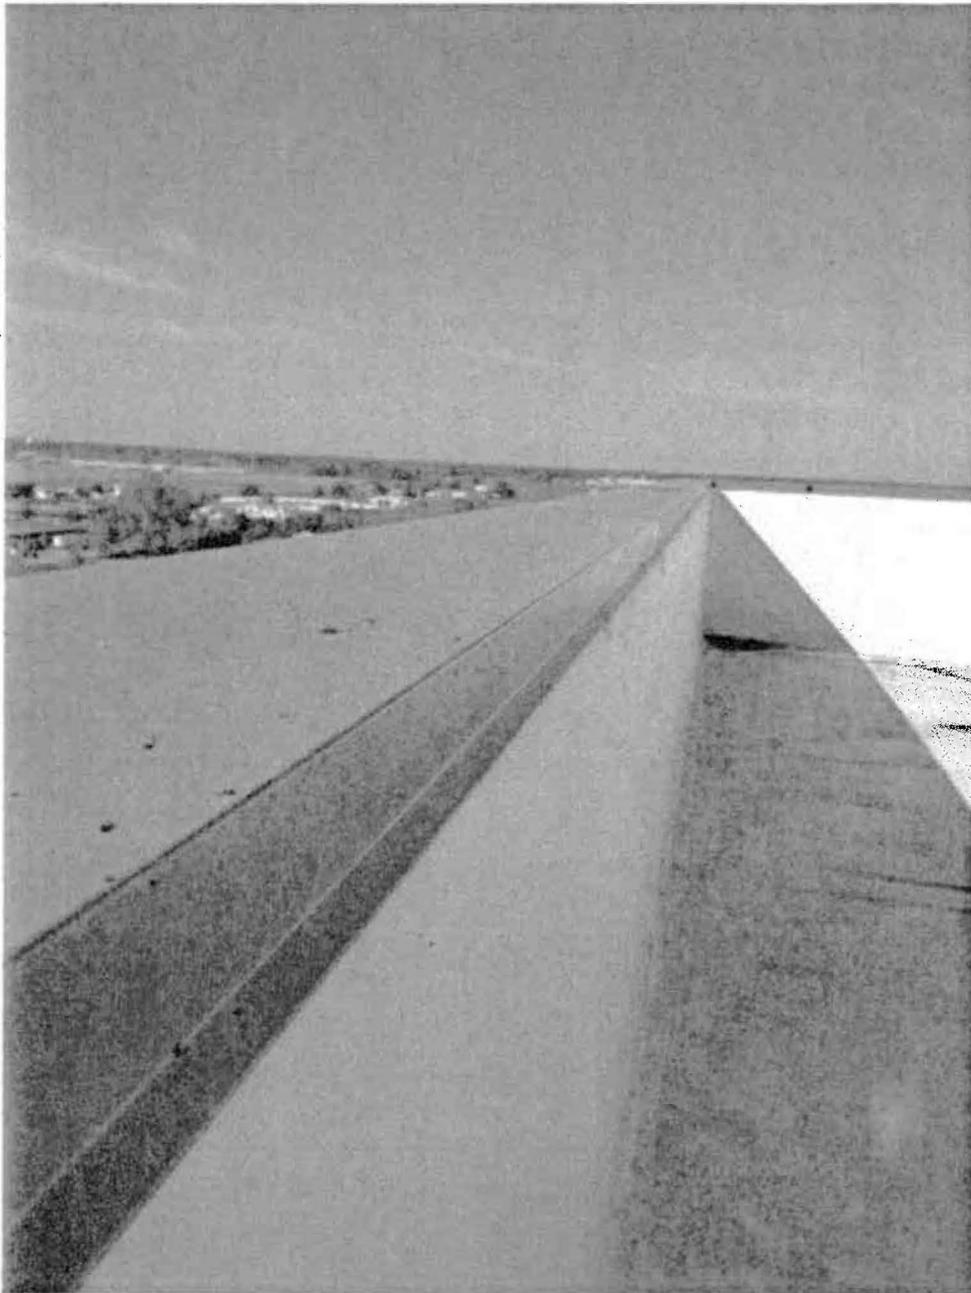
Staff, April Lazzaro met at the facility with Derrick Scheidel to finish our discussion on the material seen on the roof, which is believed to emissions from the dryer.

Mr. Scheidel conducted extensive follow up and learned that this type of material is an industry wide occurrence due to the moisture content of the exhaust stream and collection of particulate on the heat recouperator. After the dried milk accumulates on the recouperator, it can become airborne.

The pieces seen are larger than PM 10, and it is unclear at this time as to whether or not it is an air contaminant. Mr. Scheidel indicated that they do not get any particles on facility vehicles, which would indicate that they are large and do not travel from the roof area.

Image 1(Continental roof1) : View of particles on roof ledge at continental. (this ledge is over another lower section of the facility)

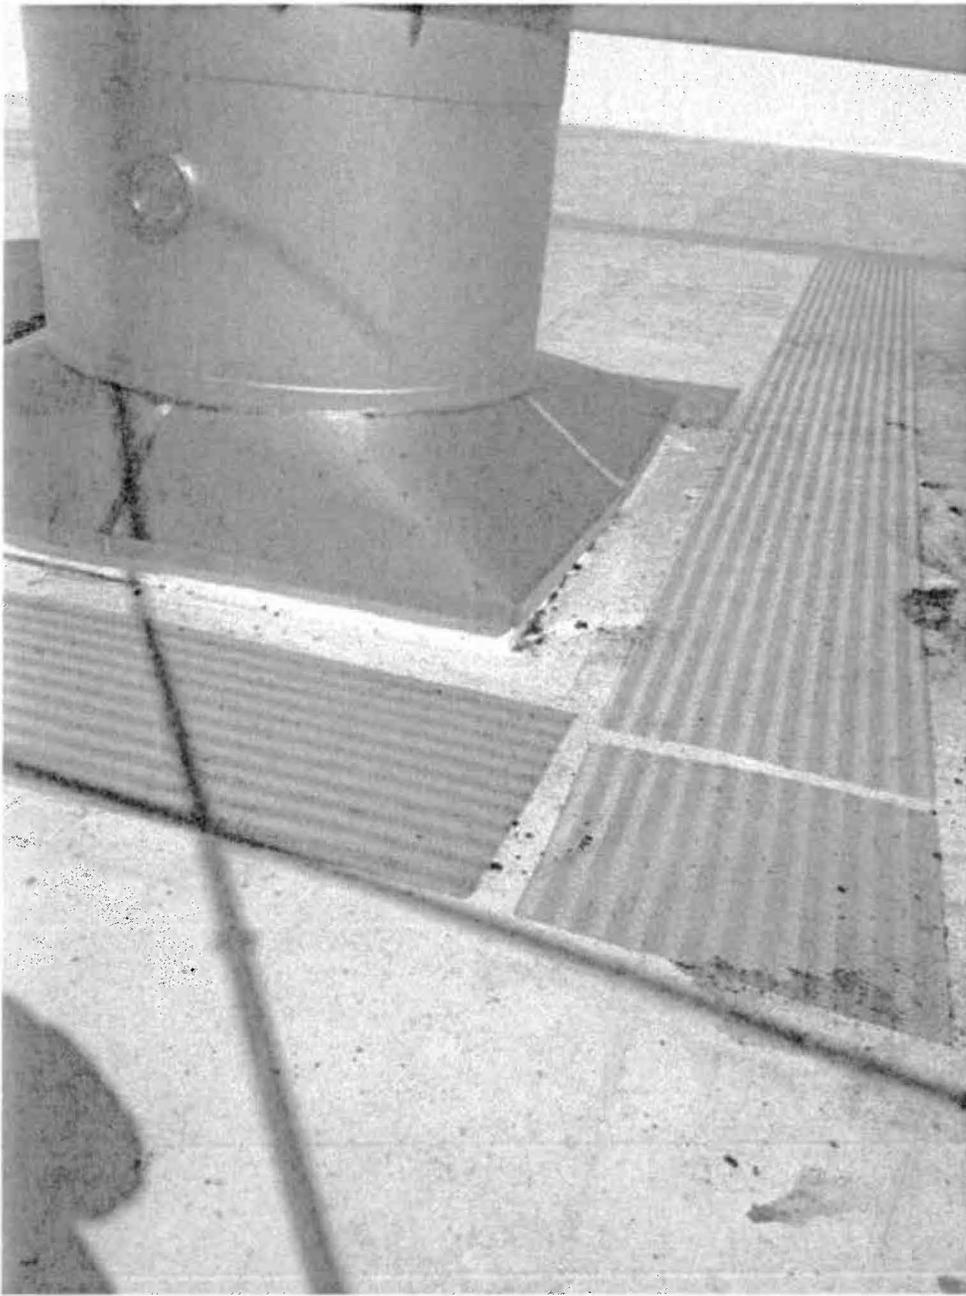
Image 2(Continental roof2) : Base of dryer stack on roof.

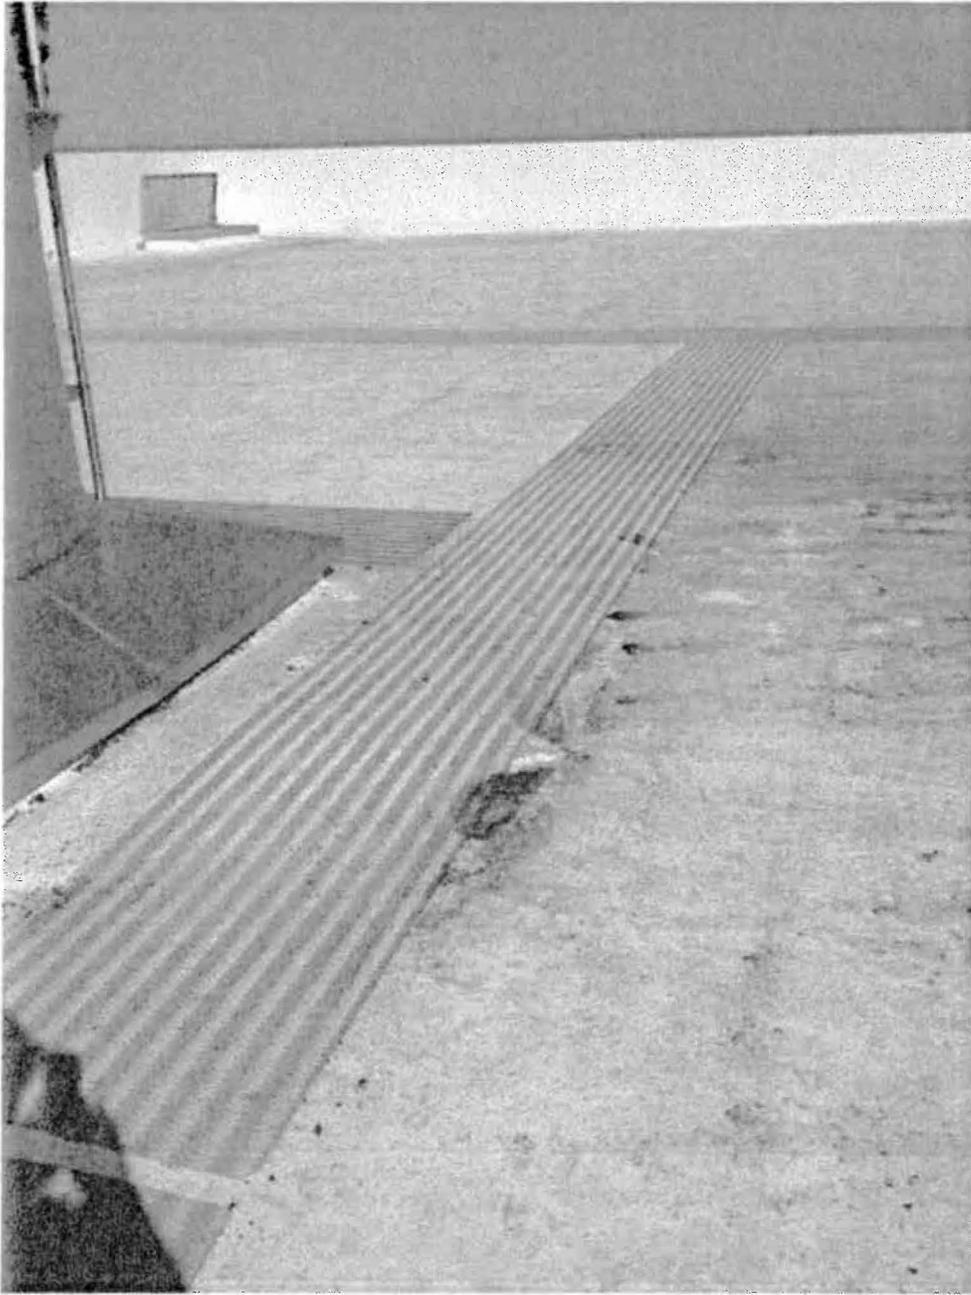
Image 3(Continental roof3) : Roof near dryer stack.
