**DEPARTMENT OF ENVIRONMENTAL QUALITY
AIR QUALITY DIVISION
ACTIVITY REPORT: Scheduled Inspection**

N298638659

FACILITY: Tecumseh Packaging Solutions, Inc		SRN / ID: N2986
LOCATION: 707 S EVANS STREET, TECUMSEH		DISTRICT: Jackson
CITY: TECUMSEH		COUNTY: LENAWEE
CONTACT:		ACTIVITY DATE: 02/16/2017
STAFF: Mike Kovalchick	COMPLIANCE STATUS: Compliance	SOURCE CLASS:
SUBJECT: Unannounced compliance inspection. No findings.		
RESOLVED COMPLAINTS:

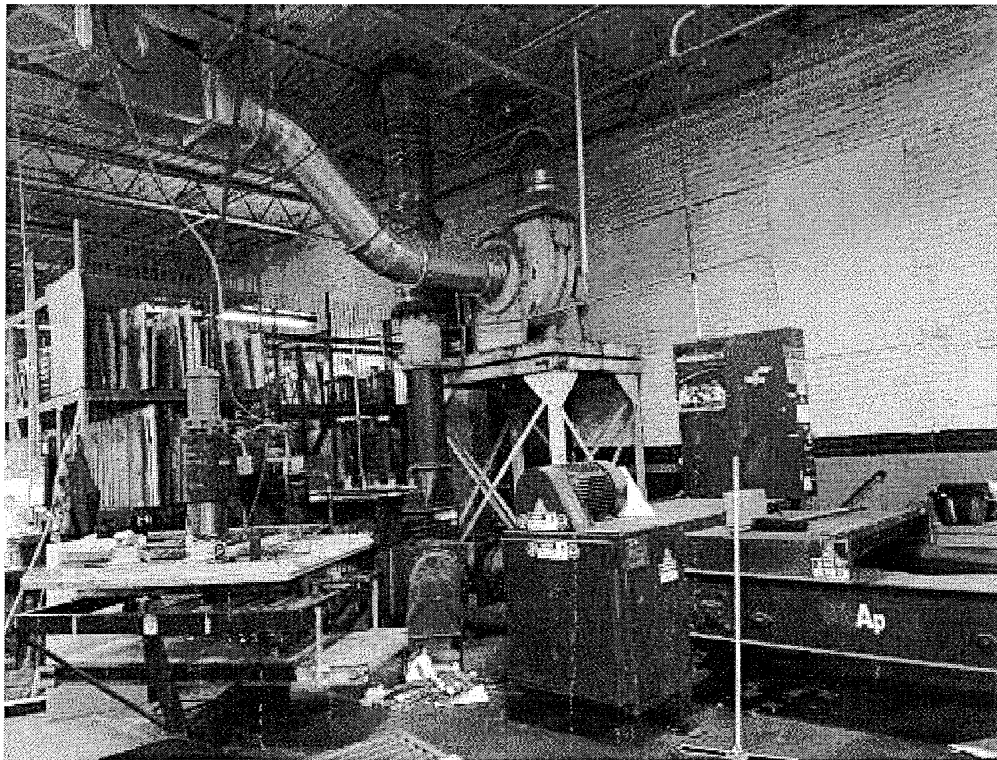
Next we walked by some of the process equipment. I observed the ventilation system around the various pieces of process equipment. Any pieces of cut cardboard were being quickly sucked up and sent to the cyclone. There appeared to be 4 different fans. 2 of the fans are on all of the time, 1 on occasionally and 1 that had no equipment hooked up to it. All were located in or adjacent to the production area. The fans that were running were of unknown size but appeared well sized to handle the ventilation requirements. (See attached photo.)

Image 2(2 fans) : 2 of the fans that discharge to the cyclone. The one on top runs all the time.

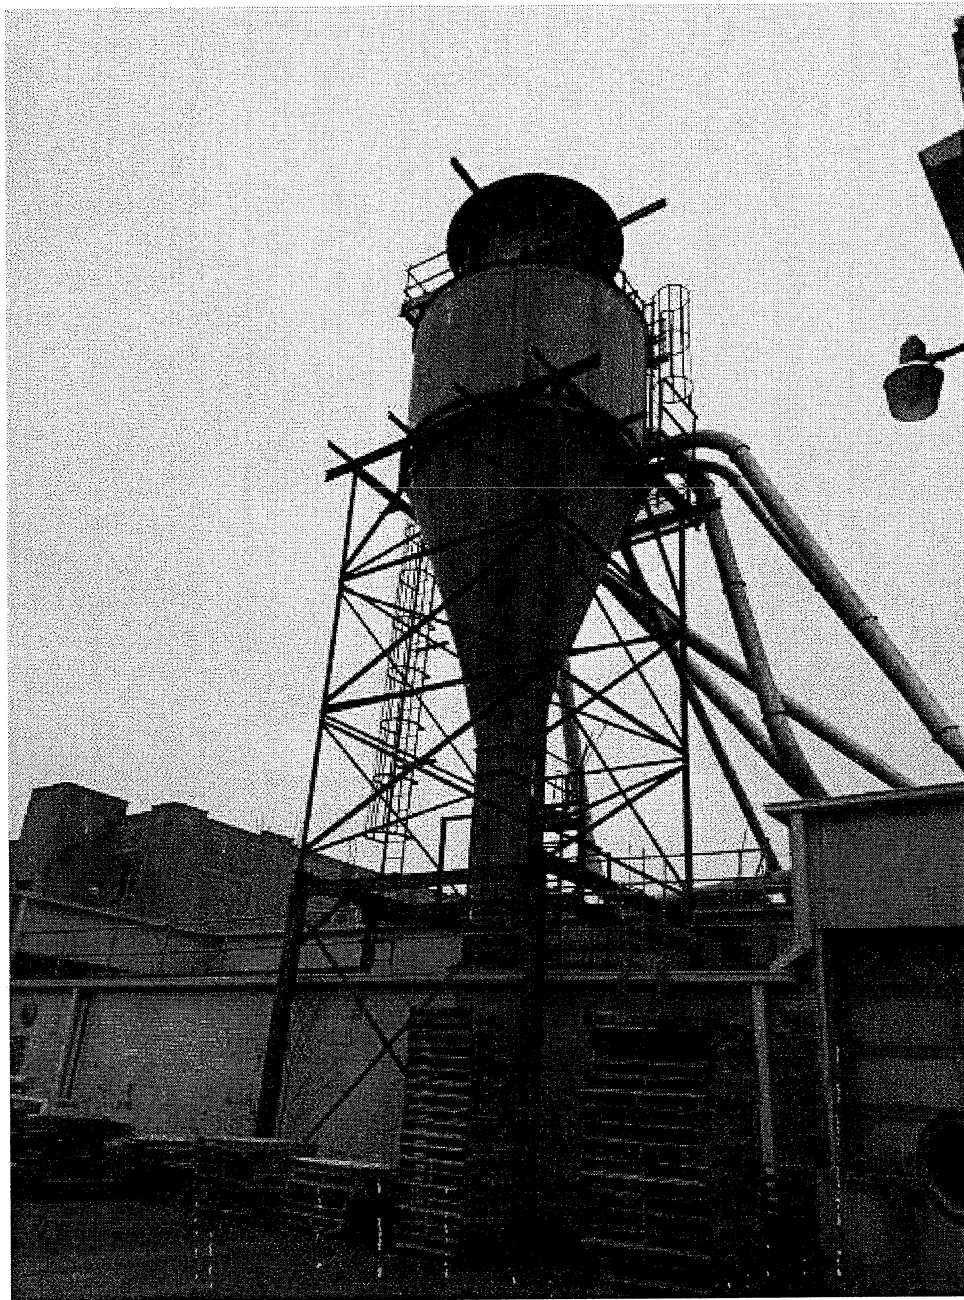
Image 3(Cyclone) : Cyclone

Next we went outside to observe the cyclone. (See attached photo.) It was operating. No fallout was noted outside near the cyclone. There were no visible emissions. Next we went back and side to a separate room containing the bailer. The bailer is located directly under the cyclone. (See attached photo.) There was a fair amount of dust on the wall of the room and in/around the bailer. However, for the most part, it appeared that the dust was being well contained to that room only and wasn't making it back outside. This concluded the tour.
