DEPARTMENT OF ENVIRONMENTAL QUALITY
AIR QUALITY DIVISION
ACTIVITY REPORT: Scheduled Inspection

N361825611

FACILITY: BOSK CORP		SRN / ID: N3618
LOCATION: 2020 N 19TH ST, ESCANABA		DISTRICT: Upper Peninsula
CITY: ESCANABA		COUNTY: DELTA
CONTACT: Joe Sliva , Operator		ACTIVITY DATE: 06/18/2014
STAFF: Joe Scanlan	COMPLIANCE STATUS: Compliance	SOURCE CLASS: MINOR
SUBJECT: Minor source inspection		
RESOLVED COMPLAINTS:

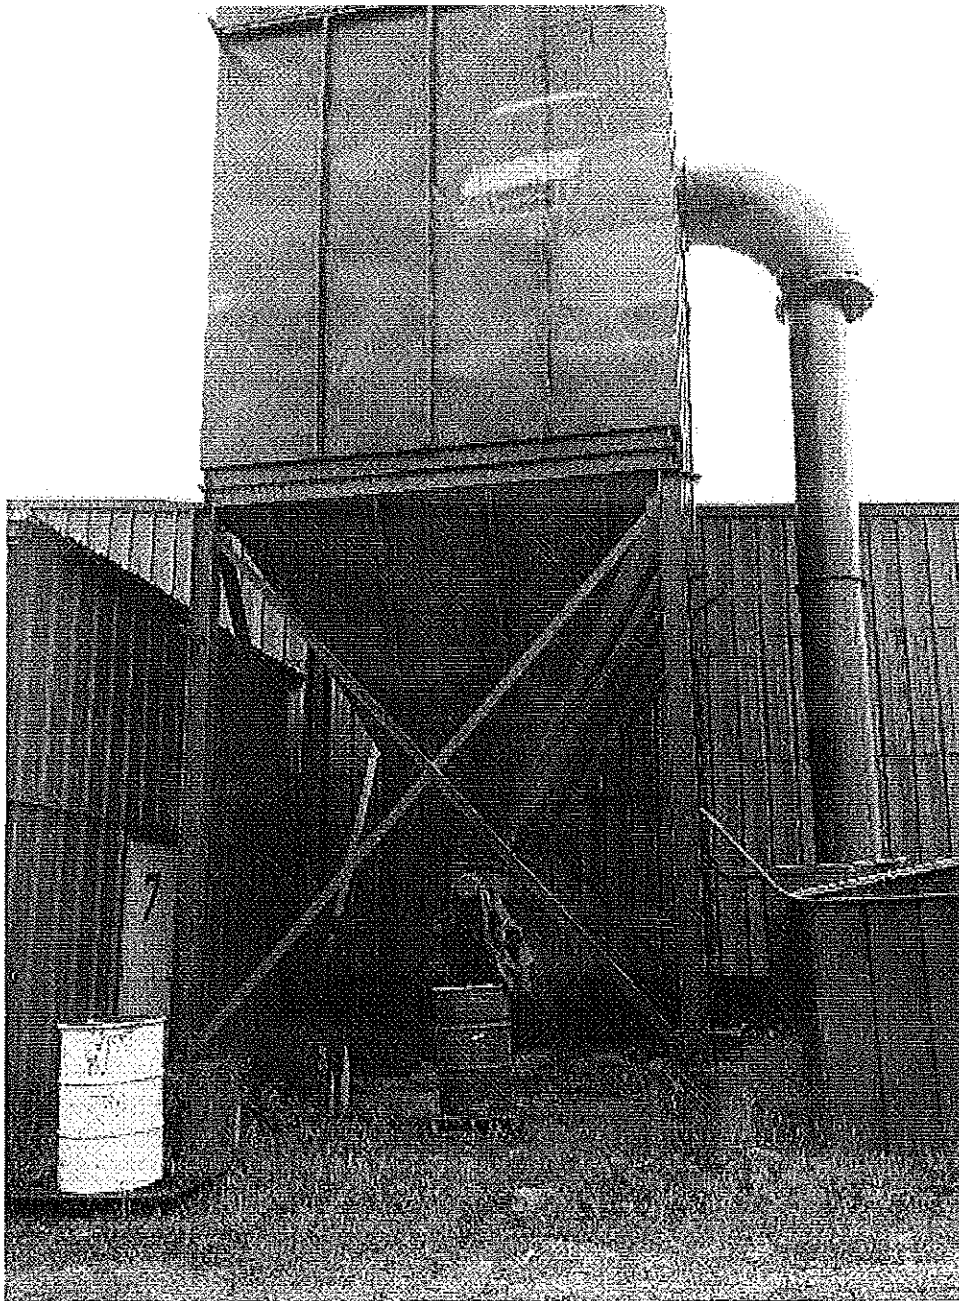
The shotblast booth uses metal shot which is continuously reclaimed as the lighter refuse material is separated from the shot and collected in generously-sized dust collector located outside the structure. The refuse dust is collected in a 55-gallon drum underneath the baghouse.

Image 1(Bosk 1) : Dust collection system

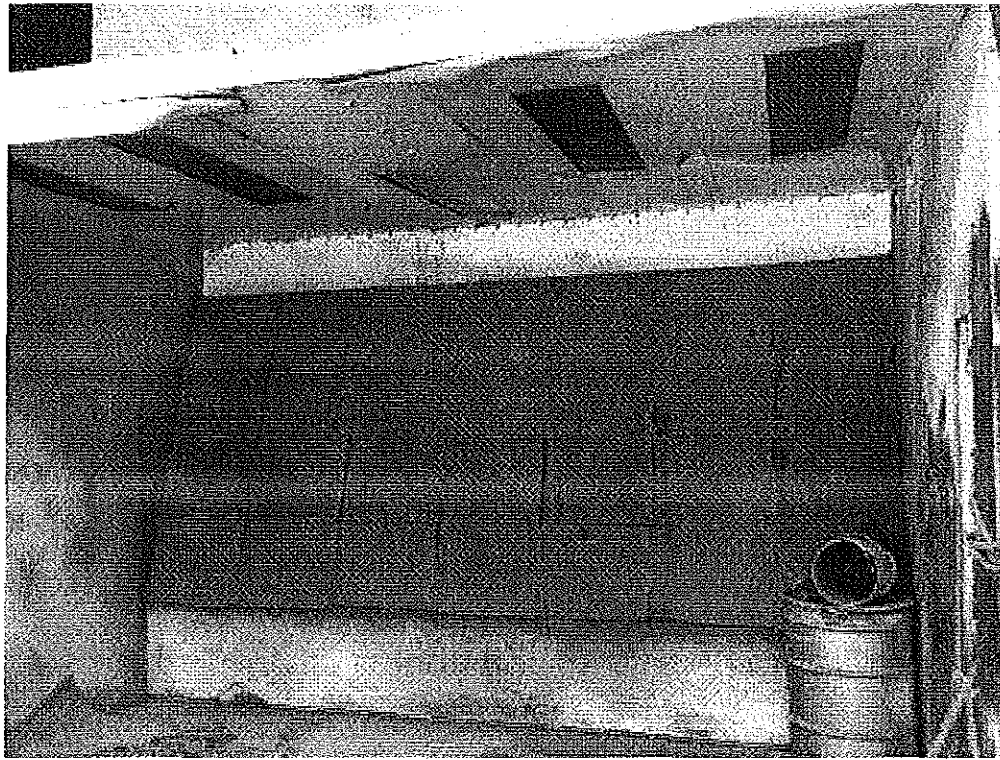
No activity was taking place in either the paint spray booth or the shotblast booth; however, Mr. Sliva had painted some metal pipe rack units the previous day and they were still curing nearby. All exhaust filters were in place at the time of inspection as required by Condition #18 of Permit to install #1039-92. It was obvious the filters in place were used during the painting of the metal pipe racks, as they were the same distinct yellow and Mr. Sliva stated the filters had been changed about 30 days prior in mid-May. Mr. Sliva stated that there was spare filter media on site and produced two boxes containing 47 new filters for the paint booth.

Image 2(Bosk 2) : Filter wall in the paint spray booth.

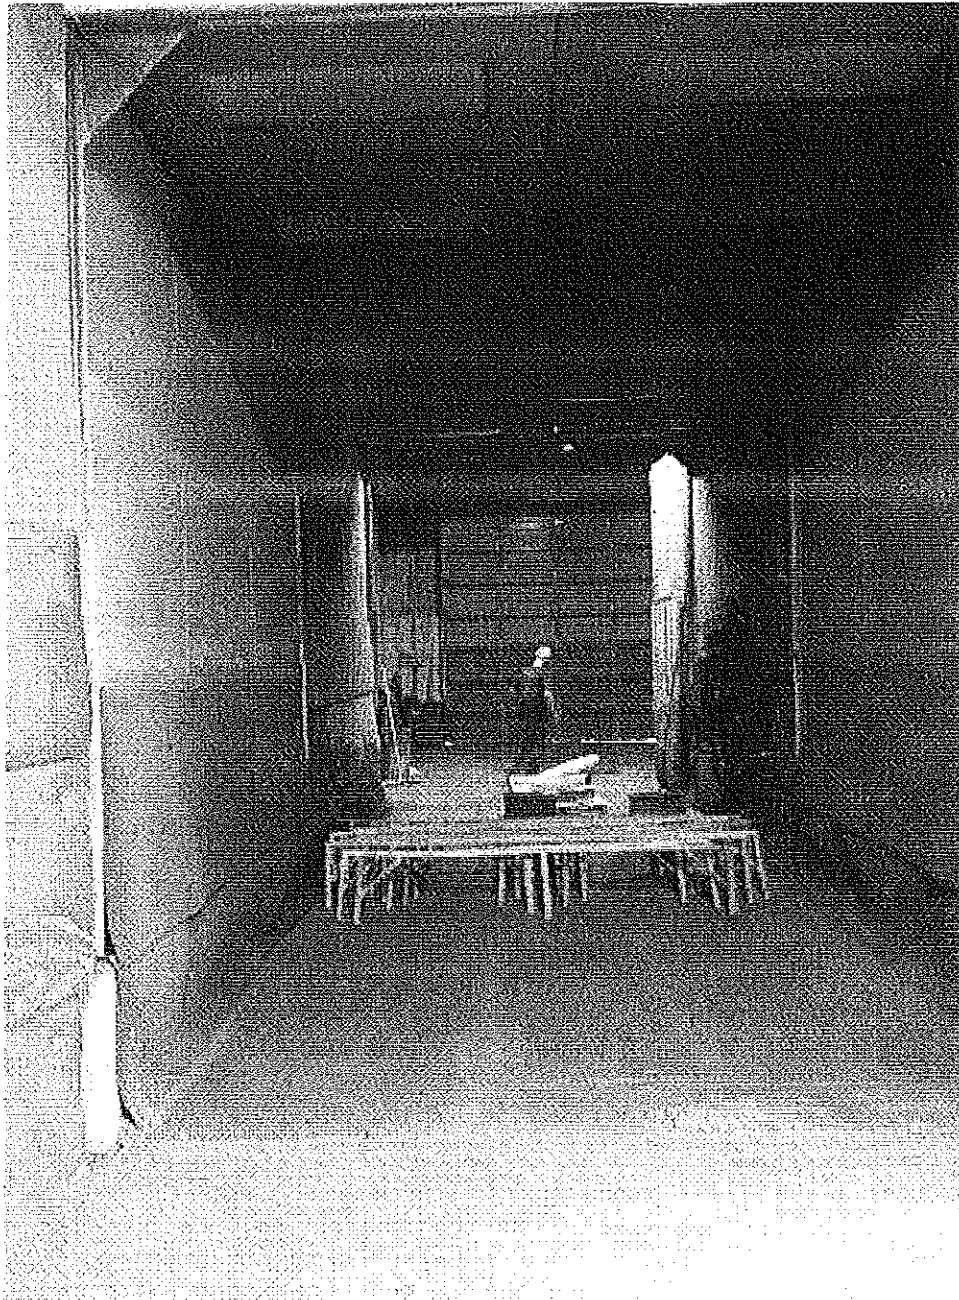
Image 3(Bosk 3) : Looking through the shotblast booth.

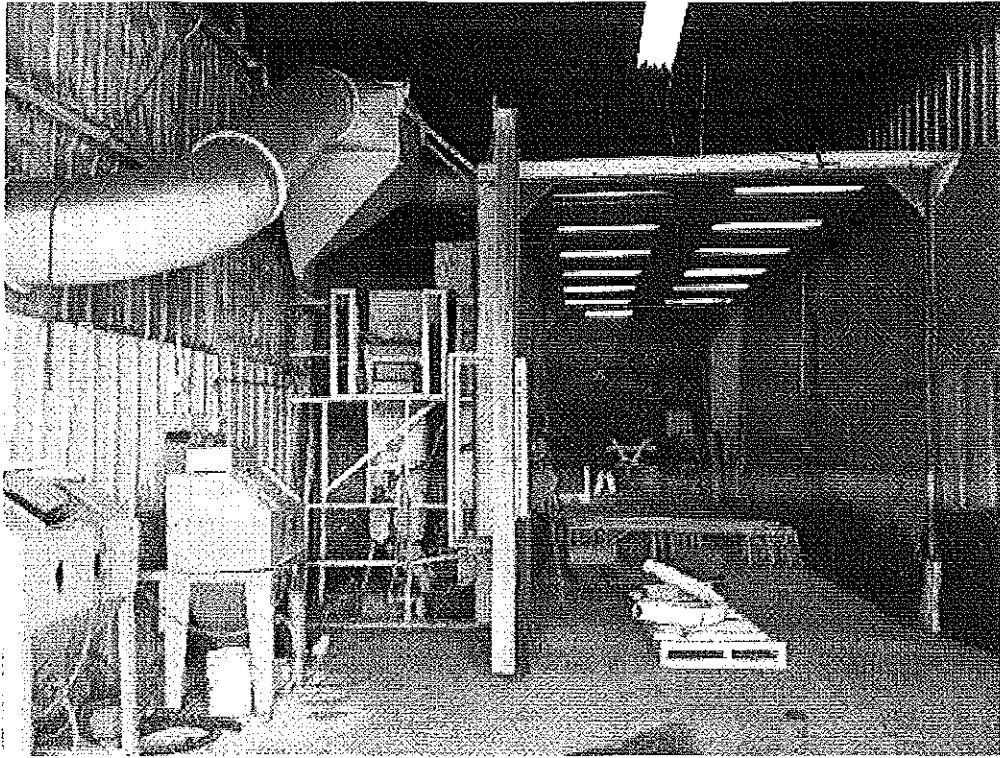
Image 4(Bosk 4): View of shotblast booth on right with portion of dust collection system leading to baghouse outside visible on left.

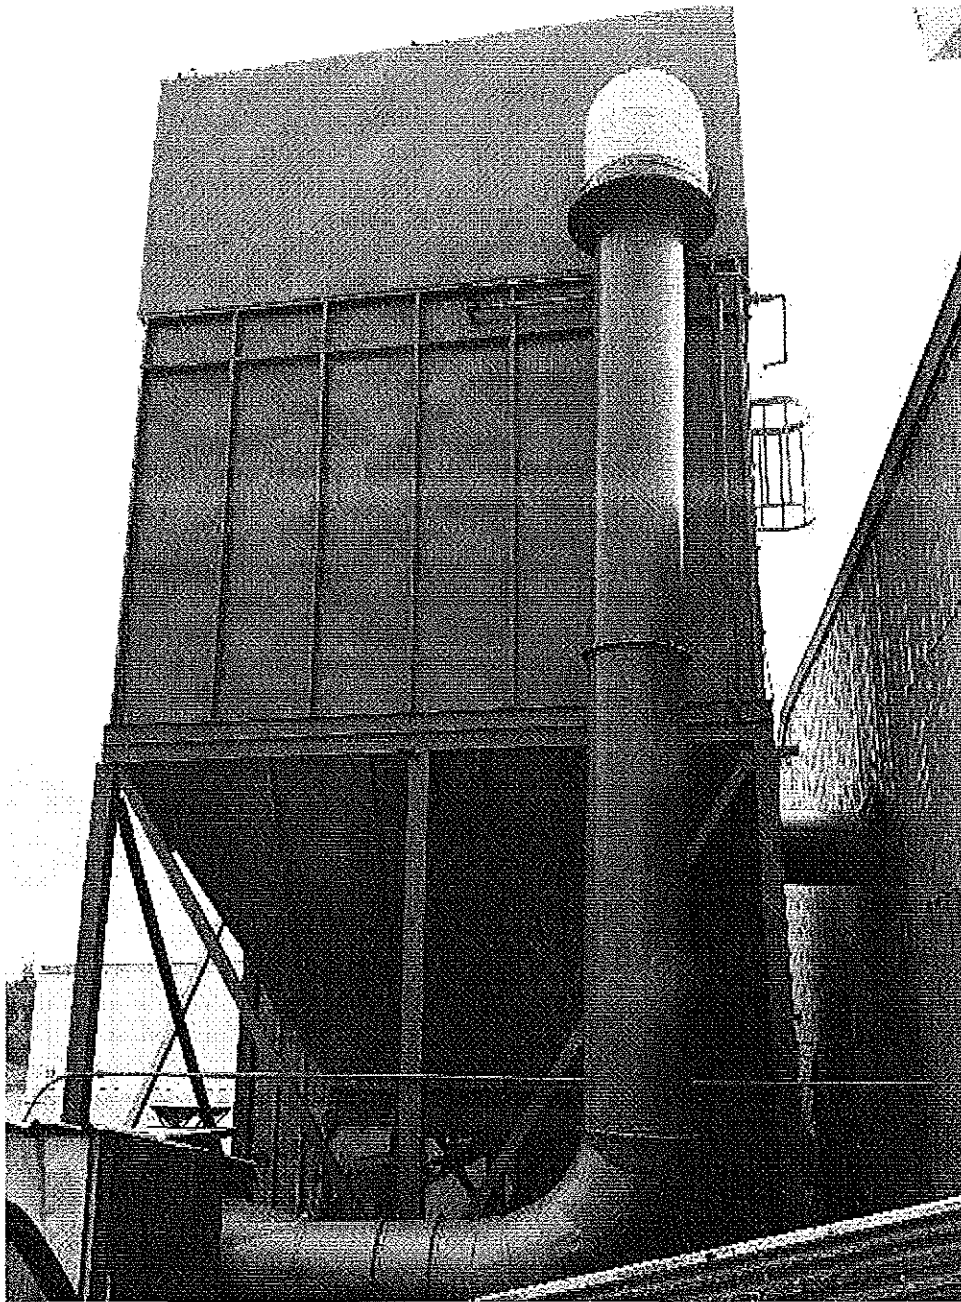
Image 5(Bosk 5) : View of dust collection system from side.

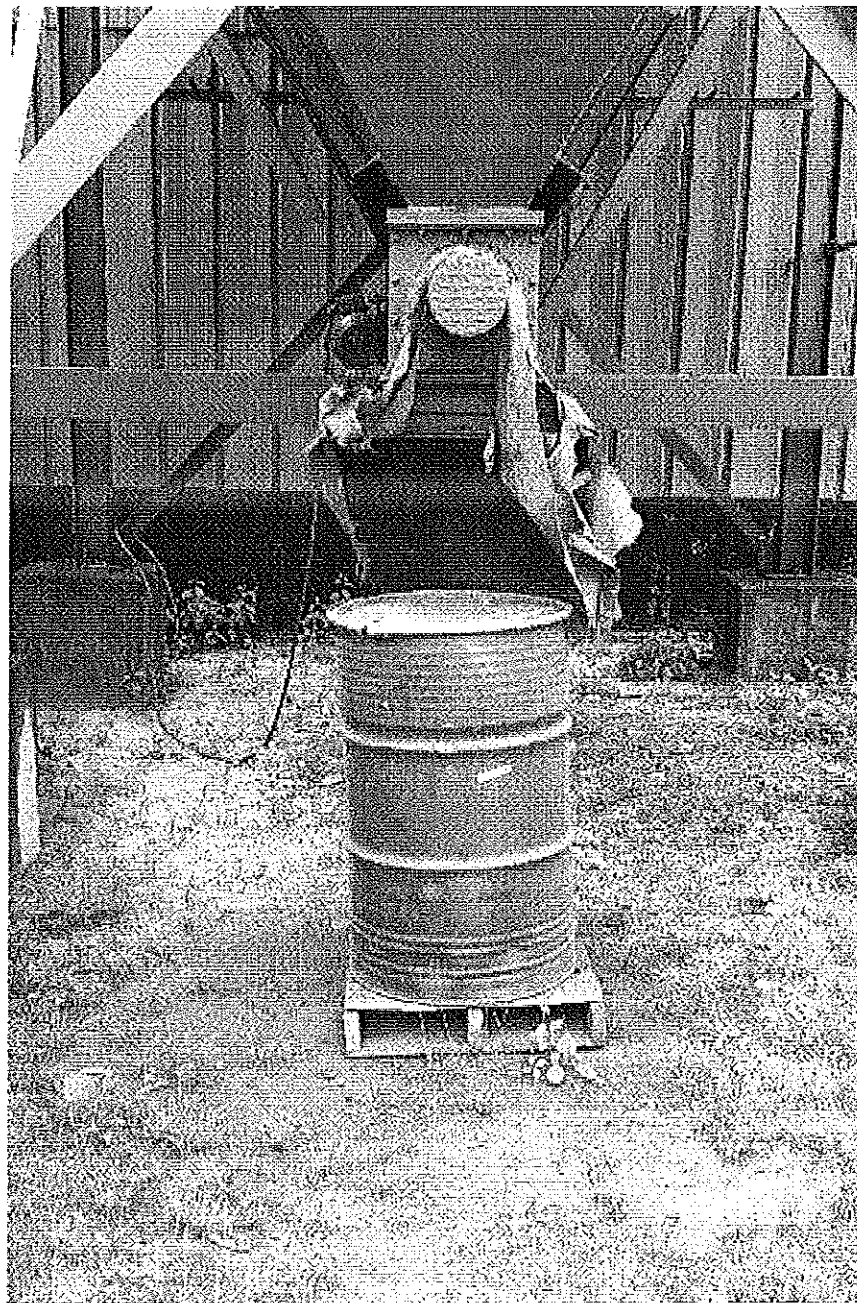
Image 6(Bosk 6) : Accumulation barrel at bottom of dust collection system for landfill disposal of refuse dust.

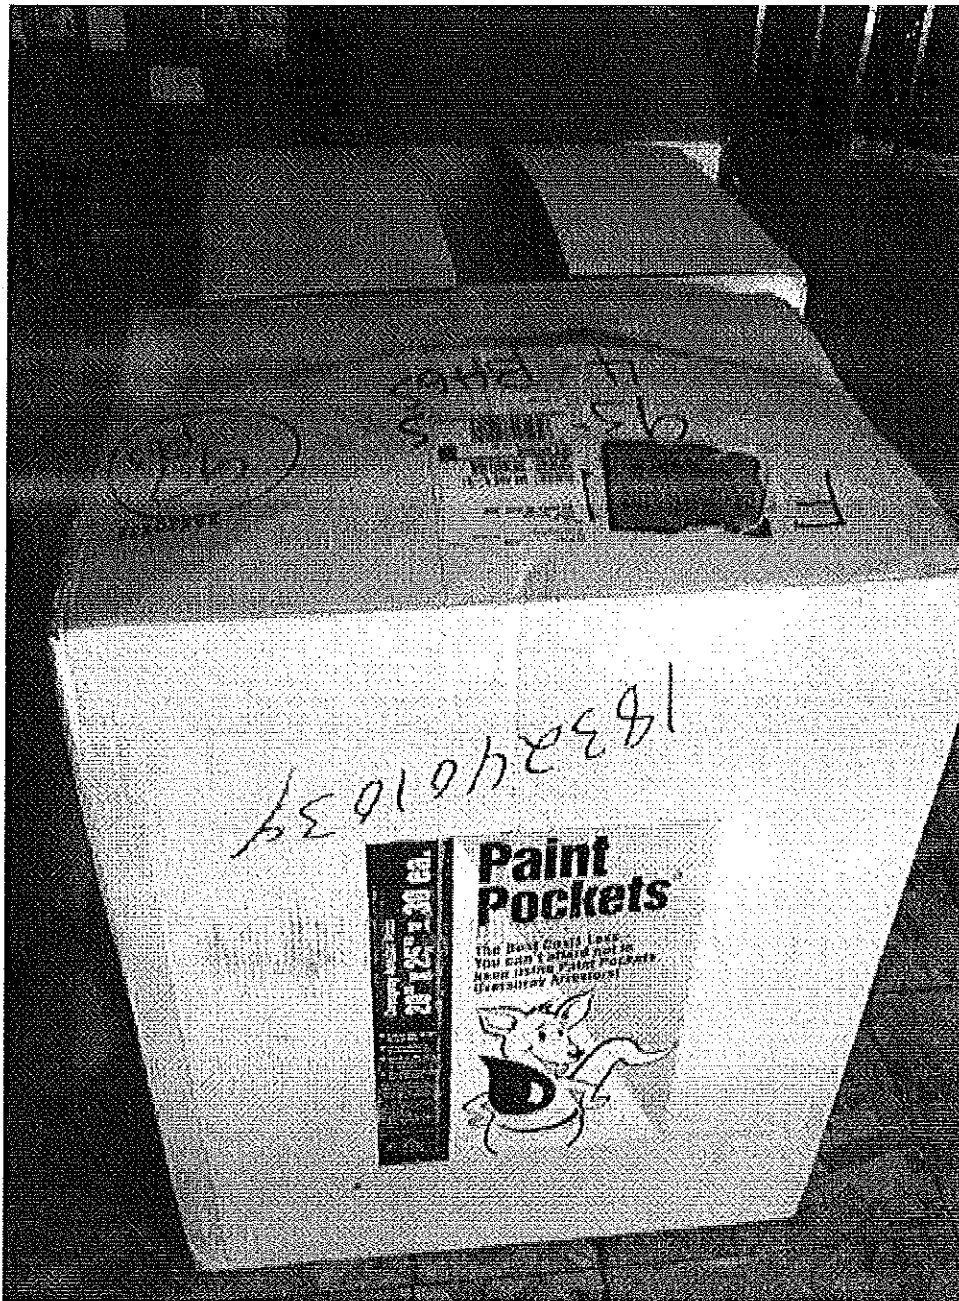
Image 7(Bosk 7) : Boxes containing spare filter media.
