DEPARTMENT OF ENVIRONMENTAL QUALITY
AIR QUALITY DIVISION
ACTIVITY REPORT: Self Initiated Inspection

FACILITY: U P FABRICATING CO INC		SRN / ID: N3763
LOCATION: 3954 W MAPLE RIDGE RD, ROCK		DISTRICT: Upper Peninsula
CITY: ROCK		COUNTY: DELTA
CONTACT: Matt Wood , Shop Foreman		ACTIVITY DATE: 03/23/2015
STAFF: Joe Scanlan	COMPLIANCE STATUS: Compliance	SOURCE CLASS: MINOR
SUBJECT: Self initiated inspection to ensure compliance with state Air Pollution Control Rules.		
RESOLVED COMPLAINTS:

INSPECTION DATE: 3/23/2015**DEQ-ASBESTOS NESHAP STAFF:** Joseph Scanlan**FACILITY:** U.P. Fabricating Company, Inc. (Rock location)**FACILITY OWNER:** U.P. Fabricating Company, Inc.**LOCATION:** 3954 West Maple Ridge, Rock, Delta County

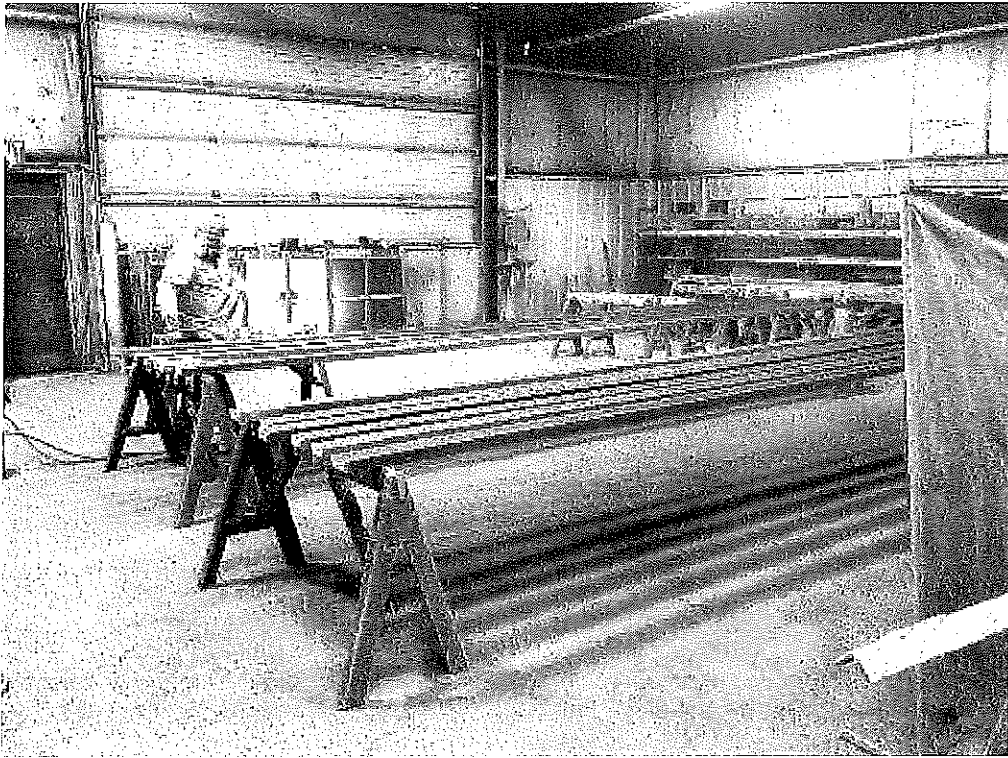
Image 1(UPF1) : Paint booth/area in operation

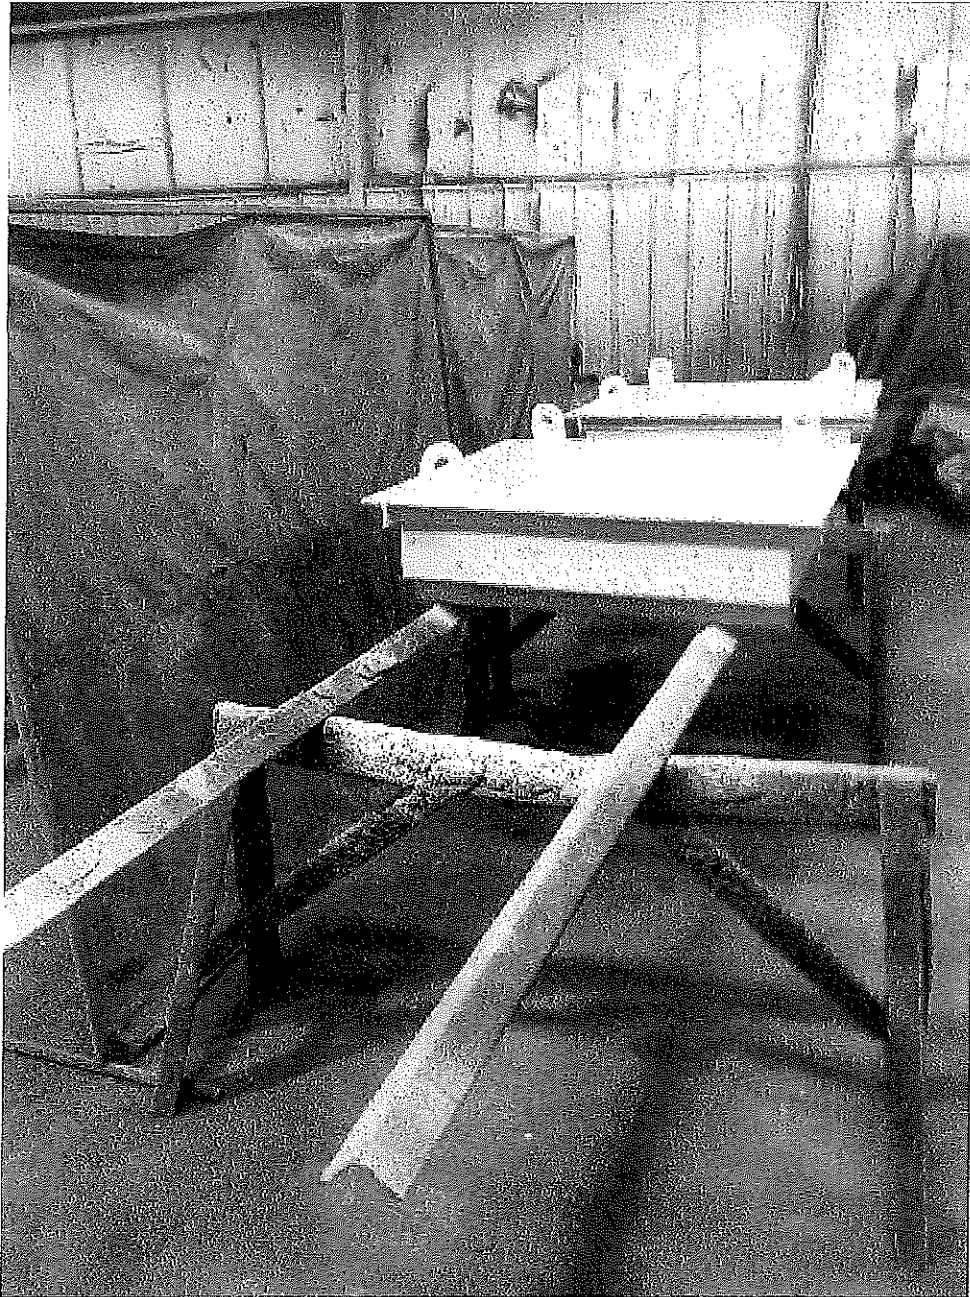
Image 2(UPF2) : Painted parts drying in paint spray area

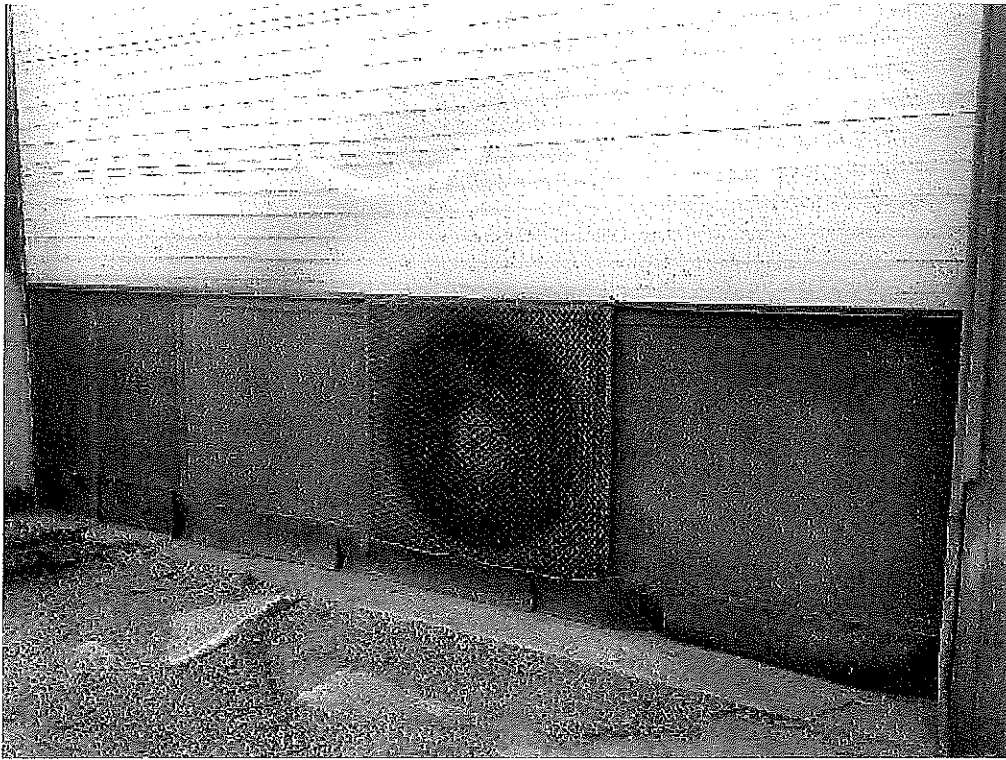
Painting of metal girders was taking place during my inspection in the large painting bay. The exhaust/ventilation fan and filter are a fabricated system in held in place by the large shop roll-up door (see photo). No visible emissions were observed outside of the shop.

Image 3(UPF3) : Exhaust fan w/filter from outside.

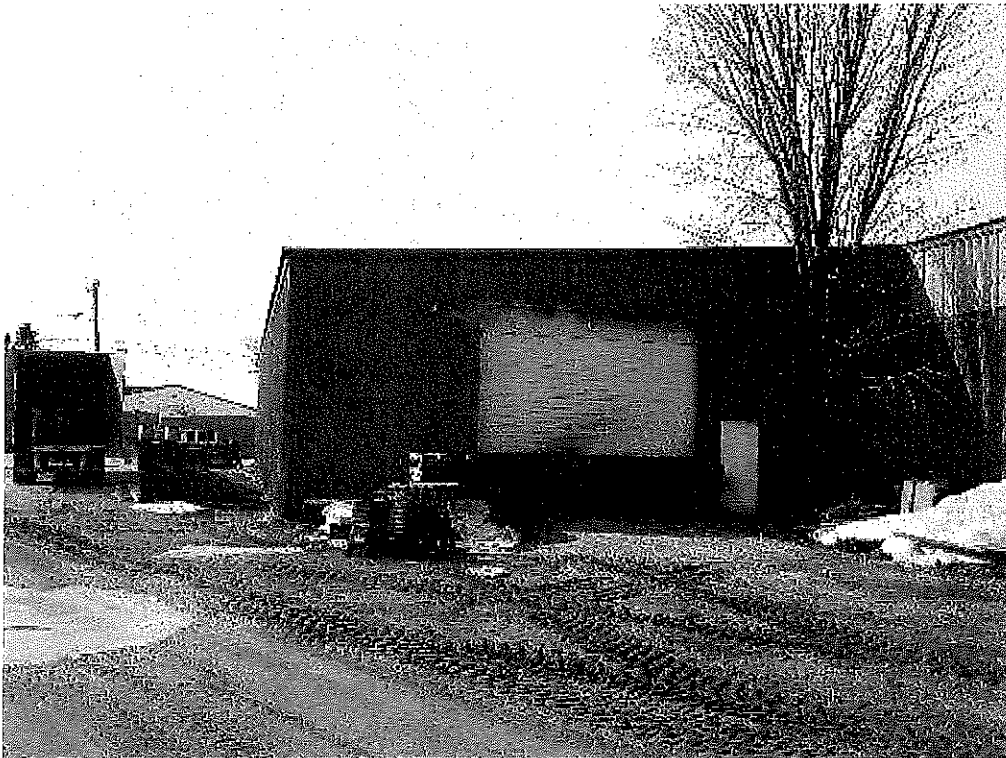
Image 4(UPF4) : Rear of paint spray area. Exhaust fan and filter are located underneath partially opened garage door. No visible emissions were observed during operation.
