**DEPARTMENT OF ENVIRONMENTAL QUALITY  
AIR QUALITY DIVISION  
ACTIVITY REPORT: On-site Inspection**

<b>FACILITY:</b> MASTER FINISH COMPANY		<b>SRN / ID:</b> N5898
<b>LOCATION:</b> 2020 NELSON SE, GRAND RAPIDS		<b>DISTRICT:</b> Grand Rapids
<b>CITY:</b> GRAND RAPIDS		<b>COUNTY:</b> KENT
<b>CONTACT:</b> Aaron Mulder , CEO		<b>ACTIVITY DATE:</b> 06/28/2022
<b>STAFF:</b> April Lazzaro	<b>COMPLIANCE STATUS:</b> Non Compliance	<b>SOURCE CLASS:</b> MINOR
<b>SUBJECT:</b> Unannounced, scheduled inspection.		
<b>RESOLVED COMPLAINTS:</b>

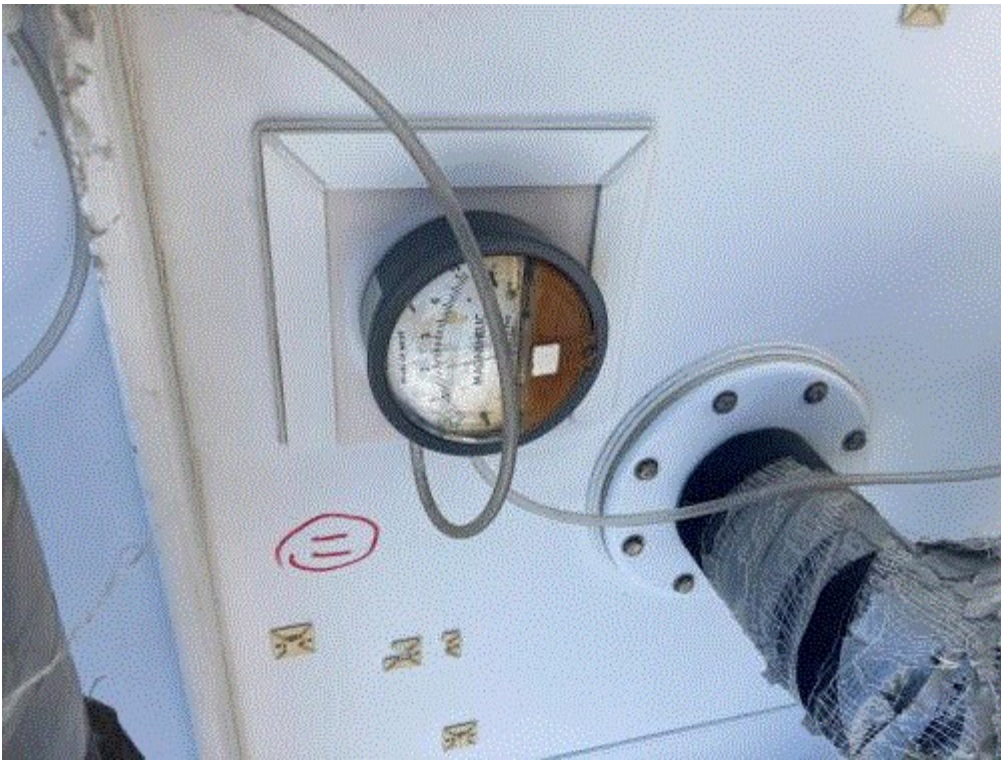
The Hoist Line (PTI No. 75-94B) scrubber was visually inspected for leaks. A small liquid leak was occurring at a seal on the lower left face of the unit, which was also present during the 2018 inspection. This was miniscule and no drip of liquid was occurring. The inlet pressure drop gauge read 0.9" H<sub>2</sub>O and the outlet pressure drop gauge read 4.4" H<sub>2</sub>O. Both gauges contained moisture, which indicates that they are failing and should be replaced. During the 2018 inspection, the inlet pressure drop gauge read 0.1" H<sub>2</sub>O and the outlet pressure drop gauge read 3.6" H<sub>2</sub>O. The acceptable range as listed in the O&M Plan is listed as 0.01-3.8" H<sub>2</sub>O +/-1" H<sub>2</sub>O. During a review of the scrubber inspection log, I learned that while the company indicates they have been completing the monthly maintenance, the information associated with the inspections is not being tracked as required by the O&M Plan. This is a violation of PTI No. 74-94B, Special Condition VI.4 for failure to properly implement the O&M Plan for the

Hoist Line. A Violation Notice will be issued. Past pressure drop readings were also requested and reviewed. Fluctuations of the pressure drop over time is noted based on the data. The allowable system pressure drop range identified on the inspection log is 0.4-3.5" H<sub>2</sub>O +/-1". The system pressure drop is a combination of the inlet and outlet pressure drop gauge values. Those are added together to generate an overall pressure drop reading as directed by the scrubber manufacturer. Since the overall pressure drop of the system on multiple days is greater than 4.5" H<sub>2</sub>O, (see attached data) this is a violation of Rule 910 for failure to properly operate the Hoist Line scrubber. A Violation Notice will be issued and will include a request for a full complete inspection of this scrubber, along with submittal of the findings.

**Image 1(Hoist Line)** : Hoist Line pressure drop gauge with water in it. Image should be viewed rotated one turn clockwise.

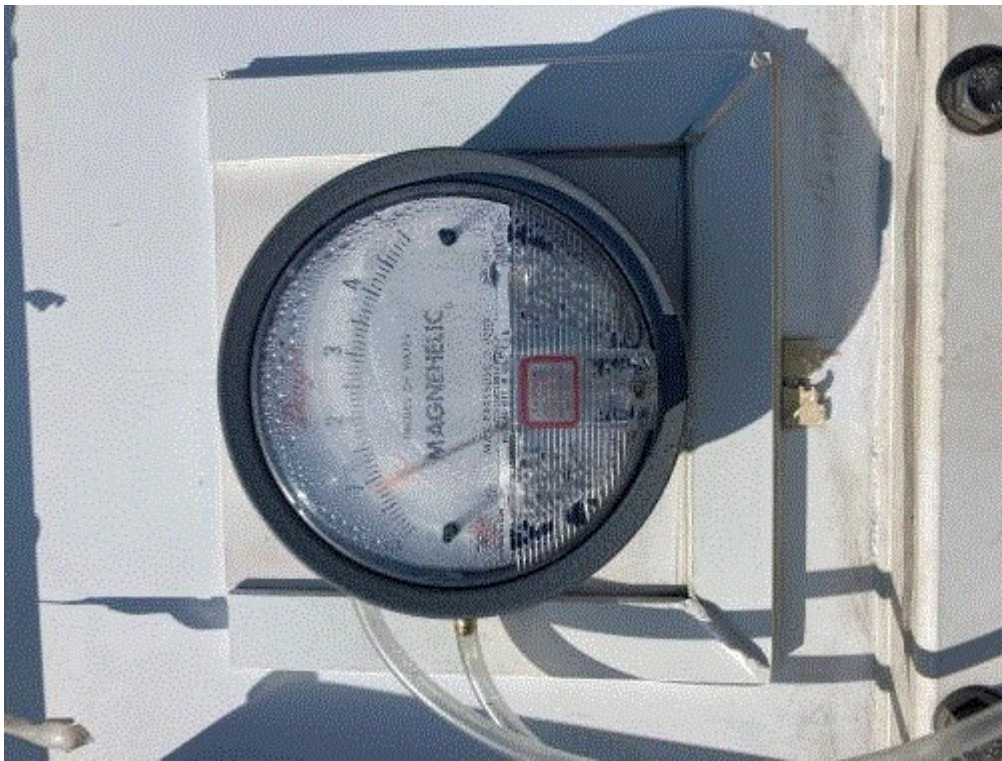
The Cyclmaster Line (PTI No. 74-94A) scrubber was visually inspected for leaks, and none were observed. This line has not operated in several months and was not operating at the time of the inspection. The pressure drop gauge had water sitting in it and was not operational. Since the line was not and has not been operating this is not considered a violation. However, the gauge must be replaced prior to operating the line. During the 2018 inspection, the inlet pressure drop gauge read 0.8" H<sub>2</sub>O and the outlet pressure drop gauge read 2.8" H<sub>2</sub>O. At the time of the 2018 inspection, the acceptable range as listed in the O&M Plan was listed as 0.04-3.0" H<sub>2</sub>O. The scrubber pressure drop in 2018 was within the parameters of the O&M Plan. During a review of the scrubber inspection log, I learned that while the company indicates they have been completing the monthly maintenance, the information associated with the inspections is not being tracked as required by the O&M Plan. As such, this is a violation of PTI No. 75-94B, Special Condition VI.2 for failure to properly implement the O&M Plan for the Cyclmaster Line scrubber. A Violation Notice will be issued. Past pressure drop readings were also requested and reviewed. Since the Cyclmaster Line has not been operated very often, limited information is available.

**Image 2(Cyclomaster Line)** : Cyclomaster Line inlet pressure drop gauge with moisture. Image should be viewed rotated one turn clockwise.

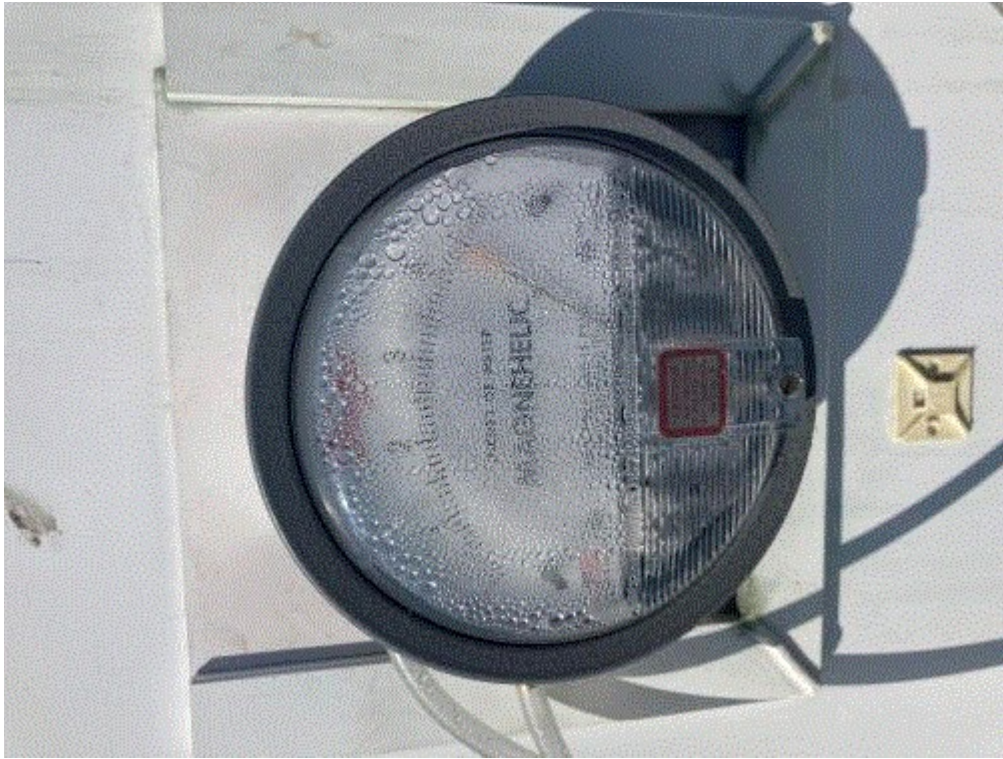
**Image 3(Cyclmaster Line) :** Cyclmaster Line outlet pressure drop gauge with moisture. Image should be viewed rotated one turn clockwise.

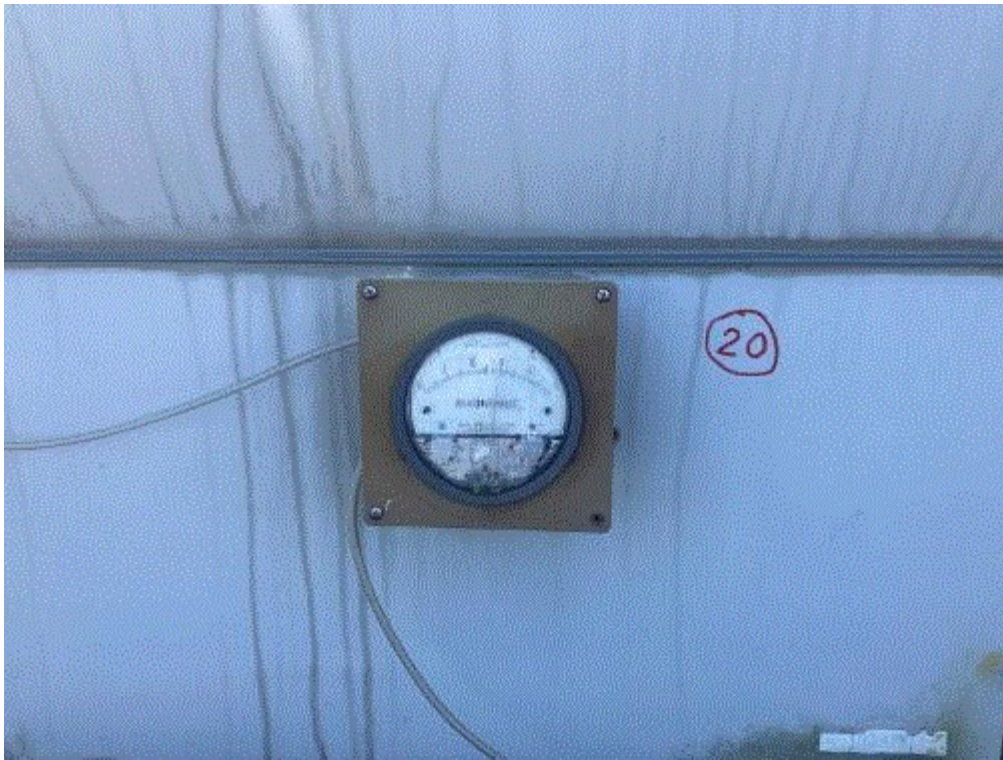
The Nitric Line (PTI No. 76-94) scrubber was visually inspected for leaks, and none were observed. During the 2018 inspection I was told that the stack and fan were recently replaced due to failure of the fan. Master Finish stated that they were replaced with identical equipment. Records of daily pressure drop readings for the Nitric Line scrubber were acceptable.

**Image 6(Nitric Line)** : Nitric Line pressure drop gauge.
