## DEPARTMENT OF ENVIRONMENTAL QUALITY AIR QUALITY DIVISION ACTIVITY REPORT: On-site Inspection

N782564306		
FACILITY: OMIMEX ENERGY - VICTORY 32 FACILITY		SRN / ID: N7825
LOCATION: 3370 W. Fisher Road, LUDINGTON		DISTRICT: Cadillac
CITY: LUDINGTON		COUNTY: MASON
CONTACT:		ACTIVITY DATE: 08/16/2022
STAFF: Caryn Owens	<b>COMPLIANCE STATUS:</b> Compliance	SOURCE CLASS: SM OPT OUT
SUBJECT: On-site Inspection		
RESOLVED COMPLAINTS:

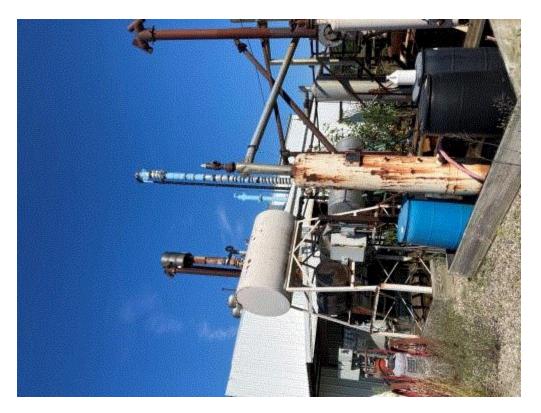
Image 1(Northern portion) : Amine & Glycol Dehydration Units

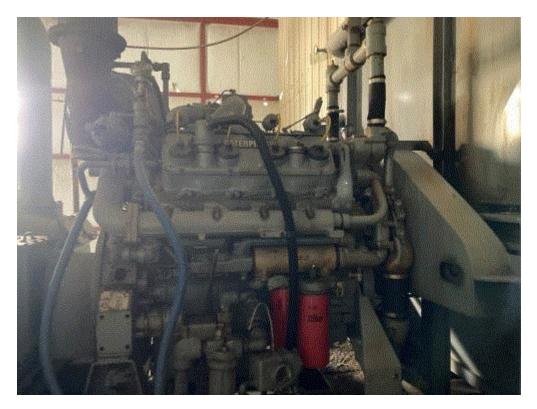
Image 2(Engine) : Caterpillar Engine at site

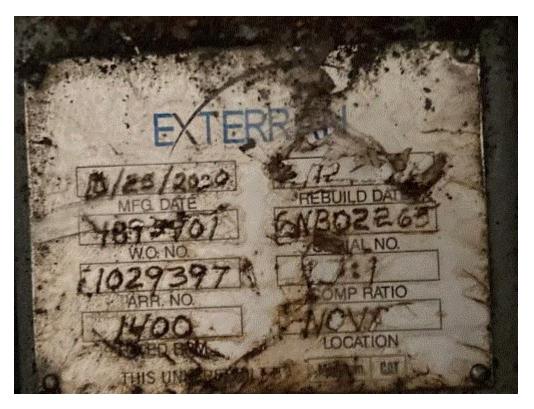
Image 3(Nameplate) : Engine nameplate

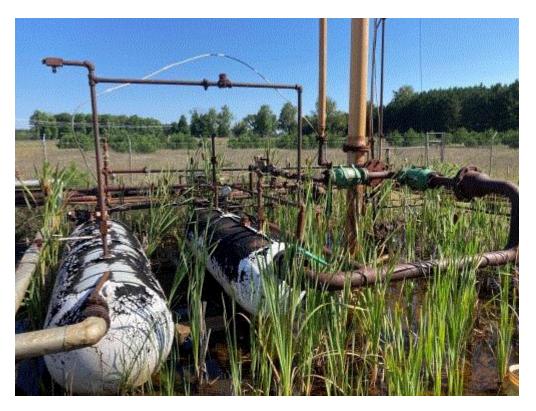
Image 4(Vegetation) : Overgrown Vegetation in flare secondary containment

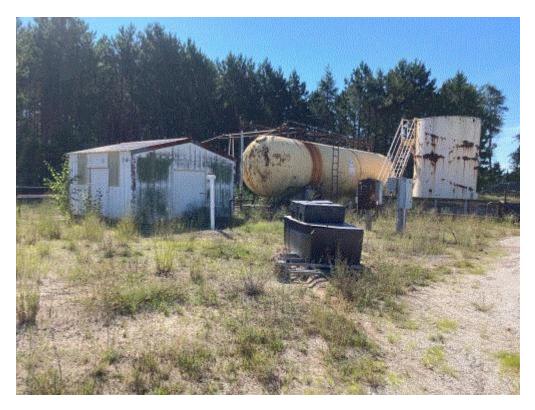
Image 5(Tanks & VRU) : Tank Battery and VRU building
