DEPARTMENT OF ENVIRONMENTAL QUALITY
AIR QUALITY DIVISION
ACTIVITY REPORT: On-site Inspection

FACILITY: PREMIER FINISHES LLC		SRN / ID: N7896
LOCATION: 28060 GROESBECK HWY, ROSEVILLE		DISTRICT: Warren
CITY: ROSEVILLE		COUNTY: MACOMB
CONTACT: Brian Borowski , Partner		ACTIVITY DATE: 09/08/2022
STAFF: Robert Elmouchi	COMPLIANCE STATUS: Non Compliance	SOURCE CLASS: MINOR
SUBJECT: Scheduled inspection.		
RESOLVED COMPLAINTS:

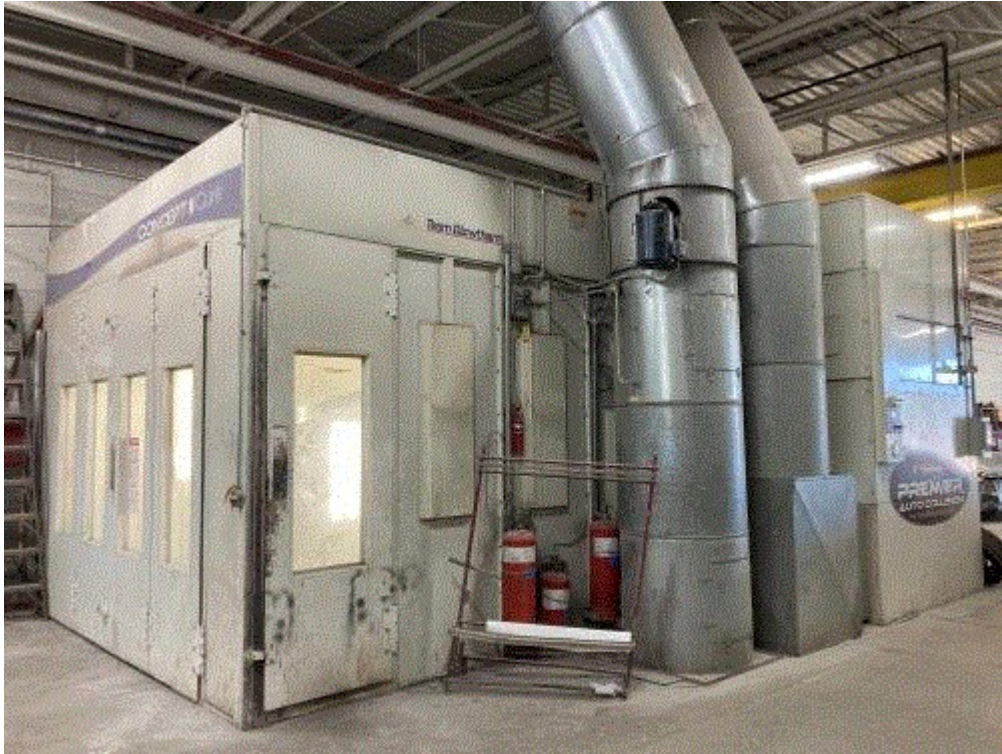
Image 1(IMG 0414) : EUBOOTH1, single-wide spray booth.

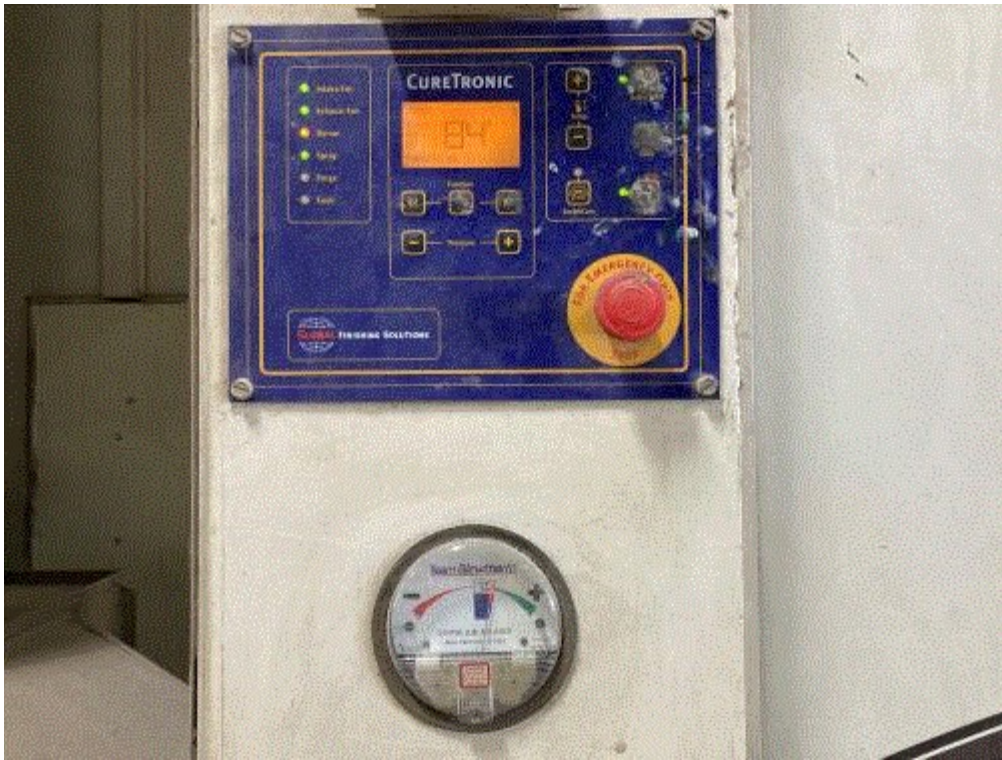
Image 2(IMG 0416) : EUBOOTH1 control panel.

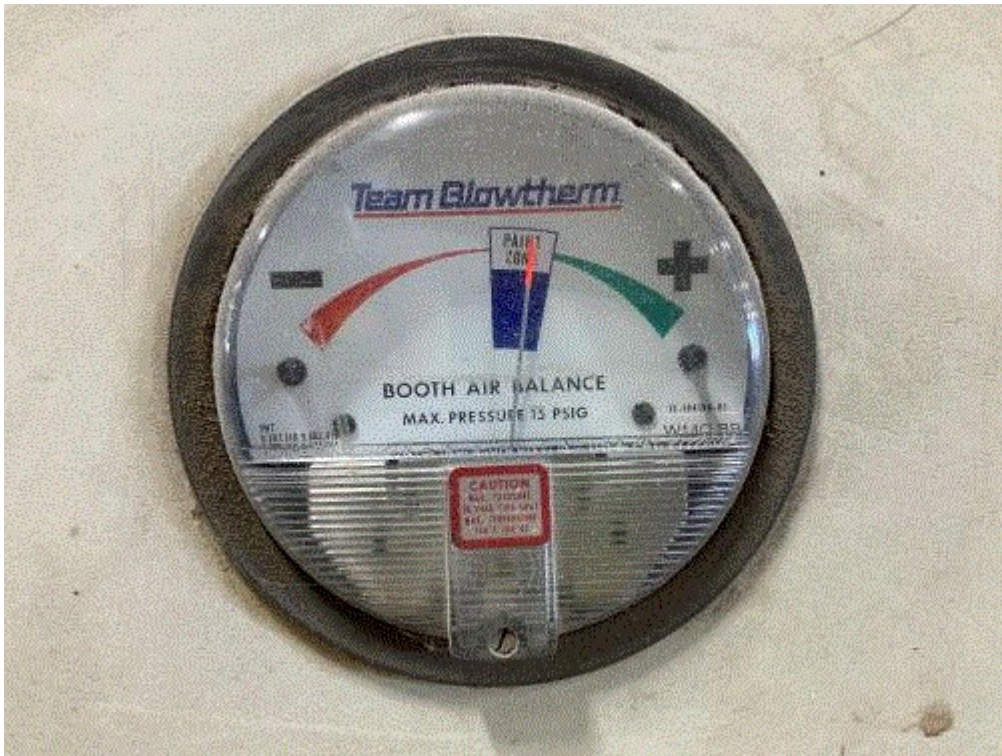
Image 3(IMG 0417) : EUBOOTH1 booth air balance gauge. The orange-tipped indicator needle moves to the right side of the "Paint Zone" when the exhaust is turned on. This appears to indicate the pressure differential is within the manufacturer's specifications.

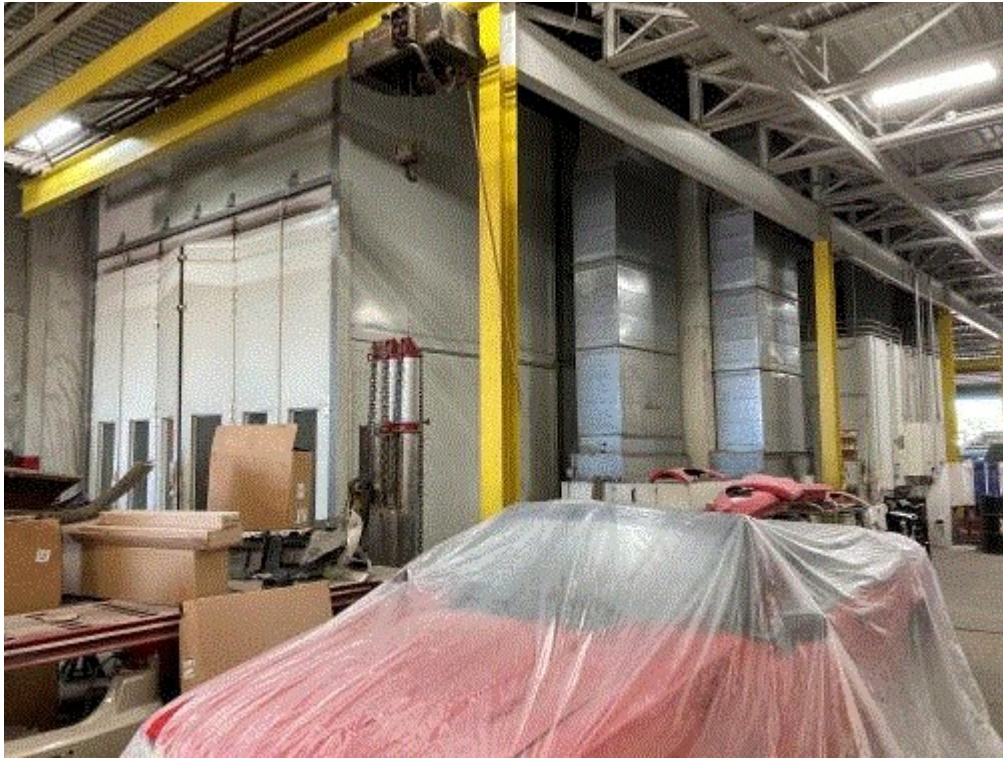
Image 4(IMG 0418) : EUBOOTH2 double-wide spray booth with a car in the foreground. This Emission Unit (EU) consists of two booths that are attached in the center. The large beige doors on the left are on the west side of the spray booth.

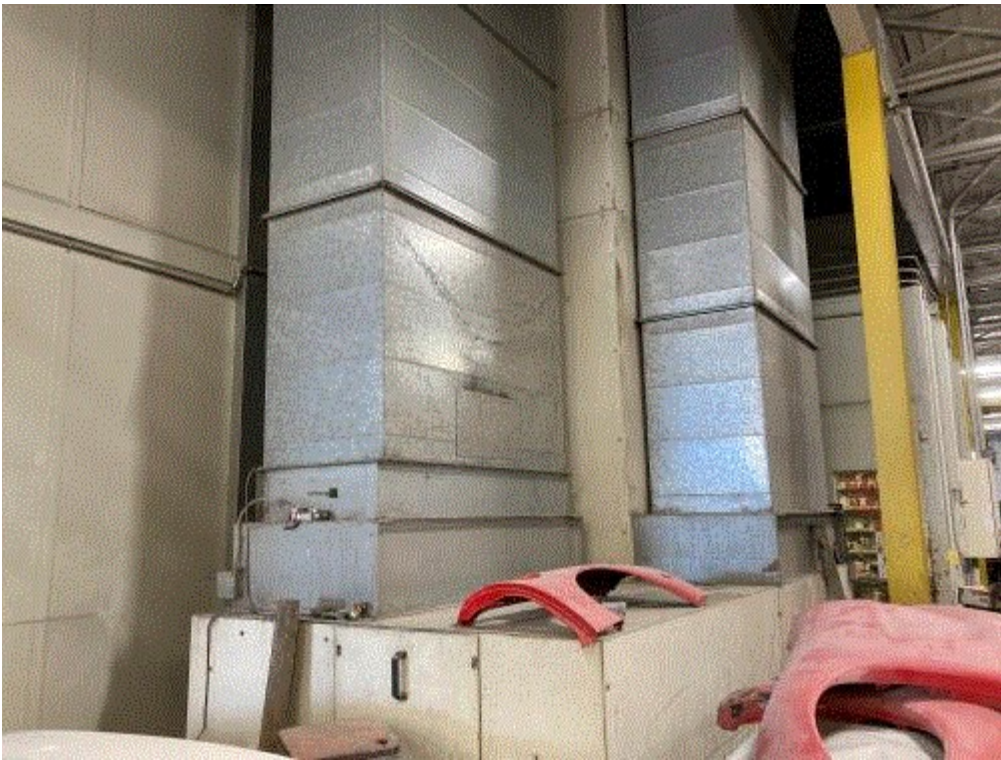
On September 8, 2022, I observed that the EUBOOTH2 west spray booth air balance actuator was removed from the damper control rod and the booth air balance pressure drop gauges were inoperative. Furthermore, the permittee operated EUBOOTH1 while the exhaust filters were not properly installed, which allowed particulate material air contaminants to bypass the control device. This constitutes a violation of Rule 910 of the administrative rules promulgated under Act 451, which requires that an air-cleaning device shall be installed, maintained, and operated in a satisfactory manner and in accordance with the administrative rules and existing law. This noncompliance shall be cited in a violation notice.

Image 5(IMG_0420) : EUBOOTH2 west booth ductwork. The west booth air balance actuator is disconnected from the damper. IMG_0421 provides a close-up view.

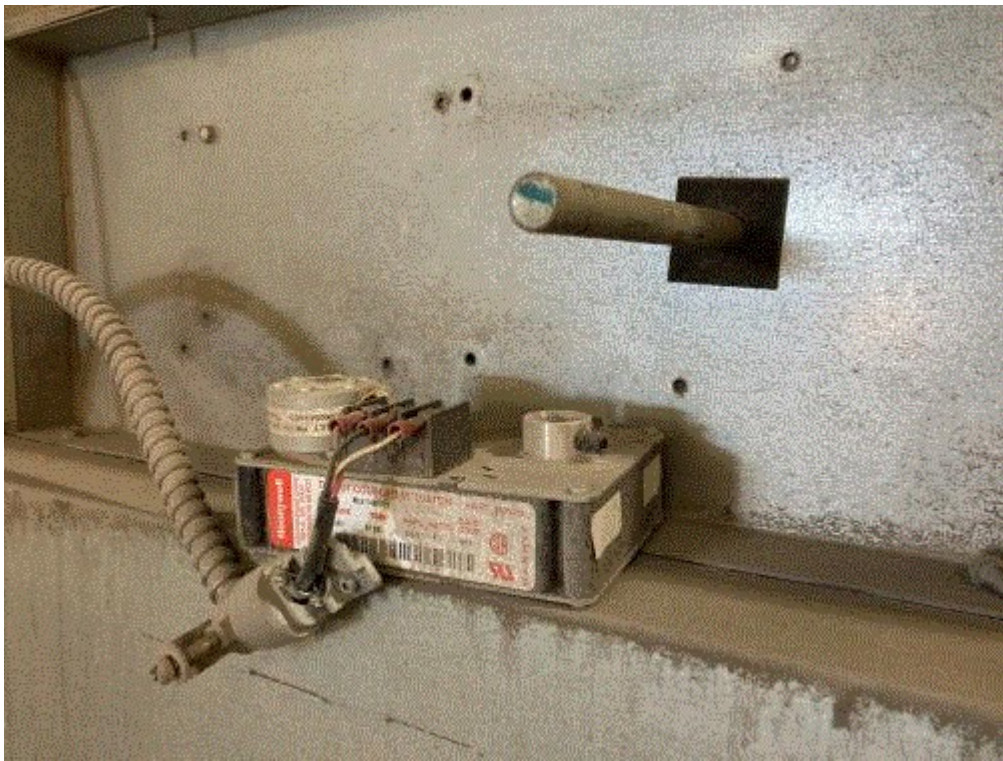
Image 6(IMG_0421) : EUBOOTH2. Close-up view of the west booth air balance actuator, which was removed from the damper control rod.

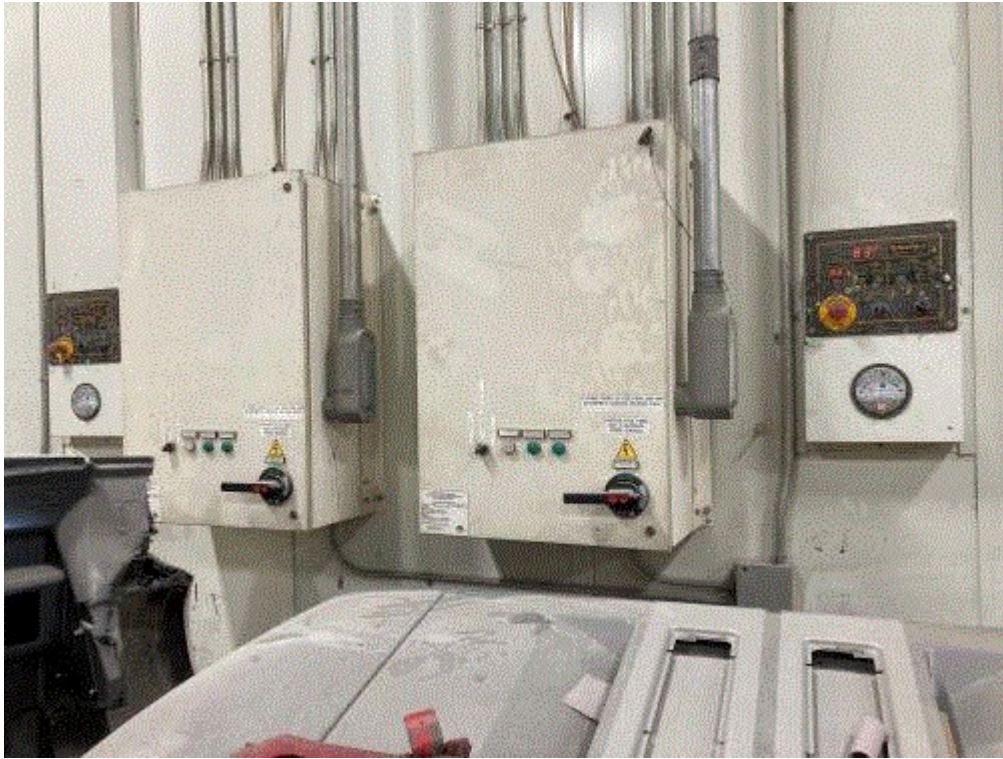
Image 7(IMG 0431) : EUBOOTH2 west (left) and east (right) control panels, each with a circular booth air balance gauge.

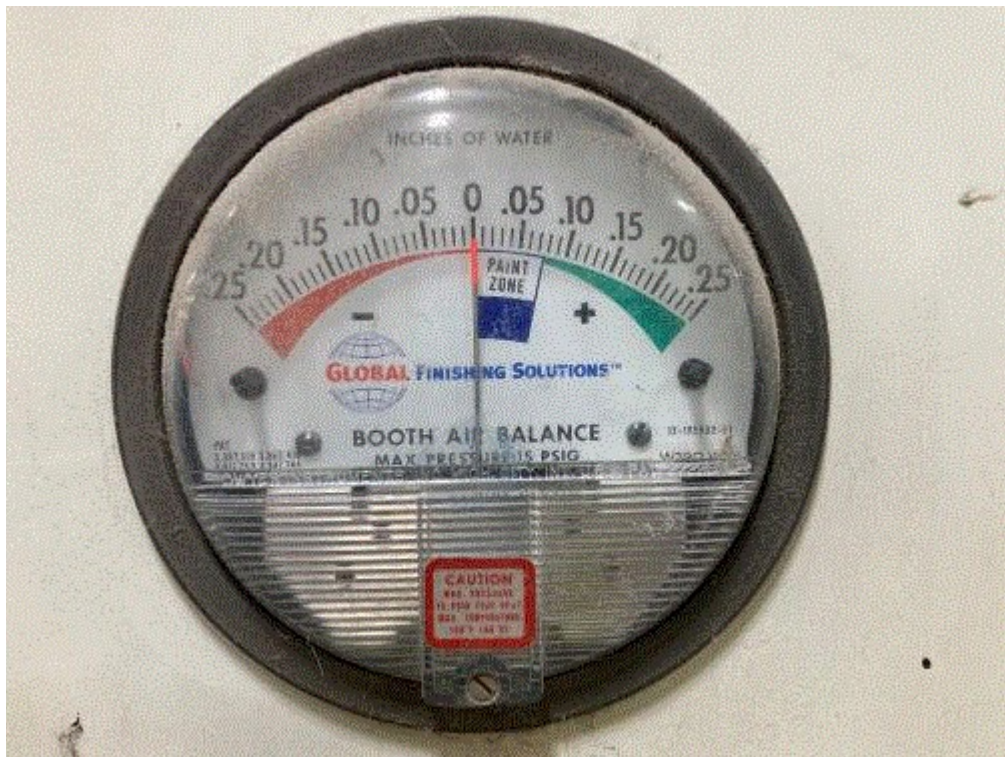
Image 8(IMG 0425) : EUBOOTH2, east side booth air balance gauge, which showed no (zero) deflection when the exhaust system, with dry particulate filters, is turned on. This non-functioning gauge is part of the emissions control device.

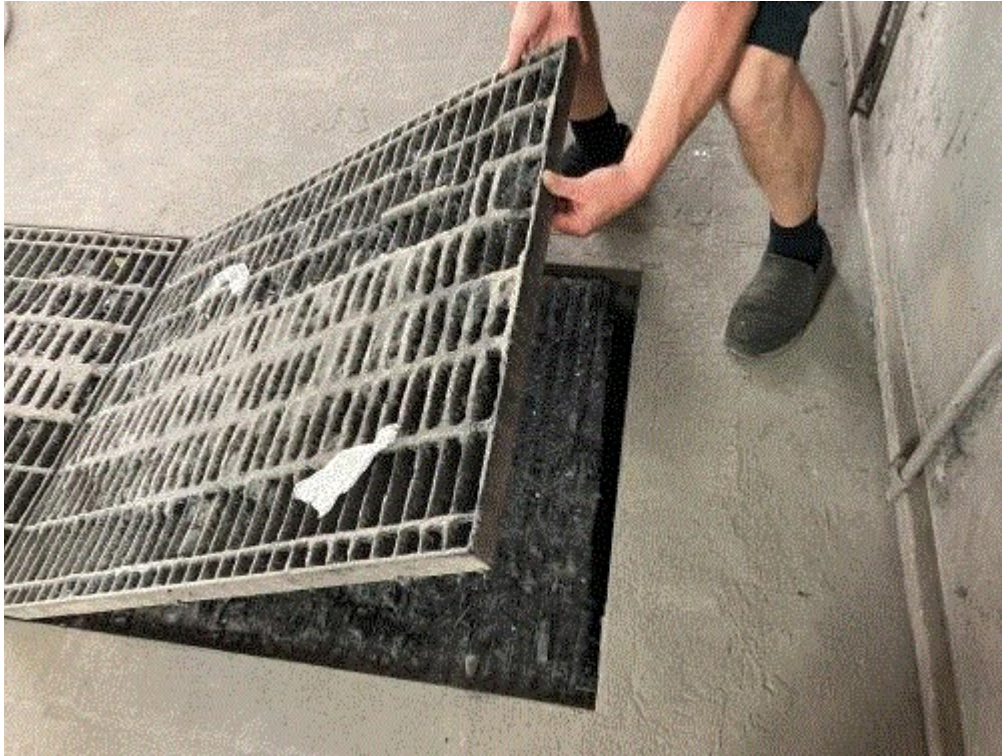
On September 8, 2022, I observed that the permittee operated EUBOOTH1 while the exhaust filters were not properly installed, which provides a path for particulate material air contaminants in the exhaust to bypass the control device. This constitutes a violation of PTI No. 36-18, FGBOOTHS Special Condition IV.1, which states, "The permittee shall not operate FGBOOTHS unless all respective exhaust filters are installed, maintained and operated in a satisfactory manner." This noncompliance shall be cited in a violation notice.

Image 9(IMG 0426) : EUBOOTH1. View of downdraft blanket filter at the east end of the booth. This image shows a gap in filter placement, along the right edge, that allows particulate material (PM) air contaminants to bypass the PM control device.

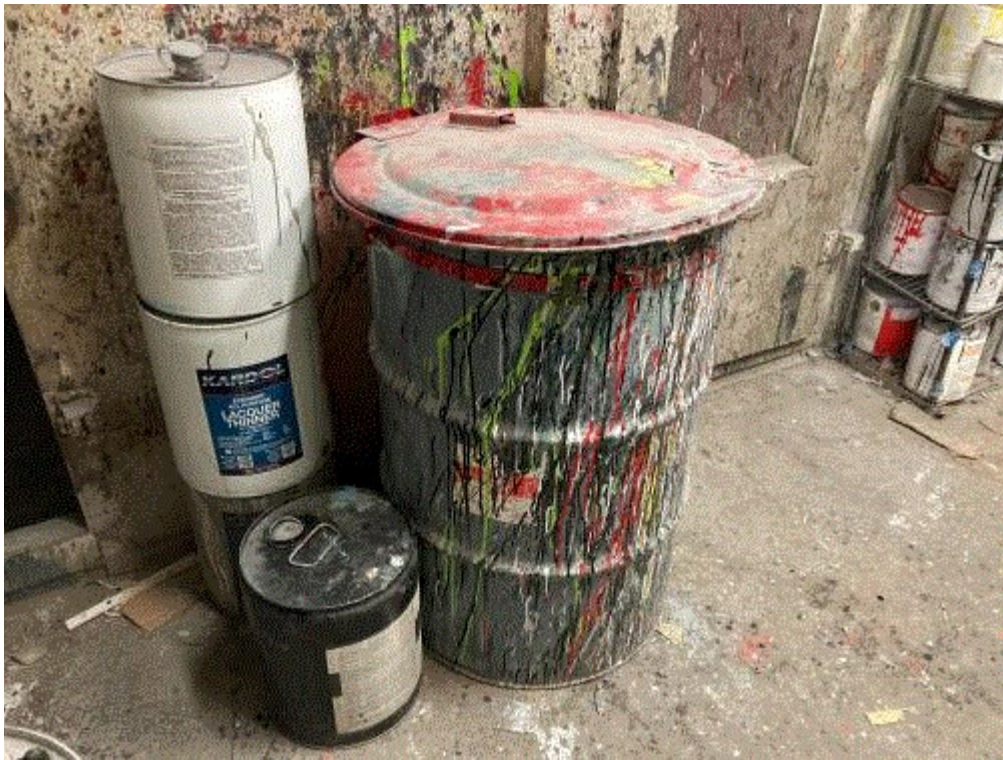
On September 8, 2022, I smelled strong solvent odors in the paint mixing room and observed that the paint mixing room waste drum lid did not properly close (Images 10 and 11). Therefore, the permittee failed to capture all waste materials and store them in closed containers. This constitutes a violation of PTI No. 36-18, FGBOOTHS Special Condition III.1, which states, "The permittee shall capture all waste materials and shall store them in closed containers. The permittee shall dispose of all waste materials in an acceptable manner in compliance with all applicable state rules and federal regulations." This noncompliance shall be cited in a violation notice.

On September 8, 2022, I smelled strong solvent odors in the paint mixing room and observed that the paint mixing room waste drum lid did not properly close. Therefore, the permittee failed to handle all VOC and HAP containing materials, including coatings, reducers, solvents, and thinners, in a manner to minimize the generation of fugitive emissions, and the permittee failed to keep containers covered at all times except when operator access is necessary. This constitutes a violation of PTI No. 36-18, FGBOOTHS Special Condition III.3, which states, "The permittee shall handle all VOC and HAP containing materials, including coatings, reducers, solvents and thinners, in a manner to minimize the generation of fugitive emissions. The permittee shall keep containers covered at all times except when operator access is necessary." This noncompliance shall be cited in a violation notice.

Image 10(IMG 0434) : Paint Mixing Room waste drum.

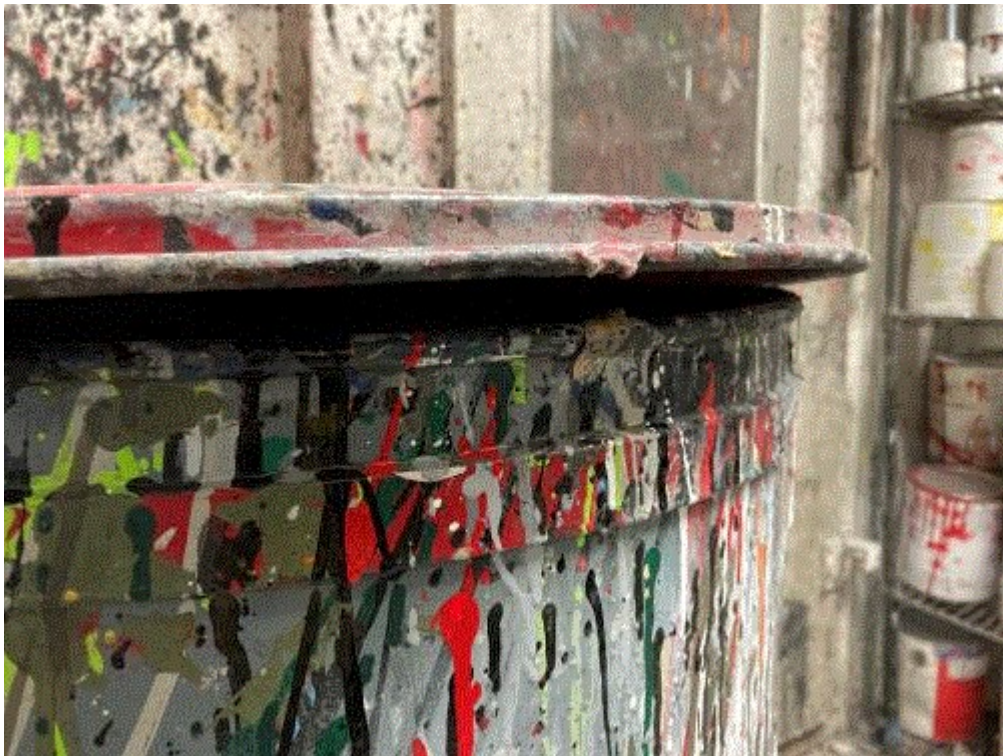
Image 11(IMG 0436) : Close-up view of drum lid in the full closed position. Note that the lid does not rest flush against the lip of the drum. This waste drum appeared to be the source of fugitive emissions, which caused a strong solvent odor in the paint room.

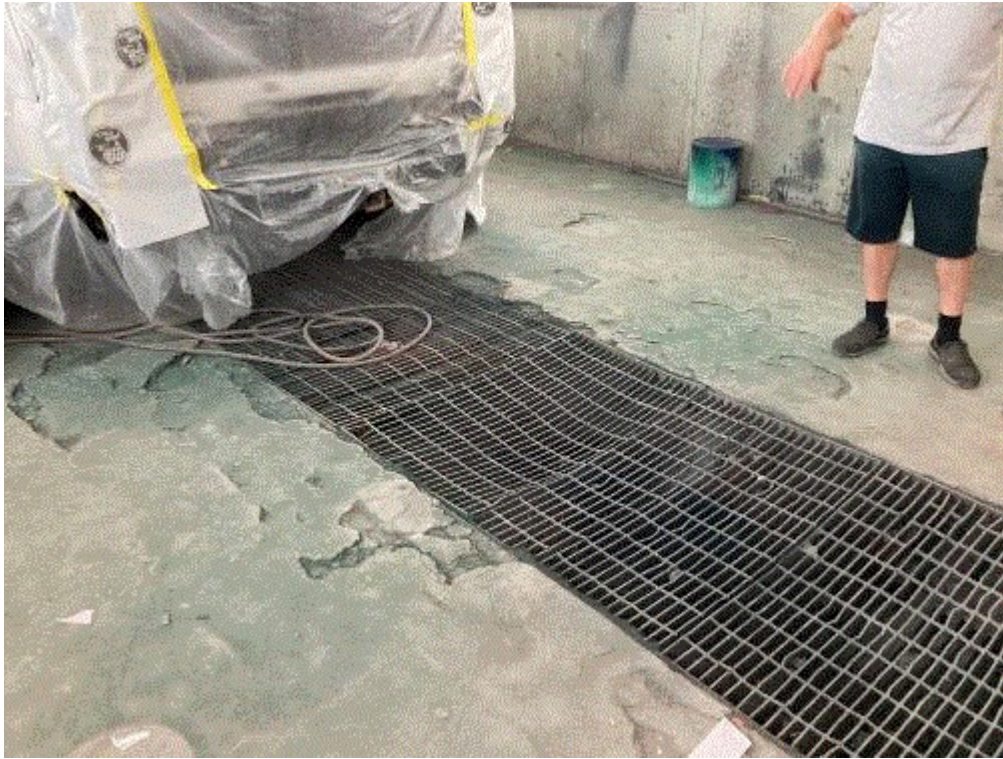
Image 12(IMG 0441): EUBOOTH2. View of the downdraft exhaust floor grates. The floor grates have been cleaned of material that obstructed the exhaust. All of the PM exhaust filters in EUBOOTH2 appeared to be properly installed.
