**DEPARTMENT OF ENVIRONMENTAL QUALITY
AIR QUALITY DIVISION
ACTIVITY REPORT: Self Initiated Inspection**

P062244767

FACILITY: STATELINE CRUSHING		SRN / ID: P0622
LOCATION: 136 South Industrial Drive, SALINE		DISTRICT: Jackson
CITY: SALINE		COUNTY: WASHTENAW
CONTACT: John Thompson , Owner Operator		ACTIVITY DATE: 06/05/2018
STAFF: Zachary Durham	COMPLIANCE STATUS: Non Compliance	SOURCE CLASS: MINOR
SUBJECT: Self initiated inspection conducted on an unpermitted portable crusher operating under Rule 290 during the scheduled inspection of the permitted portable crushing operation identified in SRN P0749, also for Stateline Crushing.		
RESOLVED COMPLAINTS:

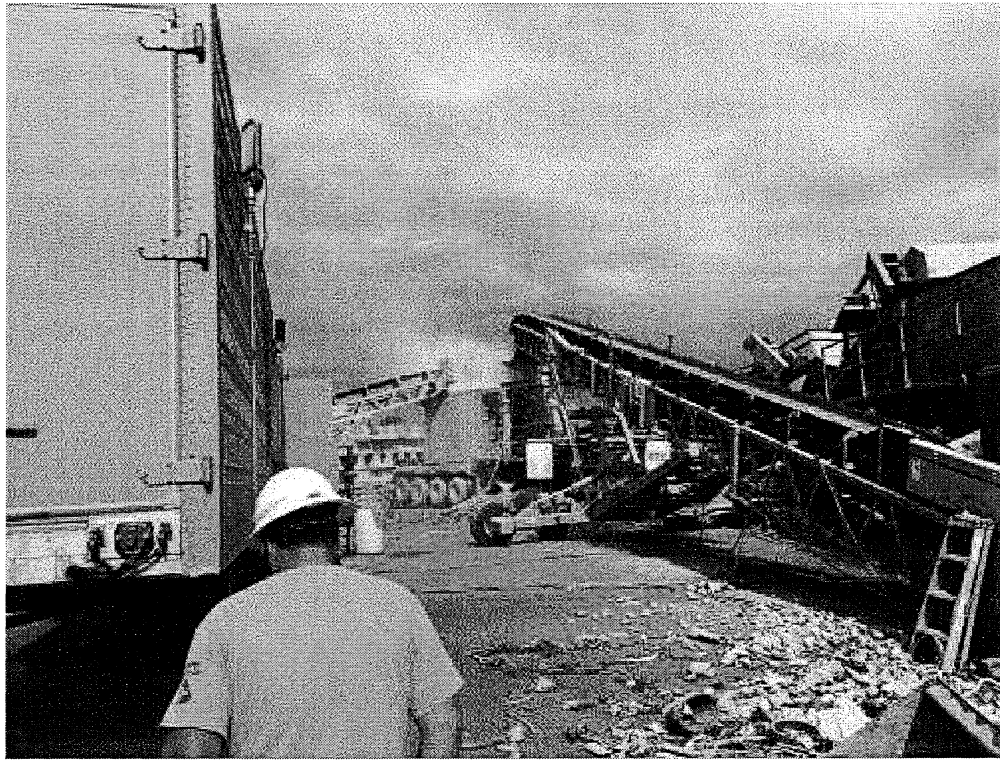
Upon arriving at the site to inspect the portable crusher which submitted a relocation notice under State Registration Number (SRN: P0749), I noticed a second crusher at the site. The attached photo shows the unit to be a KPI 4250 manufactured in 2015. Rule 290(2)(a)(iii)(A) requires appropriately designed and operated control systems, which were not operating during the time of inspection while the unit was operating. Due to a lack of operational control equipment an excessive amount of particulate matter was present during the inspection (see attached photos).

During the time of the inspection, the KPI 4250 unit was equipped with a single hose aimed into the crushing area. This setup differs from the 2015 Method 9 test that incorporated water spray as well as a misting unit to reduce VEs. While there was a misting unit onsite, it was directed towards the other crusher and had no effects on the KPI 4250.

Image 1(KPI 4250) : Walking up to the job site. Excessive VEs observed.

This facility was not in compliance with Rule 290 at the time of inspection due to a lack of an appropriately designed and operated control system required by Rule 290(2)(a)(iii)(A). A violation letter has been sent to the company.

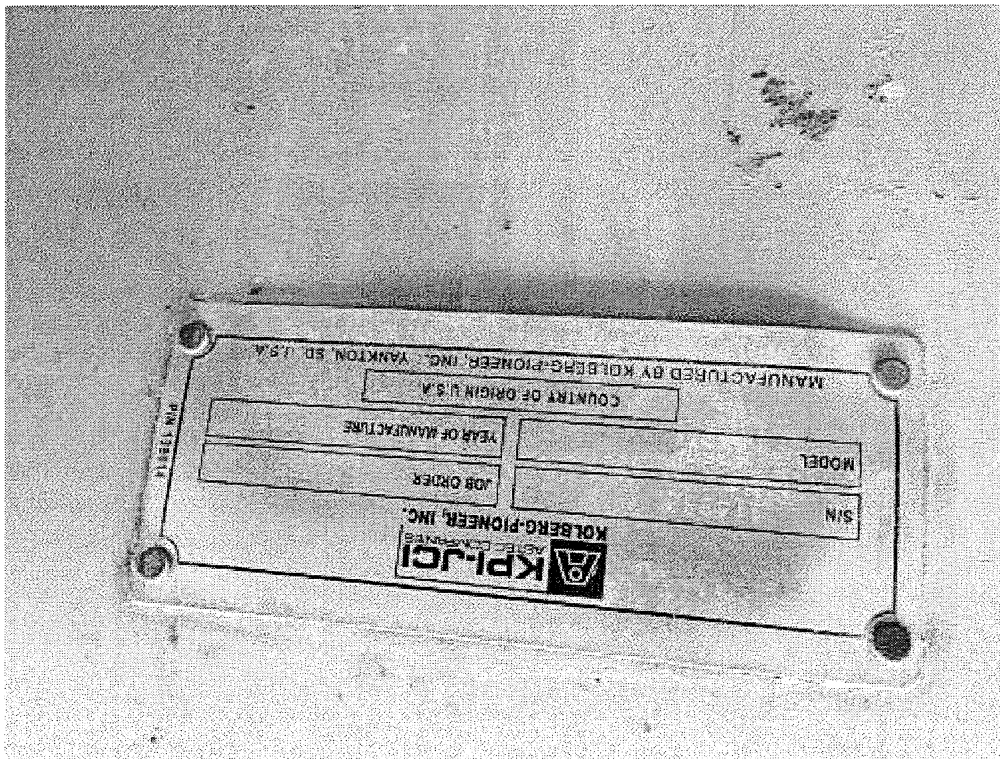
Image 2(KPI 4250 nameplate) : Nameplate with S/N 414882

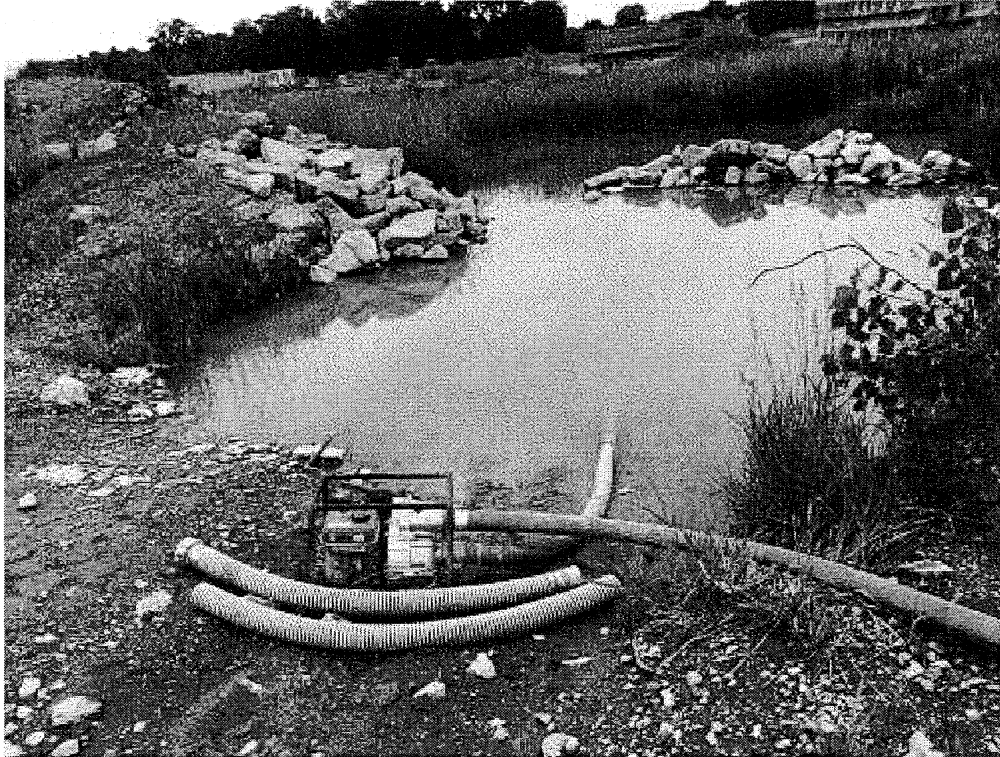
Image 3(water pump) : small water pump and pond at the job site

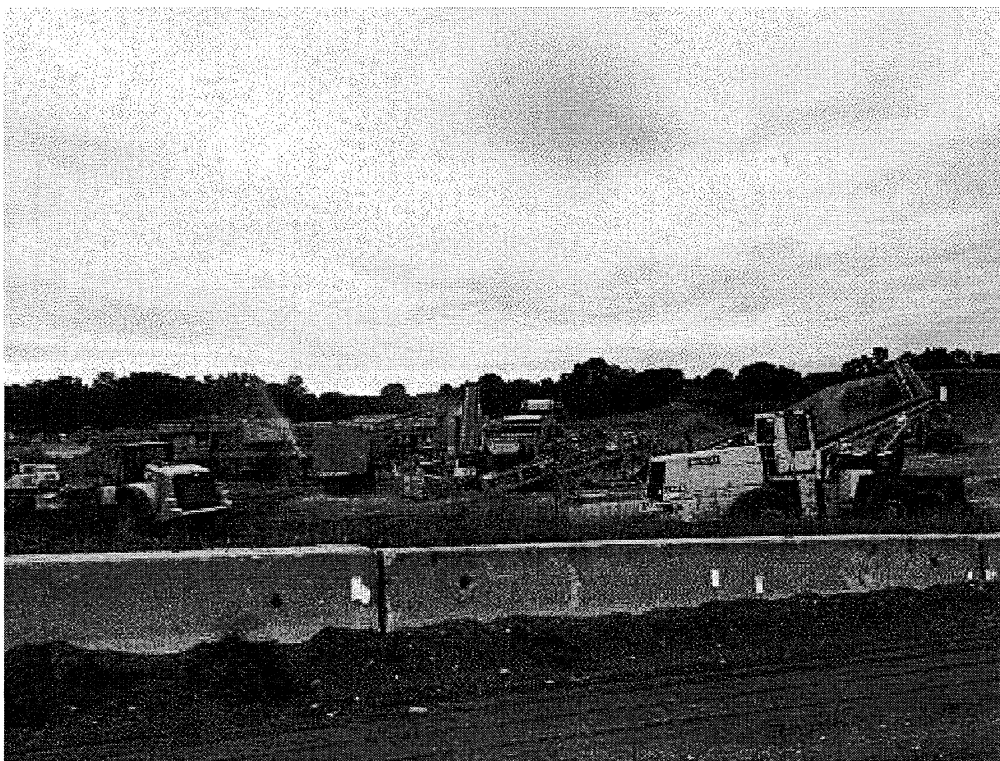
After observing for a few minutes, Robert was able to shut down the operation and restart the water flow. A certified Method 9 was not conducted at the time, however, VEs were still present coming from the KPI 4250 while the water hose was running.

Image 4(Jobsite overview) : Exiting jobsite at 10:15am. To the left water mist is visible from misting unit applied to equipment in P0749. To the right some VEs are present from KPI 4250 crusher after water had been

restored.
