DEPARTMENT OF ENVIRONMENTAL QUALITY
AIR QUALITY DIVISION
ACTIVITY REPORT: Scheduled Inspection

FACILITY: Lake Pleasant Recycling		SRN / ID: P0839
LOCATION: 3380 Hudson Rd., HILLSDALE		DISTRICT: Jackson
CITY: HILLSDALE		COUNTY: HILLSDALE
CONTACT: Mike Gootee		ACTIVITY DATE: 10/23/2018
STAFF: Mike Kovalchick	COMPLIANCE STATUS: Compliance	SOURCE CLASS: MINOR
SUBJECT: Inspection of an auto scrap yard.		
RESOLVED COMPLAINTS:

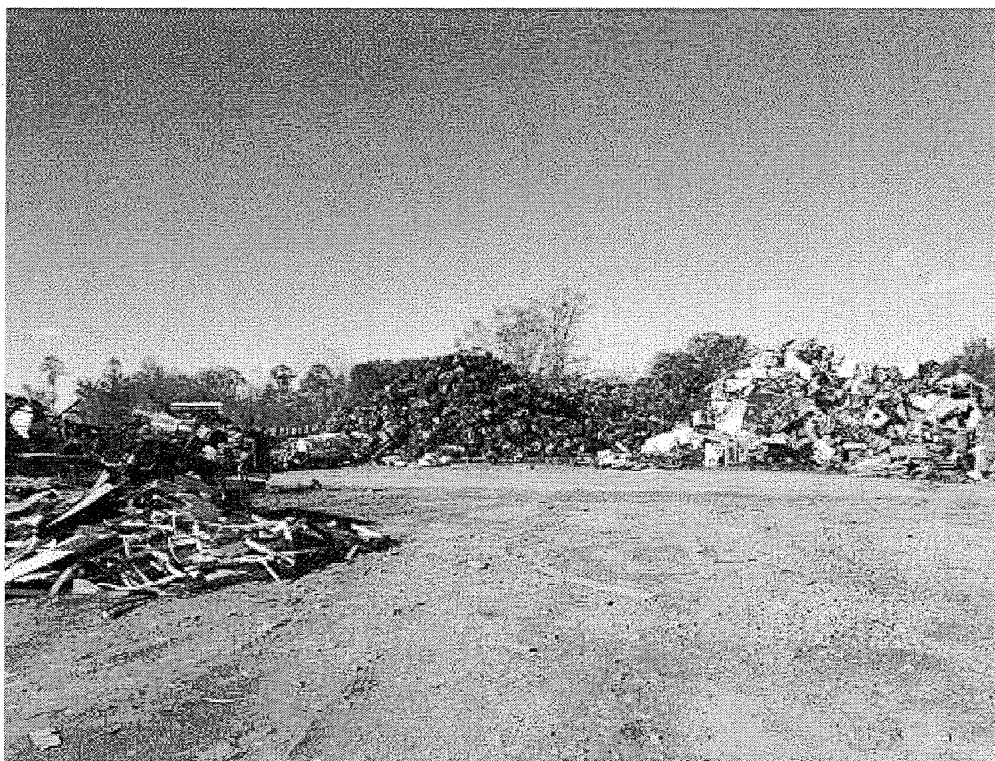
Next, we went out into the yard to look at scrap piles. The scrap piles appear to be cleaner and better organized than during the previous inspection. However, some oil was seen leaking from a couple of engine blocks on to a cement pad. Also, noted some old refrigerators in the piles. See attached photos.

Image 1(Scrap yard) : Scrap yard.

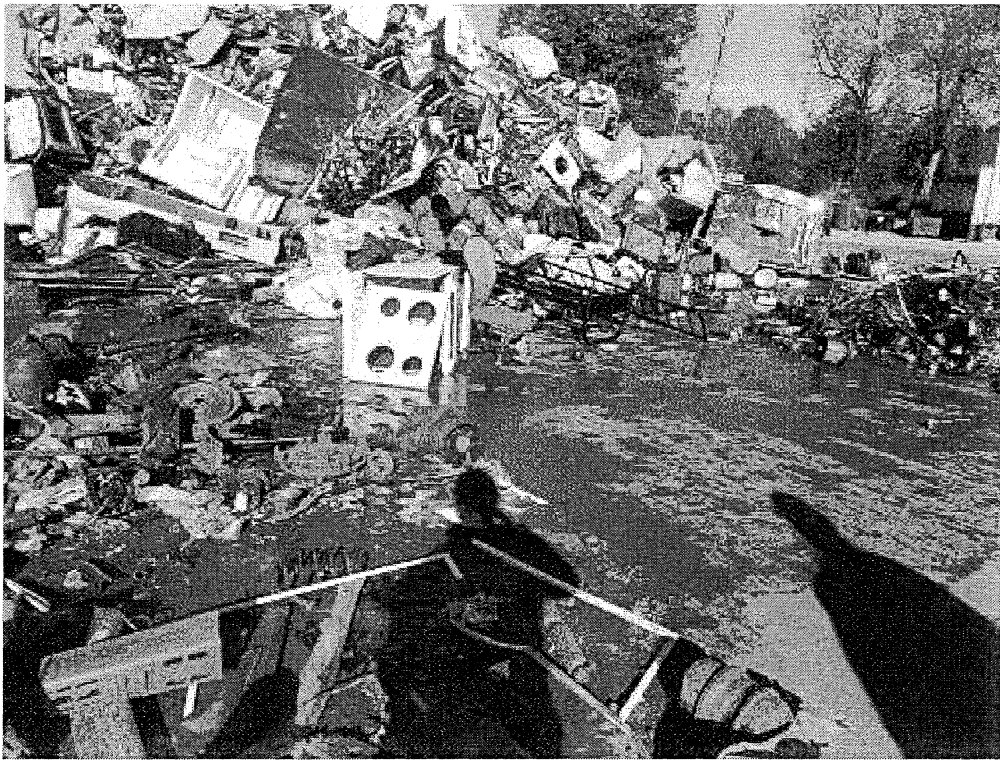
Image 2(Scrap yard-oil) : Scrap yard with oil spilled onto cement pad.

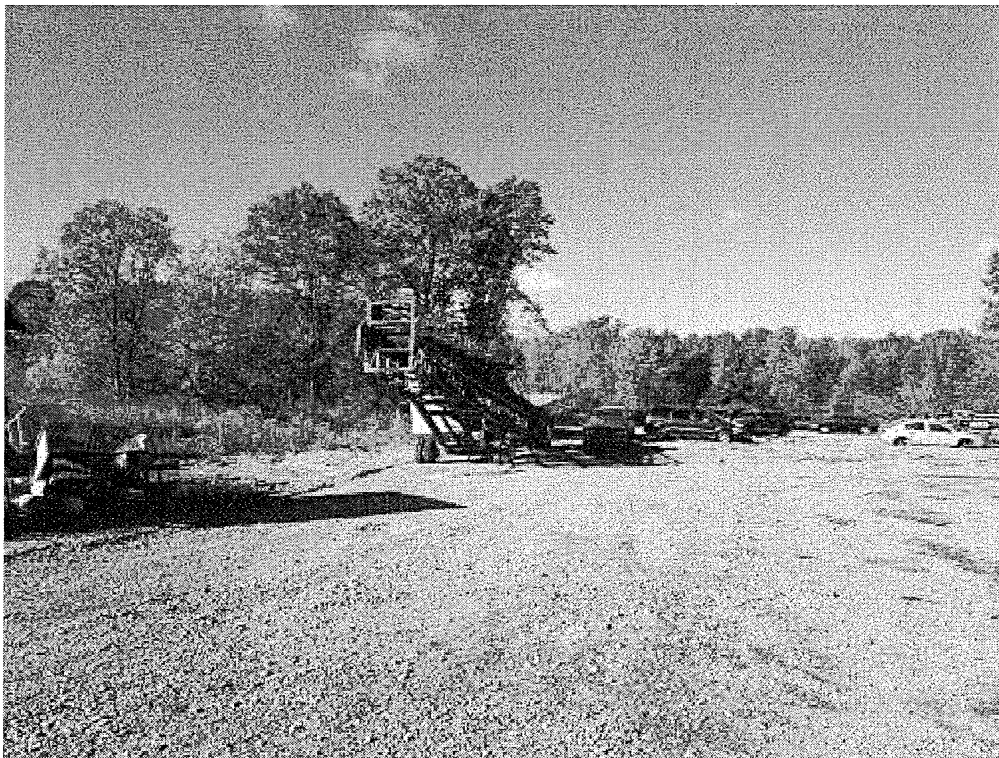
The portable auto shredder is in the process of being sold. It has not been used in 3 or 4 months. It has been disassembled into several large components. The main shredder portion of it has been moved to behind the office building where it occasionally operated to show perspective clients that it is still in working condition.

Image 3(Auto shredder convey) : Auto shredder conveyor.

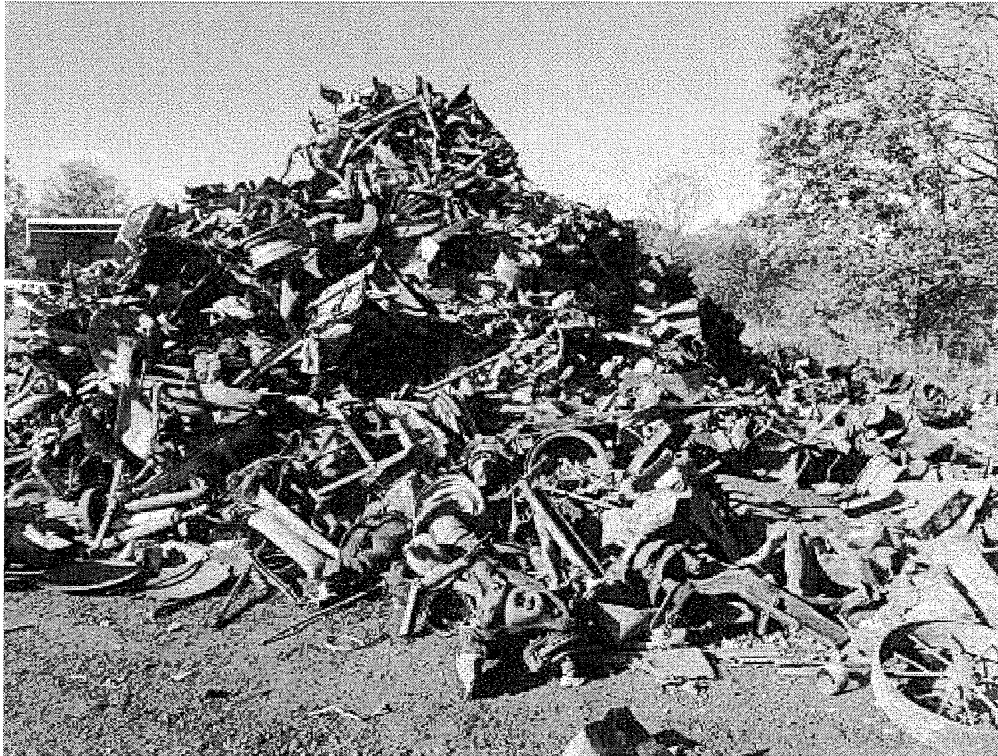
Attached photo shows a pile of scrap metal that had been recently sheared.

Image 4(Sheared scrap) : Scrap that had been sheared.

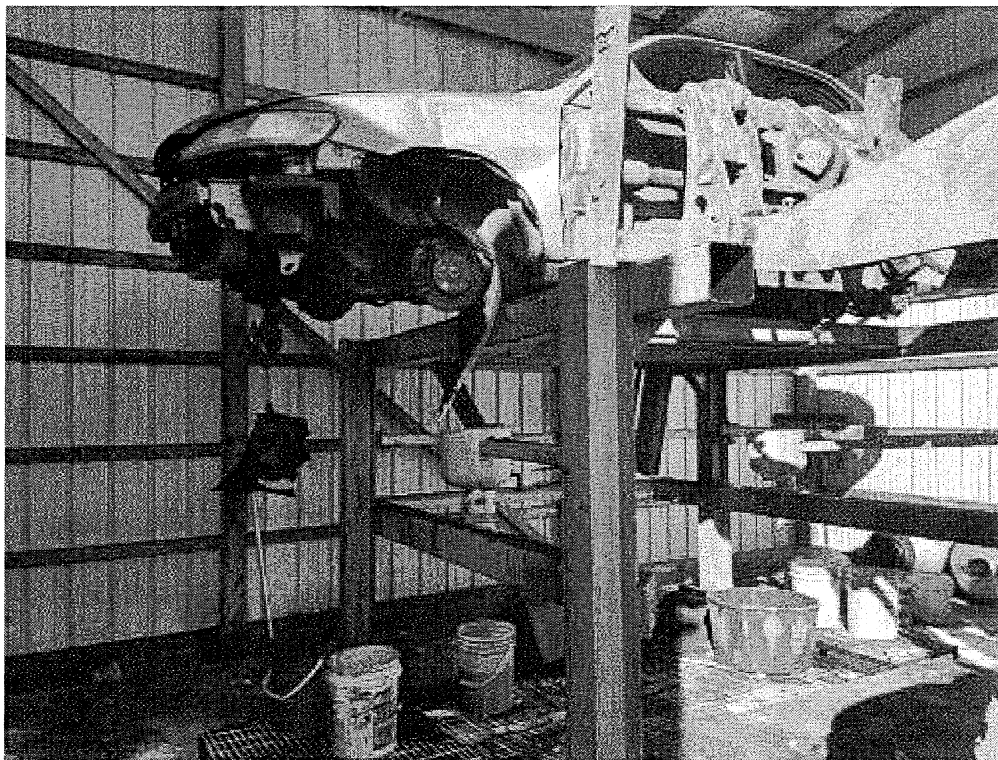
JK then showed me the depollution area. Two operators were there in the process of removing gasoline from a

Image 5(Depollution station) : Depollution station.

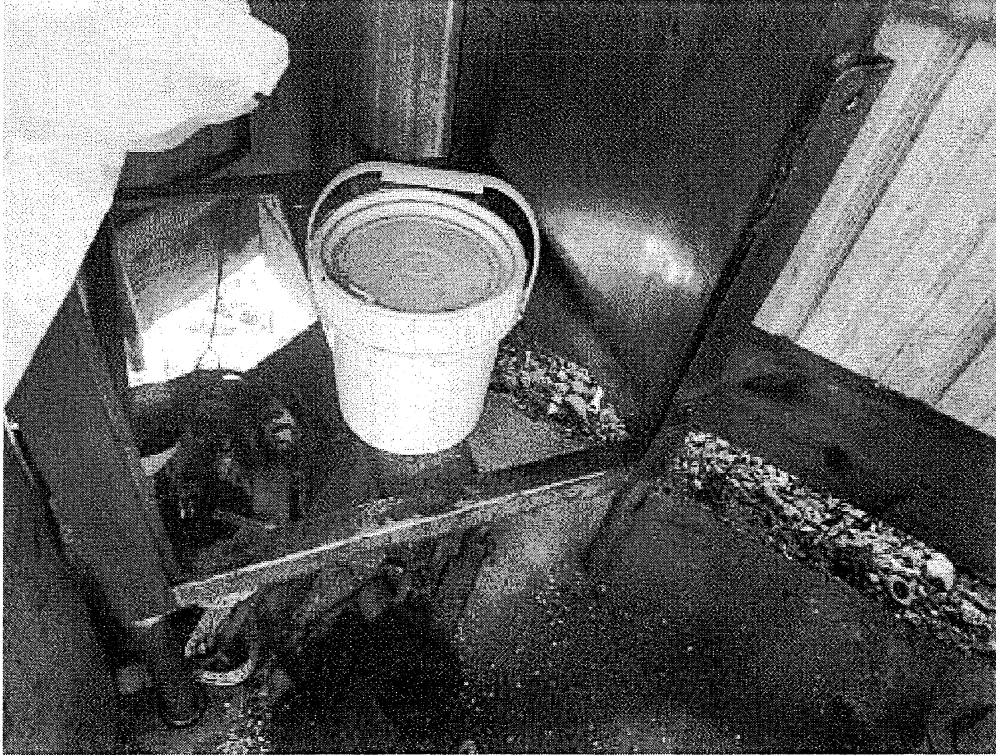
car. (See attached photo.) Nearby, were several large totes containing waste oil. In the depollution area shed, there was a white bucket that they are using for mercury switches. (Note: It was empty.) See attached photo. I questioned the two operators. They did seem well aware of the need to remove mercury switches and commented that they do so occasionally. (Rule 201 would apply if they processed/smashed the vehicles without first removing mercury switches.) I asked them if they had ever checked anti-lock brakes assemblies for mercury and they said no.

Image 6(Mercury bucket) : Mercury auto switch recovery bucket.

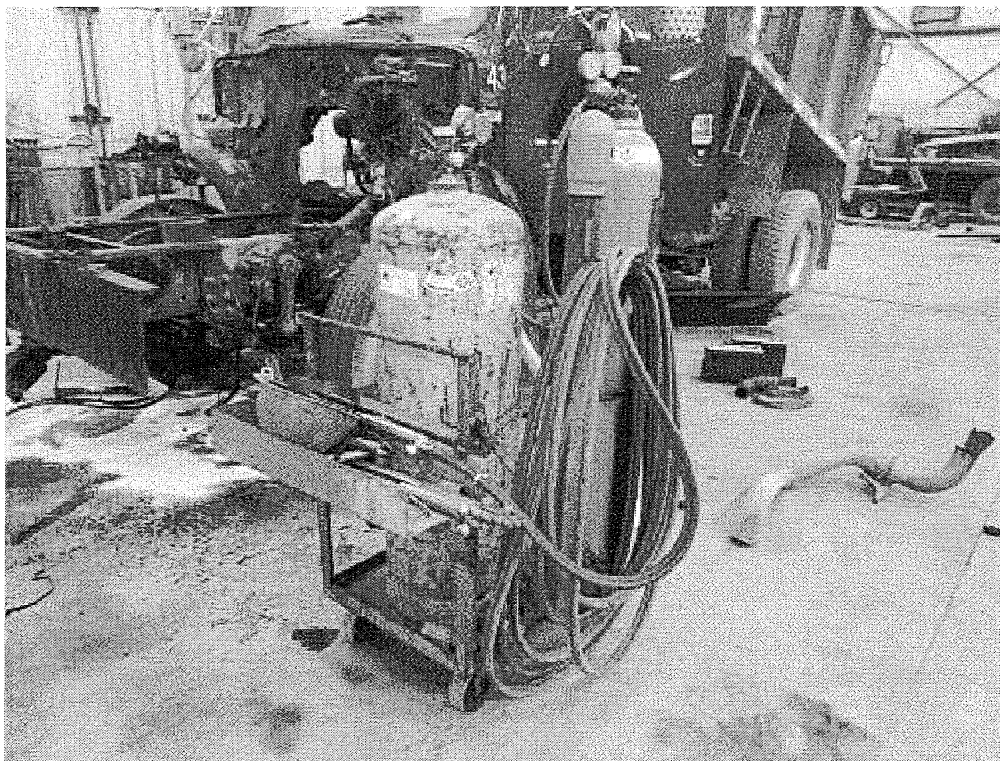
We returned to inside the main shop where JK showed me a portable torch cutting unit. See attached photo.

Image 7(Portable torch) : Portable torch cutting station inside shop.

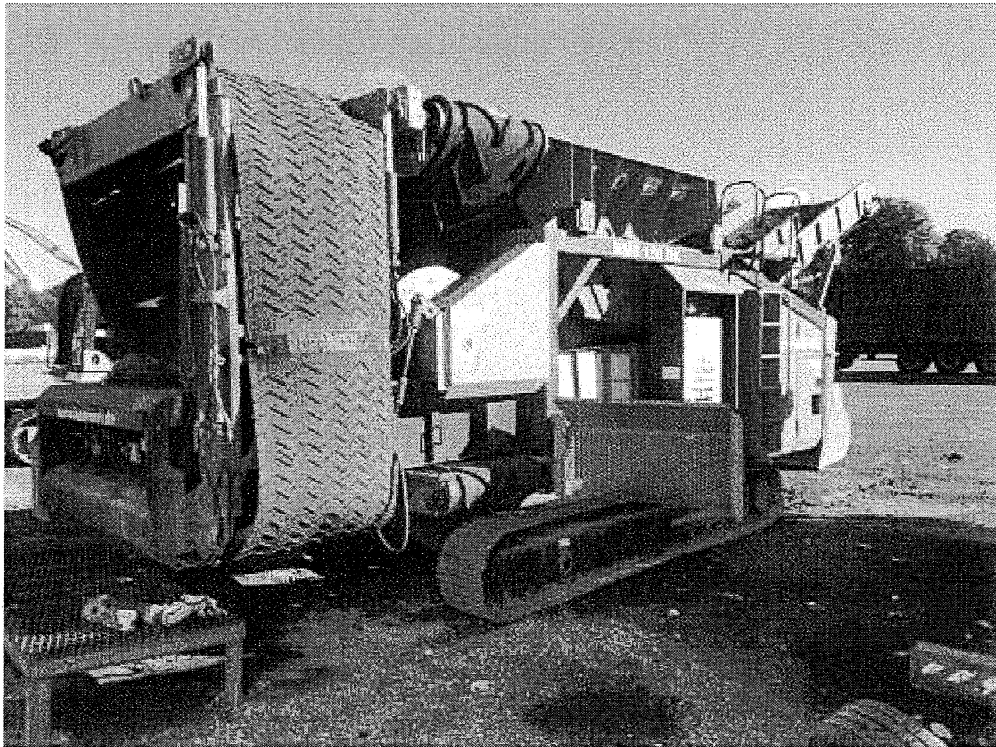
Image 8(Shredder component) : Auto shredder component.

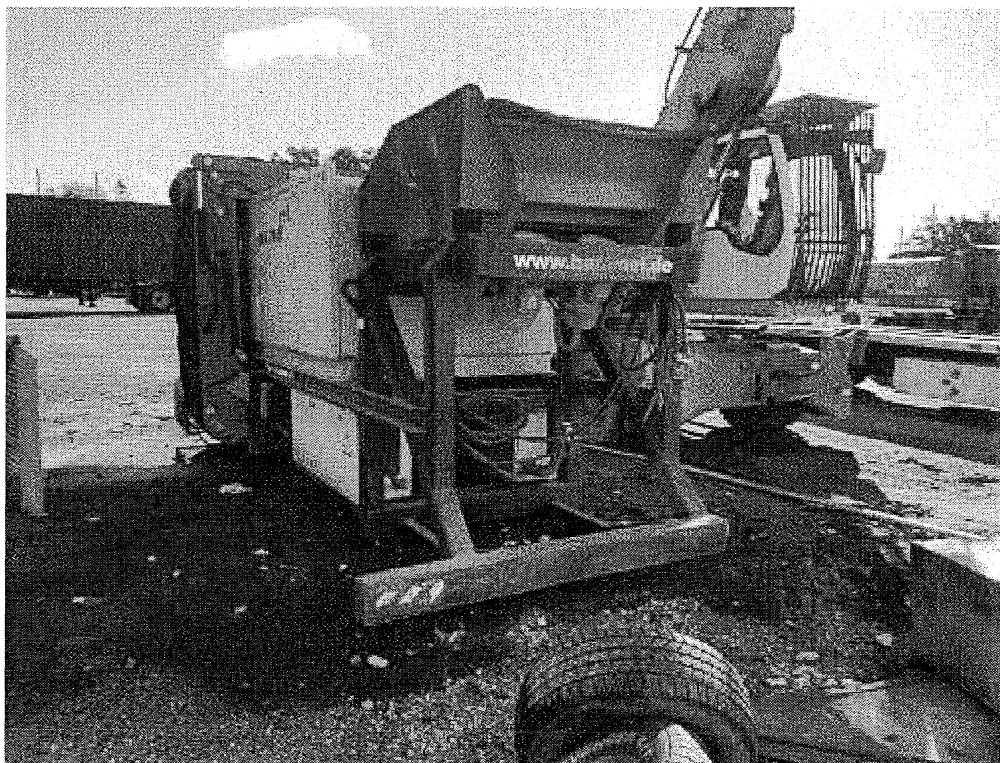
Image 9(Shredder component) : Another part of the auto shredder plant.

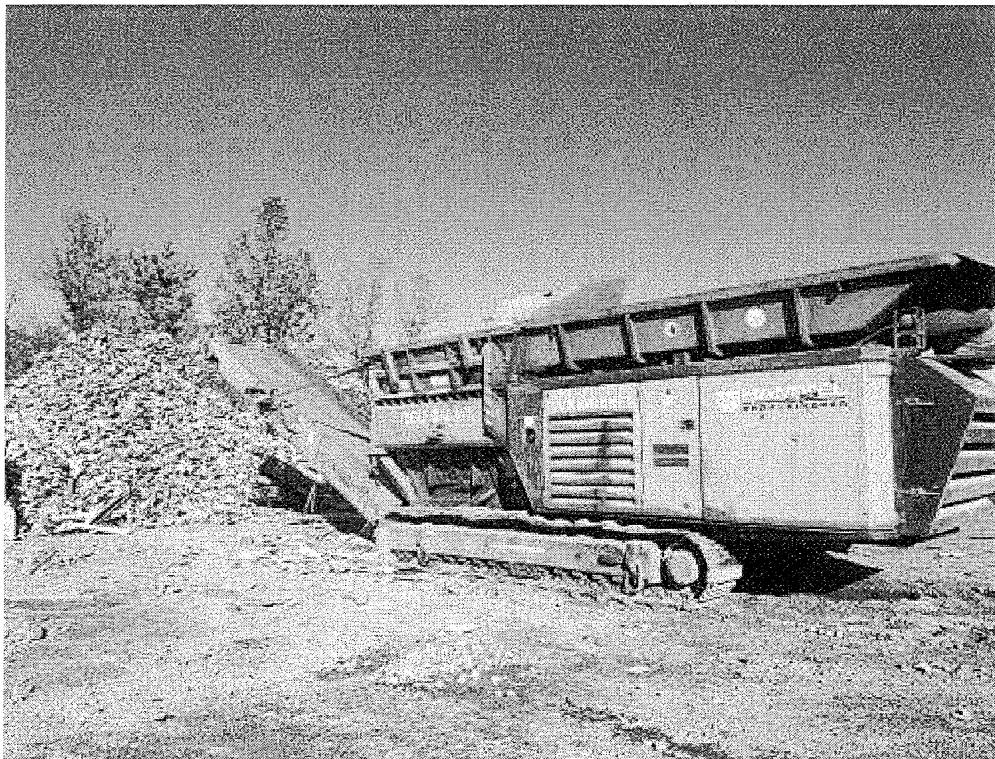
Image 11(Auto shredder) : Main component of portable auto shredder process plant.

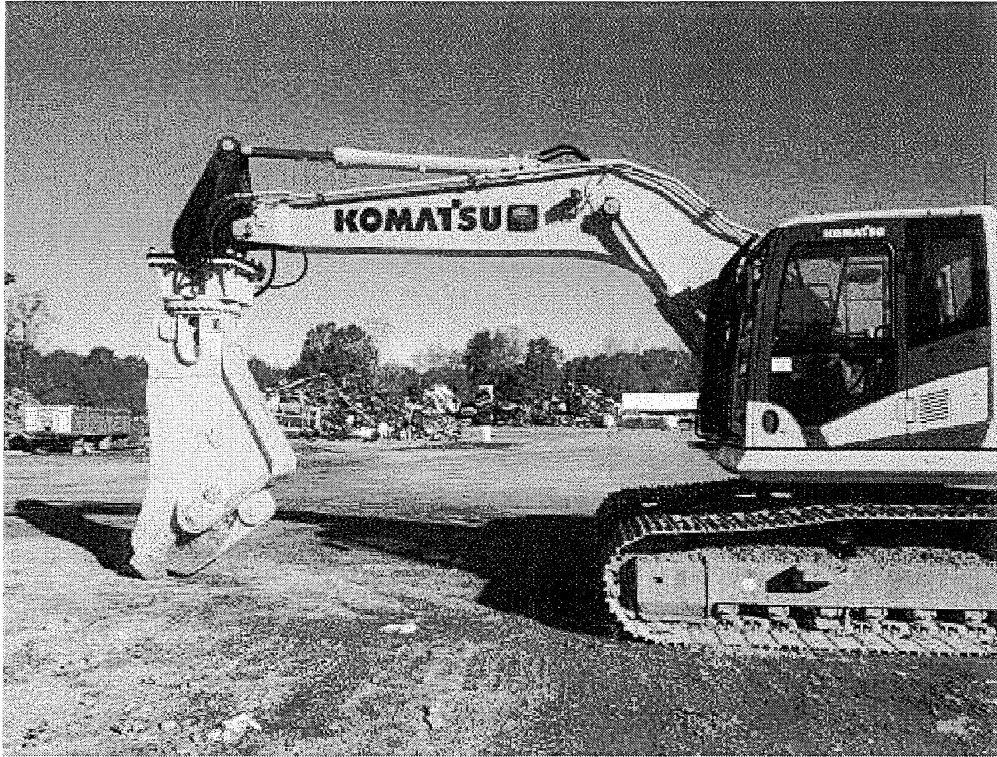
Image 12(Shear) : Shear

JK showed me the new shear they purchased when they stopped torch cutting. See attached photo.
