DEPARTMENT OF ENVIRONMENTAL QUALITY
AIR QUALITY DIVISION
ACTIVITY REPORT: On-site Inspection

FACILITY: Faithful Companion Memorials, Inc.		SRN / ID: P1245
LOCATION: 1909 Thunderbird Street, TROY		DISTRICT: Warren
CITY: TROY		COUNTY: OAKLAND
CONTACT: Thomas E. Rood , Chief Operating Officer		ACTIVITY DATE: 12/13/2022
STAFF: Robert Elmouchi	COMPLIANCE STATUS: Non Compliance	SOURCE CLASS: Minor
SUBJECT: On-site inspection.		
RESOLVED COMPLAINTS:

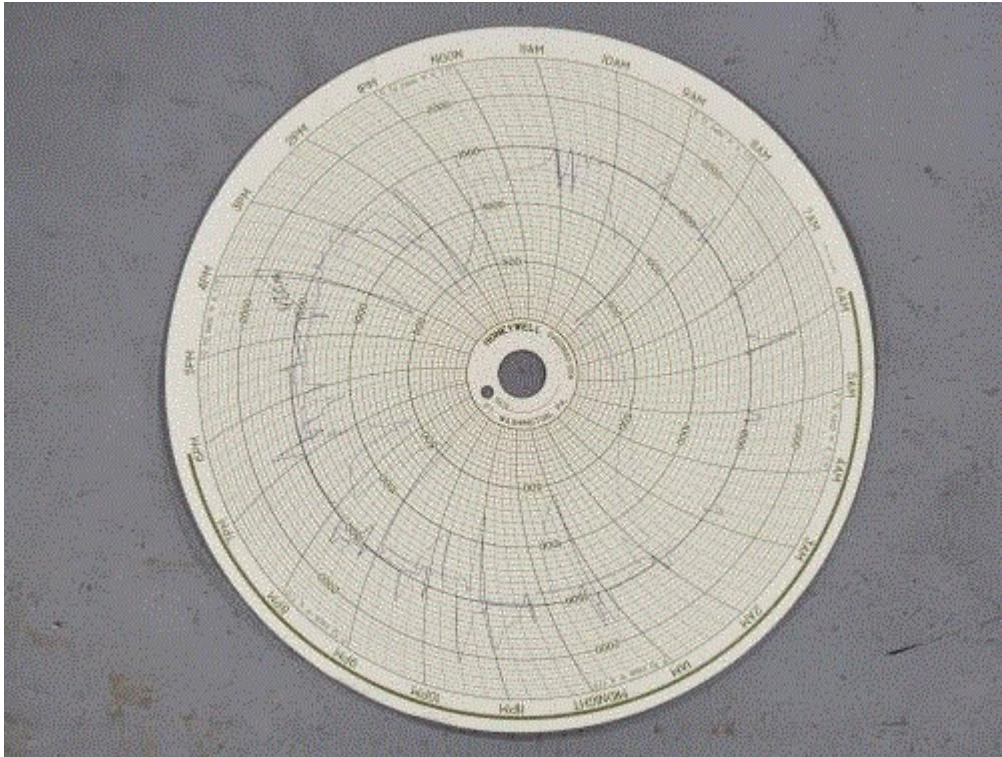
Per the temperature chart records collected during this inspection, the EUCREMATORY2 records were not satisfactory because there are no records of the emission unit ID, date, start and end time, and multiple cremation temperature records overlap. Furthermore, the temperature records show that this emission unit was routinely operated while the secondary combustion chamber was operating between 1200- and 1500-degrees Fahrenheit, which is below the AQD's minimum permitting temperature of 1600 degrees Fahrenheit. Both of these noncompliances constitute violations of R 336.1910, which states, "An air-cleaning device shall be installed, maintained, and operated in a satisfactory manner and in accordance with these rules and existing law." These violations shall be cited in a violation notice. NOTE: Because essential information was not recorded, the AQD cannot determine the dates the violations occurred.

Image 1(20221213 101636) : EUCREMATORY2 temperature chart record. The permittee failed to identify the emission unit name, date, and the start and end time of each cremation. Furthermore, the temperature records are overlapping and below the 1600 degrees F permitted minimum.

Per the January 4, 2023, follow-up telephone conversation with Tom Rood, EUCREMATORY2 will be removed and replaced with a new, higher charge capacity, cremation unit that has a greater capability to control visible emissions from group cremations.

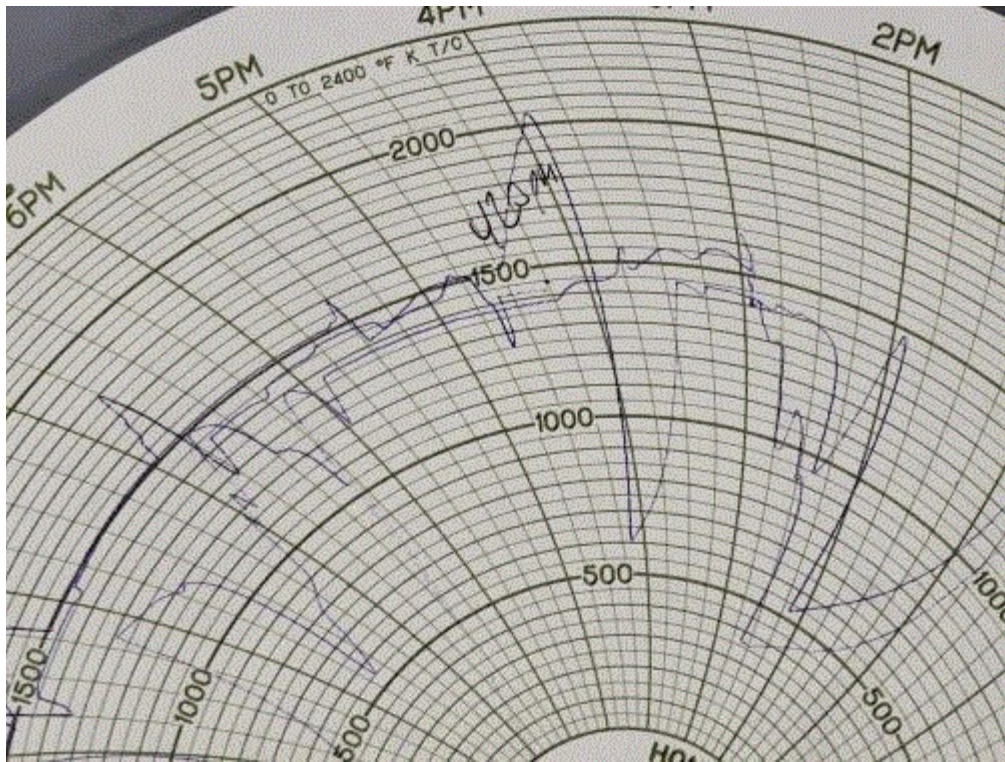
Image 2(20221213 101646) : EUCREMATORY2: Close-up view of overlapping temperature records. The records indicate the cremation unit was operating while the secondary combustion chamber temperature was less than the permitted minimum of 1600 degrees F.

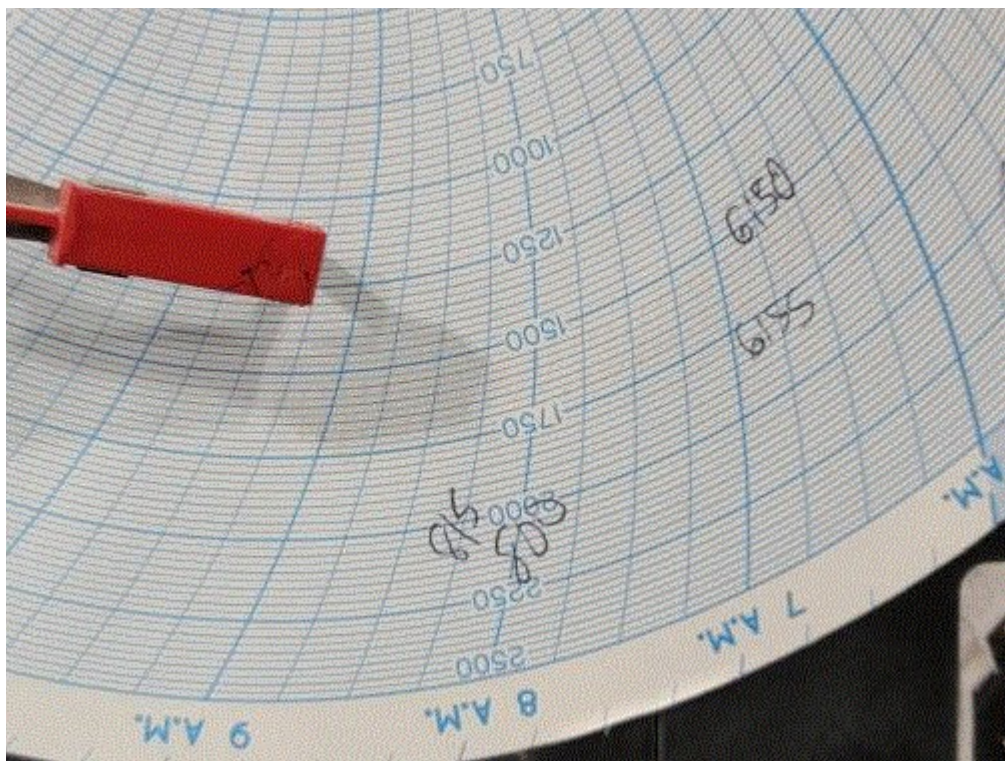
During the inspection, staff observed that the permittee failed to replace the ink pen on the EUCREMATORY6 temperature chart recorder, which resulted in faint illegible recordkeeping. This constitutes a violation of PTI 19-22, FGIEB16, VI.2, which states, "The permittee shall monitor and record the temperature in the secondary combustion chamber in each unit of FGIEB16 on a continuous basis." This recordkeeping failure shall be cited in a violation notice.

Image 3(20221213 102204) : Image of EU-CREMATORY6 temperature chart record. The permittee failed to

replace the ink pen, which resulted in very faint illegible recordkeeping. This constitutes a violation of PTI 19-22, FGIEB16, VI.2.

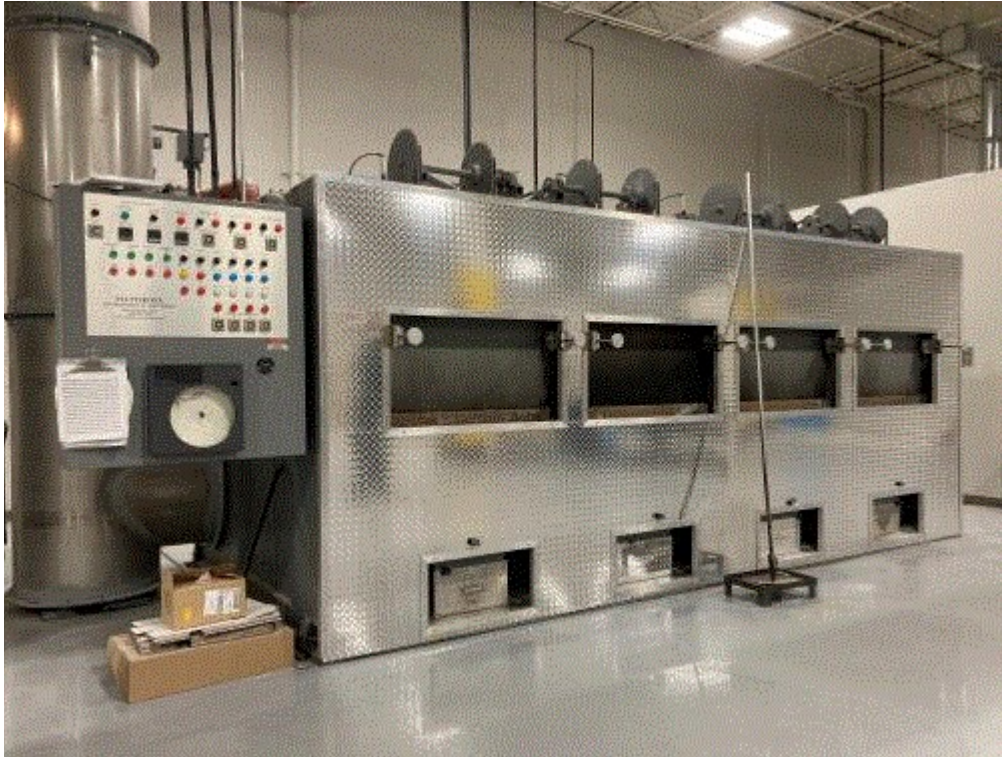
Image 4(IMG 0581) : Image of EUCREMATORY9. This is a 4-chamber animal cremation unit.

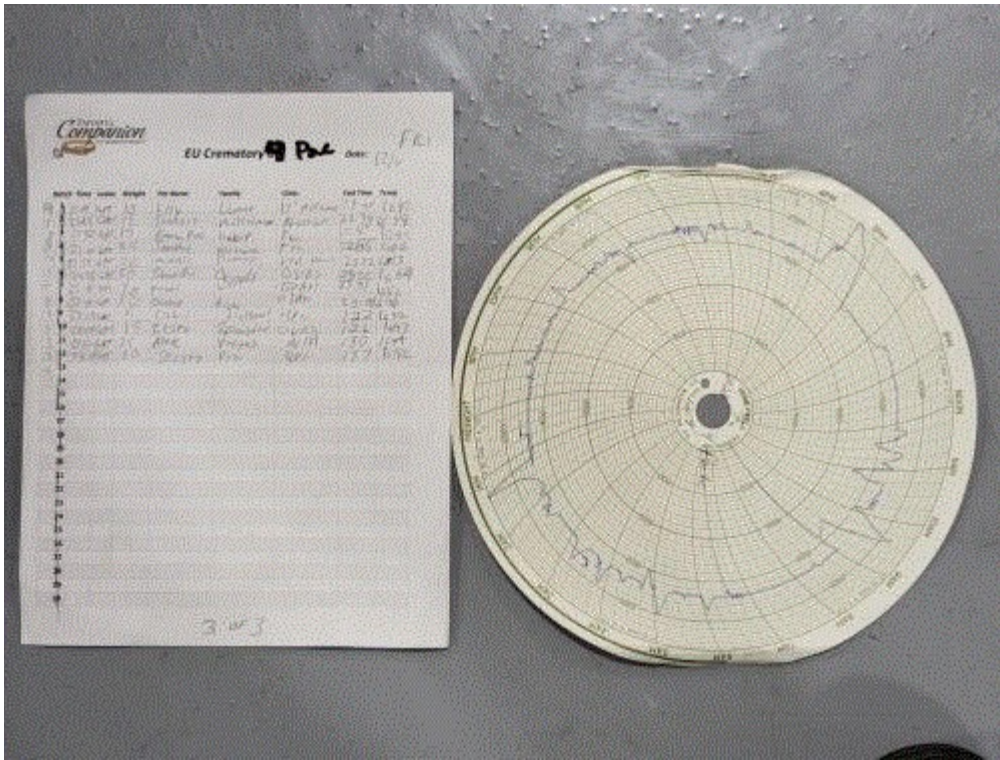
Image 5(20221213 103254) : Image of EUCREMATORY9 (4 Pack), 4-chamber animal crematorium log sheet and temperature chart for 12/9/2022.

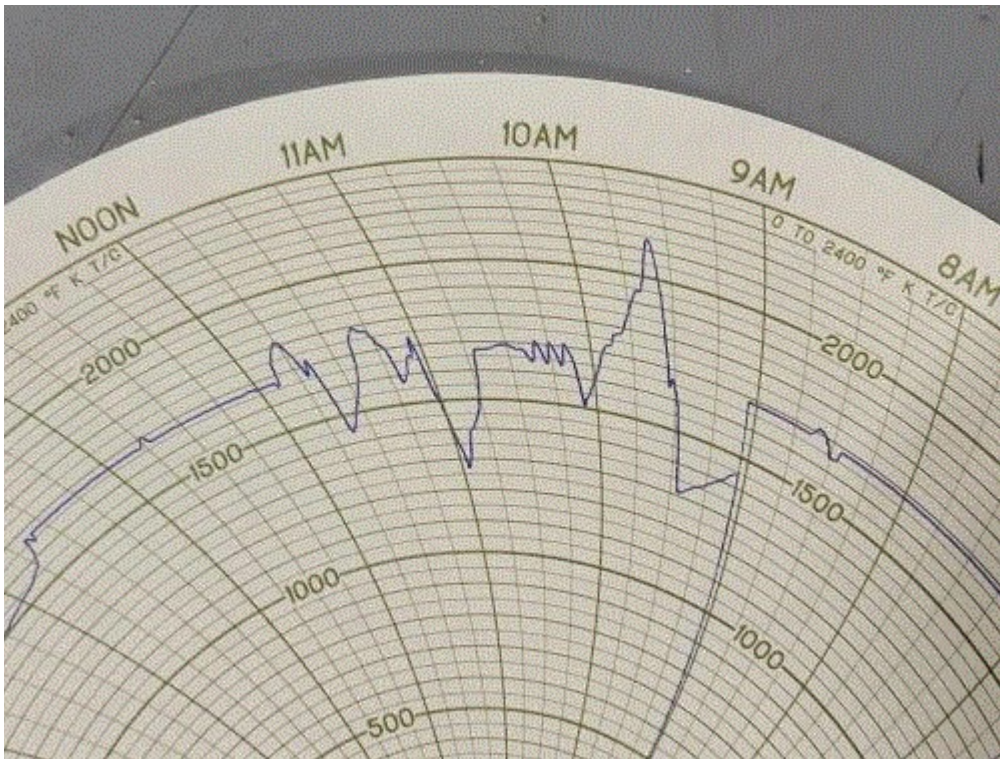
The permittee's failure to maintain a minimum temperature of 1600 degrees Fahrenheit in the SCC while any EUCREMATORY9 PCC was operating constitutes a violation of PTI 19-22, EUCREMATORY9, III.1, which states, "The permittee shall not combust waste in EUCREMATORY9 unless a minimum temperature of 1600°F and a minimum retention time of 1.0 second in the secondary combustion chamber are maintained."

Image 6(20221213 103334) : Close up view of aEUCREMATORY9 (4 Pack) temperature record chart indicating the secondary combustion chamber temperature fell below the permitted minimum of 1600 degrees F three-times

between 9AM and NOON on 12/9/2022.

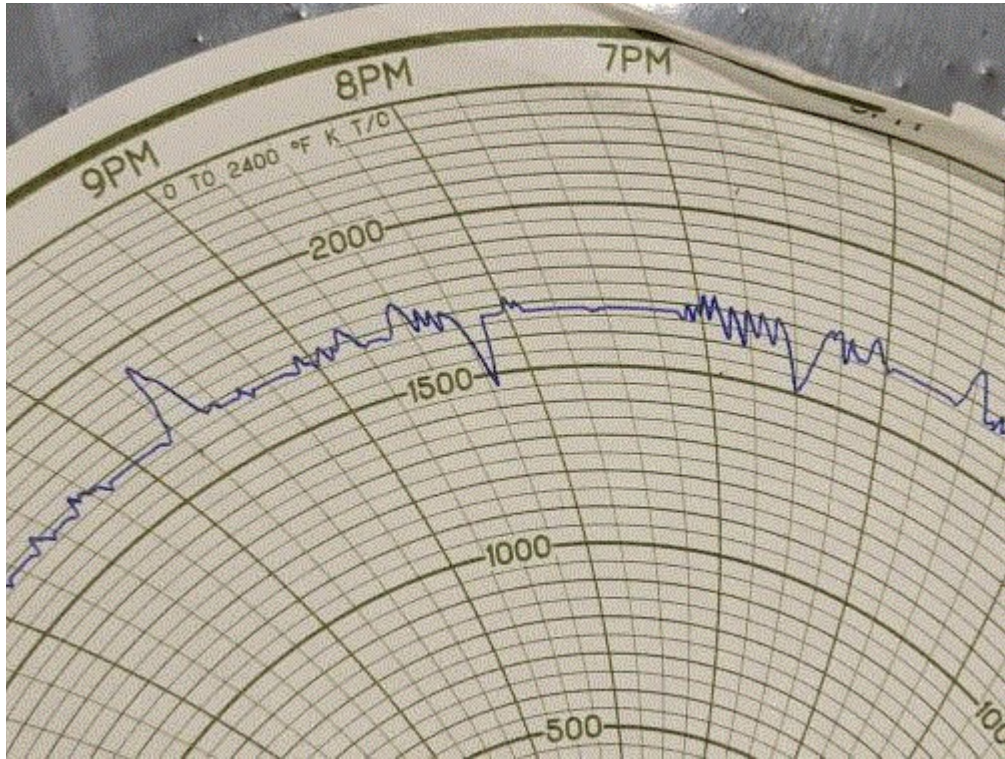
Image 7(20221213 103344) : Close up view of aEUCREMATORY9 (4 Pack) temperature record chart indicating the secondary combustion chamber temperature fell below the permitted minimum of 1600 degrees F two-times between 6PM and 9PM on 12/9/2022.
