## DEPARTMENT OF ENVIRONMENTAL QUALITY AIR QUALITY DIVISION

**ACTIVITY REPORT: Scheduled Inspection**

FACILITY: Kerkstra Precast		SRN / ID: U411413707
LOCATION: 3373 Busch Drive, Grandville		DISTRICT: Grand Rapids
CITY: Grandville		COUNTY: KENT
CONTACT: Steve Haskill , Vice President Operations		ACTIVITY DATE: 10/24/2014
STAFF: April Lazzaro	COMPLIANCE STATUS: Compliance	SOURCE CLASS: MILION
SUBJECT: Unannounced, sched	Juled inspection.	
RESOLVED COMPLAINTS:

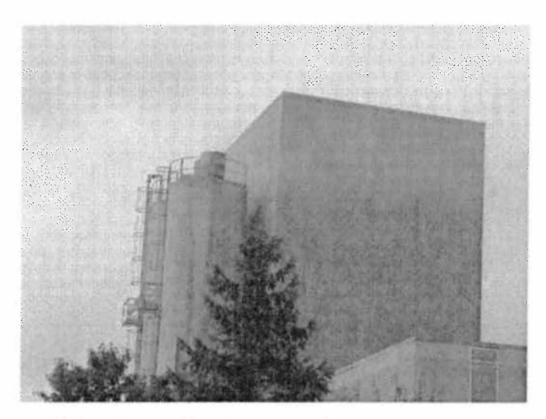
After another nearby inspection, staff drove past this facility on the way back to the office. At that time, a significant amount of dust was observed coming out of the top of the product silo baghouses. I pulled over, took a picture, (attached) and contacted Mr. Skiba to discuss this issue.

Mr. Skiba stated that he had just been made aware of the problem, and he was sending someone out right away. I asked him to detail the problem, and Kerkstra's solution in an e-mail to me. I then called and left a message for Mr. Haskill indicating that this is the second time I've seen a problem at the facility and it can not continue. The dust emissions if seen again in the future, may lead to compliance issues. I asked Mr. Haskill to call me with any questions. Mr. Skiba sent an e-mail (attached) detailing the issue. Apparently there were bag(s) with holes, and the dust would fall to the floor of the unit. Then when they started up, the residual dust would be

emitted. I sent a note on October 20th asking if the units had been repaired and was told that the bag with the holes was replaced on Friday.

Image 1(Kerkstra Precast): Silo emissions due to hole in bag/accumulation of dust inside.
