DEPARTMENT OF ENVIRONMENTAL QUALITY AIR QUALITY DIVISION

ACTIVITY REPORT: Self Initiated Inspection

Facility: Midwest Gravel, Inc.

Inspection Date: 7/24/2014

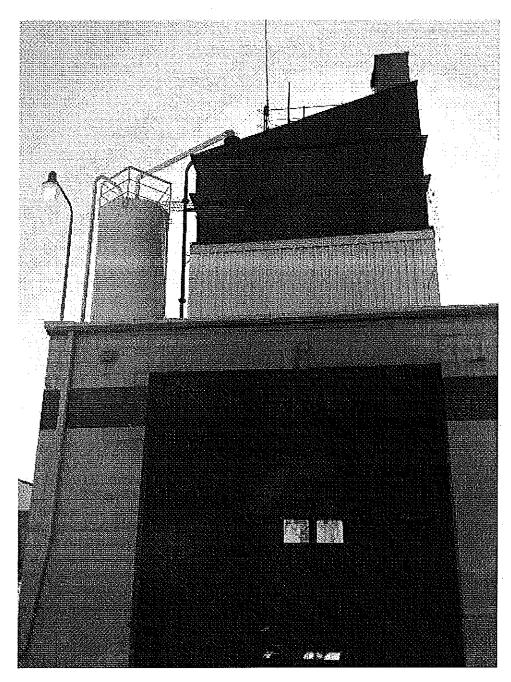
The baghouse on top of the loading area is equipped with a shaker system for maintaining bags. Bags were inspected prior to startup in the spring and a few were replaced as necessary. Mr. Broullier started the shaker system and I could distinctly hear the unit operating.

<u>Image 1(7/24/2014)</u>: Silo with baghouse on top of loading area. Shaker unit is the small unit in the upper right of the frame.

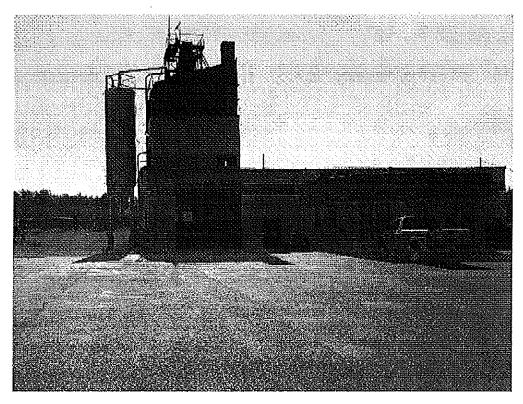
The entire yard and driveways had been paved since the previous inspection in 2009 and fugitive dust from ingress/egress to the facility is essentially nonexistent. Water is applied as needed with a cement truck to the remaining unpaved area behind the facility. The loading area is mostly enclosed, encasing almost the entire rear half of a truck as it is loading.

<u>Image 3(7/24/2014)</u>: Entire facility. Driveways of off Carpenter Street, yard, and loading are paved in front of plant.
