DEPARTMENT OF ENVIRONMENTAL QUALITY
AIR QUALITY DIVISION
ACTIVITY REPORT: Self Initiated Inspection

N251326294

Facility: Champion Concrete

Inspection Date: 7/23/2014

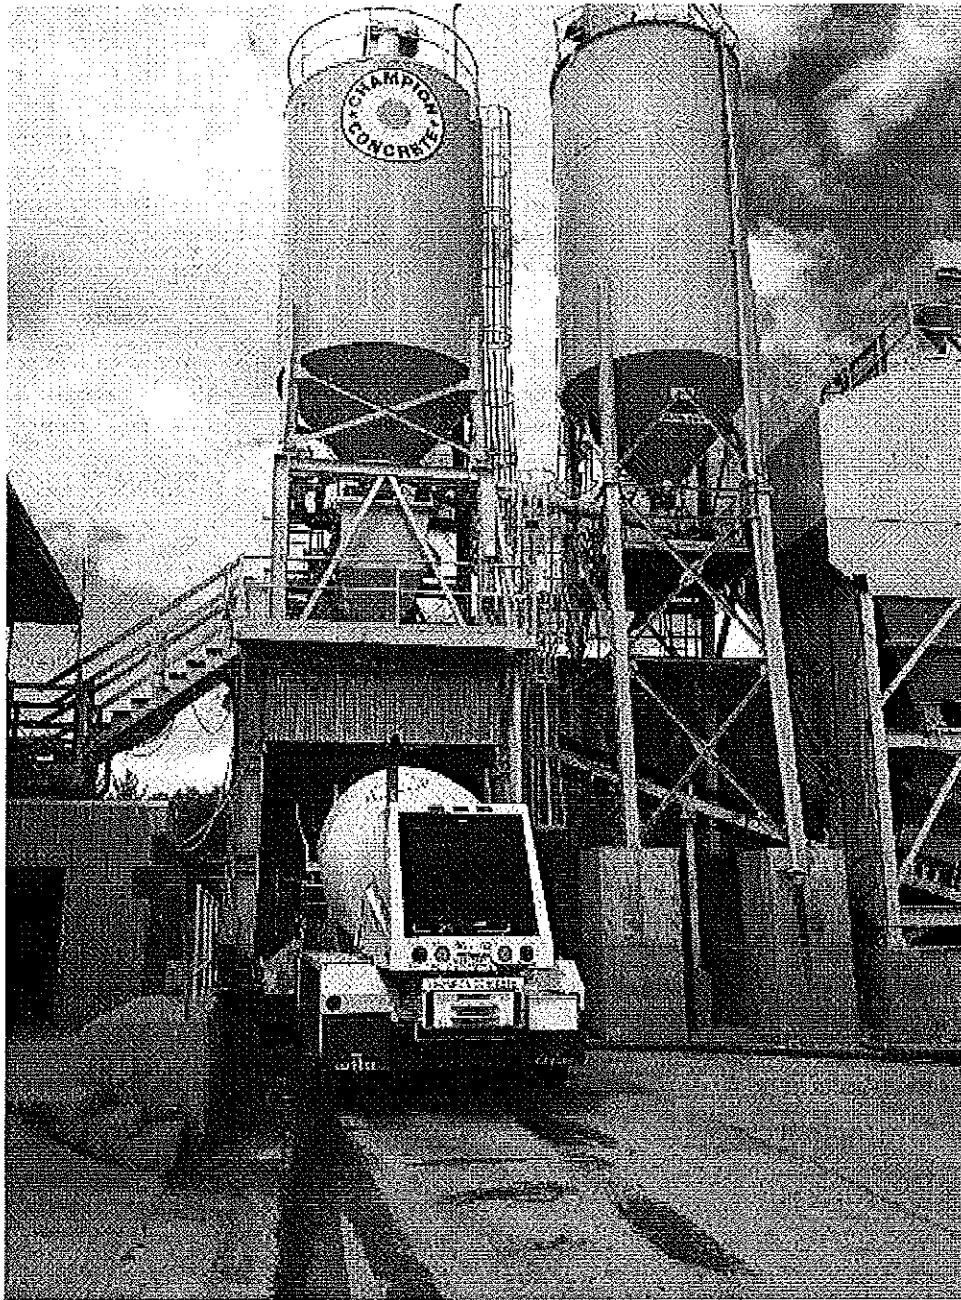
Image 1(7/23/14) : Truck loading, 75 ton fly ash silo on left and 100 ton cement silo on right.

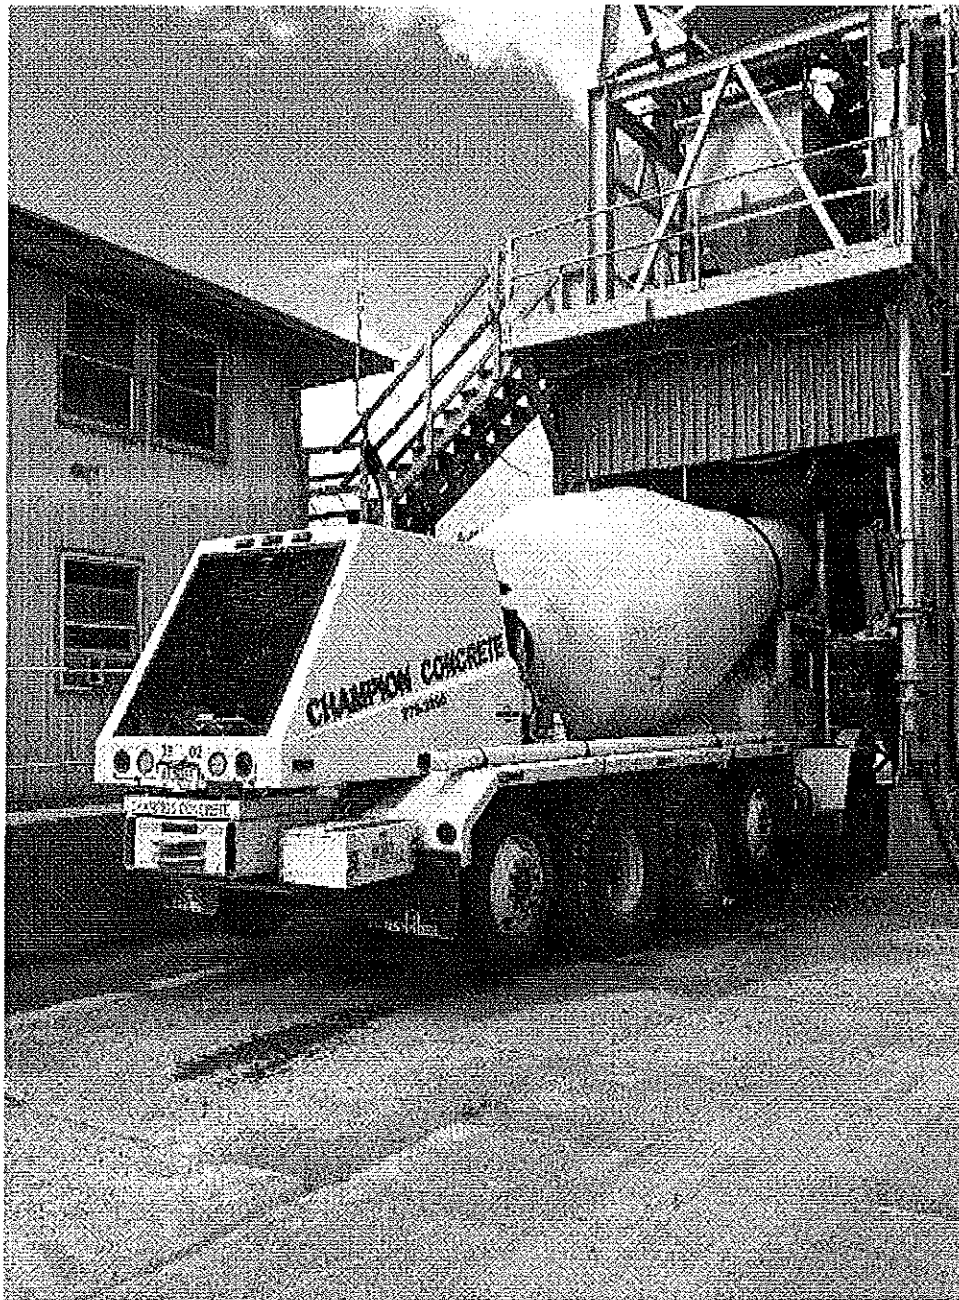
Ingress/egress drives are wetted as needed on production days and had been watered that morning. The truck loading area is located within a 3-sided enclosure and utilizes a shroud at the loading interface which is ducted to one of the baghouses. I saw no fugitive dust issues while observing the truck load or any accumulation of uncontrolled product around the loading area. The silos and baghouses appeared in good condition and working order.

Image 2(7/23/14) : Truck loading; no fugitive dust observed; dust collection shroud at loading interface provides satisfactory dust control.

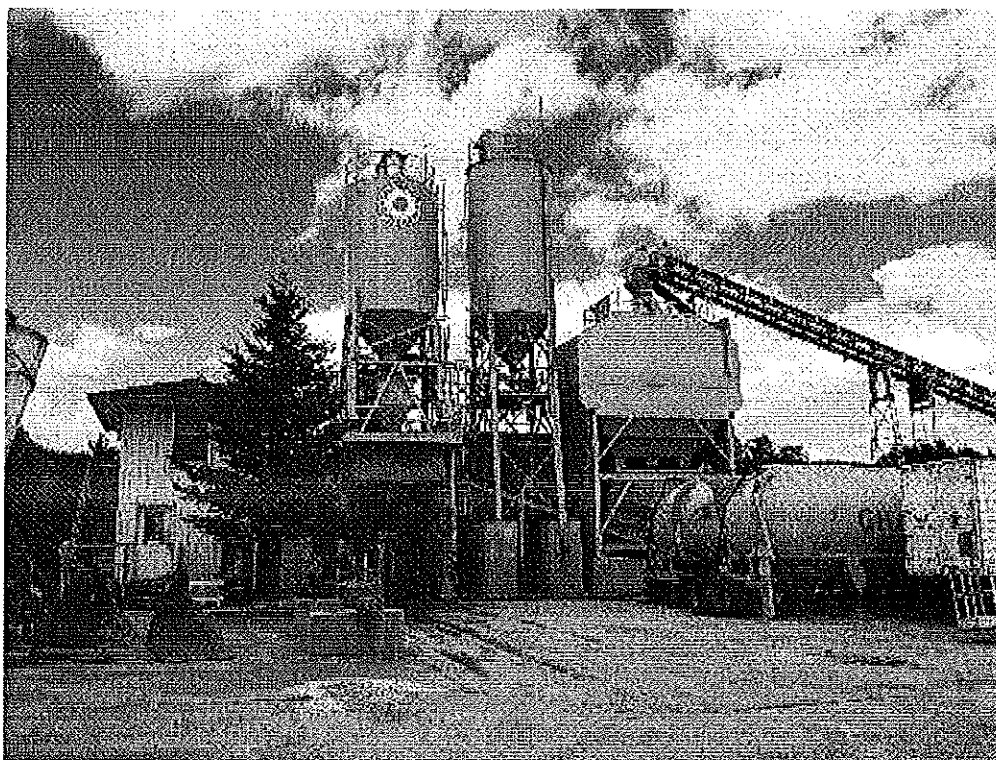
Image 3(7/23/14) : Champion Concrete batch plant, entire facility.
