DEPARTMENT OF ENVIRONMENTAL QUALITY  
AIR QUALITY DIVISION  
ACTIVITY REPORT: On-site Inspection

FACILITY: CARLETON FARMS LANDFILL		SRN / ID: N5986
LOCATION: 28800 CLARK RD, NEW BOSTON		DISTRICT: Detroit
CITY: NEW BOSTON		COUNTY: WAYNE
CONTACT: J. Bobby Reese , Environmental Manager		ACTIVITY DATE: 07/19/2022
STAFF: Mike Kovalchick	COMPLIANCE STATUS: Compliance	SOURCE CLASS: MAJOR
SUBJECT: SEM Survey		
RESOLVED COMPLAINTS:

**Major / ROP Source. Full Compliance Evaluation (FCE) and Partial Compliance Inspection (PCE) Which Consisted of an Abbreviated Methane SEM Survey**

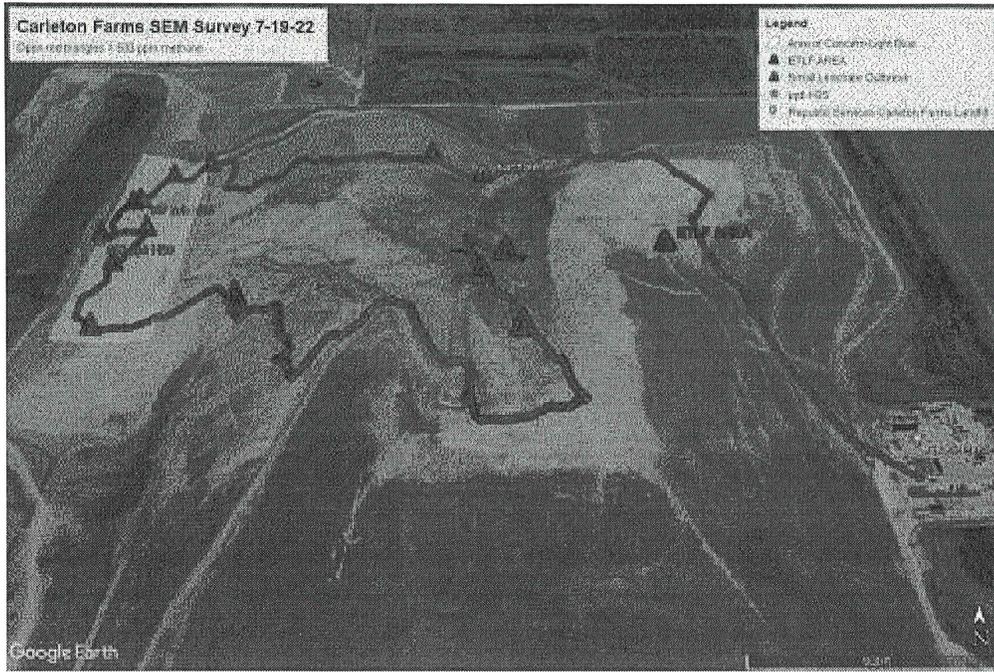
**Image 1(N5986 SEM Survey Map) :** N5986 SEM Survey Map 7/19/22

As provided in a previous table, **14** locations were found to have exceeded the 500 ppm above background threshold during the inspection. The attached aerial image of the Carleton Farms Landfill shows the path followed during the survey and the locations of methane concentrations above 500 ppm.

- Address/fix all 14 SEM hits per federal requirements.
- Upgrade the Gas Collection and Control System (GCCS) on the upper western slopes of the landfill as soon as possible.
- Conduct enhanced monitoring of the wells in the ETLF area. EGLE to provide specific requirements at a later date.
- Submit a Permit to Install (PTI) application to AQD as soon as possible so a back-up flare can be installed to address a shortfall between the amount of gas being generated by the landfill and the flaring capacity.
