DEPARTMENT OF ENVIRONMENTAL QUALITY  
AIR QUALITY DIVISION  
ACTIVITY REPORT: Scheduled Inspection

FACILITY: Cardinal Aggregates		SRN / ID: P0167
LOCATION: 3660 Carpenter Rd, YPSILANTI		DISTRICT: Jackson
CITY: YPSILANTI		COUNTY: WASHTENAW
CONTACT: Phil Eisel , Vice-President		ACTIVITY DATE: 07/26/2018
STAFF: Mike Kovalchick	COMPLIANCE STATUS: Non Compliance	SOURCE CLASS: MINOR
SUBJECT: Inspection of portable crusher on subleased land from StoneCo who leases it from Doan Companies.		
RESOLVED COMPLAINTS:

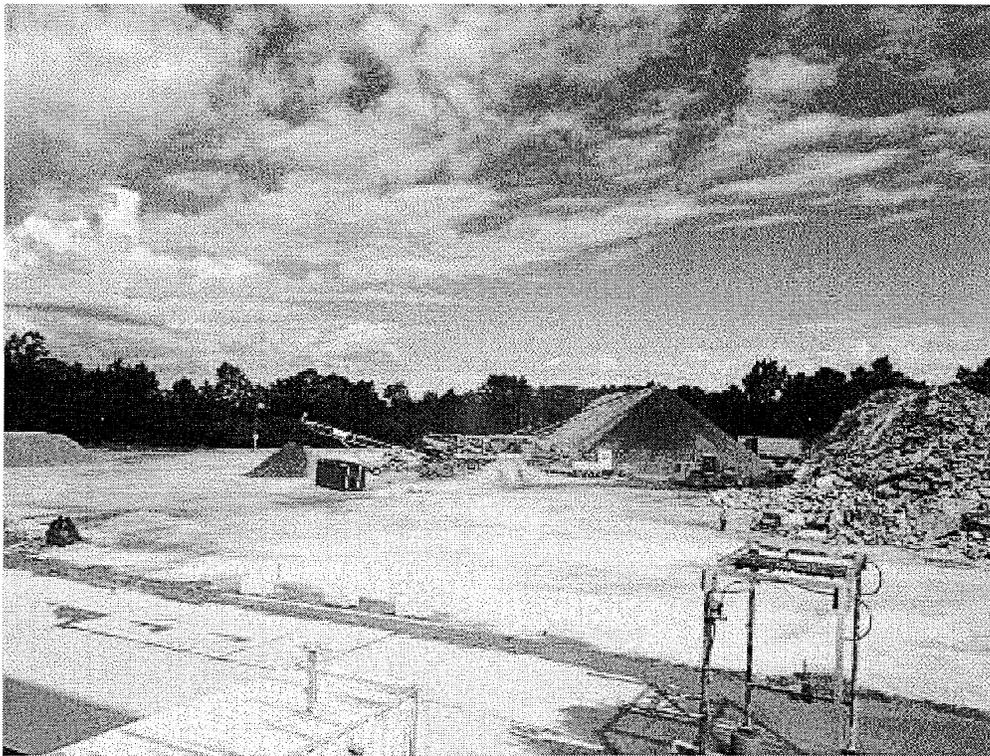
**Image 2(Crushing facility)** : Crusher on left, crushed pile in center, to be crushed pile on right. The truck wash station for Doan Companies can also be seen.

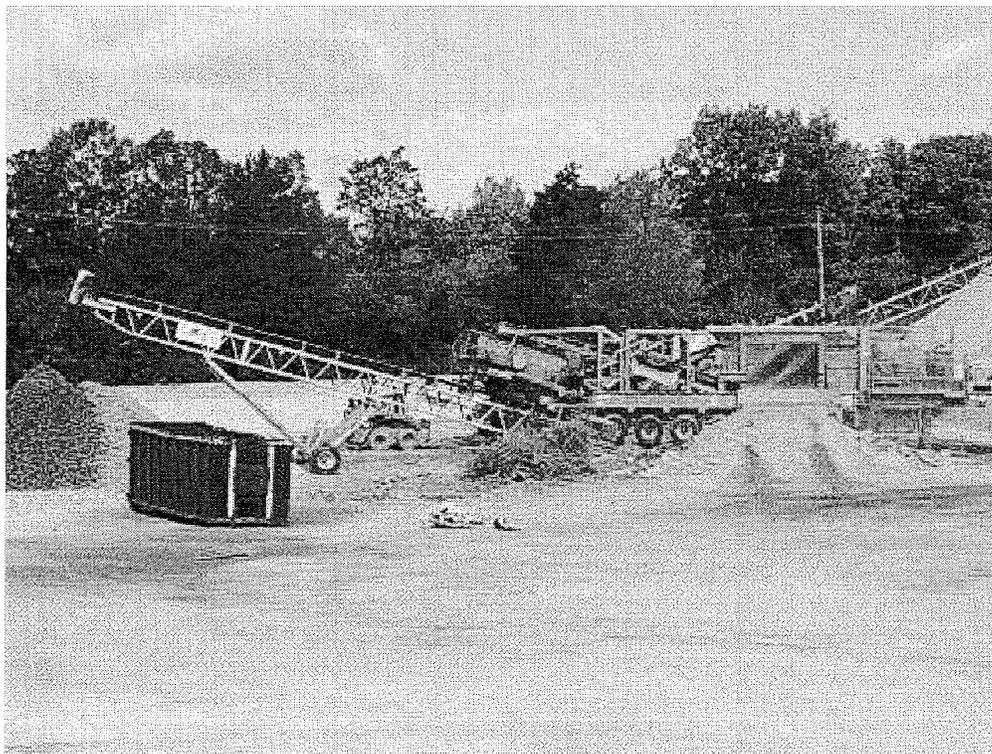
The portable plant was in operation, so I elected not to get too close to it. See attached photo. The plant was equipped with water sprays supplied by a water tank. However, the tank had run out of water and was in the process of being refilled during my inspection. The lack of water spray was resulting in excessive opacity being generated from the crushing. I estimated opacity to vary between 25 and 50%. When the water spray was turned back on, opacity dropped to less than ten percent. Dustin explain that it takes an hour to fill up the water tank so they have trouble keeping water supplied to the facility. They get their water from nearby Doan Companies facility.

**Image 3(Crusher plant)** : Crusher plant

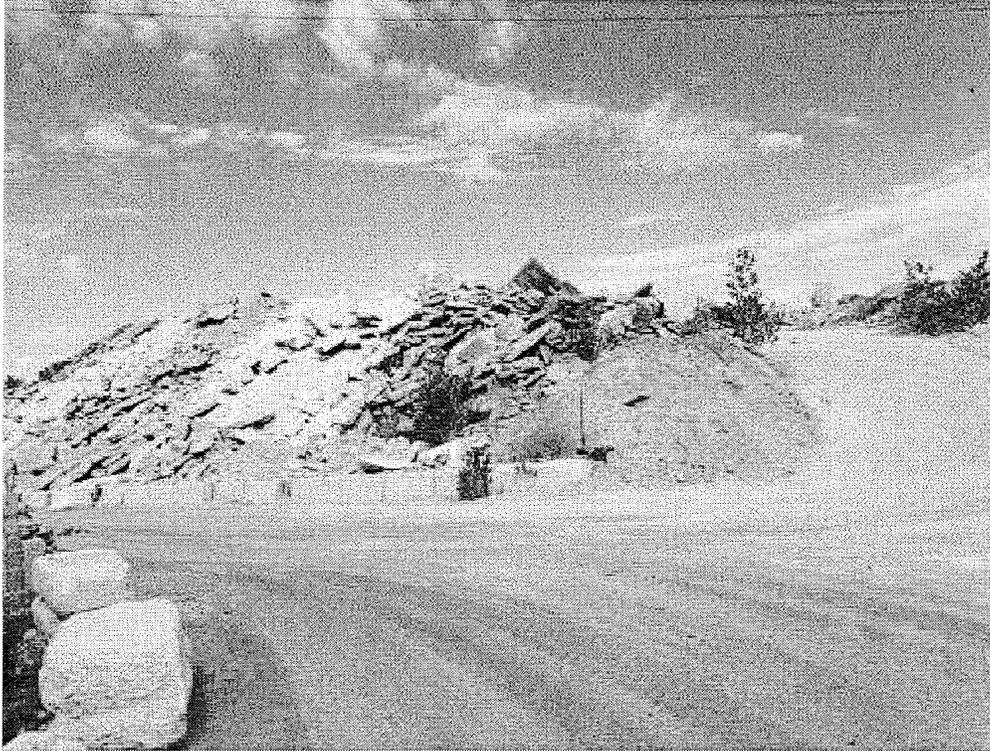
Otherwise, the only significant dust was noted was on the haul road to the top of the waste concrete dump pile. See attached photo. There was no evidence that water or dust suppressant was being used on this part of the haul road possibly because there was some confusion on who was responsible to apply it. (StoneCo, Doan, Cardinal?) Every time a truck went up this part of the haul road, excessive dust was noted.

PTI Condition # 1.6 Company not complying with their Fugitive Dust Plan Section III. Dust suppressant not be applied to concrete pile haul road.

**Image 4(Dusty haul road)** : Dusty haul road on uncrushed concrete pile.

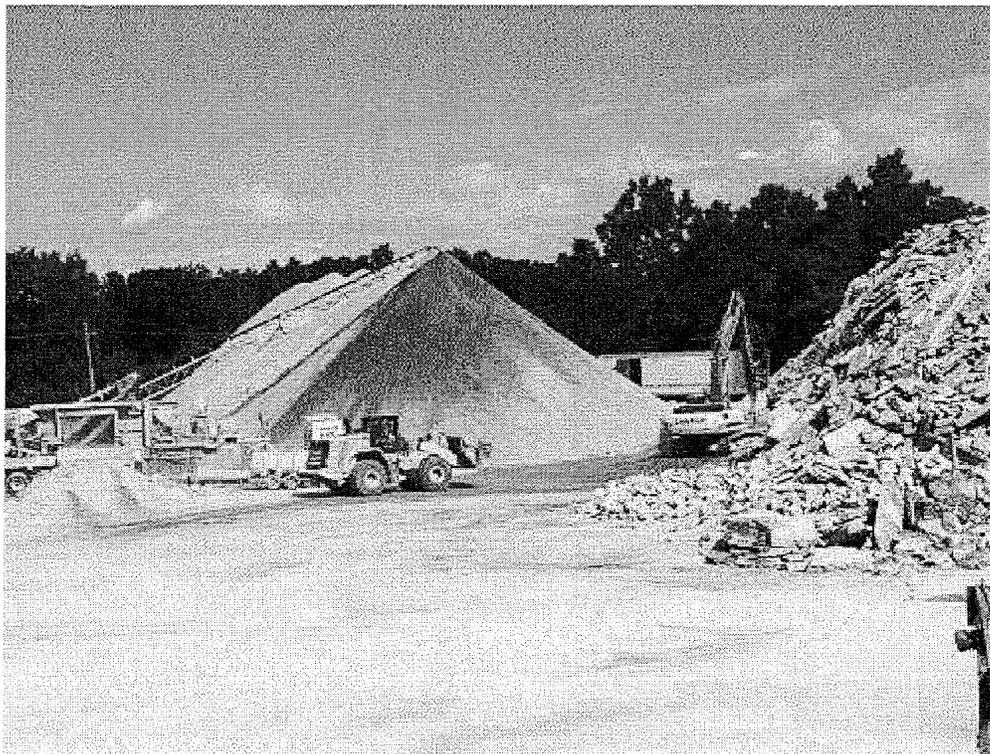
PTI Condition # 1.7 Water spray not being properly operated. Water supply to water spray not adequate to maintain enough water for continuous production.

**Image 5(Water tank)** : Small water tank that supplies the water sprays can be seen just to the left of yellow

truck.
