DEPARTMENT OF ENVIRONMENTAL QUALITY
AIR QUALITY DIVISION
ACTIVITY REPORT: On-site Inspection

P131268158

FACILITY: MICHIGAN REAGG INC		SRN / ID: P1312
LOCATION: 2420 N Grand River Avenue, LANSING		DISTRICT: Lansing
CITY: LANSING		COUNTY: INGHAM
CONTACT: Mike Busterna , Project Manager		ACTIVITY DATE: 07/12/2023
STAFF: Michelle Luplow	COMPLIANCE STATUS: Compliance	SOURCE CLASS:
SUBJECT: Onsite, self-initiated compliance inspection to determine compliance with site-specific PTI 74-23.		
RESOLVED COMPLAINTS:

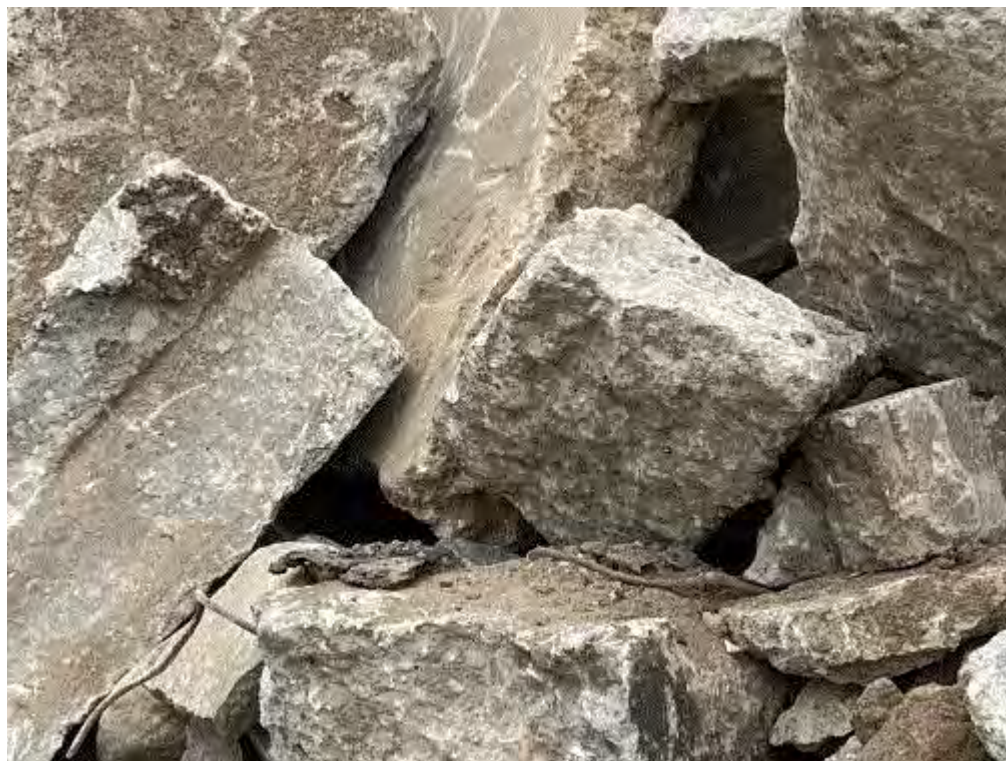
C. Dechy obtained 3 samples from the source pile that appeared suspect. Attached are the COC and sample results. All 3 samples came back negative for asbestos. MI ReAgg took 3 samples from the same materials that C. Dechy took, in addition to a 4th sample which C. Dechy identified as suspect and recommended that MI ReAgg test. MI ReAgg had their samples analyzed and the 4th sample (the sample that the AQD did not sample) came back positive for asbestos. I was informed of this 4th sample being positive on July 19, 2023, per a phone call w/ C. Dechy.

Image 1(Suspect ACM) : Photo of suspect asbestos containing material identified on site by Craig Dechy, AQD, TPU

I had a call with M. Suty to discuss this issue. In response to these findings, MI ReAgg immediately isolated the source pile where the positive sample had been found. They used caution tape to ensure it remained isolated from the rest of the material. This pile, he said will not be touched for processing. Instead, the materials in the isolated pile will be disposed of in a dumpster lined properly for asbestos-containing materials and waste-manifested and disposed of as such. He explained that as a result of this finding, they will develop a standard operating procedure. While this SOP is being developed, he said that they will train the front-end loader operator and the 2 crusher operators on what to look for. If they find suspect materials, they will stop work, take samples, and leave the area within which they found the suspect materials untouched until they can confirm whether the materials are asbestos-containing or not.

On July 26, 2023, M. Suty provided a rough draft of the SOP and on August 17, 2023, M. Suty sent me a finalized copy of their SOP, attached. The SOP appears to address asbestos-containing materials found in the source pile. Future inspections may be conducted to confirm the SOP is sufficient for addressing these issues.
