**DEPARTMENT OF ENVIRONMENTAL QUALITY
AIR QUALITY DIVISION
ACTIVITY REPORT: On-site Inspection**

FACILITY: Mid Michigan Materials-Vella Pit		SRN / ID: P1357
LOCATION: 4984 EARHART ROAD, ANN ARBOR		DISTRICT: Jackson
CITY: ANN ARBOR		COUNTY: WASHTENAW
CONTACT: Robert Wilson , Vice President		ACTIVITY DATE: 10/02/2023
STAFF: Mike Kovalchick	COMPLIANCE STATUS: Compliance	SOURCE CLASS:
SUBJECT: Compliance inspection of a sand and gravel operation. No dust observed.		
RESOLVED COMPLAINTS:

Minor Source: Compliance Inspection

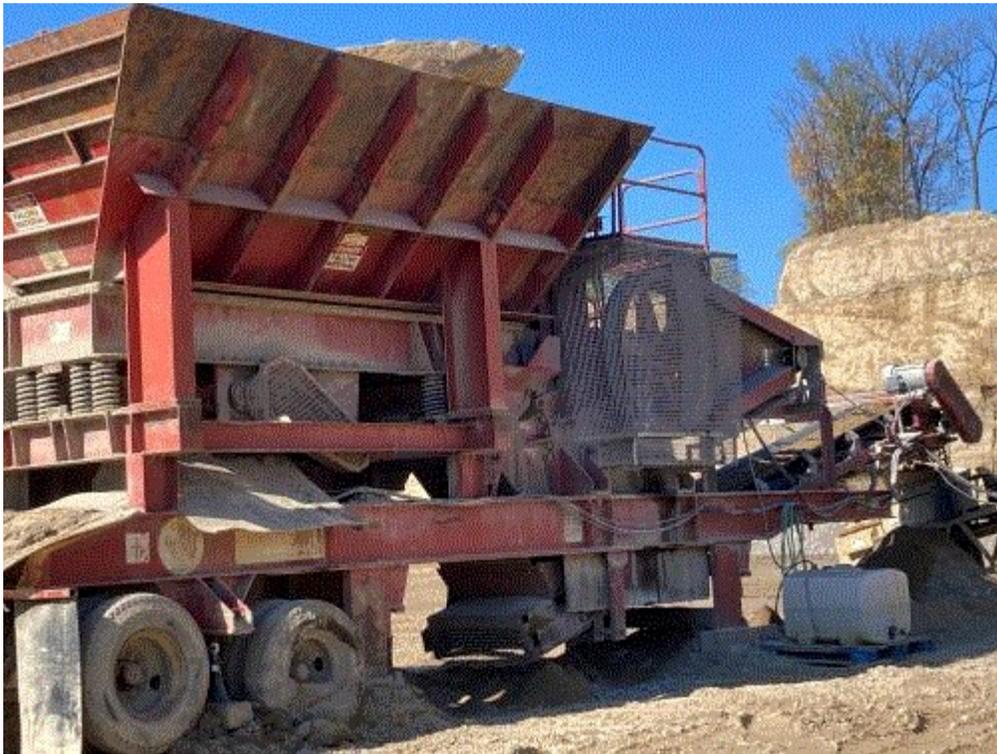
NK gave me a tour of the facility which included first visiting a primary crusher rated at 450 ton/hour. This crusher was equipped with a water spray bar and a water tank. The spray bar needed a new part and wasn't operating during the inspection. However, despite this, no dust was observed from the actively operating crusher as the material being processed was mostly moist sand mixed with rocks. Next, we visited other locations inside the quarry including the wash plant and various material storage piles (See attached photos.) No dust was observed either in the air or on vegetation that surrounded the operation nor from any of the conveyors, feeders, screens or storage piles. A water truck was observed. NK indicated that the truck waters all accessible areas at least a couple of times a day and had already been out that morning. Occasionally, an outside contractor is used to apply brine to the roads. Finally, we visited an area just West of the existing quarry. This area is significantly elevated above the quarry floor and is being prepped for future quarry expansion. It appeared that vegetation had been recently removed and the ground graded. It is probable that this area was likely the cause of recent dust complaint. (See attached photo.) No dust was observed in this area either as it appeared that they had mostly finished work in this area for present time. Overall, given the type/moisture content of material and the high levels of water in the quarry, the potential for dust generation is much lower than other quarry locations that we inspect.

Image 1(Crusher) : Primary crusher

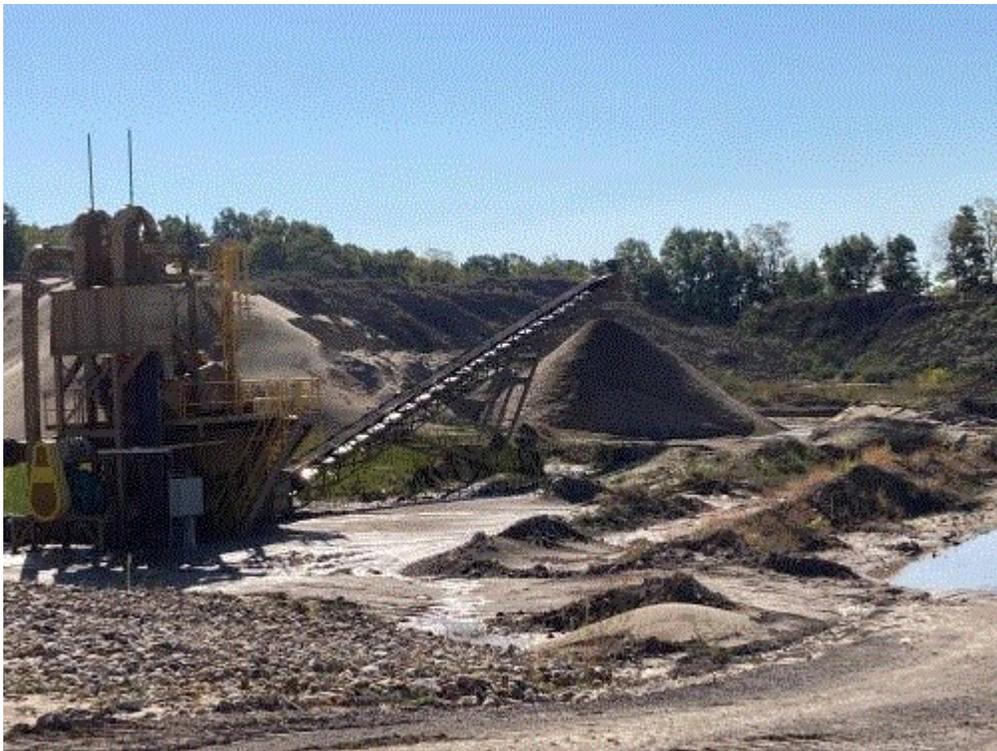
Image 2(Wash Plant) : Wash Plant

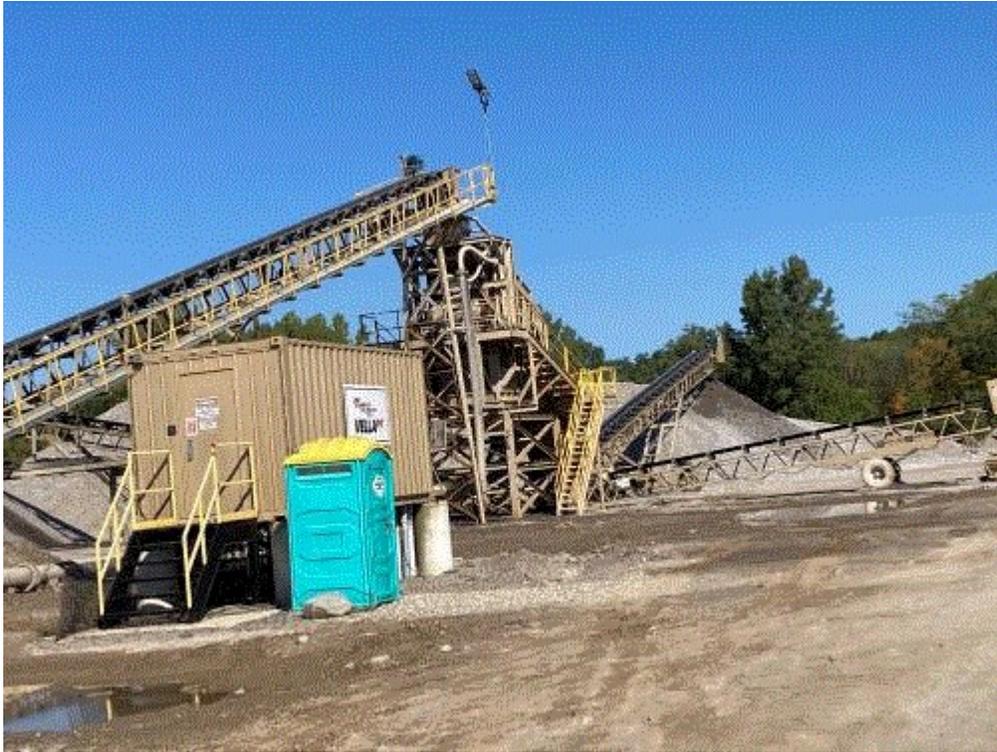
Image 3(Wash Plant) : Part of wash plant.

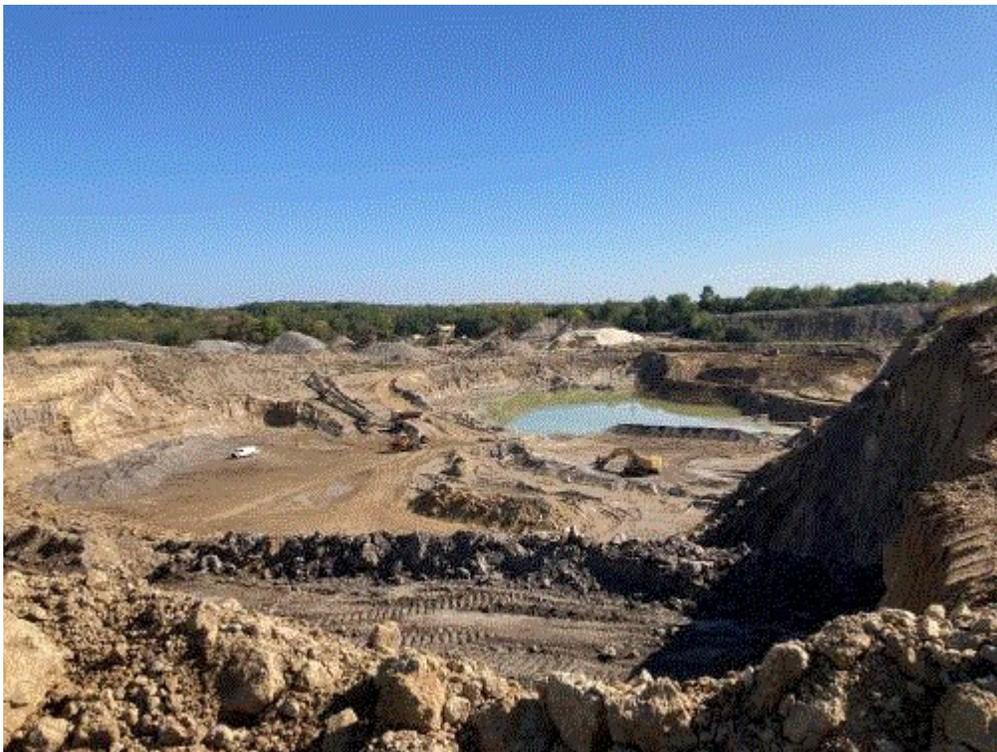
Image 4(Quarry) : Quarry looking east.

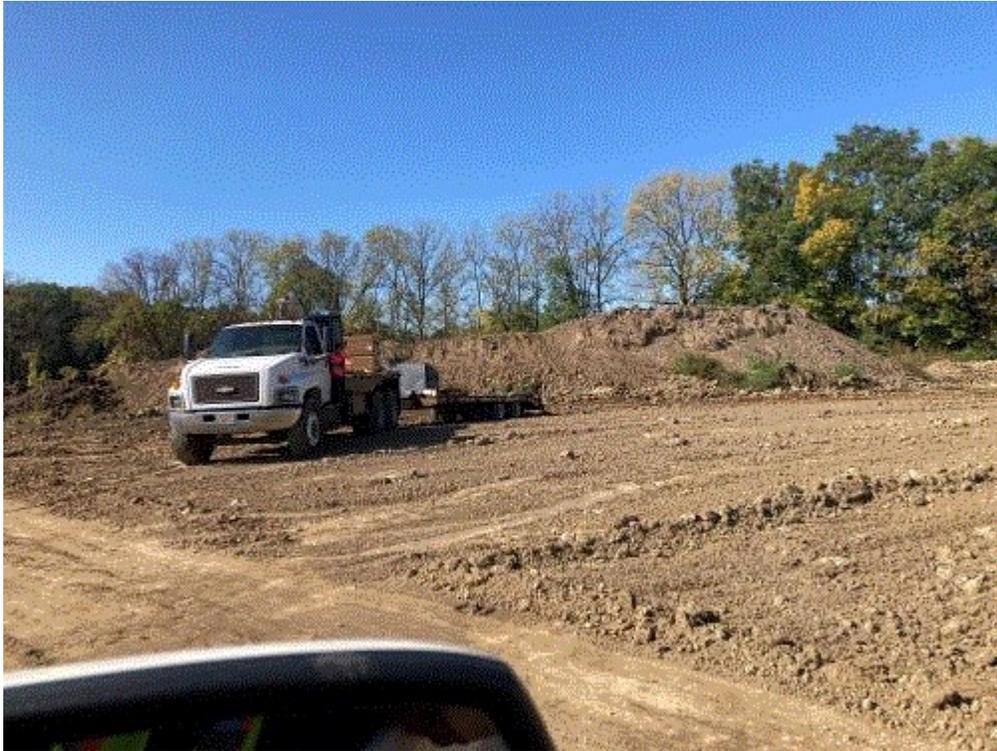
Image 5(New Area) : New area being prepped for future expansion.

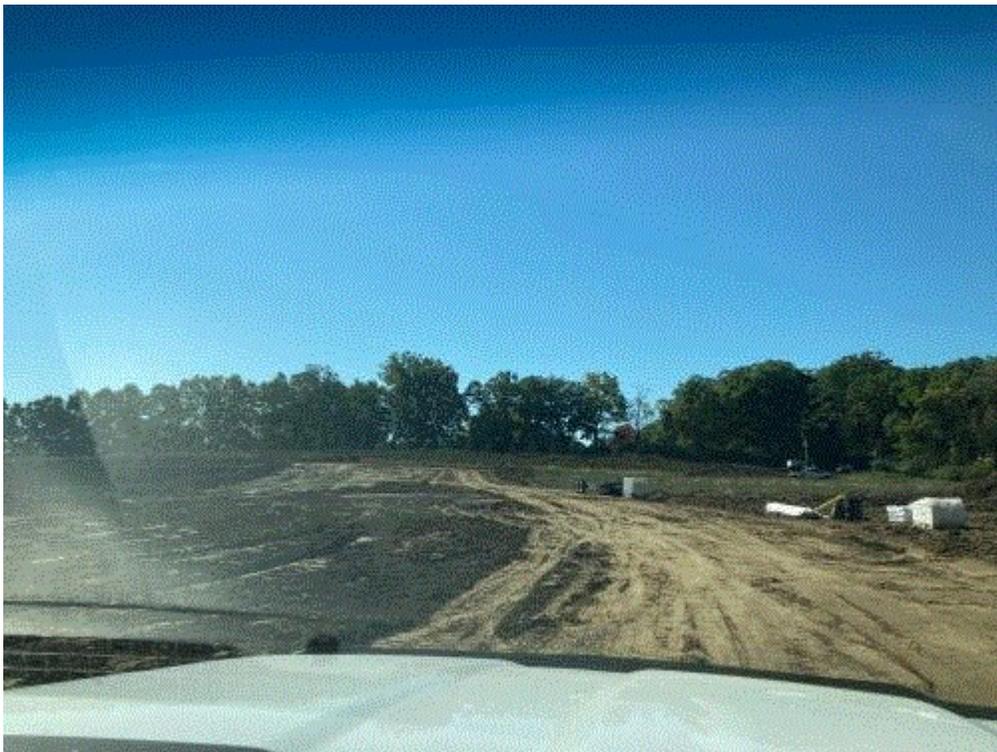
Image 6(New Area) : New area being prepped for future expansion.
