December 16, 2024

## **Re: Violation Notice:** Failure to provide 10 working day notification prior to demolition-8046 Hardyke

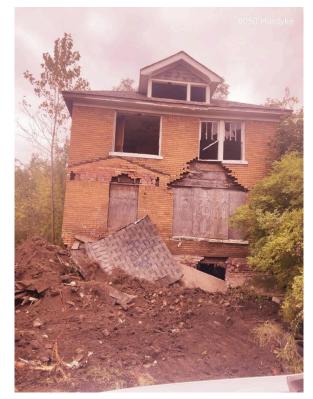
Upon completing this activity phase, the site was incorrectly marked 8050 Hardyke.

Figure 2. Photo provided by crew after water disconnect, with address marked on the collapsed roof

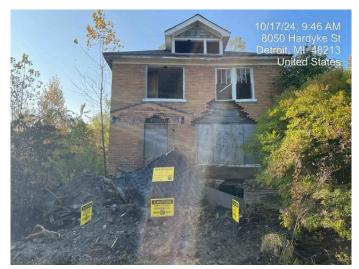
Upon completing this activity phase, the site was incorrectly staged as 8050 Hardyke.

Figure 3. Photo provided by crew after staging the home, with address marked on poster

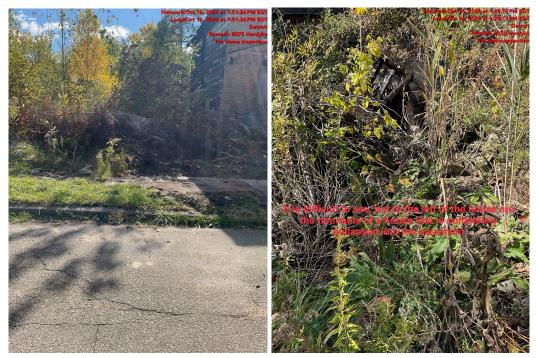
Figure 4. Photo provided by crew during our pre-demo inspection, what has now been identified as the collapsed structure of 8050 Hardyke was called out, but unidentifiable.
