DEPARTMENT OF ENVIRONMENTAL QUALITY
AIR QUALITY DIVISION
ACTIVITY REPORT: Scheduled Inspection

FACILITY: BMC Global, LLC dba Blissfield Manufacturing		SRN / ID: A2889
LOCATION: 626 DEPOT ST, BLISSFIELD		DISTRICT: Jackson
CITY: BLISSFIELD		COUNTY: LENAWEE
CONTACT: Rebecca Parott , Quality Auditor		ACTIVITY DATE: 04/27/2017
STAFF: Mike Kovalchick	COMPLIANCE STATUS: Compliance	SOURCE CLASS: SM OPT OUT
SUBJECT: Scheduled Inspection of an Opt-Out Source.		
RESOLVED COMPLAINTS:

SM Opt Out Source for HAPs. Full Compliance Evaluation (FCE) 2017

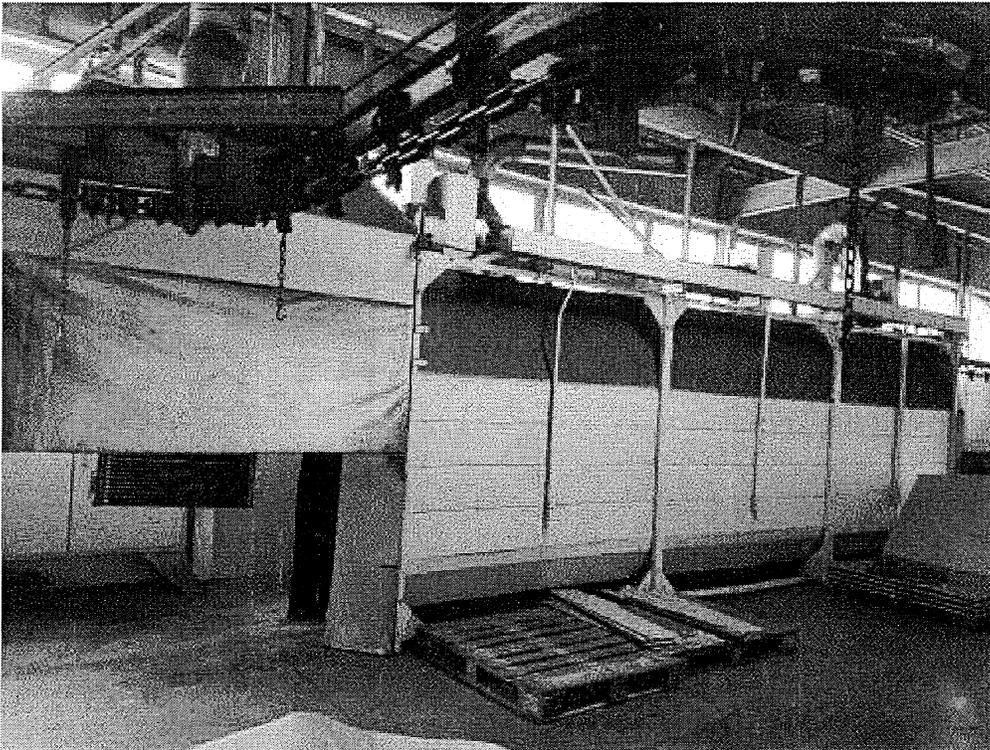
metal oil cooler parts hanging on the conveyor but wasn't turned on during the inspection. Parts come into a booth like structure around the dip tank, lowered then raised out of the paint reservoir. At that point, a hand held air gun is pointed at the part to remove the excess paint. The air stream essentially blasts off the excess paint which hits the side of the wall then drains back into the paint reservoir. Then the conveyor brings the part to a nearby oven that has 2 exhaust stacks. There is no thermocouple on the oven but the operator estimated the temperature to be 250 to 300 deg. F. It takes about 15 minutes for a part to go through the oven. See attached pictures.

Image 2(Oven #3) : Exit of the oven for dip tank #3

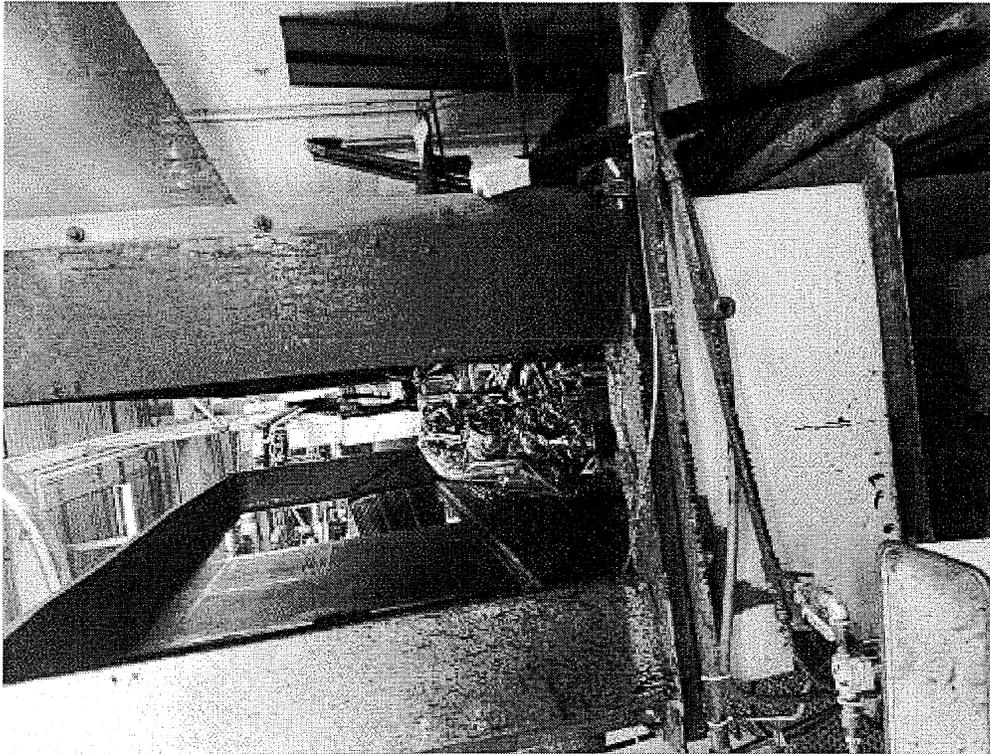
We first went over to inspect dip tank # 3 and the associated electric powered oven. The line had a few

Image 3(Dip tank #3) : Dip tank #3. (Rotate right 90 degrees)

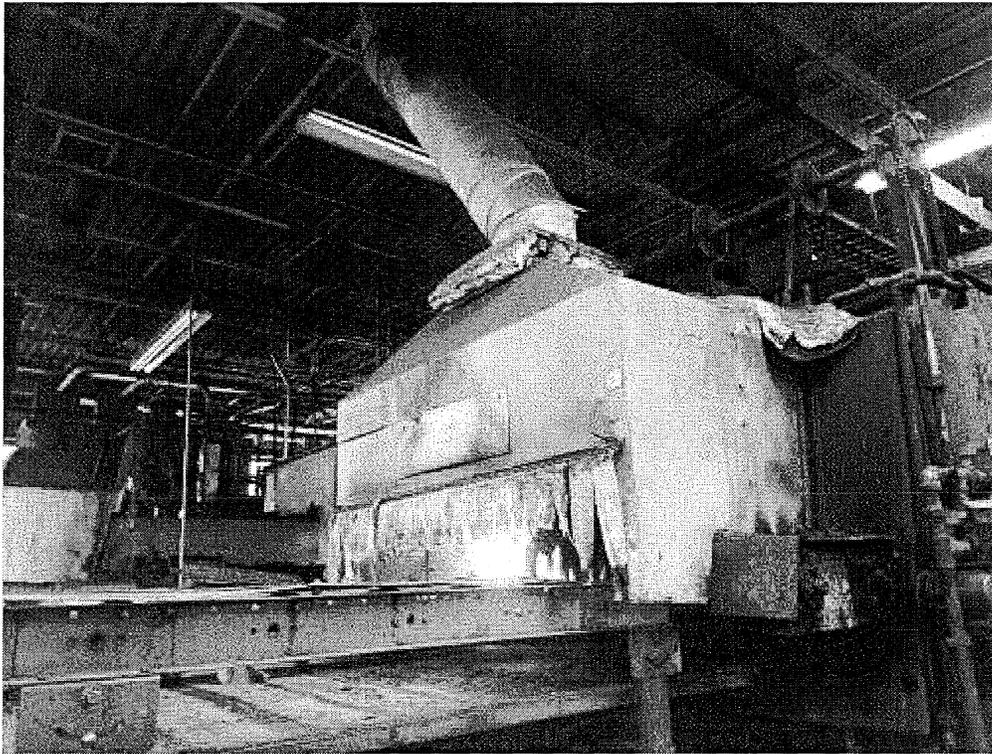
Next we walked by a brazing oven. Small amounts of a copper paste that contains up to 20% nickel along with a copper powder that contains up to 40% zinc are applied to metal parts then heated to 2000 deg F. in the oven. There are open flames on both sides of the oven with an exhaust stack with no blower on each end. See attached photos. In the middle of the oven there is a water cooling system that exhausts to a water cooling tower on the roof. The process was on but no parts were going through it during the inspection and no smoke was observed. The process was very old and the operator was unaware of the BTH ratings on the oven.

Image 4(Entr. Brazing Oven) : Entrance to the Brazing Oven

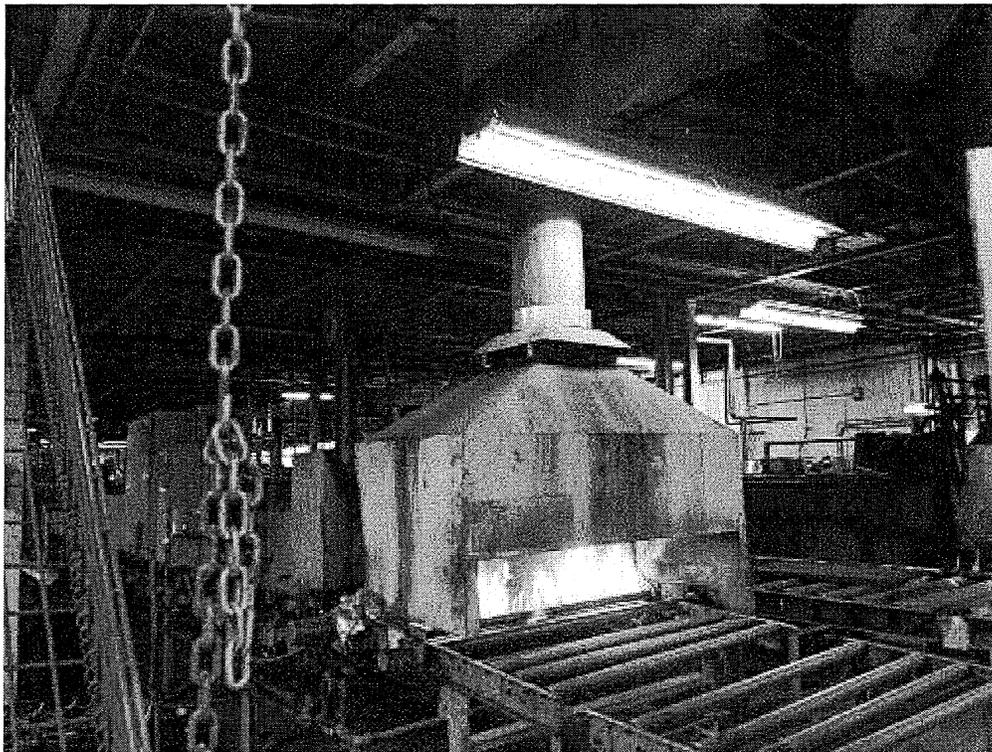
Image 5(Exit Brazing Oven) : Exit Brazing Oven

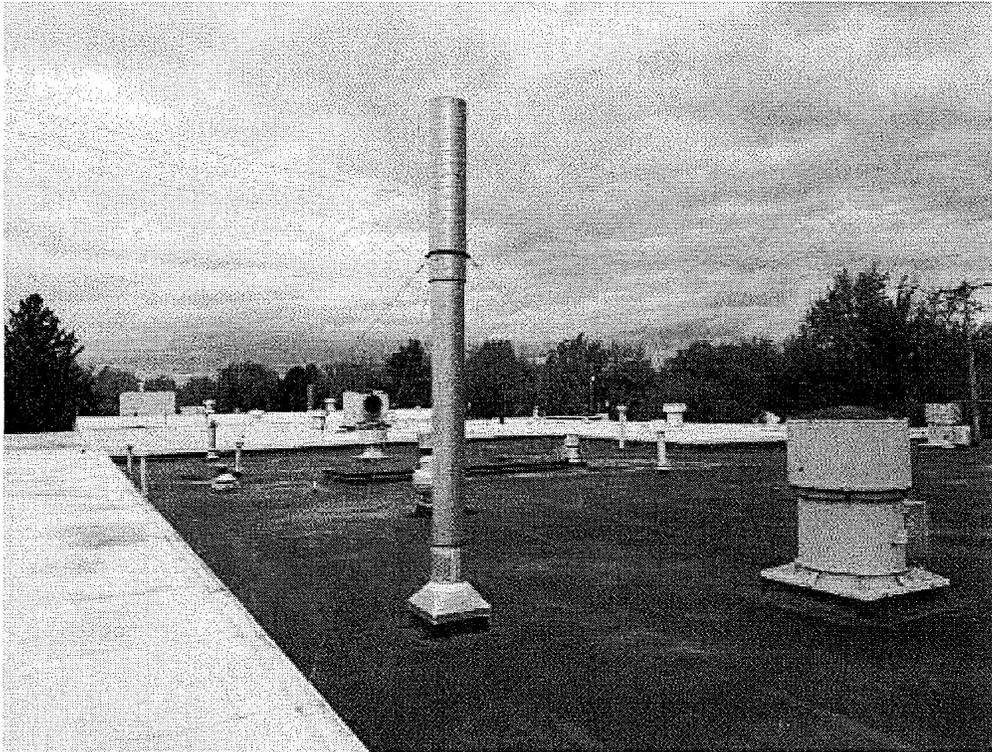
Image 6(Oven Stacks) : One of the oven stacks

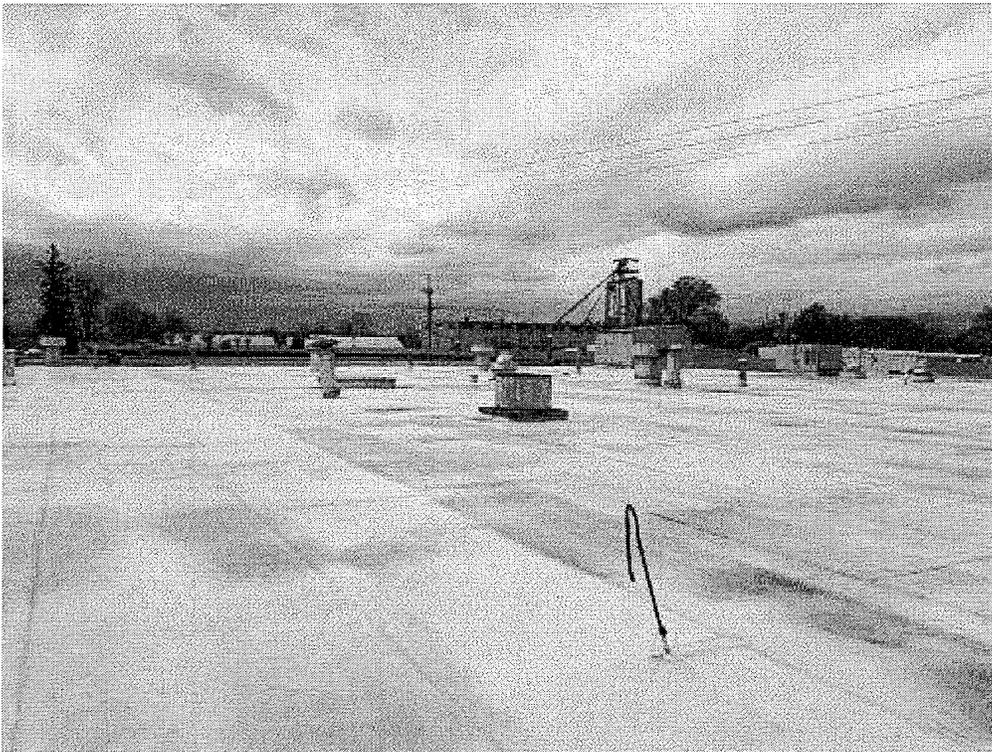
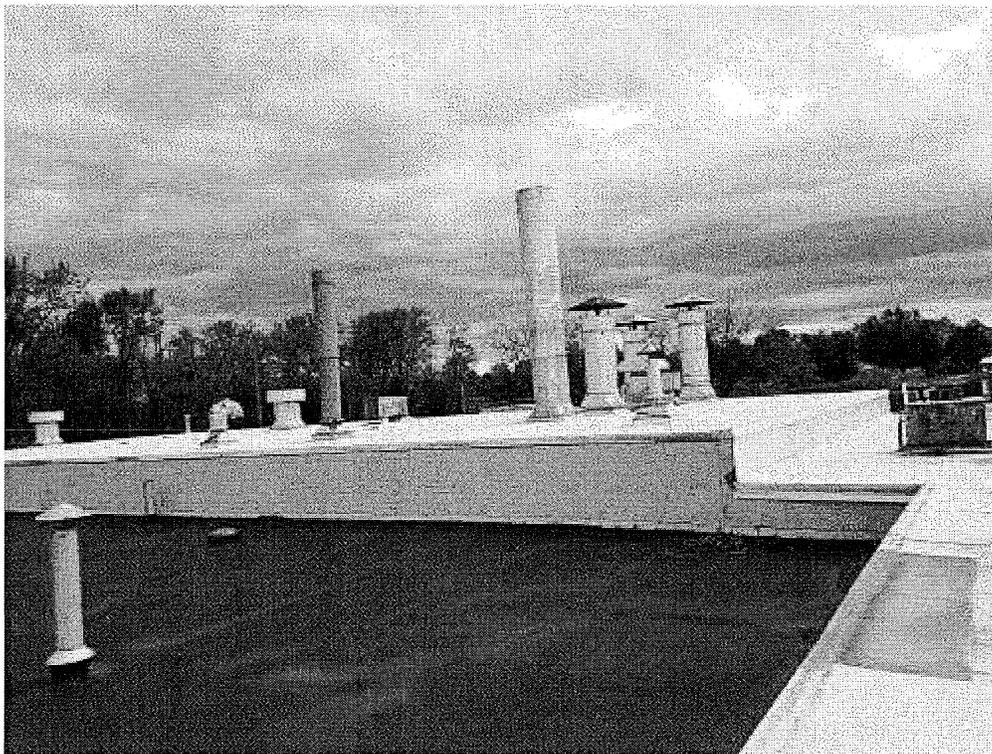
We concluded the inspection by going up on the roof. The roof is accessed by a permanent ladder attached to the outside wall. The roof area was very extensive with numerous stacks and vents of all shapes and sizes. See attached photos. Many of the stacks were no longer active. No smoke or particulate fall out was observed. Heat waves were observed coming out of one of the stacks associated with the brazing furnace. The water cooler tower was inspected. Water could be seen pouring down the side of it. Small amount of water was leaking out of the tower and on to the roof. Essentially, air is drawn in one side of the apparatus and exits the other side. There is some minor concern for mold/fungus growth and associated odor due to presence of the hot water and the filter like interior of the water cooler but little odor was noted.

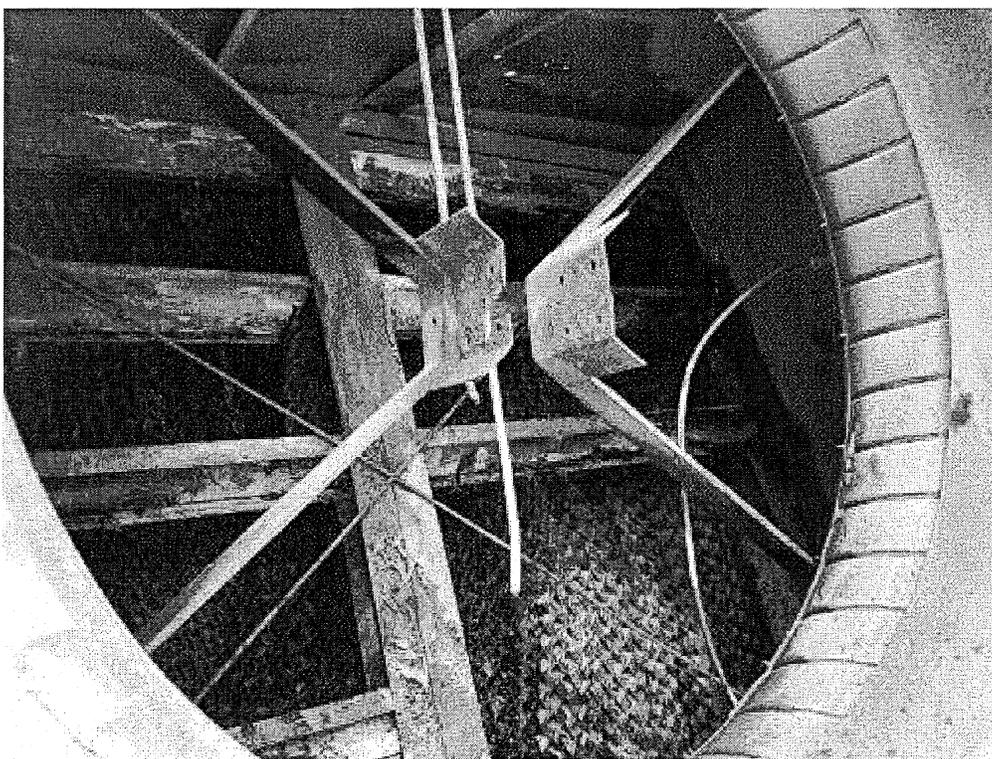
Image 9(Exit Water Cooler) : Exit exhaust from water cooler tower used for the brazing furnace

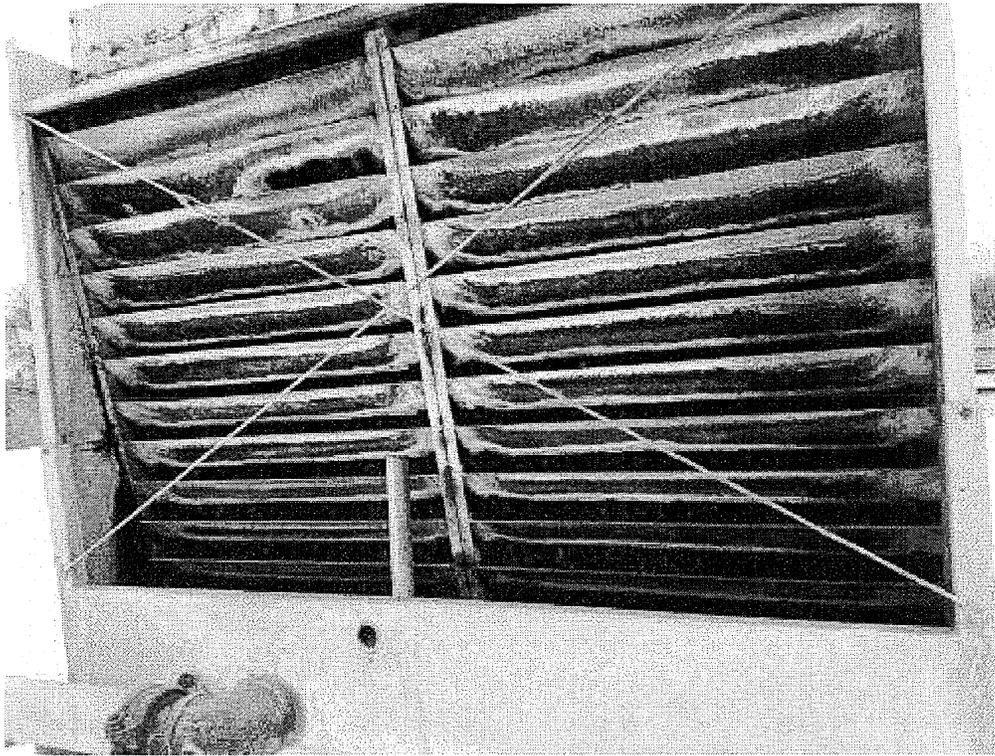
Image 10(Entrance Water Coole) : Entrance exhaust to water cooler tower for brazing oven located on the roof above the brazing process
