RE: Diamond Chrome Plating, Inc. Response to October 30, 2019 Violation Notice

Attachment 1
Photographic Log – Diamond Chrome Vapor Degreaser
November 1, 2019

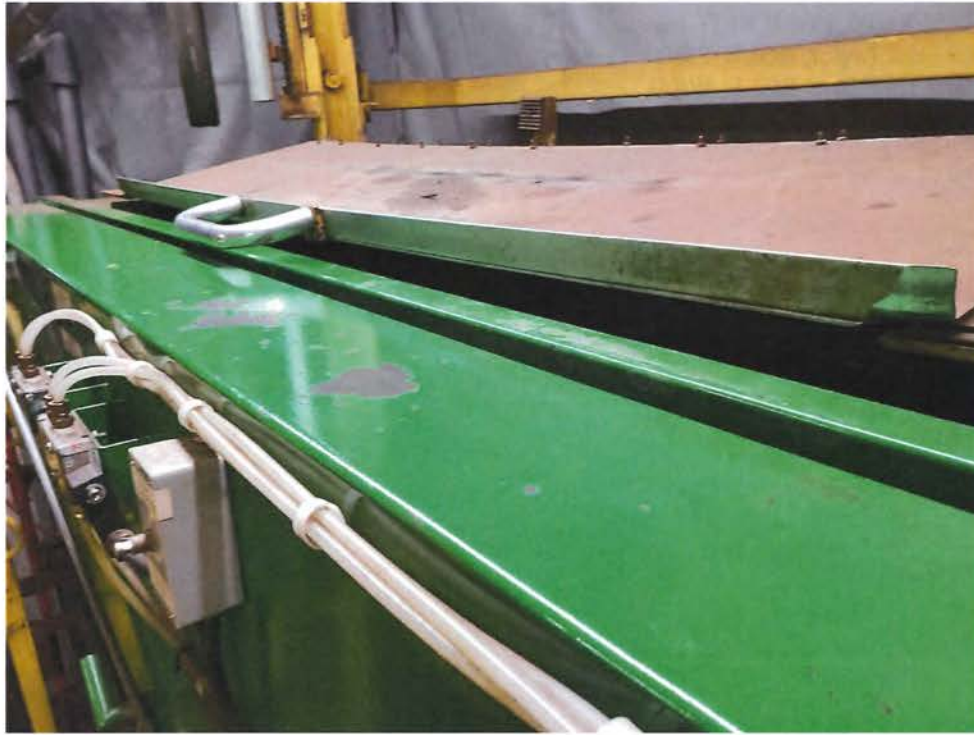
During the inspection conducted by the AQD on October 17, 2019, staff observed operation of the BACT-72A vapor degreaser, while examples of parts were being cleaned. The built-in roof of the parts basket, which had been lowered into the degreaser, was functioning as the working mode cover of the degreaser. However, there was a gap of more than an inch between the working mode cover and the degreaser itself. It is my understanding that DCP intends to cover or seal this opening with a TCE-resistant material.

The cover is intended to function as one of the air pollution controls for the degreaser, but the gap between cover and degreaser appeared to be a source of fugitive TCE emissions. This constitutes a violation of Rule 910 of the administrative rules promulgated under Act 451, which requires that an air-cleaning device shall be installed, maintained, and operated in a satisfactory manner, and in accordance with the administrative rules and existing law.

The gap between the working mode cover and the vapor degreaser indicates that it does not completely cover all cleaning machine openings when closed. This is a violation of Section 63.463(e) (iii) (A).

The gap between the working mode cover and the vapor degreaser is considered by the AQD to be a defect with the cover. This is a violation of Section 63.463(e)(iii)(B).

Photo 1: View of approximate 1-inch gap between the working mode cover and degreaser.

As discussed with EGLE AQD during the on-site inspection on October 17, 2019, DCP has addressed the gap between the working mode cover and the degreaser itself by installing a new seal; the new seal was installed on November 1, 2019. Photographs prior to, and following implementation of the corrective action, are included in **Attachment 1**.

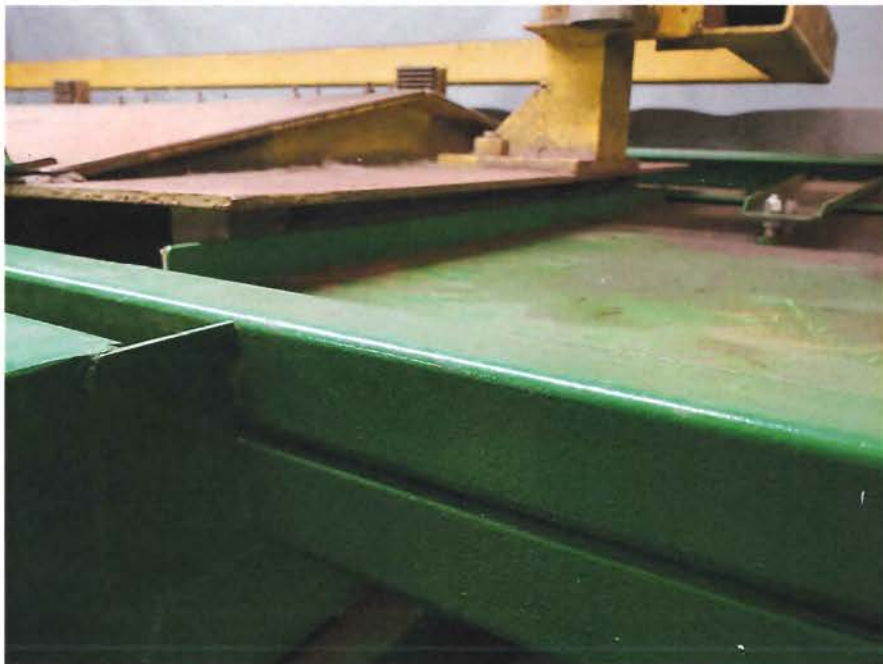
Photo 2: View of approximate 1-inch gap between the working mode cover and degreaser.

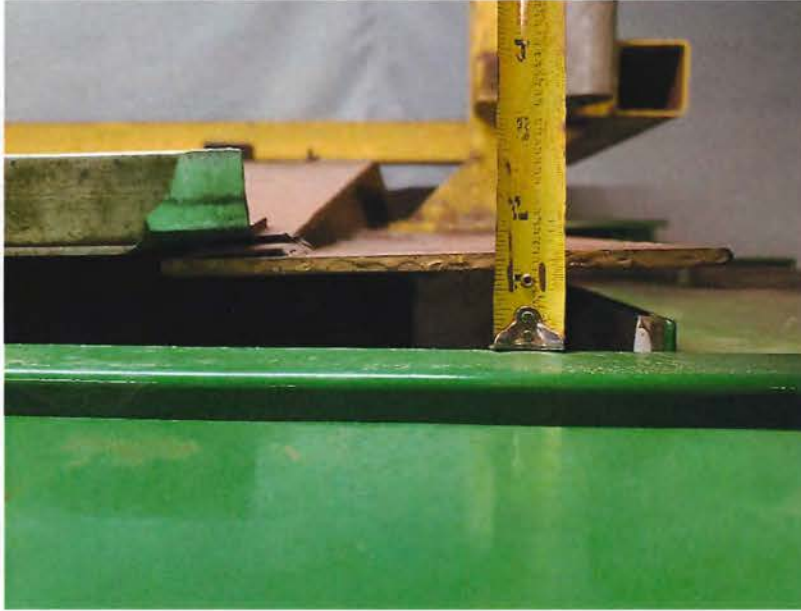
Photo 3: View of approximate 1-inch gap between the working mode cover and degreaser.

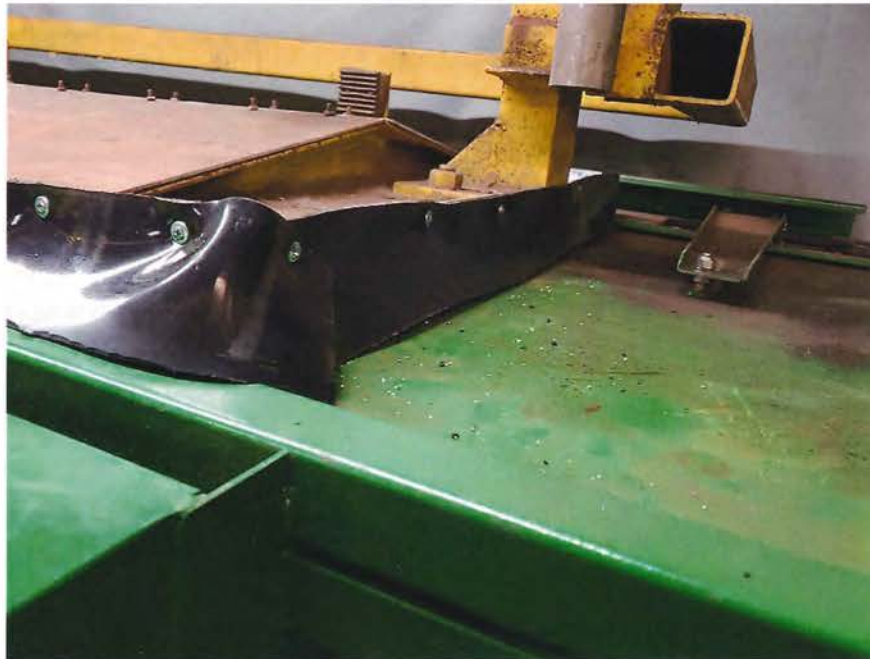
Photo 4: View of rubber shield installed on November 1, 2019 to cover gap between working mode cover and degreaser.

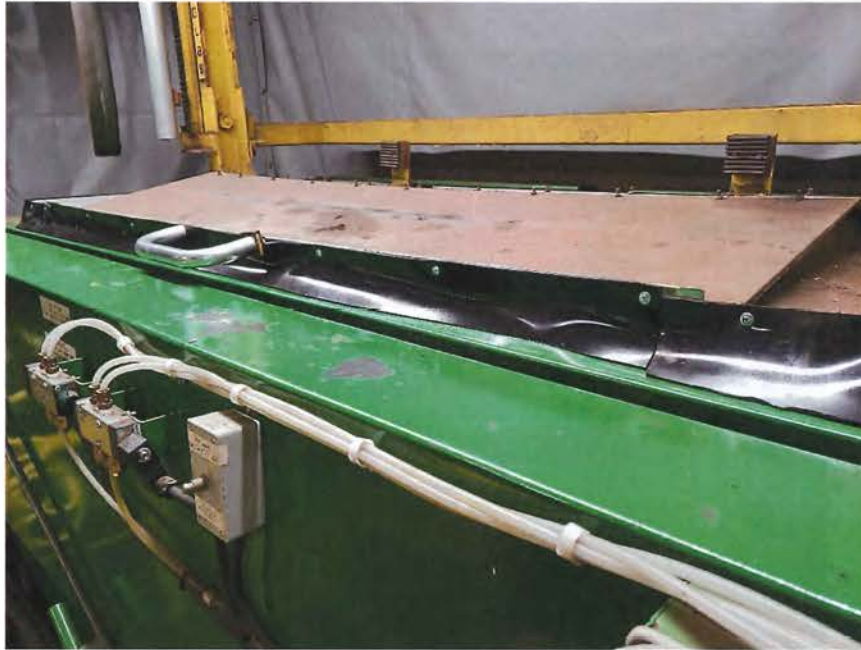
Photo 5: View of rubber shield installed on November 1, 2019 to cover gap between working mode cover and degreaser.

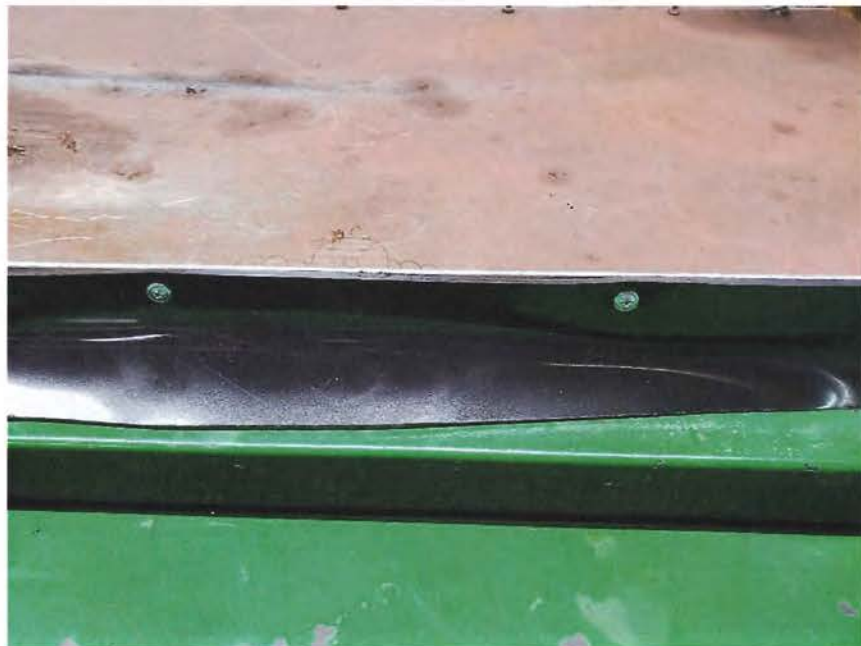
Photo 6: View of rubber shield installed on November 1, 2019 to cover gap between working mode cover and degreaser.

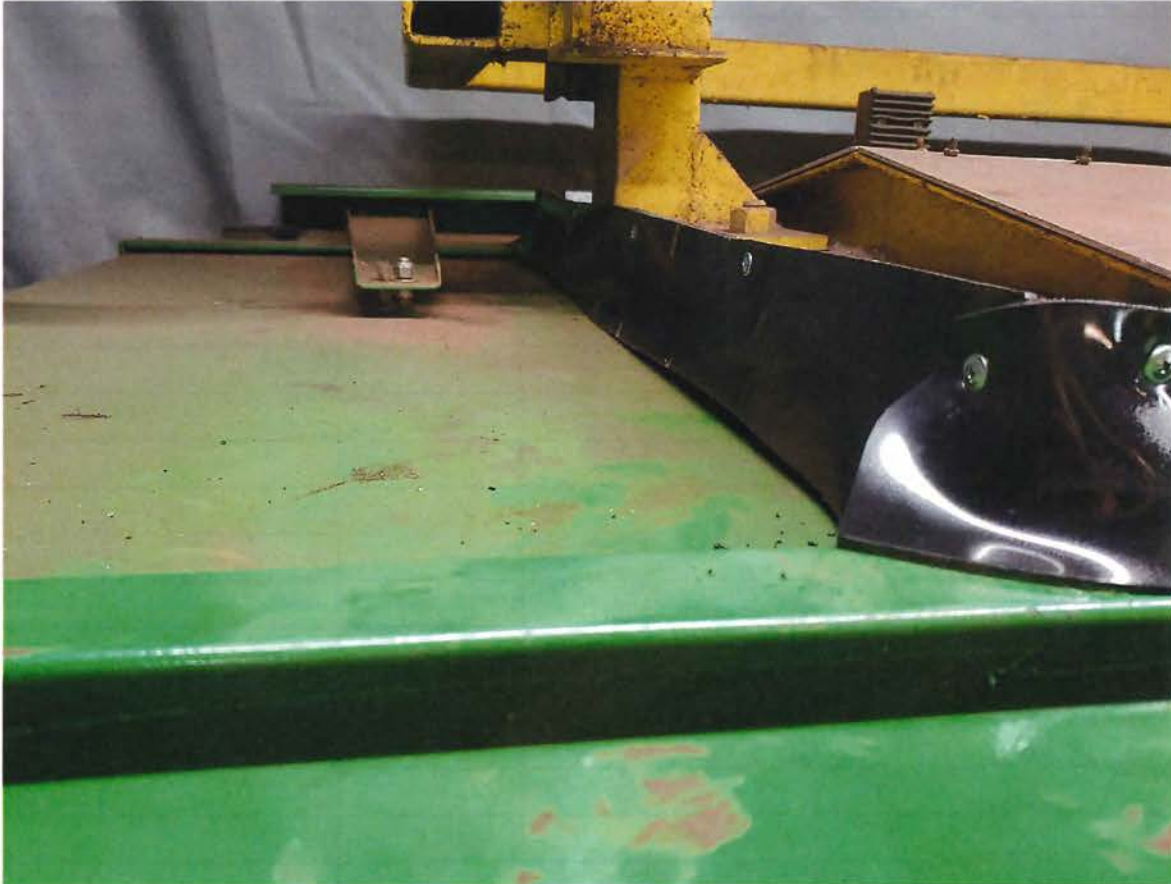
Photo 7: View of rubber shield installed on November 1, 2019 to cover gap between working mode cover and degreaser.
