DEPARTMENT OF ENVIRONMENTAL QUALITY
AIR QUALITY DIVISION
ACTIVITY REPORT: Scheduled Inspection

FACILITY: DIAMOND CHROME PLATING INC		SRN / ID: A2931
LOCATION: 604 S MICHIGAN, HOWELL		DISTRICT: Lansing
CITY: HOWELL		COUNTY: LIVINGSTON
CONTACT: John Wagner, Director - Health, Safety & Environmental Affairs		ACTIVITY DATE: 09/16/2015
STAFF: Daniel McGeen	COMPLIANCE STATUS: Compliance	SOURCE CLASS: MINOR
SUBJECT: Unannounced, scheduled inspection.		
RESOLVED COMPLAINTS:

On 9/16/2015, the Department of Environmental Quality, Air Quality Division, conducted an unannounced, scheduled inspection of Diamond Chrome Plating (DCP).

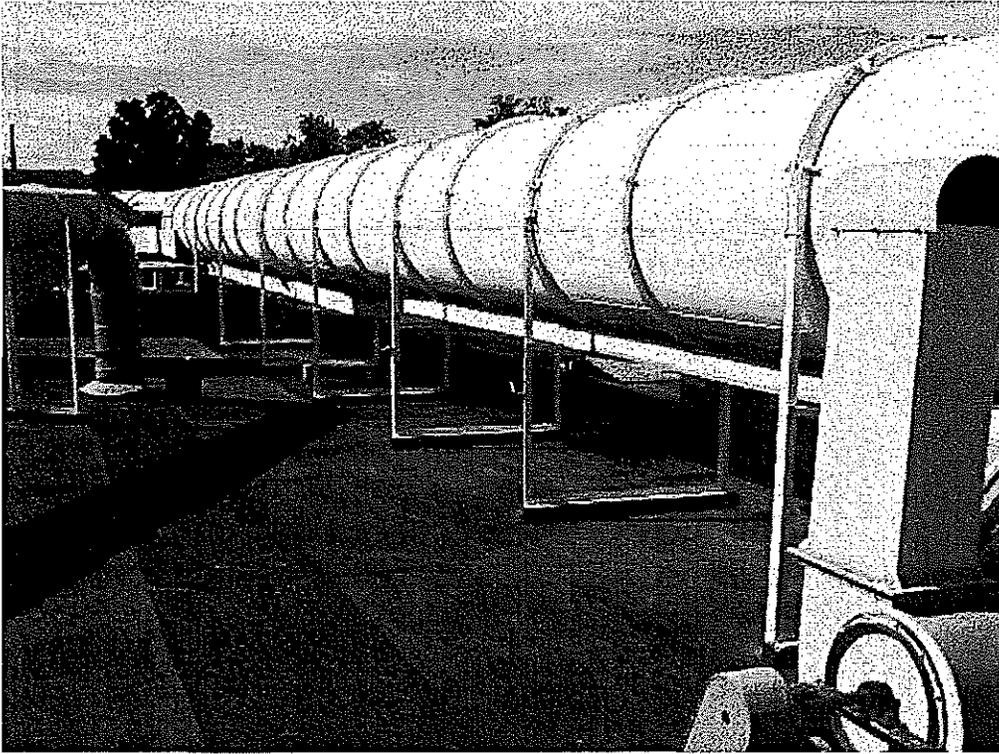
All of the ductwork on the roof appeared clean, and free of leaks or "weeps." Please see attached photos. I looked on the underside of the rooftop ductwork, as well I could not find signs of any wet or dried leaks. I also looked in the catch trays underneath the ducts, and could not find any puddles of chromic acid. The catch trays have hoses which would route collected liquids into the plant and into the pits underneath the chrome plating tanks. Side shields or wind baffles along the ducts and catch trays were intended to offer shelter from wind and/or rain, to prevent re-entrainment of any collected chromic acid liquids that might be in the catch trays. I could not see any chromic acid stains visible on the asphalt-covered roof.

Image 1(Photo 1) : Looking south, at ductwork south of scrubber No. 3.

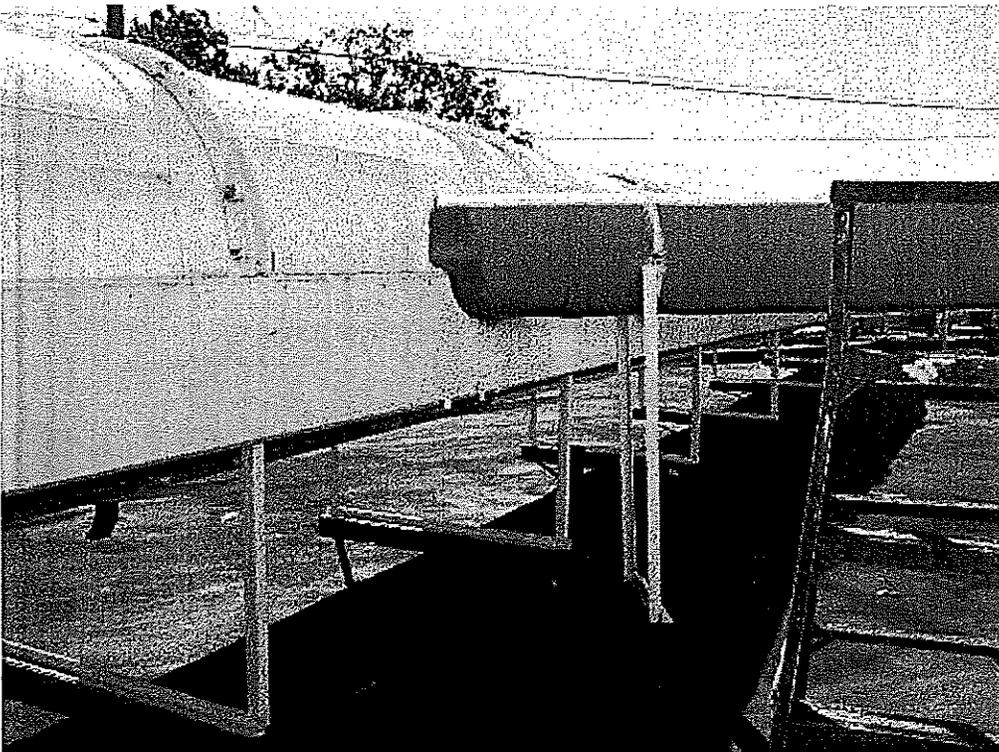
Image 2(Photo 2) : Looking south at ductwork leading away from scrubber No. 4.

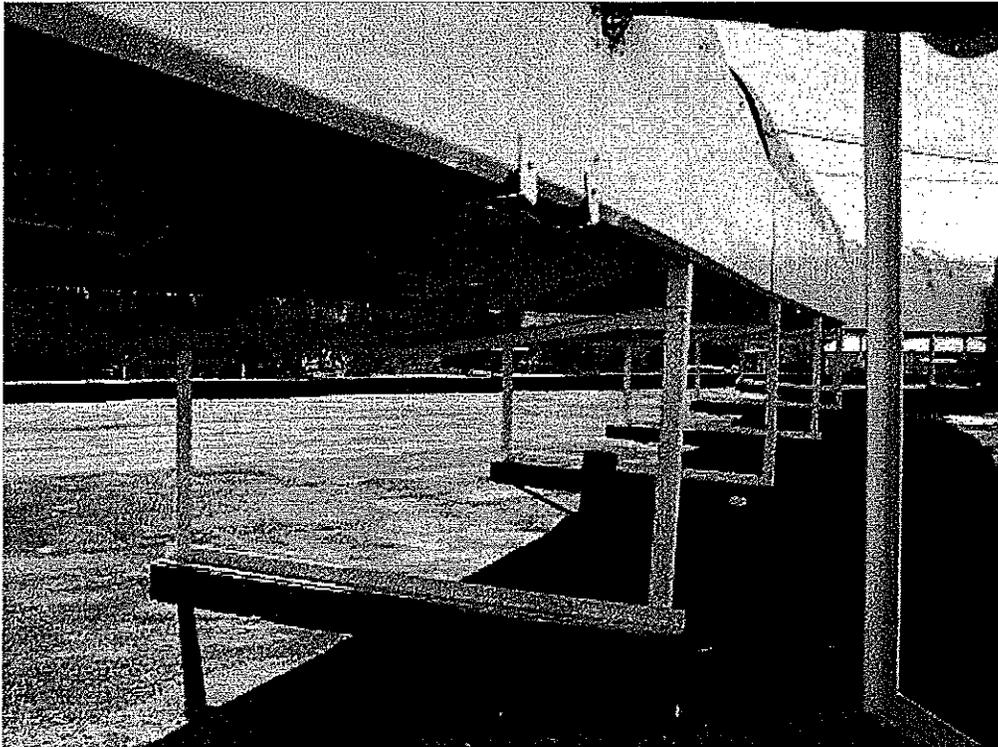
Image 3(Photo 3) : Underside of the ductwork in photo 2.

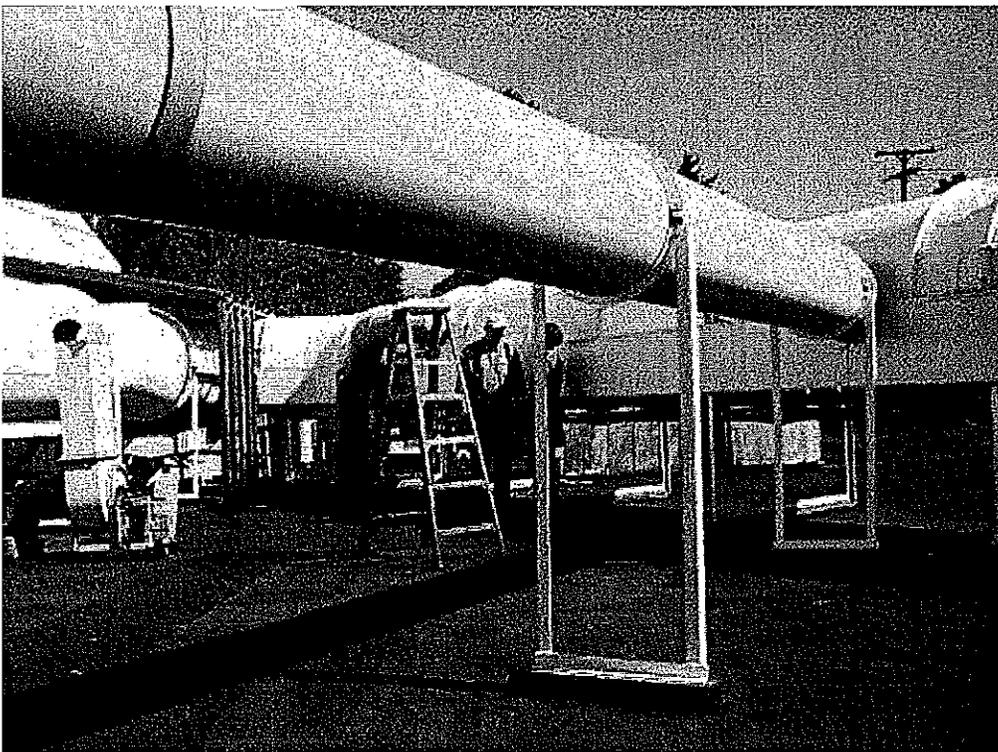
We were shown the section of 54 inch diameter segmented ductwork which will be replaced with two longer, parallel, extruded ducts, each 24 inches in diameter. The ductwork to be replaced is, at present, the most maintenance intensive, in terms of finding, cleaning, and repairing leaks/weeps.

Image 4(Photo 4) : Looking N, at 54 inch diam. ductwork (background), to be replaced with twin 24 inch ducts.

We were advised that there will be a further updated diagram, once the large section of 54 inch diameter PVC ductwork associated with scrubber #4 (north scrubber) has been replaced by two longer, extruded sections of 24 inch diameter PVC ductwork. The ductwork will be replaced on an upcoming weekend, in October.

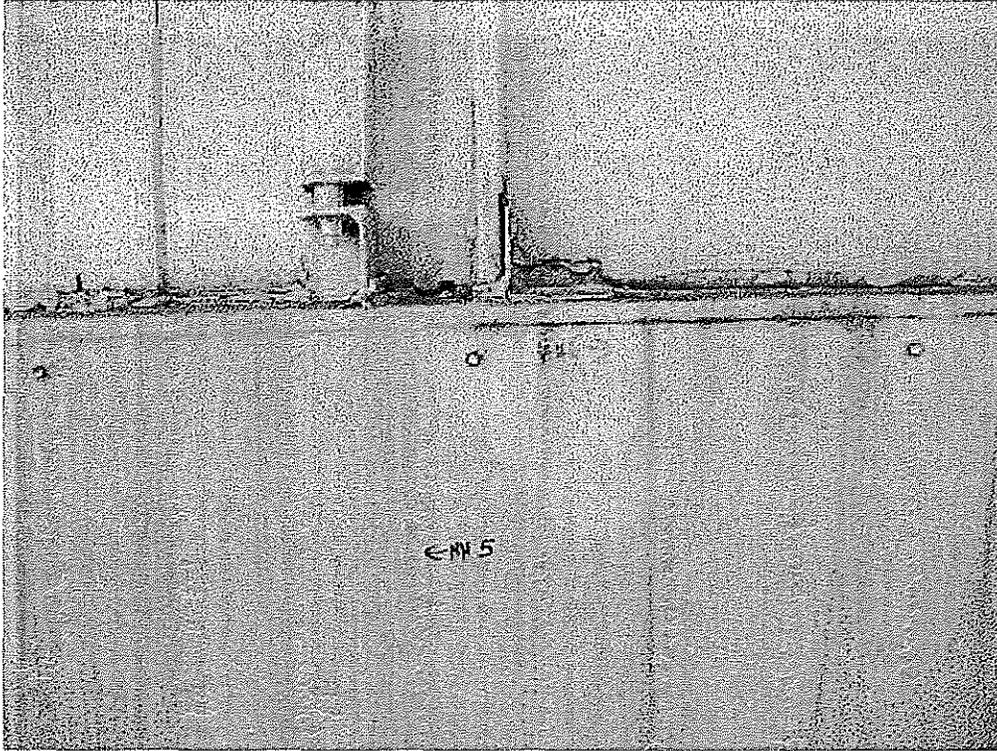
Image 5(Photo 5) : Initial, hand written labeling of ductwork, to be done in formal manner, in future.

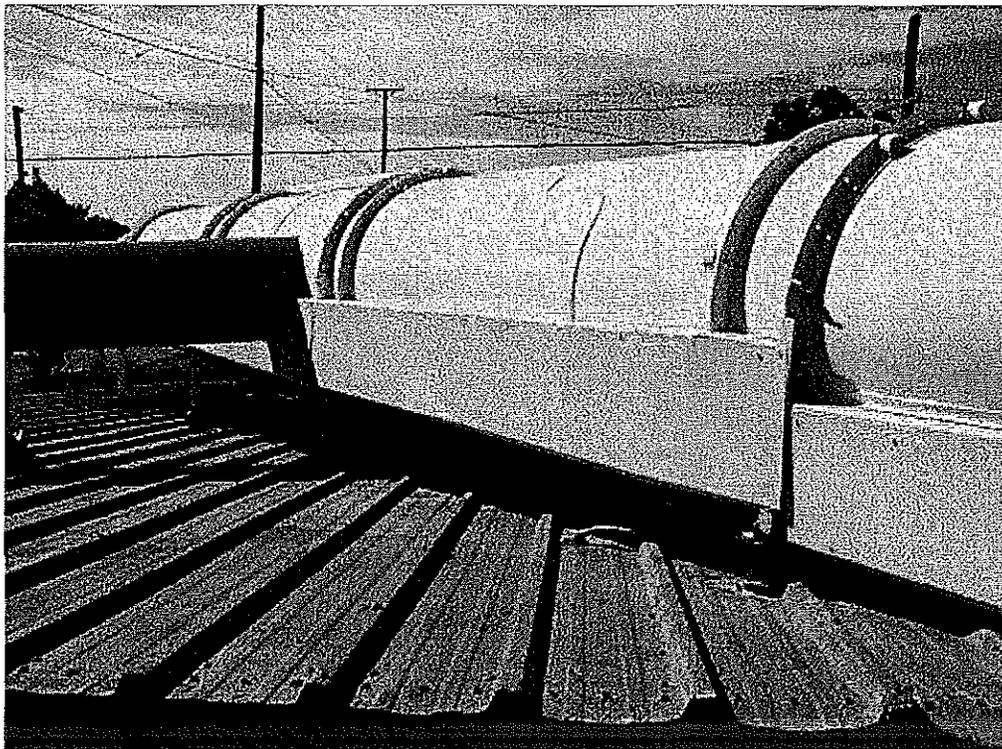
Image 8(Photo 8) : Looking south, towards the south end of the east roof.

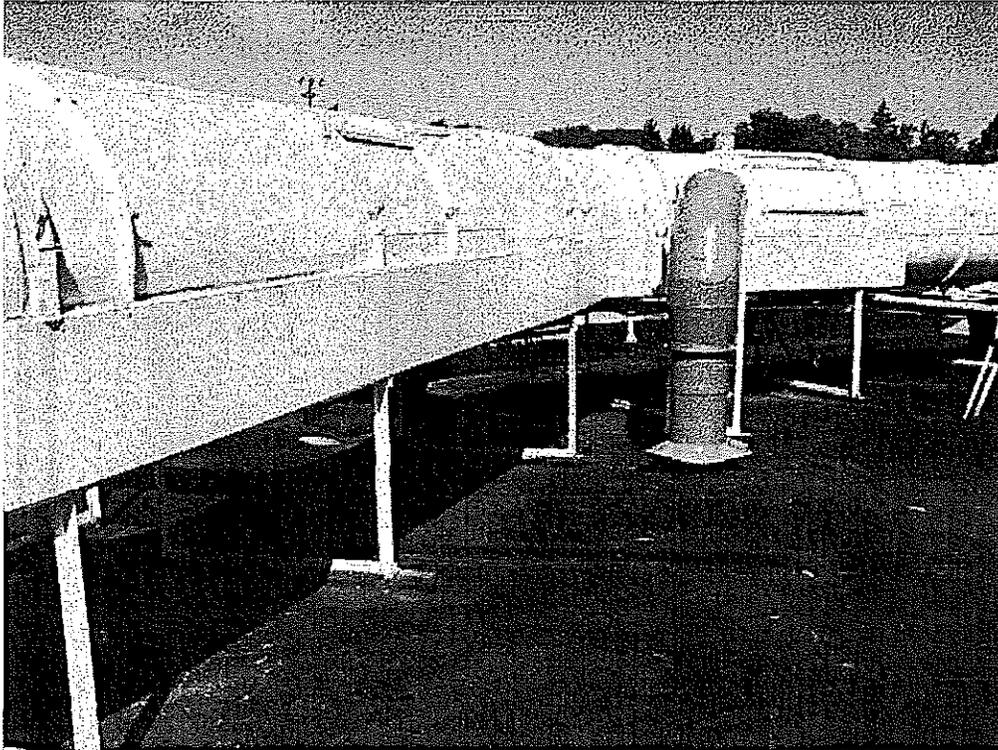
Image 9(Photo 9) : Looking north, at ductwork leading to scrubber No. 3.
