DEPARTMENT OF ENVIRONMENTAL QUALITY
 AIR QUALITY DIVISION
 ACTIVITY REPORT: Scheduled Inspection

FACILITY: DIAMOND CHROME PLATING INC		SRN / ID: A2931
LOCATION: 604 S MICHIGAN, HOWELL		DISTRICT: Lansing
CITY: HOWELL		COUNTY: LIVINGSTON
CONTACT: John Wagner, Director - Health, Safety & Environmental Affairs		ACTIVITY DATE: 09/19/2016
STAFF: Daniel McGeen	COMPLIANCE STATUS: Non Compliance	SOURCE CLASS: MINOR
SUBJECT: Unannounced, scheduled inspection.		
RESOLVED COMPLAINTS:

On 9/19/2016, the DEQ, AQD conducted an unannounced, scheduled inspection of Diamond Chrome Plating (DCP).

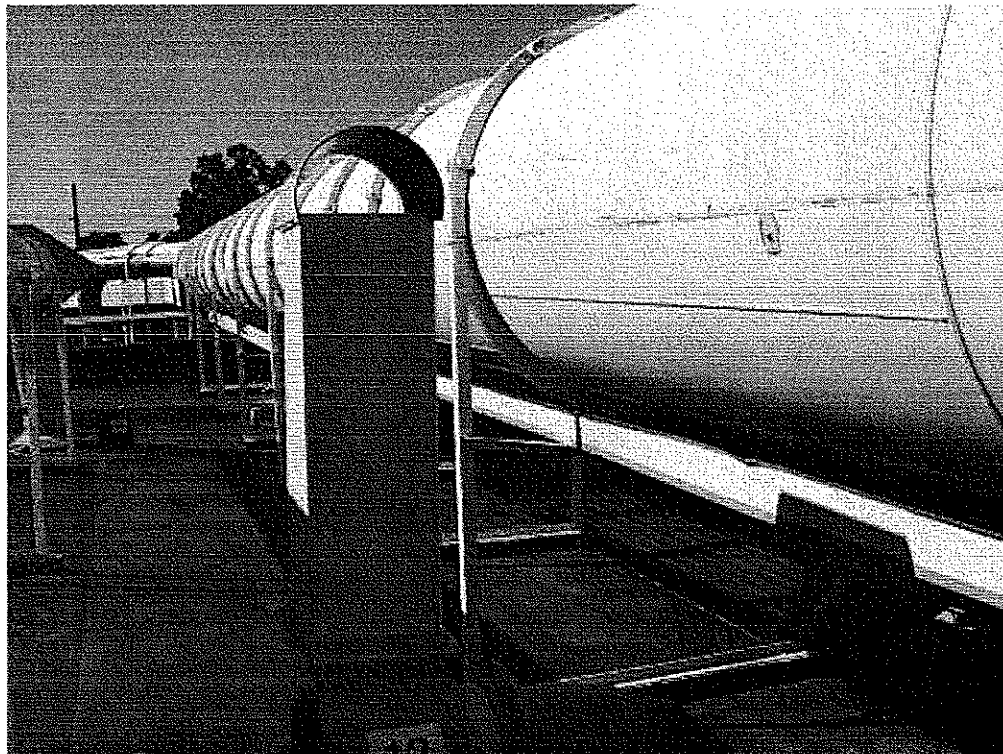
All of the ductwork on the roof appeared clean, and free of leaks or "weeps." Please see attached photos 1-9. I looked on the underside of the rooftop ductwork, and I could not find signs of any wet or dried leaks. I also looked in the catch trays underneath the ducts, and could not find any puddles of chromic acid. I observed a small puddle of water in one tray, which was clear. Mr. Wagner pointed out that there had been substantial rain recently (on 9/17). The catch trays have hoses which would route collected liquids into the plant and into the pits underneath the chrome plating tanks. Side shields or wind baffles along the ducts and catch trays were intended to offer shelter from wind and/or rain, to prevent re-entrainment of any collected chromic acid liquids that might be in the catch trays. I could not see any chromic acid stains visible on the asphalt-covered roof.

Image 1(Photo 1) : Scrubber #3 54" ductwork, looking south.

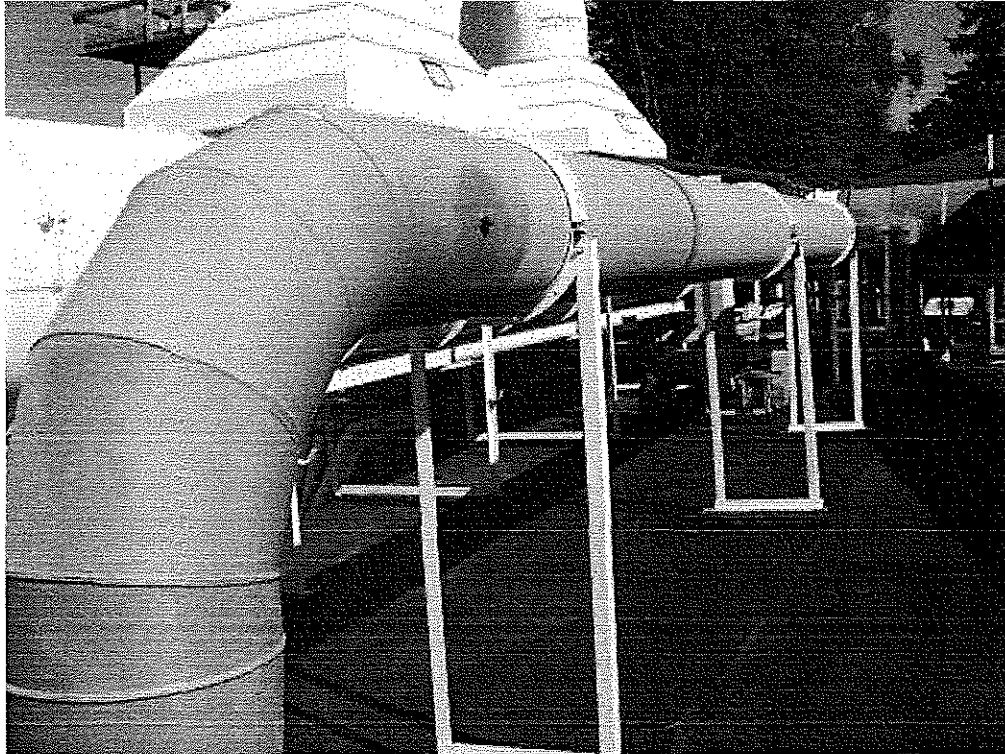
We walked out onto the plant's east roof. Scrubbers #3 and 4 had no visible emissions. The scrubbers showed no indications of any chromic acid leaks. At 11:30 AM, scrubber #3 pressure drop was 2.3 inches water column (w.c.), and scrubber #4 pressure drop was 2.5 inches, w.c.

Image 2(Photo 2) : Looking north, towards scrubbers #3 and 4.

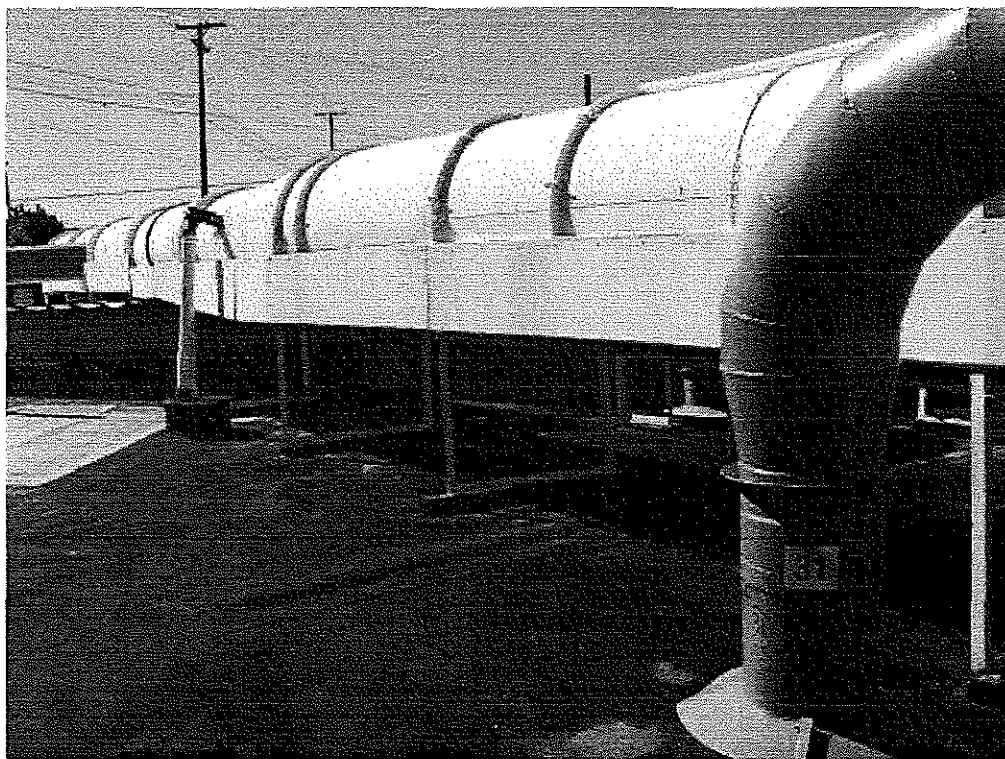
Image 3(Photo 3) : Scrubber #3 ductwork, looking SE.

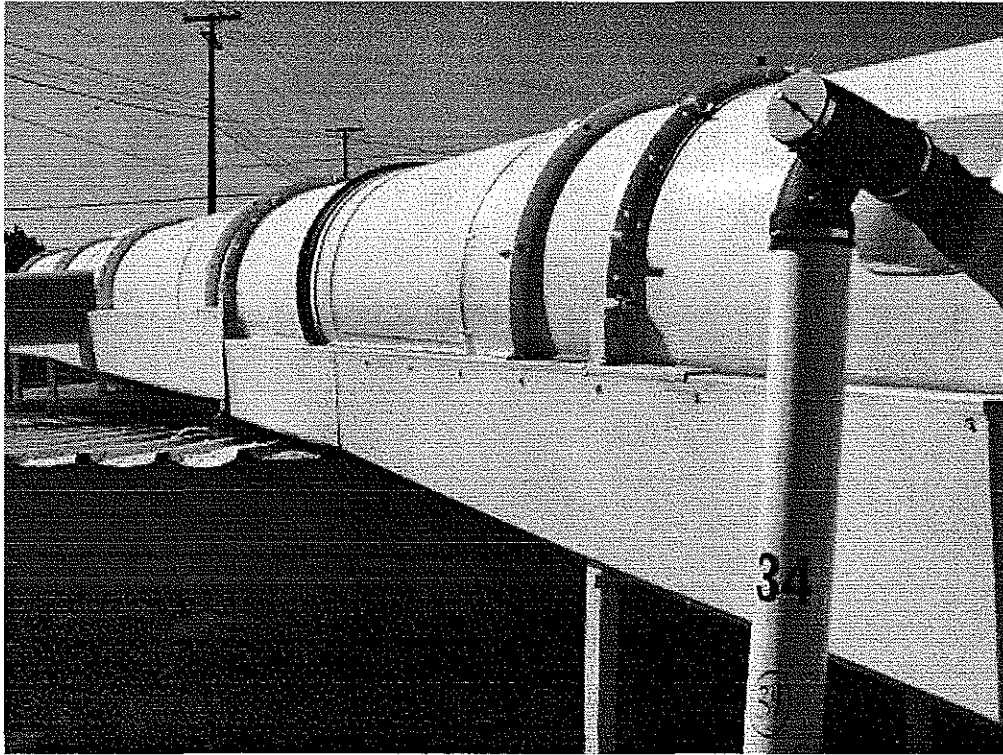
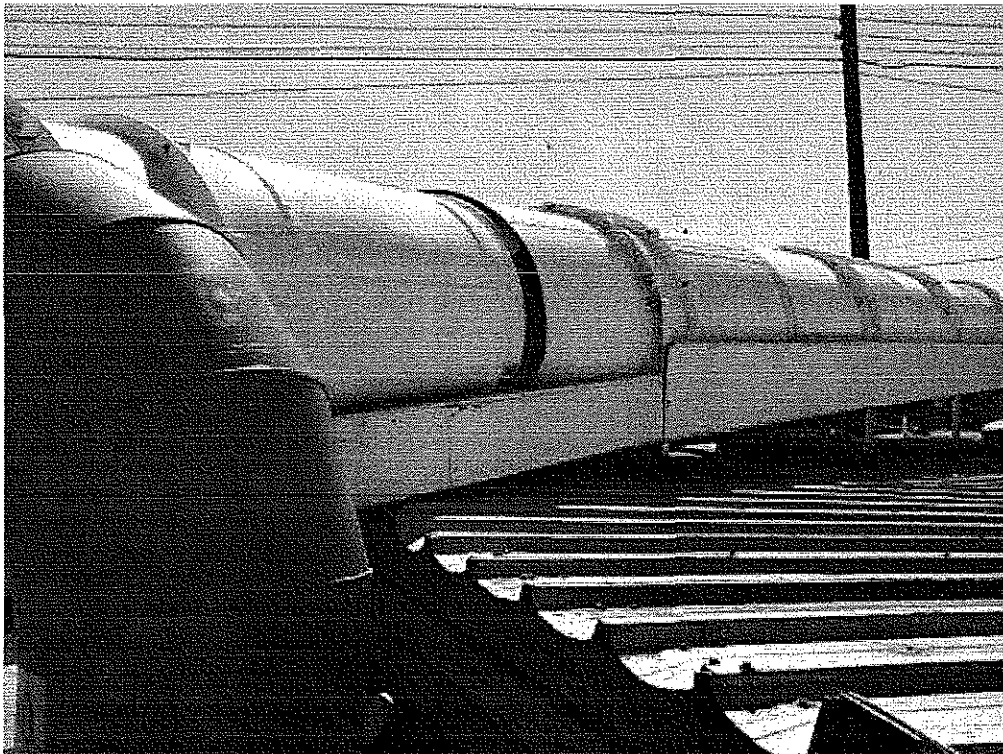
Image 4(Photo 4) : Scrubber #3 ductwork, looking southeast.

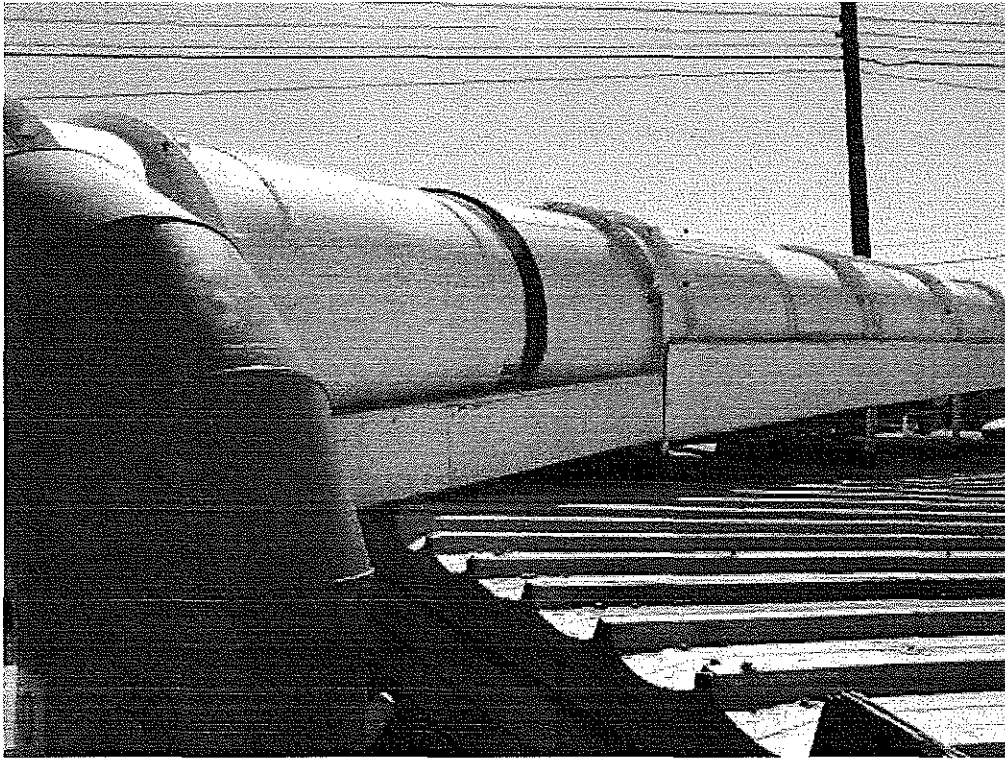
Image 5(Photo 5) : Scrubber #3 ductwork seen from west side, at south roof.

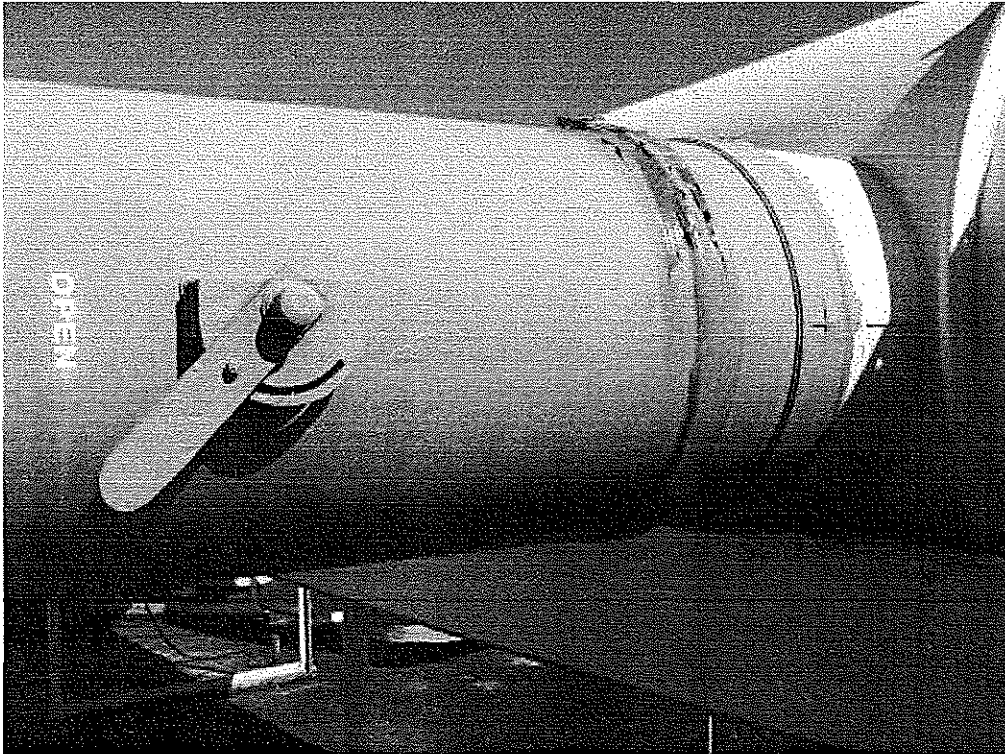
On an elbow-shaped section of gray painted ductwork, which connects to the white PVC ductwork for scrubber #3, I observed blue tape showing through peeling gray paint. It is my understanding that the gray vertical duct, V9, serves chrome tank 9, and comes up through the roof. V9 is joined to a gray horizontal section of ductwork, SH28, which in turn connects to the white 54 inch duct section SH15. The blue tape is on section SH28. Please see photos 6 and 7.

Mr. Wagner explained that this is not uncommon. He informed me the blue tape is vinyl, and is chemically resistant. He indicated that it is used for various purposes throughout the plant, including masking of parts about to be chrome plated. He informed me that it is probably used in other locations on the roof, and it does not leak. He drew my attention to vertical duct V9 (labeled as exit point 41 for the roof diagram), where blue vinyl tape had been applied, and then painted over, please see photos 8 and 9. He added that it is a fairly quick method for making repairs, whereas plastic welding is a more complex process, and it is not as quick a method for repairs.

Rule 910 requires that an air-cleaning device shall be installed, maintained, and operated in a satisfactory manner and in accordance with the administrative rules and existing law. There did not appear to be a violation of Rule 910 here, as the ductwork with the vinyl tape appeared to be free of chromic acid leaks and/or stains. Additionally, the tape was not peeling, and no ductwork seams were exposed.

Image 6(Photo 6) : Blue vinyl tape on SH28, which connects to SH15.

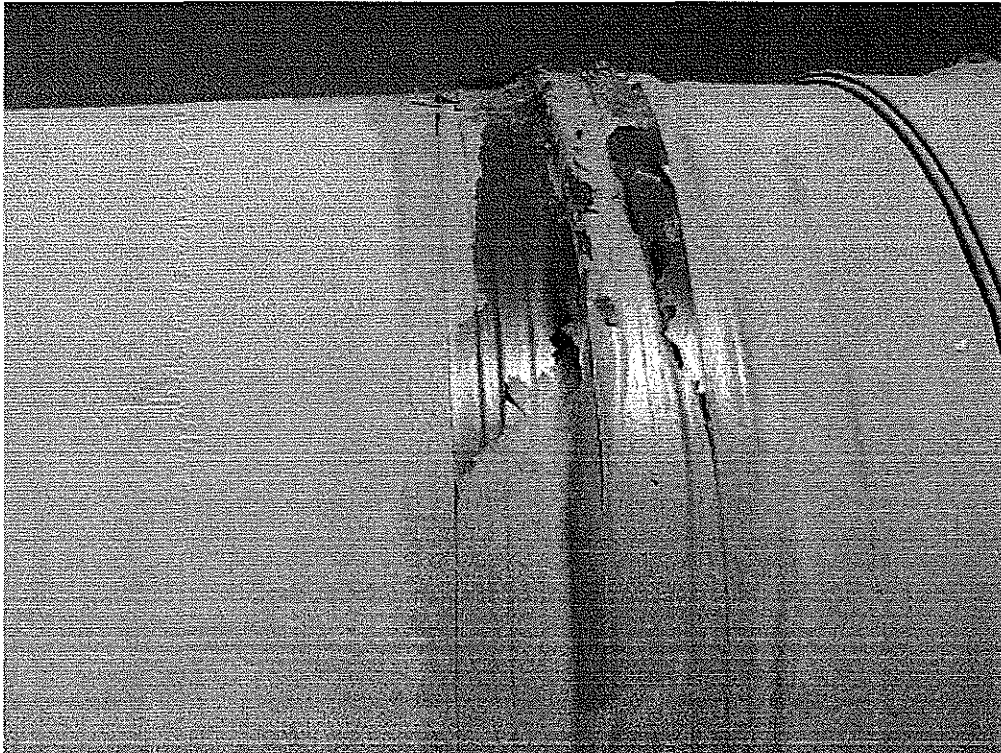
Image 7(Photo 7) : Blue vinyl tape on SH28, showing through gray paint.

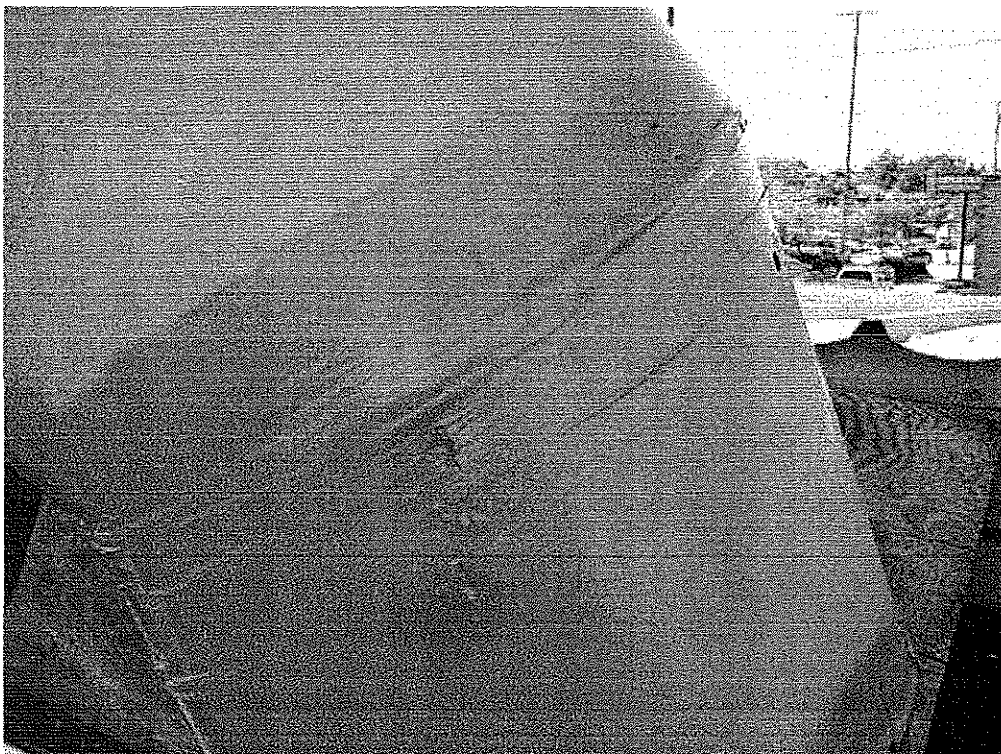
Image 8(Photo 8) : Vinyl tape painted gray, on duct V9.

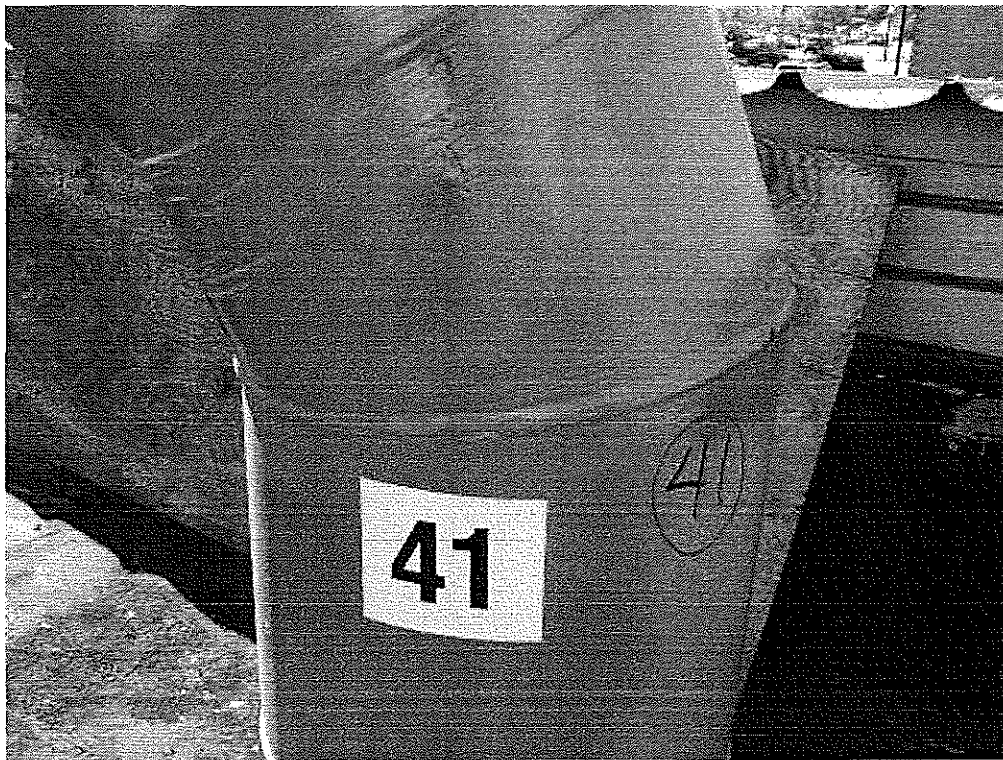
Image 9(Photo 9) : Vertical duct V9 is labeled as exit point 41, for DCP rooftop diagram.

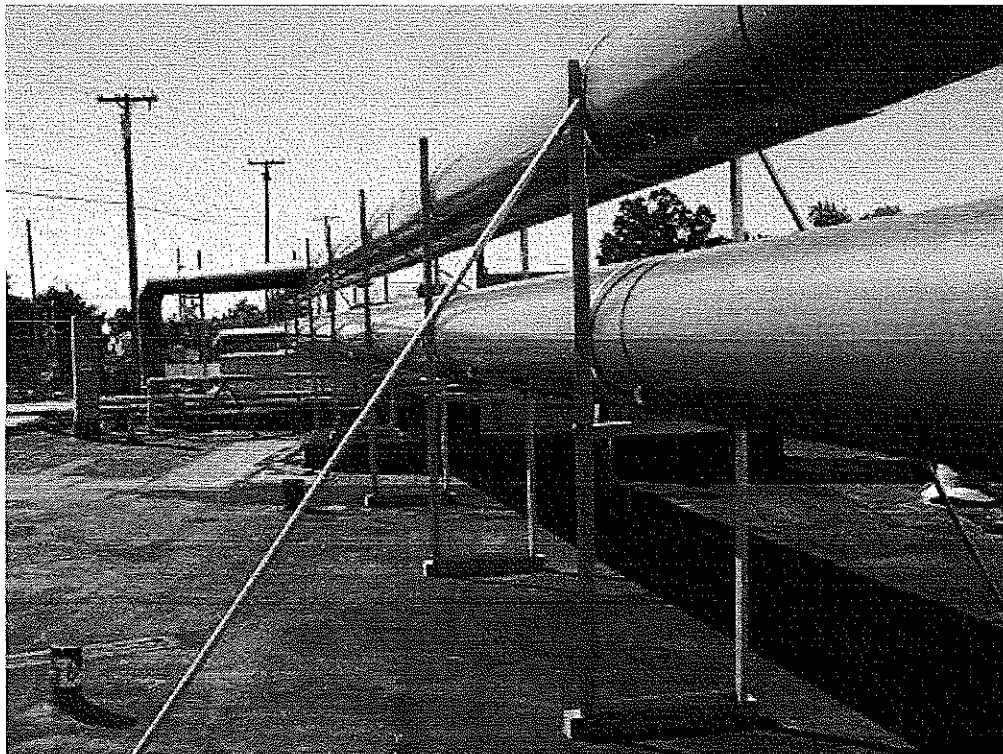
Mr. Wagner explained that DCP had hoped to replace the 54 inch diameter white PVC plastic ductwork leading up to scrubber #3 with twin, extruded 24 inch diameter ductwork this year, like they did in October 2015 for the 54 inch diameter ductwork leading up to scrubber #4. He informed me that unexpected expenses in other environmental areas have put that project on hold, for now. This new 24 inch ductwork from October was free of leaks. Please see photo 10.

Image 10(Photo 10) : Twin 24" extruded ducts for scrubber #4.
