DEPARTMENT OF ENVIRONMENTAL QUALITY
 AIR QUALITY DIVISION
 ACTIVITY REPORT: Scheduled Inspection

FACILITY: Ervin Amasteel Division		SRN / ID: B1754
LOCATION: 915 TABOR ST., ADRIAN		DISTRICT: Jackson
CITY: ADRIAN		COUNTY: LENAWEE
CONTACT: Richard Payne , Plant Engineer		ACTIVITY DATE: 08/01/2019
STAFF: Mike Kovalchick	COMPLIANCE STATUS: Compliance	SOURCE CLASS: MAJOR
SUBJECT: FCE of a secondary steel mill. The facility is in compliance.		
RESOLVED COMPLAINTS:

Major Source for CO-Area Source for HAPs-Full Compliance Evaluation (FCE)

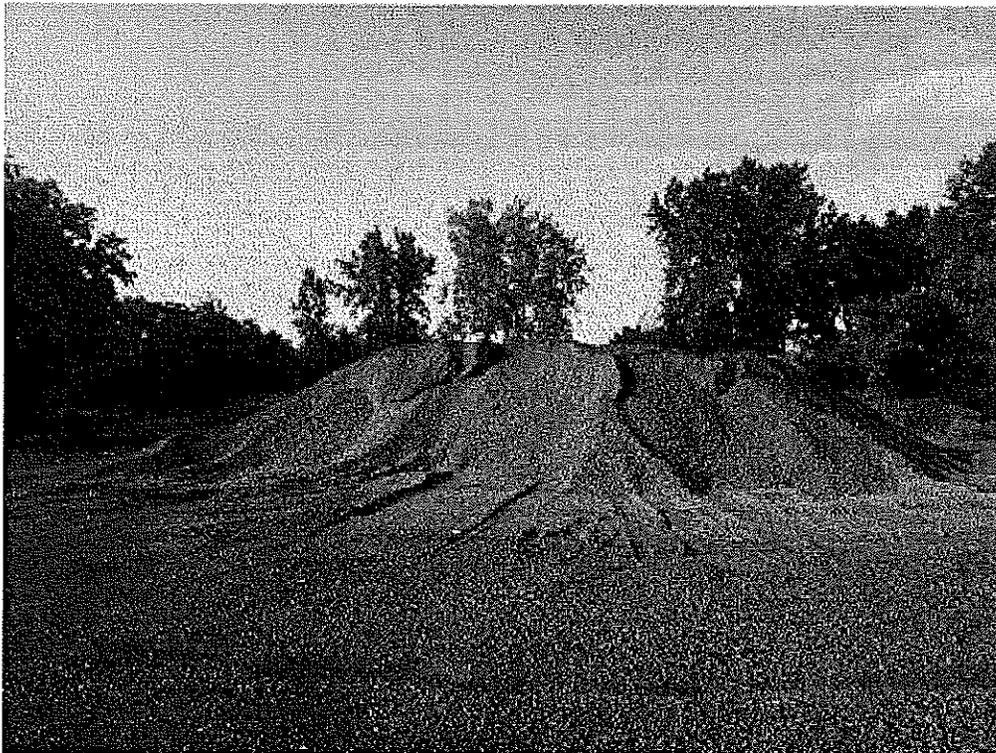
Image 1(Slag Pile) : One of 3 slag piles. Raw, middle, fine grade. This one is the middle grade that has already been screened to produce this size of material.

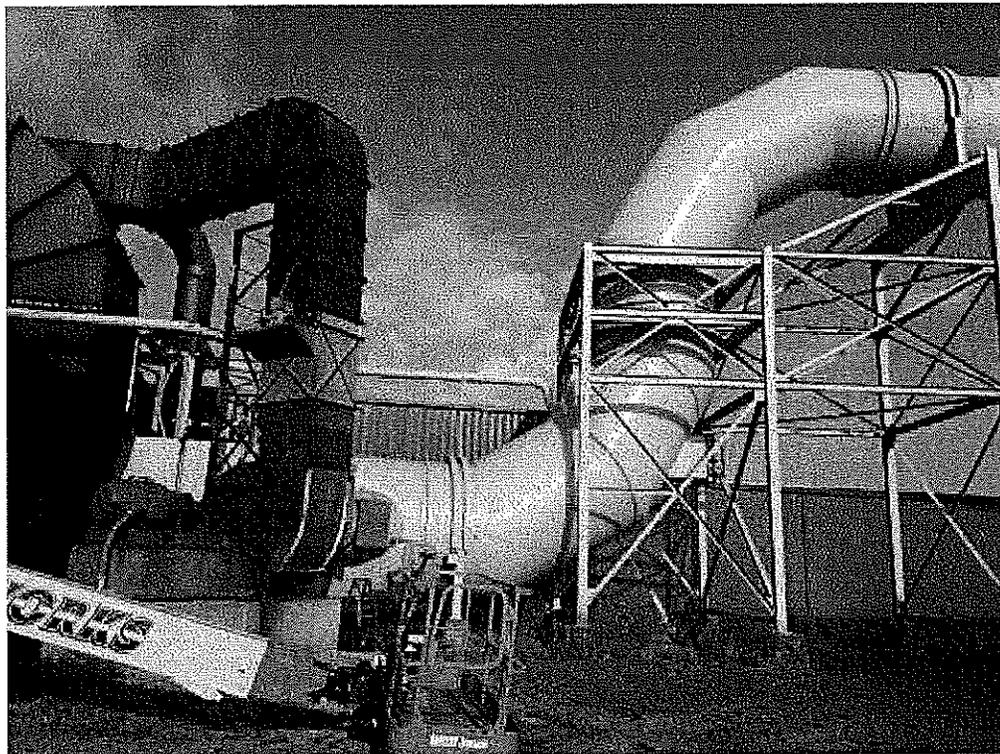
The pre-inspection meeting was brief. I asked them if there had been any changes at the facility since I had last inspected the facility. The only change of note was that about a week ago, they replaced a large ventilation duct elbow which was part of the ventilation duct between the EAF building and the large dust collector located in the southern part of the property. The previous elbow was heavily deteriorated due to acidic emissions and erosion from particulates impacted it. (Note: Lime is added just downstream of the elbow. It is used to protect the baghouse and to ensure that the captured baghouse fines are non-hazardous.) I then outlined to RP what I wanted to inspect and indicated that I would request some records after the inspection. It was also noted that the annual CO stack test was scheduled for August 13-14.

Image 3(New Elbow) : New elbow that had been installed recently located just before EAF baghouse.

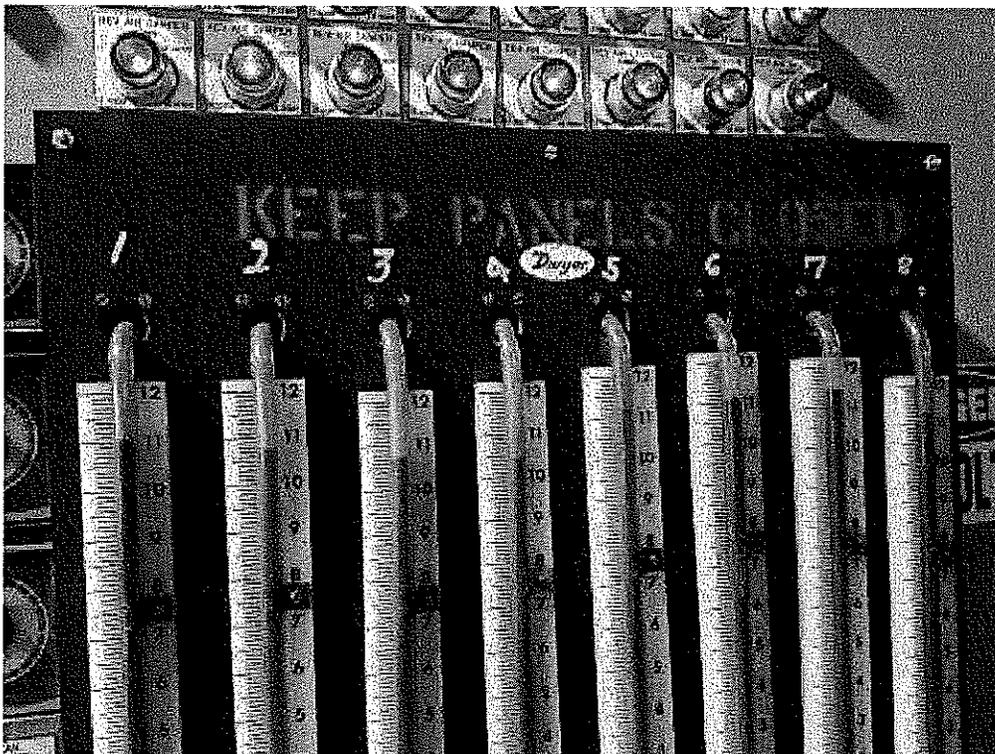
RP took me to look at EAF baghouse. Just outside the 8-section positive pressure-reverse jet baghouse is where a large ventilation duct was coming in from the Northside of the facility where the EAF is located. A smaller auxiliary fan has been added siting directly adjacent to the original fan. This auxiliary fan is used when the EAF is not in operation. Next, we entered the baghouse control room. See attached photos of the control panel and pressure drop meters for each section of the baghouse. The readings were generally close to 11" of inches of water.

Image 4(EAF Baghouse Press.) : EAF Baghouse pressure differential for each of the 8 compartments. Shows 10 to 11".

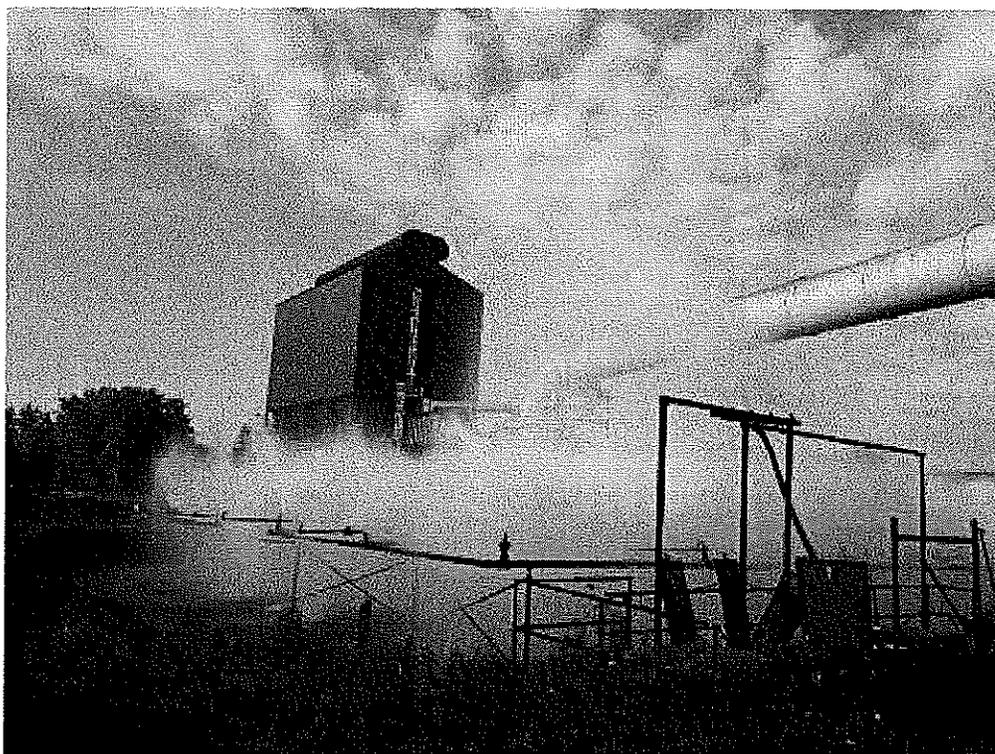
Image 5(EAF Baghouse) : EAF Baghouse. No opacity coming from roof monitor vent.

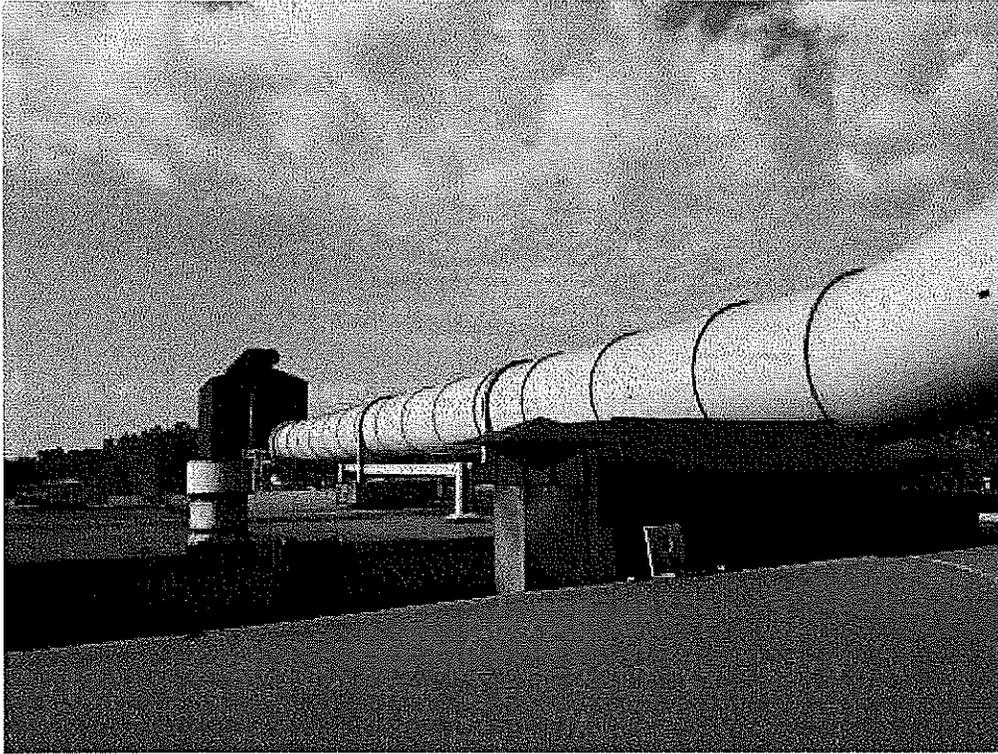
Image 6(EAF Baghouse Vent.) : EAF baghouse ventilation pipe from roof.

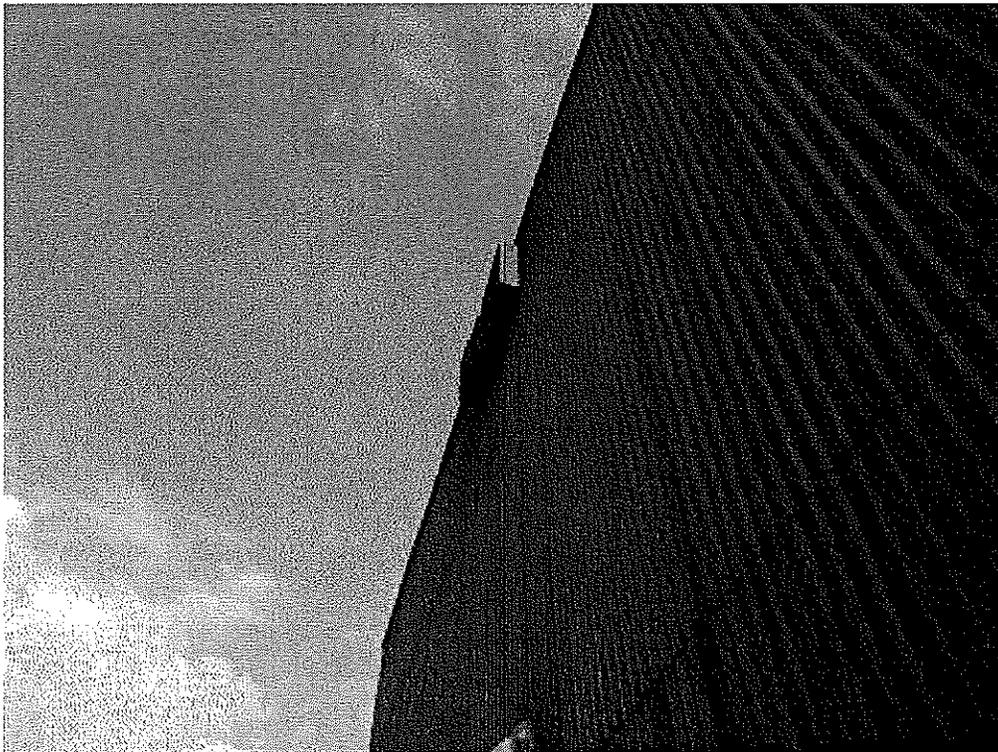
1. I was unable to determine compliance with the 6% opacity limit for fugitive dust emissions coming from the EAF building. The Company is required to
 - a) Investigate what methods/procedures that they can implement that would reduce opacity coming from the vent on the upper south wall of the EAF building. An example would be to look at/adjust damper settings during tapping to improve capture in that part of the building to see if this could result in an improvement.
 - b) Conduct Method 9 readings to show compliance.

Image 7(South Vent-EAF Bldg.) : South vent of EAF building showing minor opacity.

c) Provide an update by the end of August.

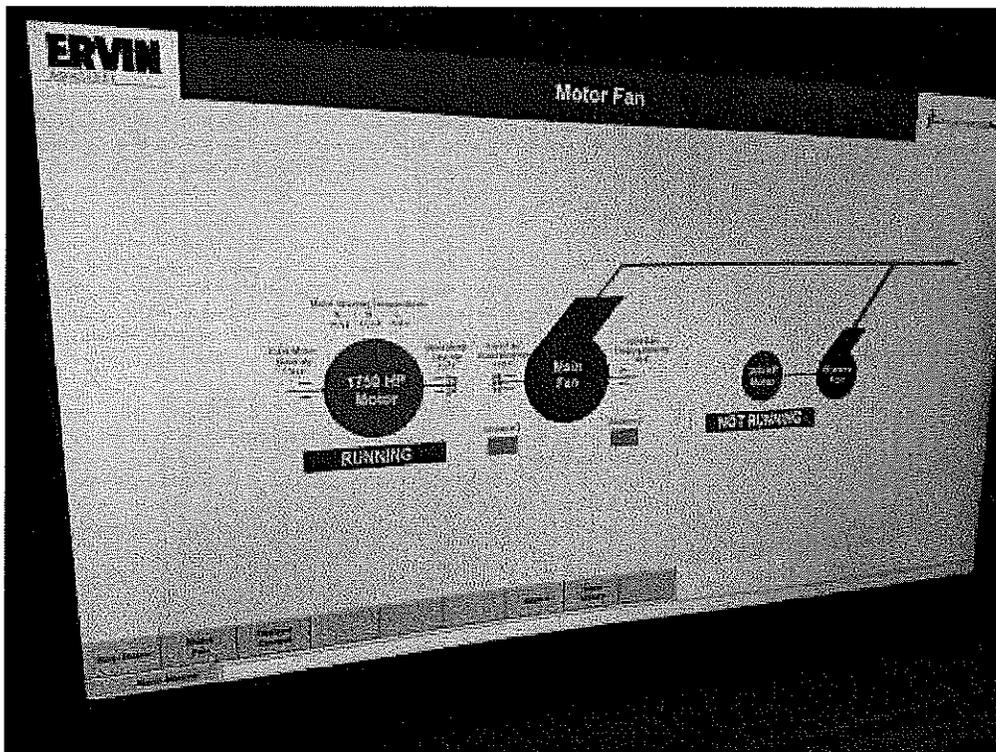
Image 9(EAF Control Screen 1) : EAF Control screen showing baghouse exhaust status.

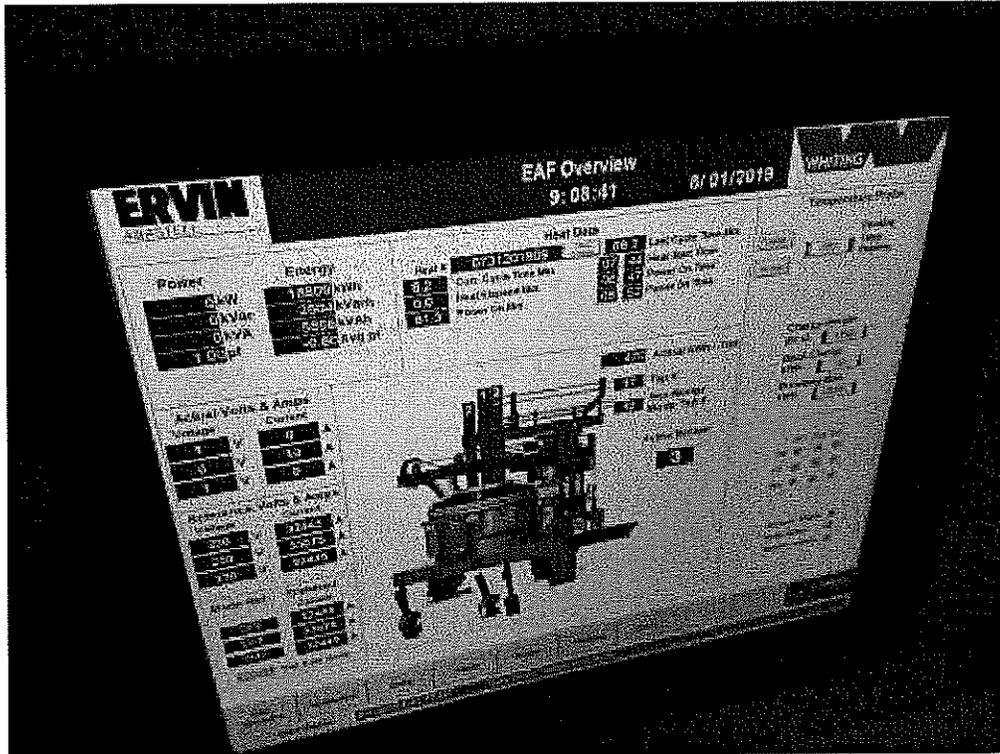
Image 10(EAF Control Screen 2) : EAF Control Screen Overview

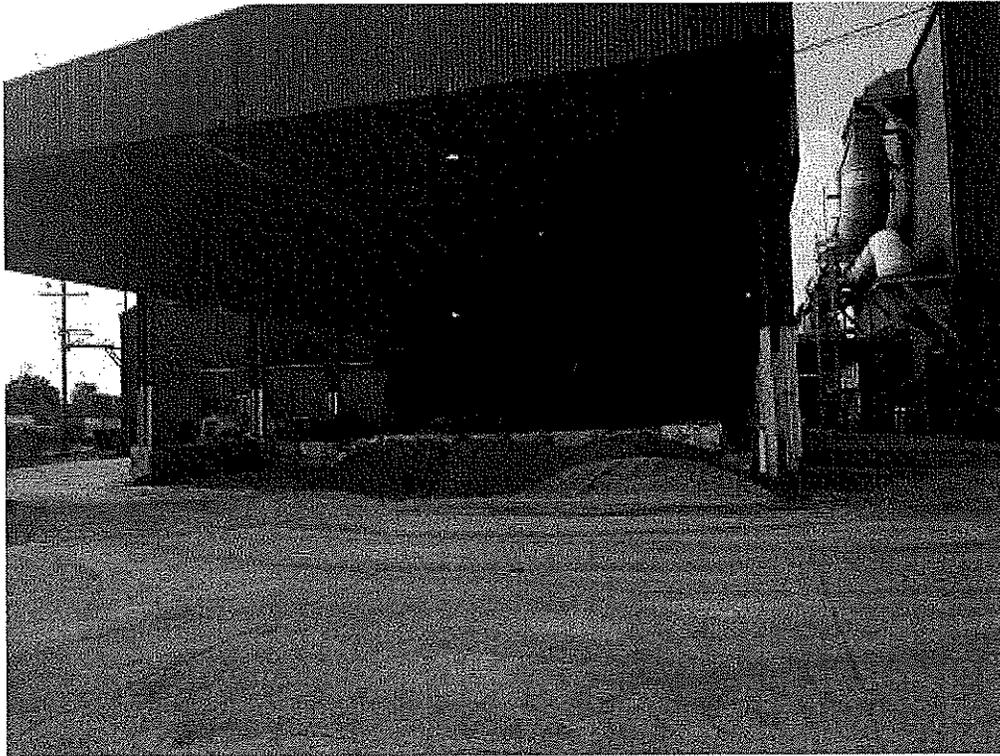
Image 13(Scrap Metal Shed) : Scrap metal shed.
