May 27, 2020

Subject: Response to May 11, 2020 Violation Notice

Three Rivers Gray Iron

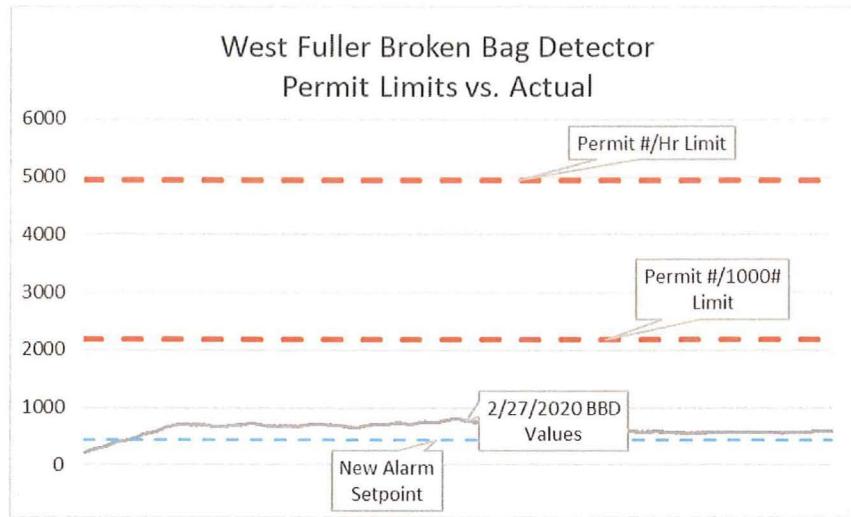
- Using the data referenced above, we are able to go back and determine what the actual particulate emissions were during these periods of upset. The following graph shows the relationship between the actual emissions at that time and the permitted limits. It also shows the re-established alarm setpoint based on the performance test data. This graph shows data for the West Fuller. The East Fuller and North Fuller results are similar to the West Fuller but left out of this response for brevity.

- While the VN does not include any violations related to exceeding permit limits, the information obtained from the performance testing is interesting. It shows that TRG was operating well below the permitted thresholds during the times related to the violations.
- TRG has designed and implemented new interlocks and alarms within its electronic controls system. This was already in place when the incidents took place, but we have used the information collected during the incident response to further refine the programs to ensure such issues are flagged immediately. The screenshot below shows the new program and the associated interlocks (green dots). In the event an environmental indicator gets out of range (e.g. differential pressure exceeds allowable limit), interlocks are triggered to shut down the emission unit that the malfunctioning dust collector is controlling.
