**DEPARTMENT OF ENVIRONMENTAL QUALITY
AIR QUALITY DIVISION
ACTIVITY REPORT: Scheduled Inspection**

FACILITY: Omnisource Corporation	SRN / ID: B2281
LOCATION: 701 LEWIS ST, JACKSON	DISTRICT: Jackson
CITY: JACKSON	COUNTY: JACKSON
CONTACT: C. Kevin Gross , Safety/Environmental Manager	ACTIVITY DATE: 08/03/2017
STAFF: Mike Kovalchick	COMPLIANCE STATUS: Non Compliance
SUBJECT: Compliance inspection to check on torch cutting operation and shredder.	SOURCE CLASS: MINOR
RESOLVED COMPLAINTS:

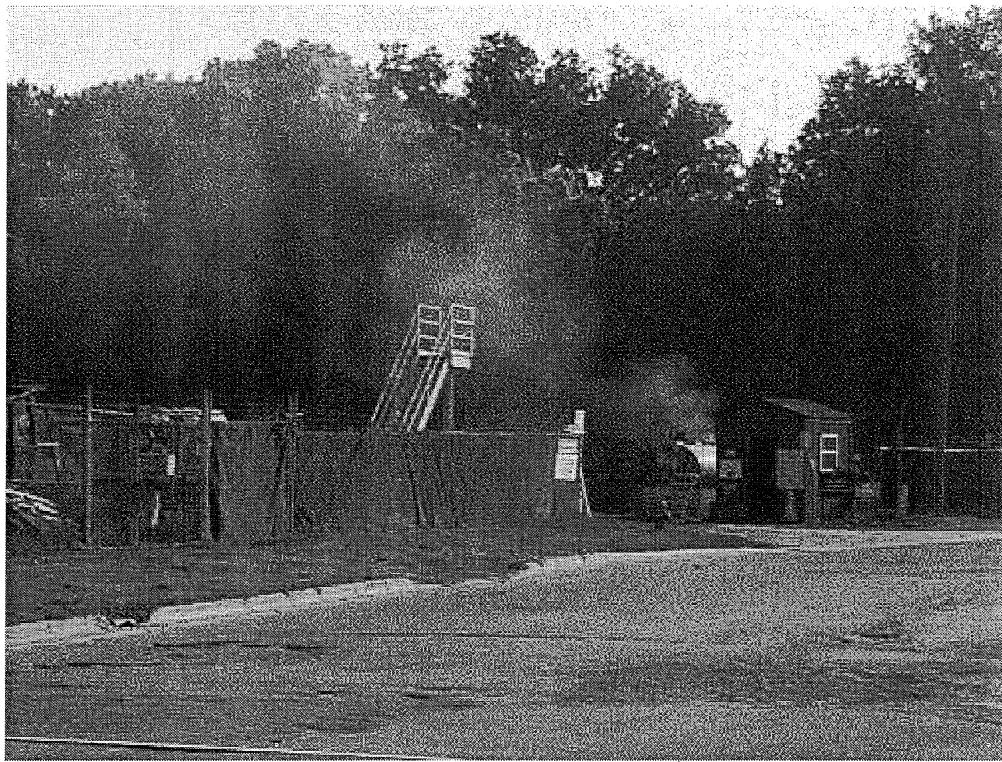
Visible emissions from torch cutting were observed upon my approach to the Company's facility. See attached photo. I arrived Kevin Gross (KG)-Safety/Environmental Manager and Doug McDonald (DM) the plant manager. I informed them of my intent

Image 2(Torch Cutting) : Smoke from torch cutting observed when arrived at facility

The torch cutting operation is in violation of Rule 201-no PTI. A Violation Notice (VN) will be sent to the Company regarding this issue that will request a plan of action within 21 days.

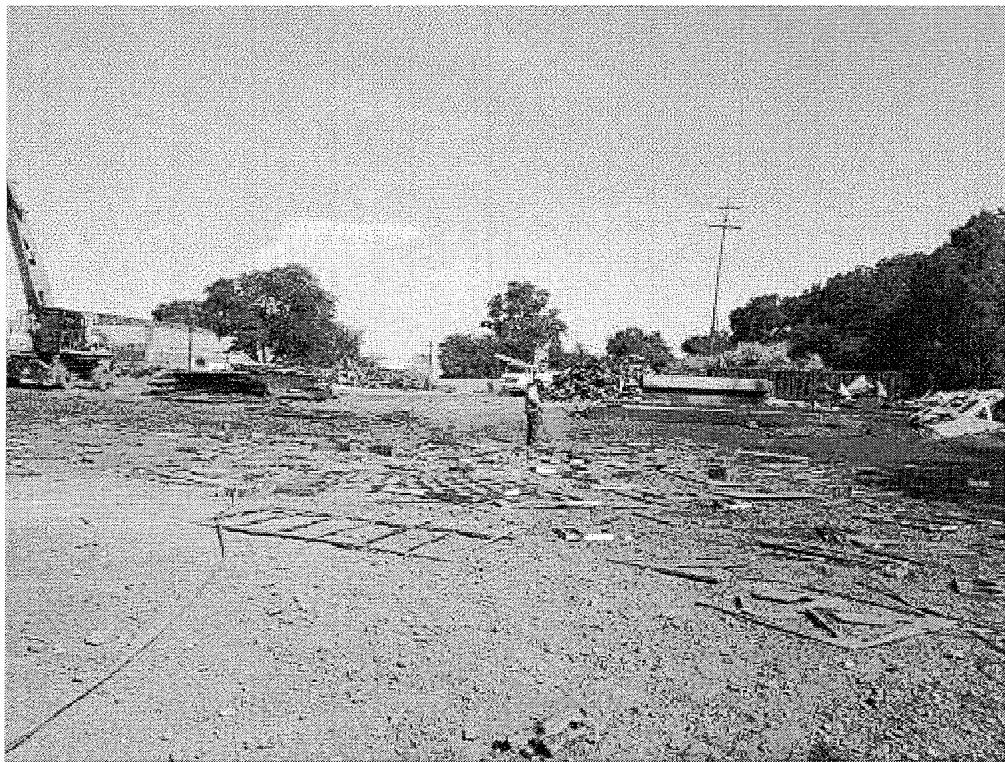
An outside contractor, RJ Industrial Torching, conducts all the torch cutting at this facility. They technically only come there on brand name Smith.) There is 3000 gallon portable oxygen tank on a truck trailer and smaller propane tank sitting on the ground years old. RJ cuts any scrap metal that is too thick to process by the shear that is located directly adjacent to the field that the the bare minimum and have passed on jobs that require torch cutting. Pieces to be cut are simply laid out on the ground and the brown/yellow smoke plume during the torch cutting. Opacity from the torch cutting was generally well above 20% but was read smoke.) I also observed several pieces of wood/debris that was smoking/burning after being set on fire from torch cuttin

Image 3(torch yard) : Torch cutting yard. Shear is in the background on the left.

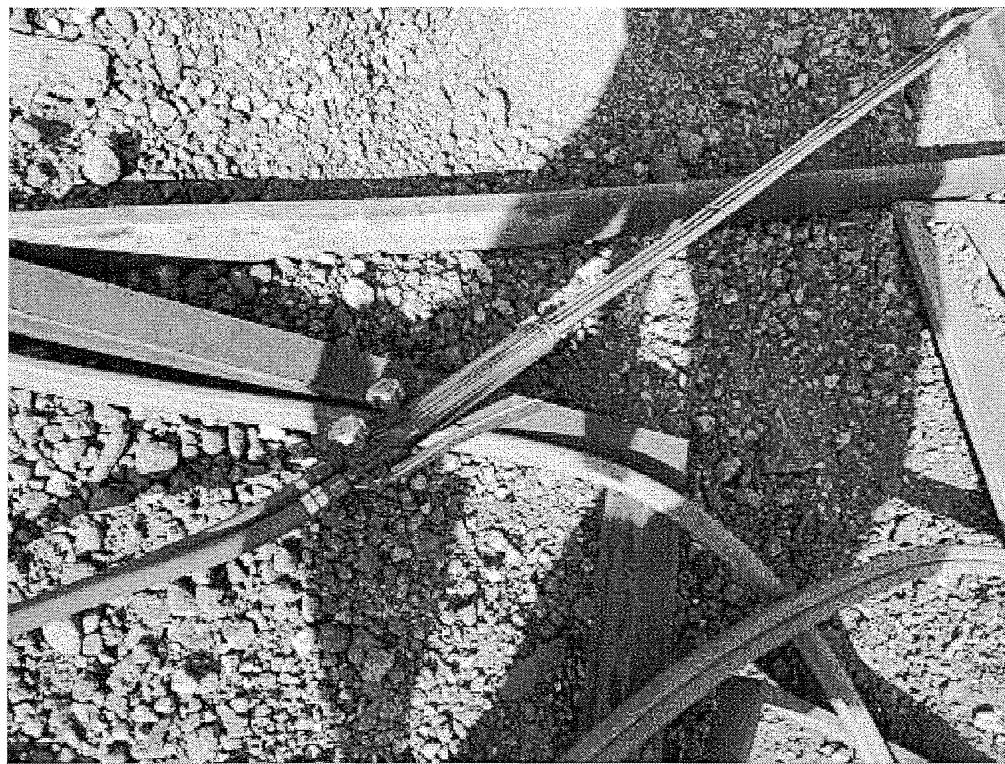
Image 4(torch) : torch

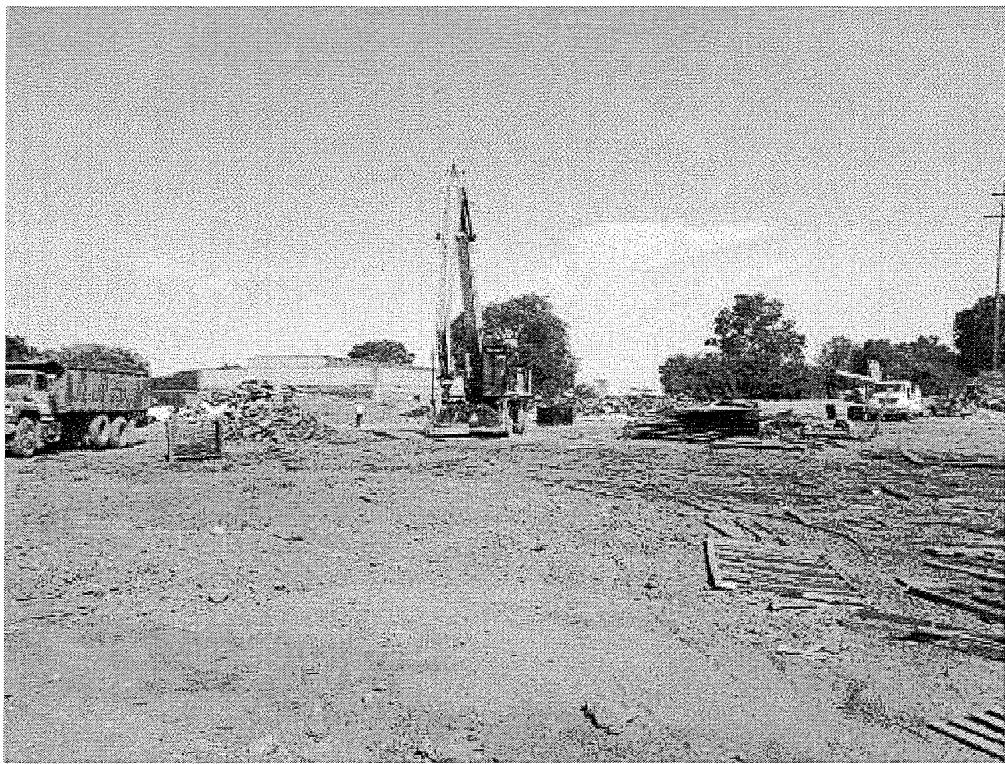
Image 5(shear) : Shear at torch cutting area

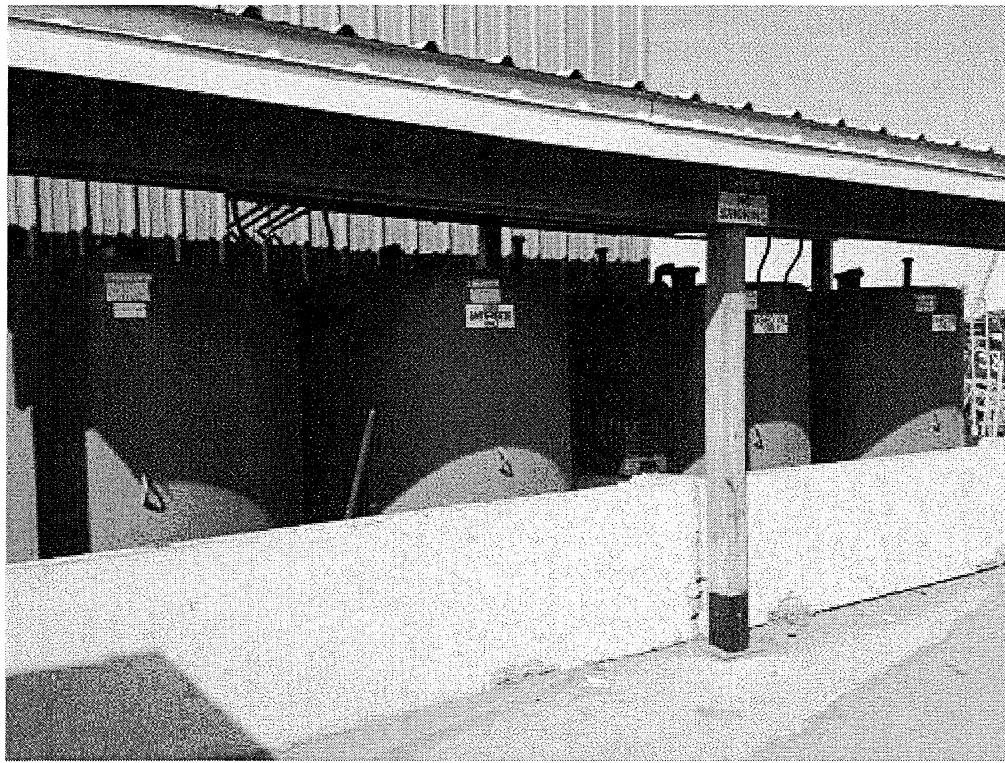
Image 6(storage tanks) : Storage tanks at depollution area

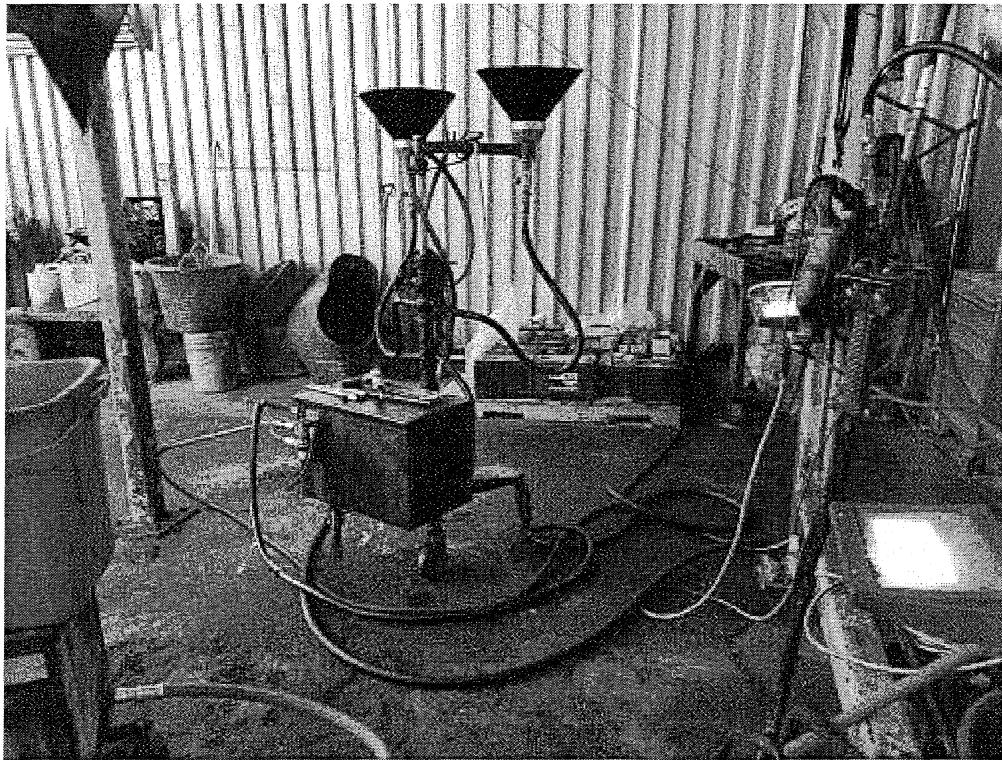
Next we visited the depollution area. It is where they process vehicles prior to entering the shredder. Freon, engine oil, gasolin requirements. Inspected and depolluted scrap was then placed in a stock pile. (Process cars are spray painted with red.) API (Buses/trucks can also be processed but generally need to be cut up some before entering the shredder.) Mercury switches ir equipment/switches. See attached photos. One of the photos shows a waste drum labeled radioactive. Scrap metal that ente

Image 7(Depollution) : Depollution area

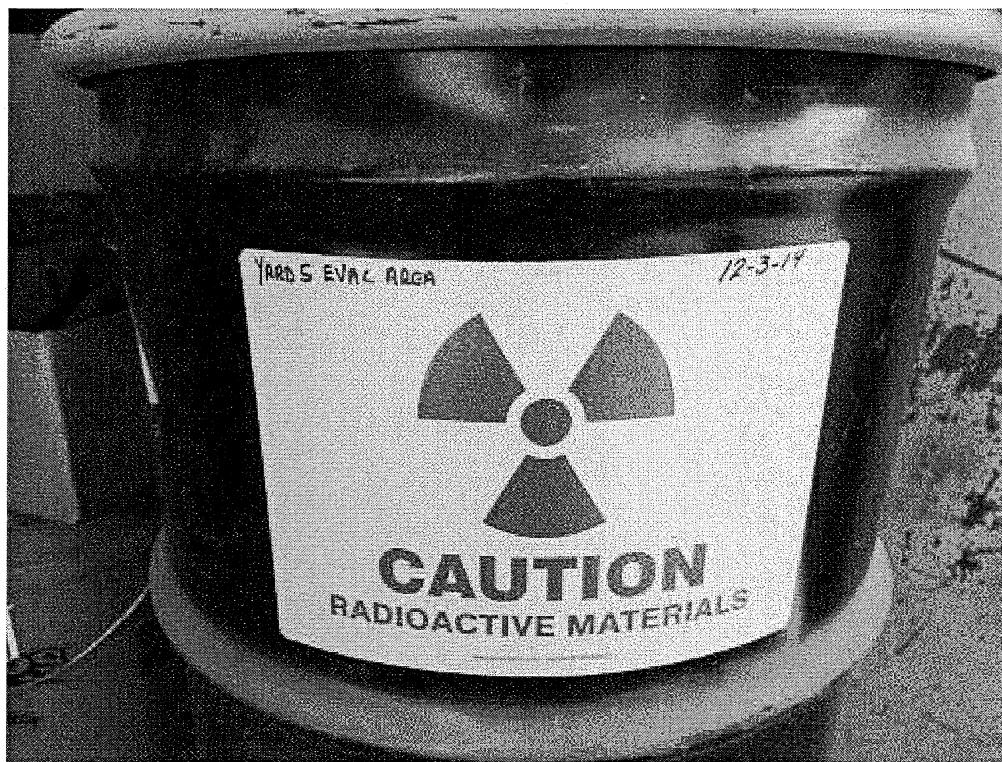
Image 8(Radioactive) : Collected radioactive material

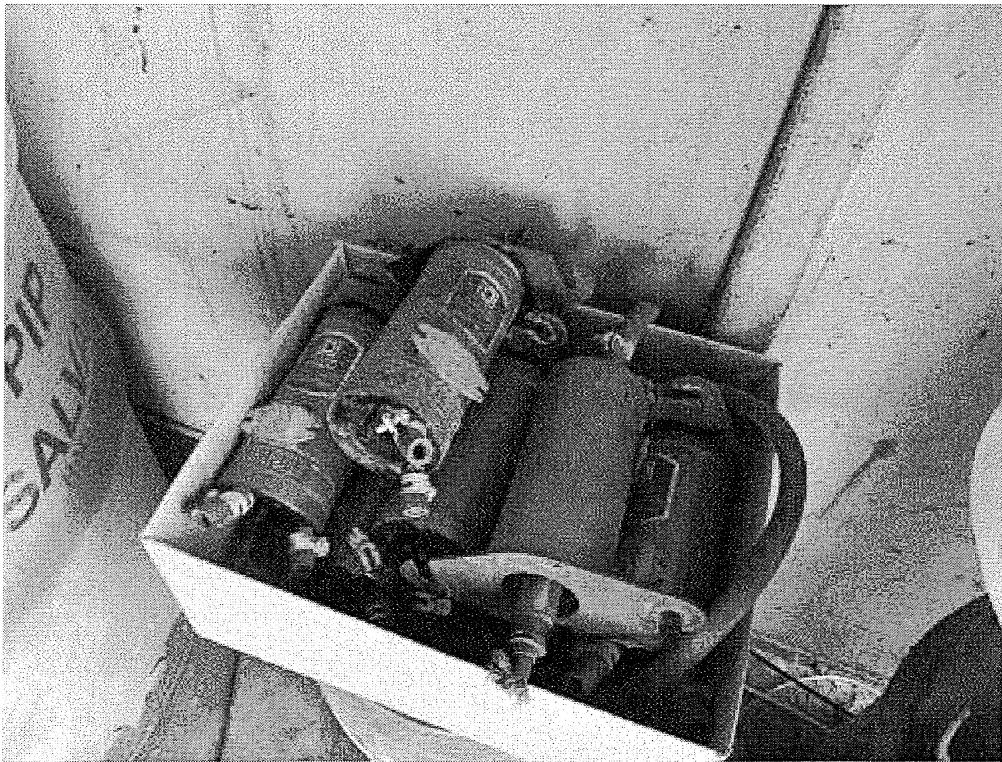
Image 9(mercury switches) : Mercury switches

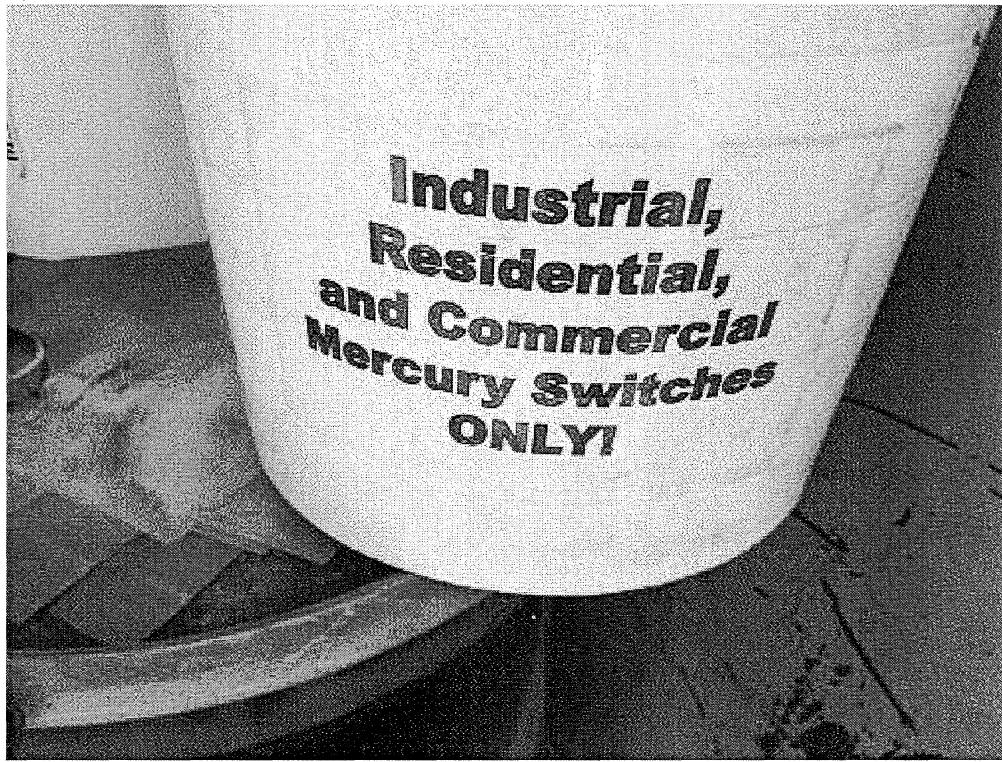
Image 10(mercury switches) : Mercury switch collection container

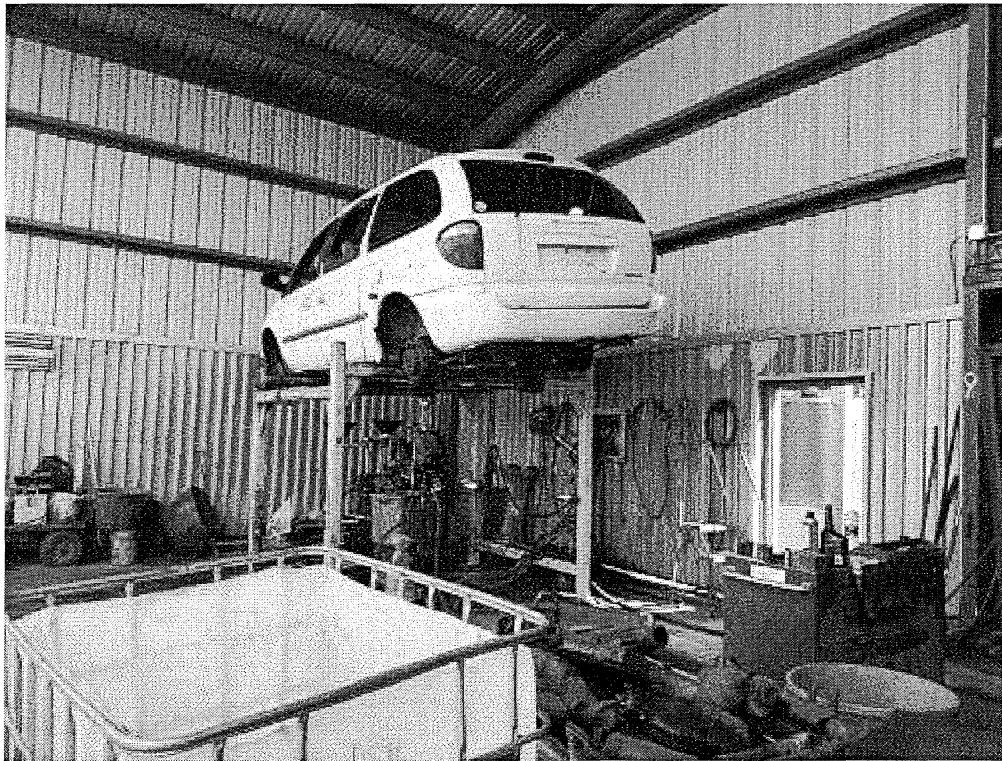
Image 11(Depollution area) : Depollution area

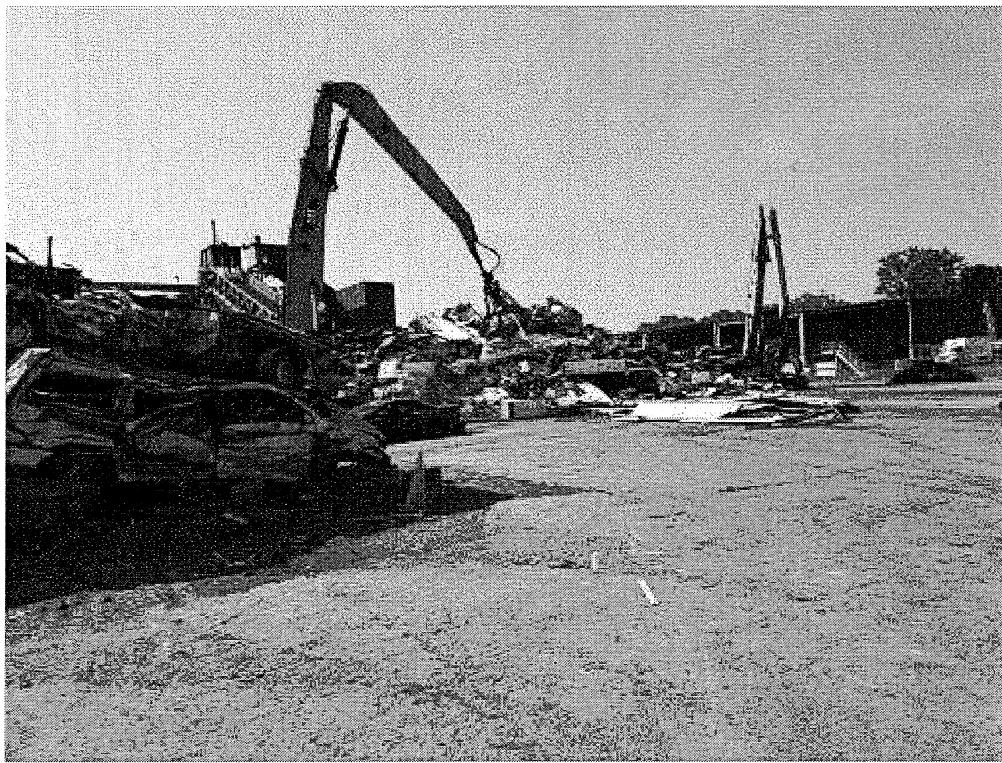
Image 12(Crane) : Crane near shredder

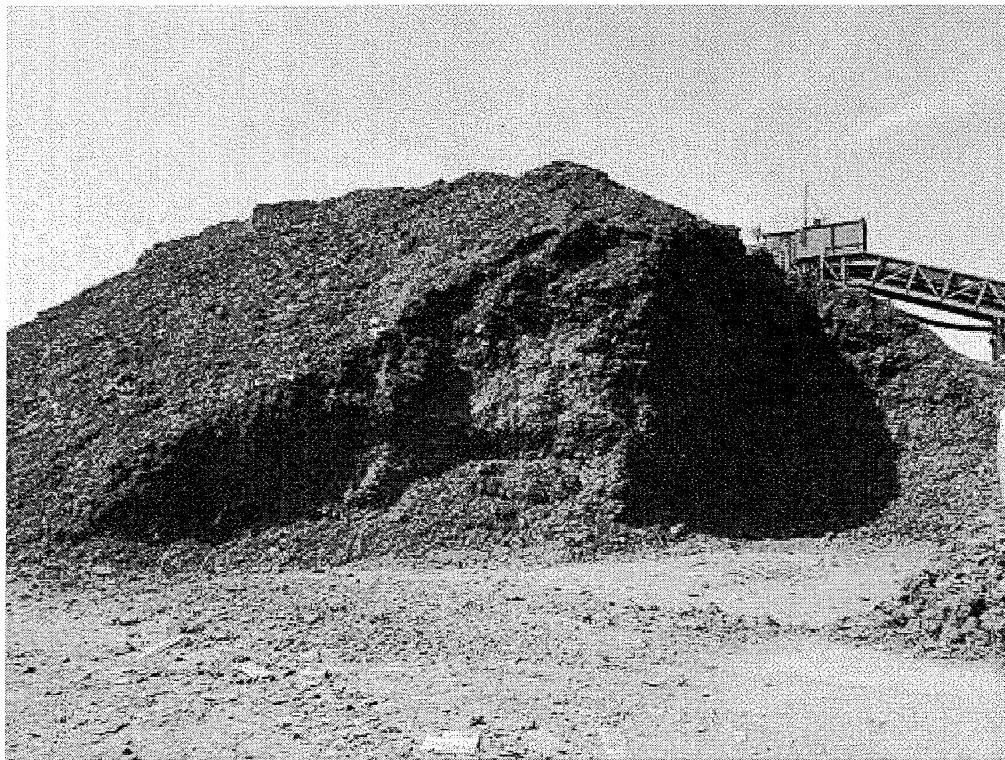
Next, we went over to observe the "fluff" bunker area. Various conveyors carry processed material from the shredder. The non-magnetic portion of it is considered the "fluff". The fluff may contain plastic, which may have melted due to the heat generated by the shredding processing. The Company currently has a large pile of fluff directly adjacent to the bunker but not actually in the bunker. No fugitive dust was noted as the material appeared quite wet to the point that some liquid was seeping out the bottom of the pile onto the paved ground. The material appears to be wet due to the spray bar associated with the shredder. The Company no longer processes the fluff on site. It remains onsite for only a short period of time before a front end loader scoops it up and places into a truck that goes to Toledo for processing there.

Image 13(Fluff pile) : Fluff pile

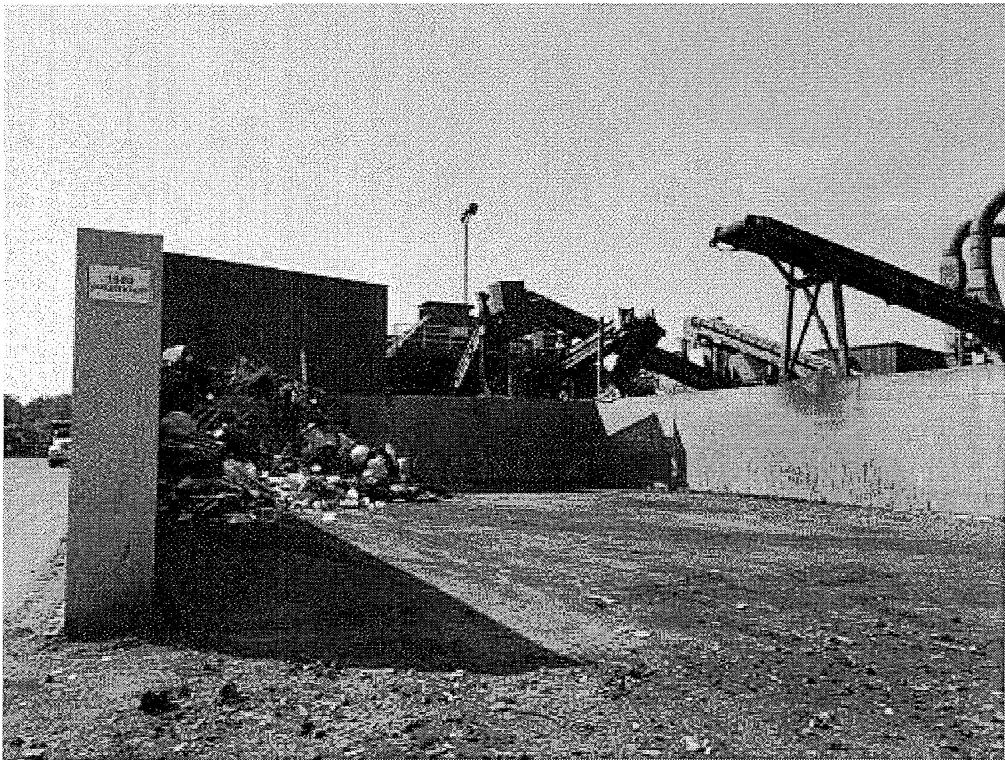
Image 14(Fluff bunker) : Fluff bunker

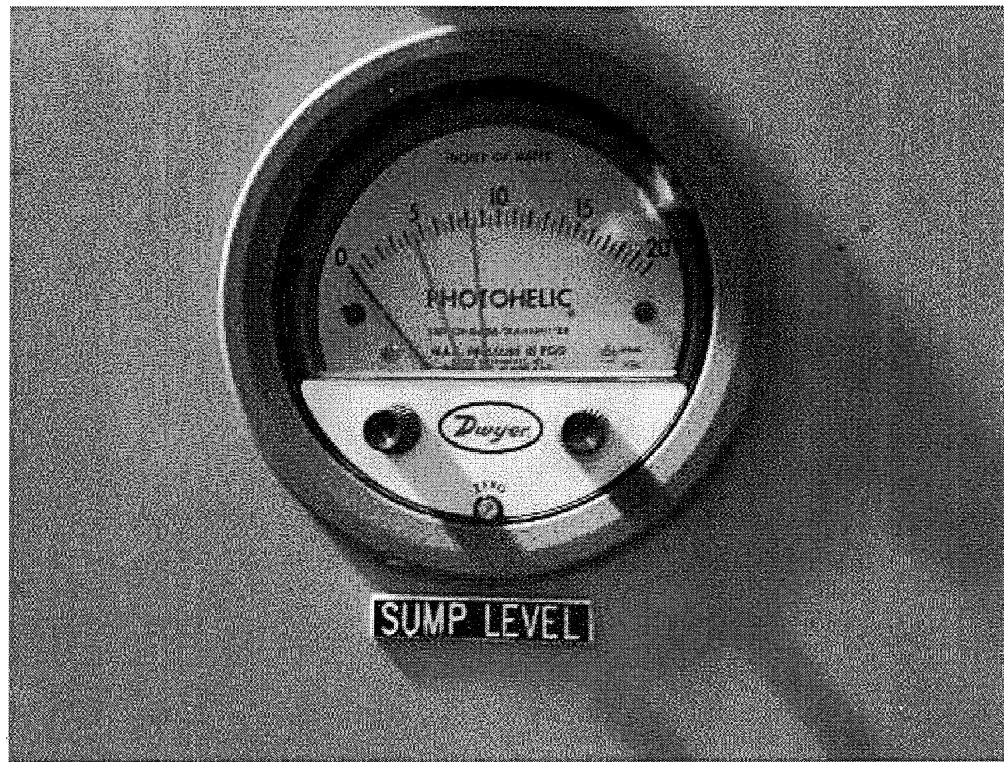
I was shown the room housing the scrubber. (It was not operating.) I observed a gauge that was labeled "sump level" which appeared to actually be measuring the pressure drop across the scrubber based on where the pressure sensors were located. (See attached photo.) I observed the gauge that is used to measure flow rate to the scrubber. It is reset every day (See attached photo.) Overall, the scrubber appeared to be in good shape. I asked how the waste from the scrubber is being handled. KM indicated that very little sludge is being generated at all but thought it was being handled as a non-hazardous solid waste. The vast majority of the collected material is being captured by the 2 cyclones. (See attached photos.) The Z-box cyclone exhausts back into the process and is the larger of the 2 cyclones. Material collected from the 2 cyclones directly enters a conveyor system.

Image 15(Venturi gauge) : Venturi scrubber pressure drop gauge

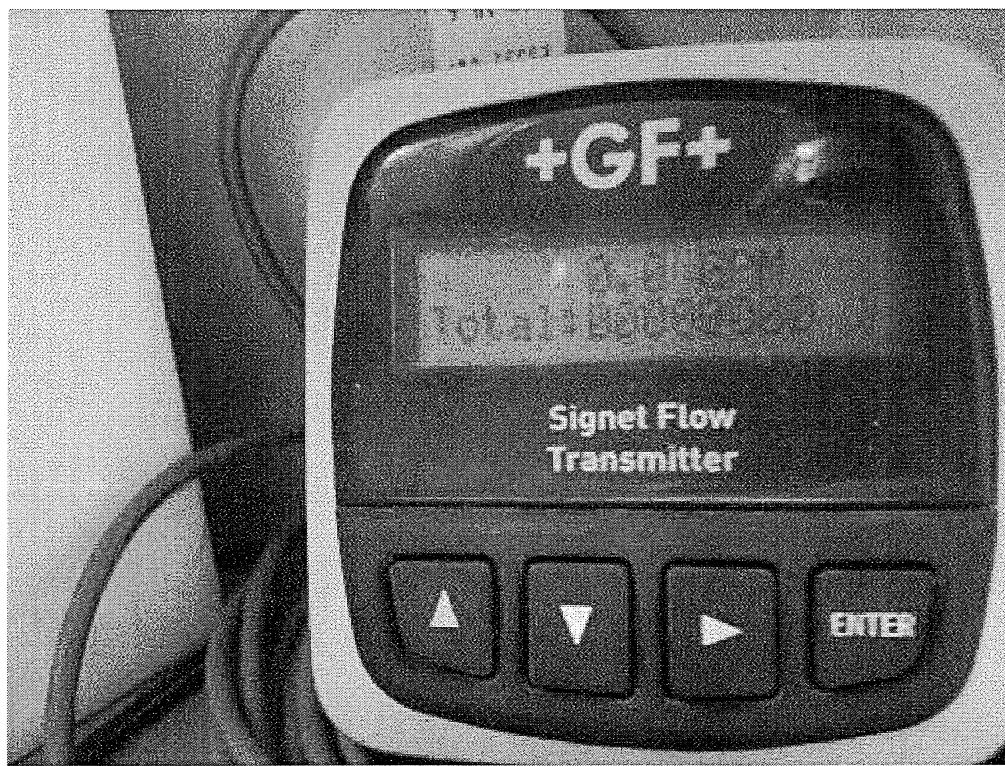
Image 16(flow rate gauge) : Venturi scrubber flow rate gauge

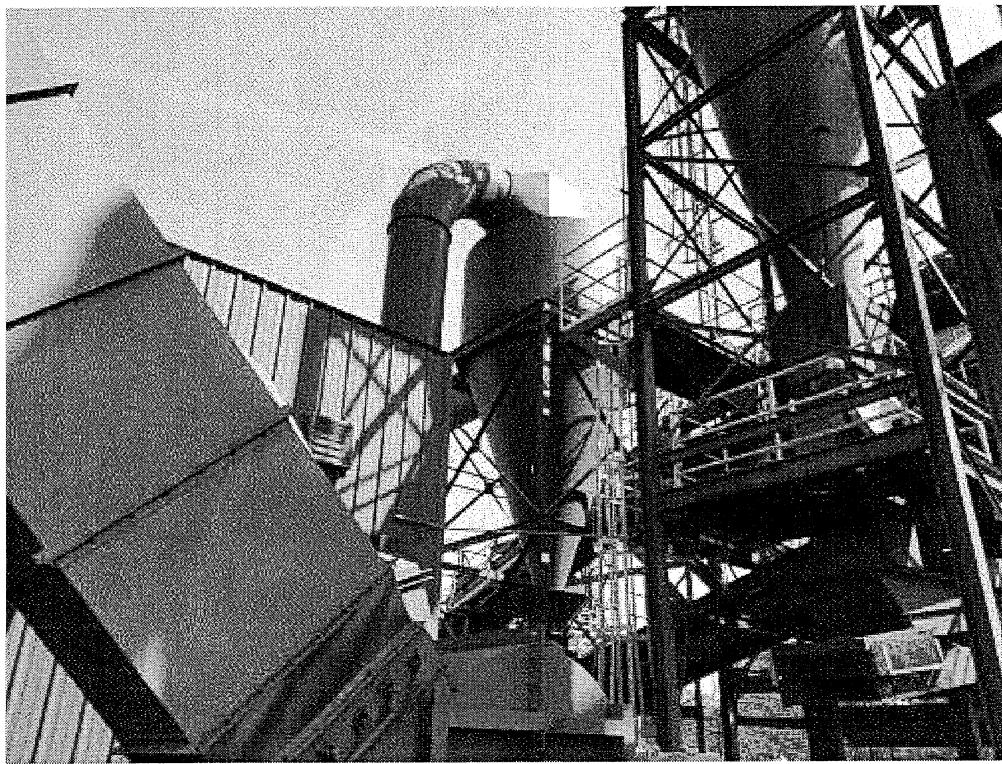
Image 17(cyclones) : Main cyclone on left, Z-box cyclone on right

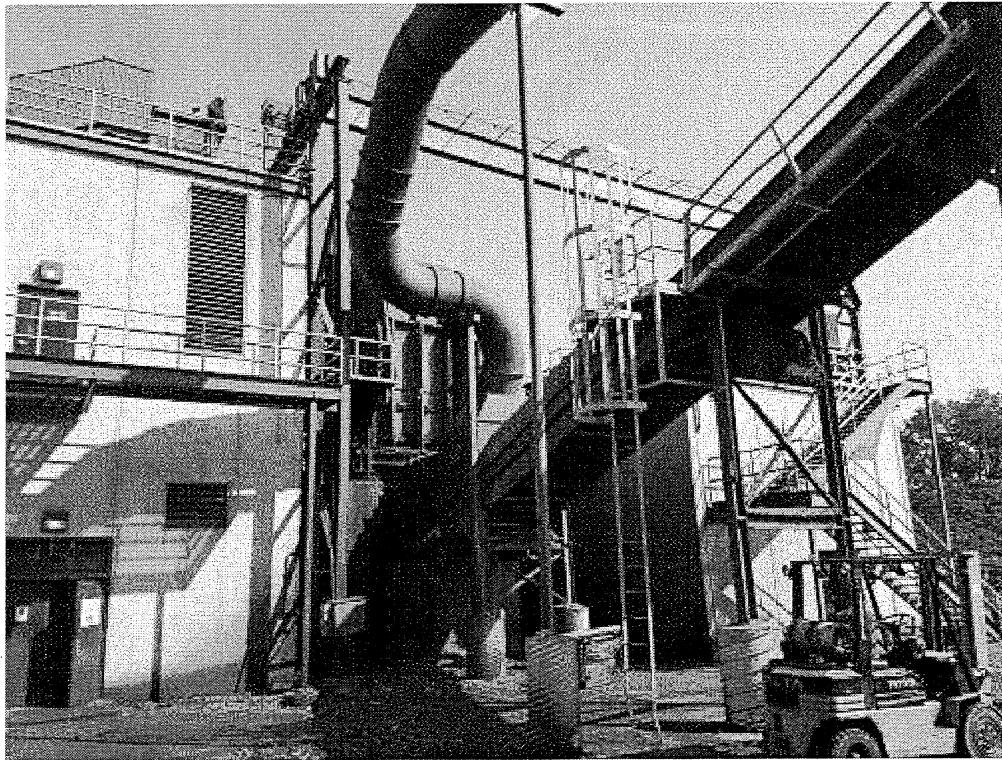
Next, we headed over to observe the shredder and associated equipment. The shredder was not in operation. It was down because the amount of feed scrap material in the pile adjacent to the shredder wasn't large enough yet to make it worthwhile to turn on the equipment. Since the process was not in operation, only a brief walk through of it was conducted.

Image 18(shredder) : Shredder
