DEPARTMENT OF ENVIRONMENTAL QUALITY  
AIR QUALITY DIVISION  
ACTIVITY REPORT: On-site Inspection

FACILITY: Carmeuse Lime & Stone		SRN / ID: B2362
LOCATION: PO BOX 529, DRUMMOND IS		DISTRICT: Marquette
CITY: DRUMMOND IS		COUNTY: CHIPPEWA
CONTACT: Roger Nash, Site Operations Manager		ACTIVITY DATE: 06/08/2021
STAFF: Michael Conklin	COMPLIANCE STATUS: Non Compliance	SOURCE CLASS: MINOR
SUBJECT: Inspection to determine compliance with PTI No. 15-20 and complaint investigation.		
RESOLVED COMPLAINTS: C-21-00645

**Facility: Carmeuse Lime & Stone (SRN: B2362)**

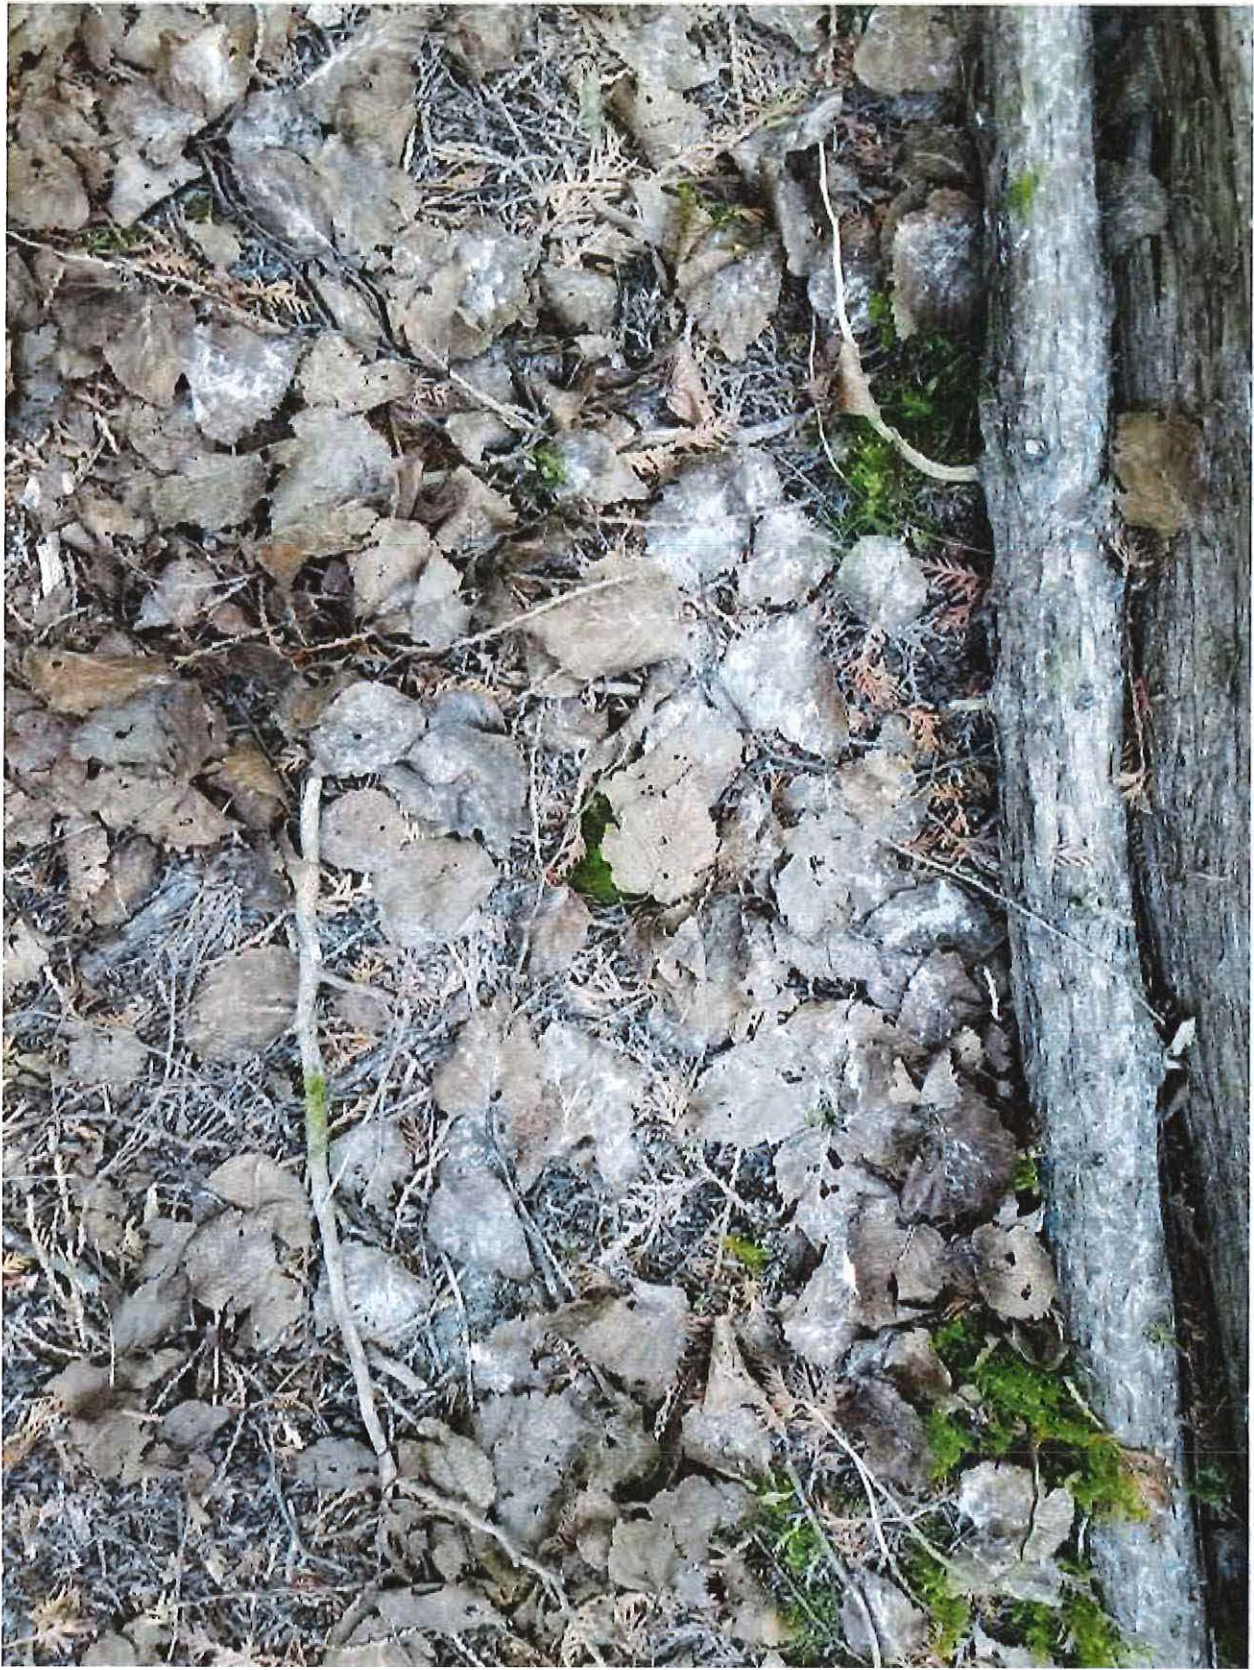
Min/sec	0	15	30	45
1	30	20	10	10
2	0	0	0	0
3	5	30	40	5
4	0	0	0	0
5	0	0	0	0
6	0	0	0	0

Process: Haul Road

Emission Point: Rear of haul trucks

Emissions: Dust from truck traffic
