**SUBJECT: REO TOWN PLANT EUNGENINE
RESPONSE TO NOTICE OF VIOLATION**

Appendix A: Reo Town Emergency Engine VN Response

Revised Report of Results: MVA12978

Identification of Material in Stack Samples

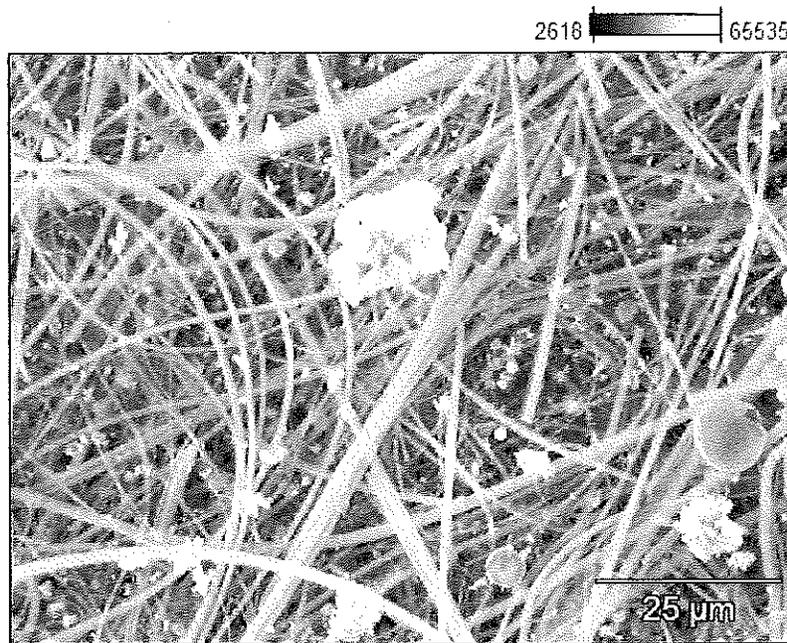
12978AE0002(5)

Filter Samples. The types of particles found on the filter samples and their approximate compositions are given in Table 1. The dominant particle types in all three samples are a calcium-phosphorus-oxygen-rich type (probable calcium phosphate, $\text{Ca}_3(\text{PO}_4)_2$) and iron oxide/hydroxide (possible corrosion products). The putative calcium phosphate particles are often associated with variable amounts of zinc and sulfur. There is a slight tendency for an increasing ratio of calcium phosphate to iron oxide from Test 1 to Test 3. We noted during our analyses that the iron oxide particles are generally larger than the calcium phosphate particles and likely make up a larger percentage of the samples on a mass basis (Table 1 results are on a particle count basis.) Representative images and EDS spectra are shown in Figures 1 through 5.

Calcium phosphate is not expected the flue gas of a natural gas-fired generator and likely originates outside of the combustion process. Calcium phosphate is a common industrial mineral with principal use in fertilizer. Similarly, iron oxide is not an expected combustion product of natural gas. It has been found as a corrosion product in flue gasses resulting from corrosion of the stack itself. Calcium phosphate is sometimes used as a corrosion inhibitor.

The particulate on the filters is composed of iron oxide consistent with iron corrosion product and a calcium/phosphorus/oxygen compound consistent with calcium phosphate.

Figure 1. SEM image of particulate on sample "Test 1 Filter." The irregular particles are iron oxide; the more rounded and spherical particles are consistent with calcium phosphate.

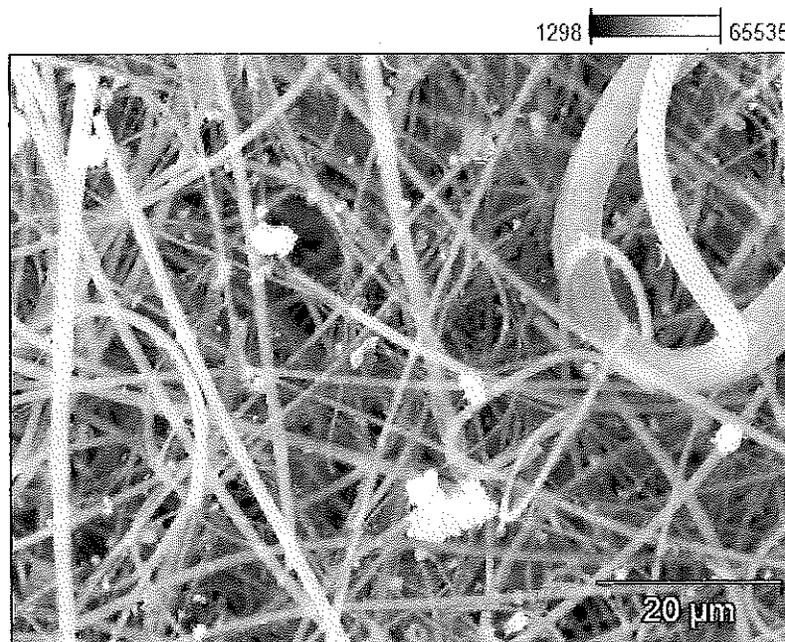
12978AE0003(4)

Figure 2. SEM image of particulate on sample "Test 2 Filter."

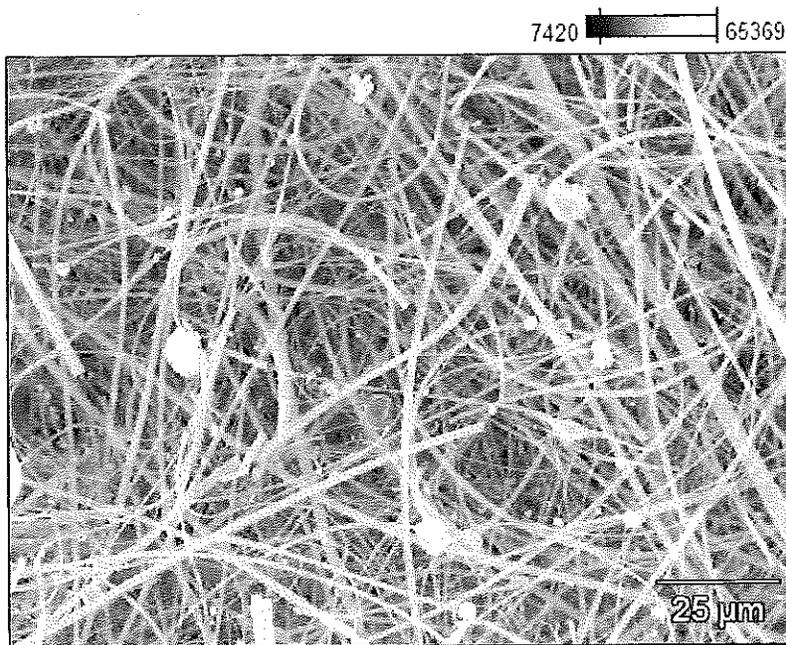
12978AE0004(3)

Figure 3. SEM image of particulate on sample "Test 3 Filter."

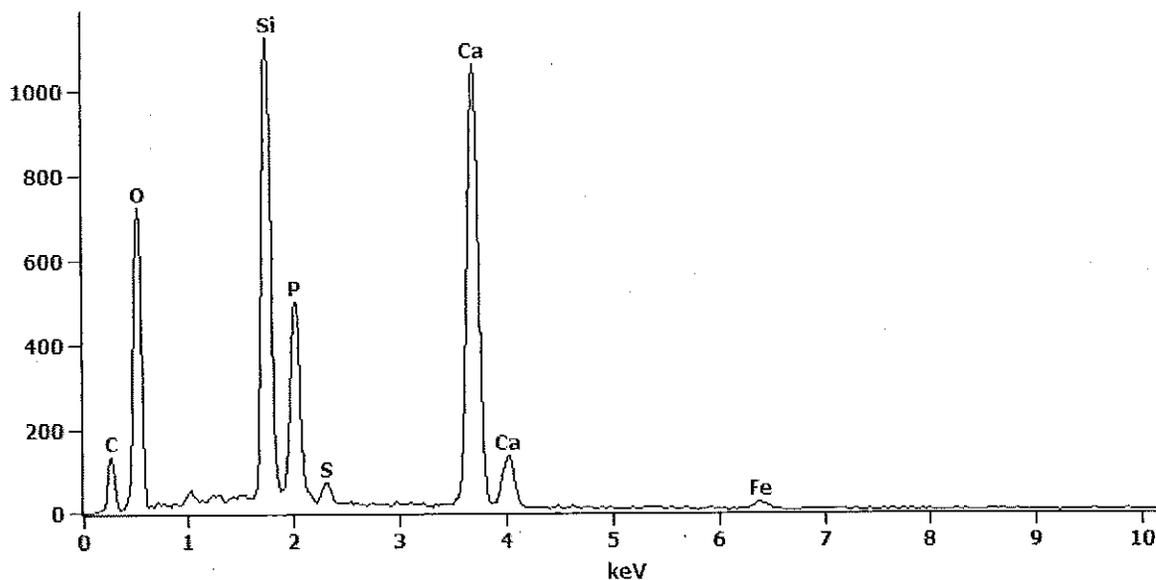
12978AE0003(2)_pt2

Figure 4. The EDS spectrum obtained from a typical calcium-phosphorus-oxygen-rich particle, probable calcium phosphate. Sample "Test 2 Filter." C = carbon (from applied carbon coating), O = oxygen, Si = silicon (from the quartz filter fibers), P = phosphorus, S = sulfur, Ca = calcium, Fe = iron.

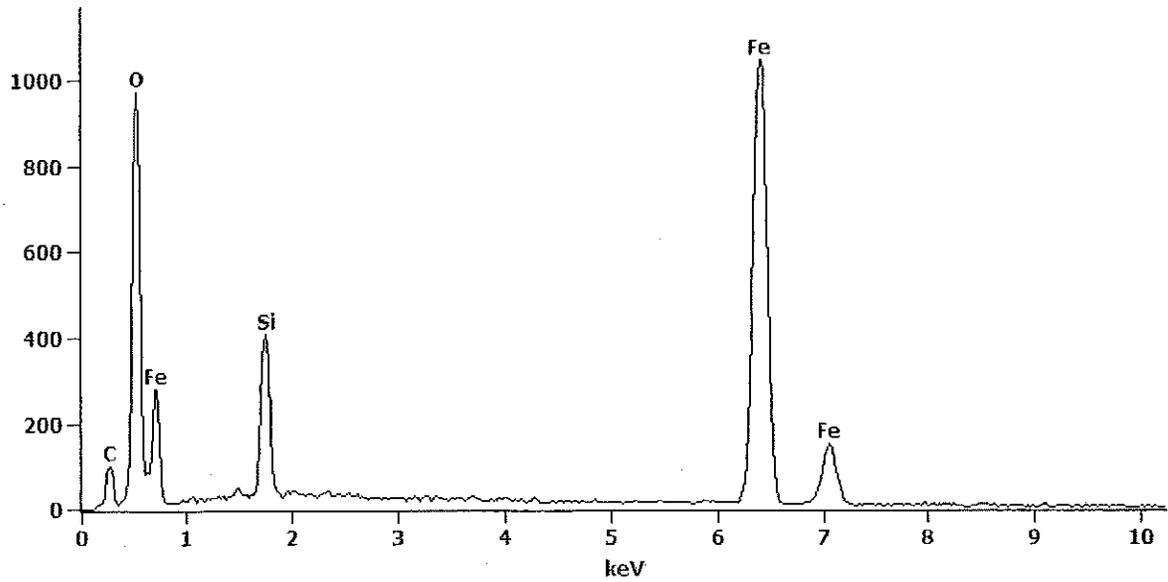
12978AE0002(5)_pt1

Figure 5. The EDS spectrum obtained from a representative iron oxide particle. Sample "Test 1 Filter."

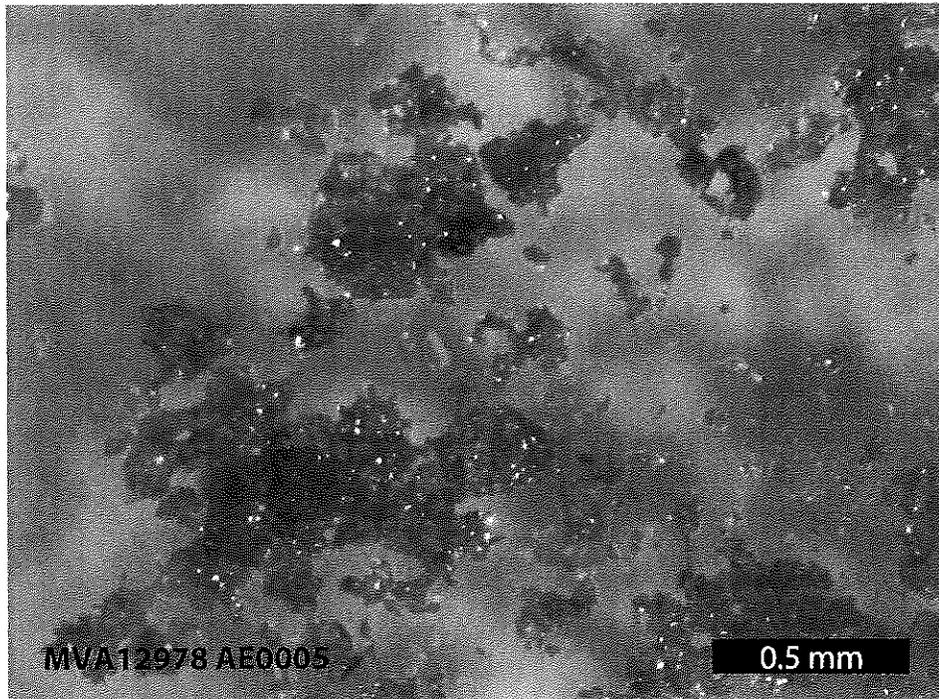
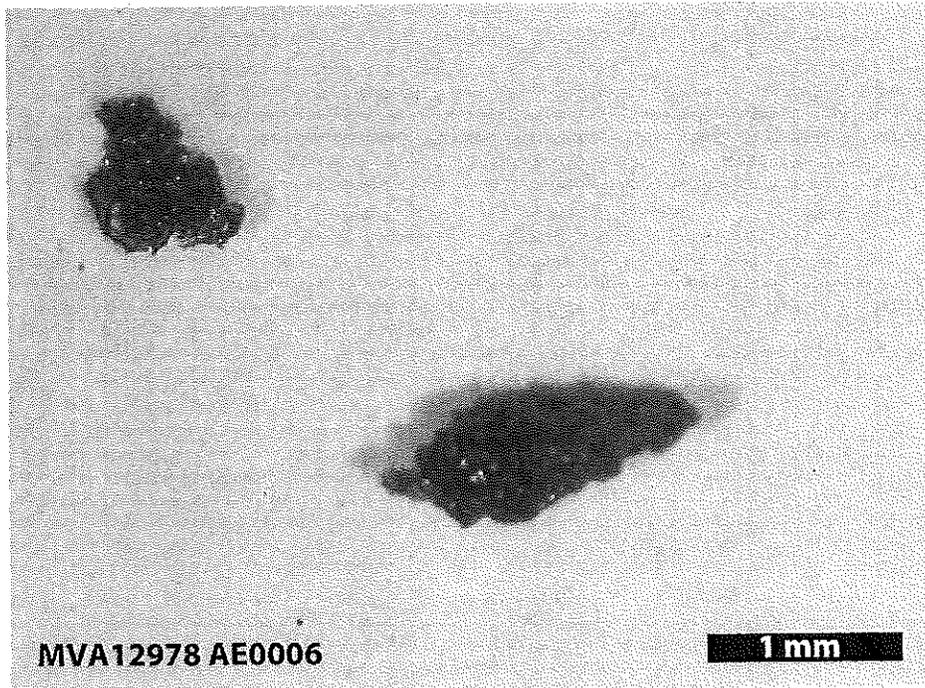
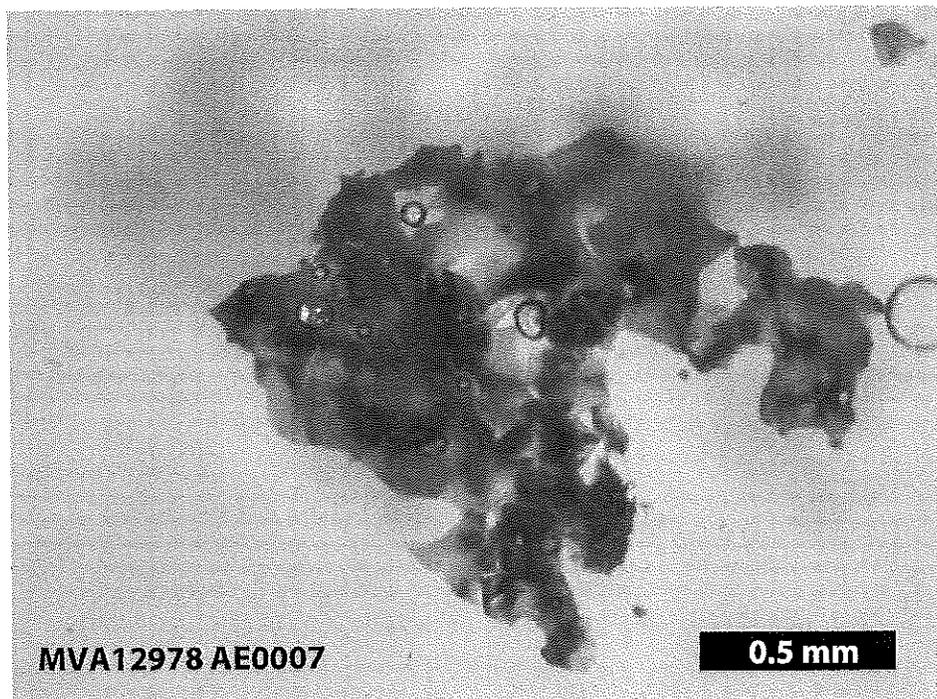
Water from Imps Samples. All three samples present as an orange/rust-colored residue in glass vials (Figures 6 through 8). Analysis by PLM indicated that all three samples consist principally (60-80% v/v) of an orange isotropic resinous material with entrained glass and fibers consistent with cellulose making up as much as 20% of the sample (e.g. Figure 9). Crystals consistent with gypsum (e.g. Figure 10) and fan-like arrays of acicular crystals (e.g. Figure 11) are present in all samples and make up as much as 40% of sample "Test 1 Water from Imps."

Figure 6. Stereomicroscope image of a portion of the residue from sample "Test 1 Water from Imps."

Figure 7. Stereomicroscope image of a portion of the residue from sample "Test 2 Water from Imps."

Figure 8. Stereomicroscope image of a portion of the residue from sample "Test 3 Water from Imps."

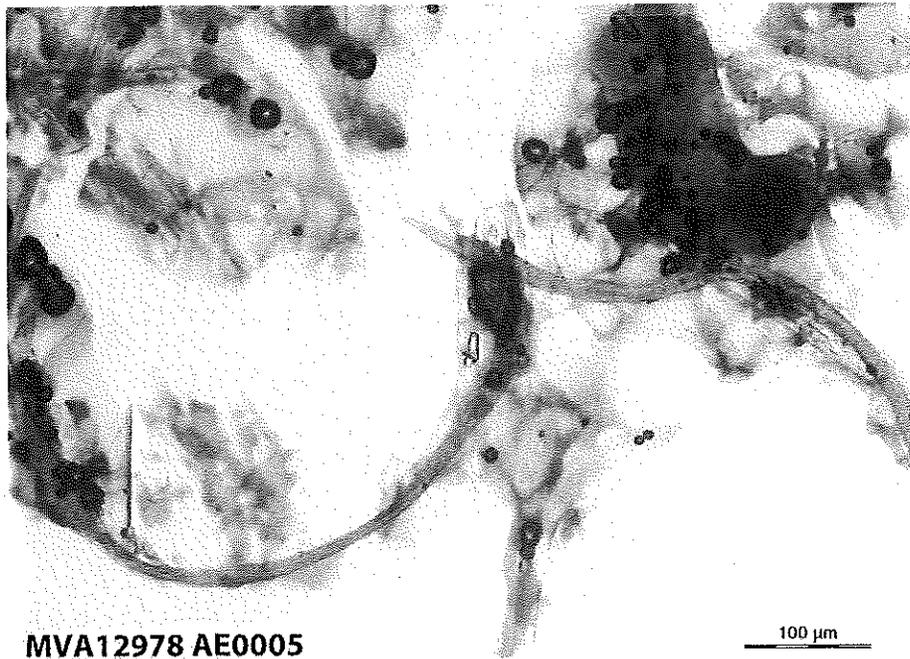
Figure 9. Embedded fibers consistent with cellulose in sample "Test 1 Water from Imps."

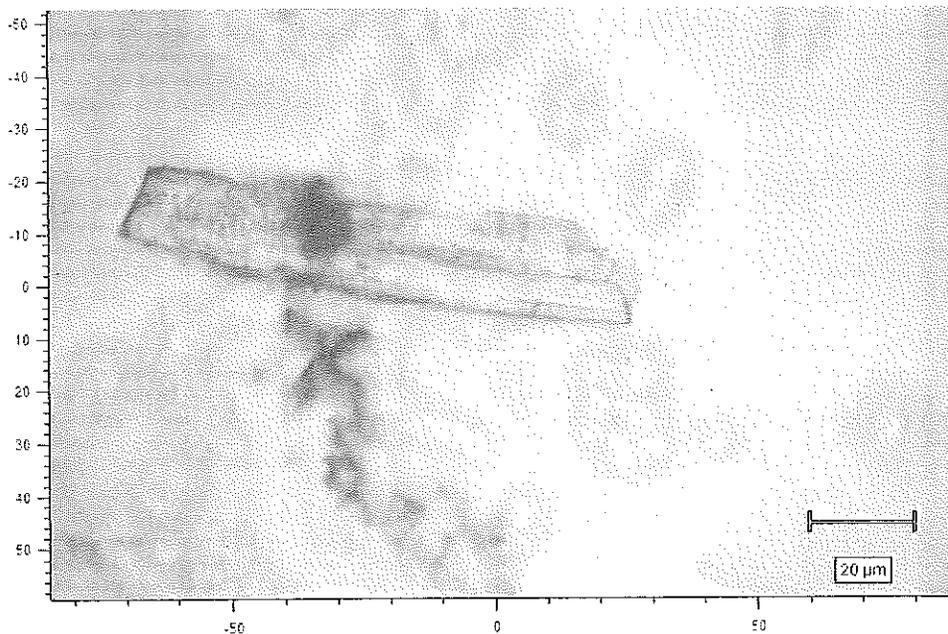
gypsum crystal in the run 1 impinger set. EDS analysis of the Method 202 back half samples indicates the presence of carbon, nitrogen, oxygen, sodium, aluminum, sulfur, potassium, calcium, magnesium, and iron.

Figure 10. Gypsum crystal isolated from sample "Test 1 Water from Imps."

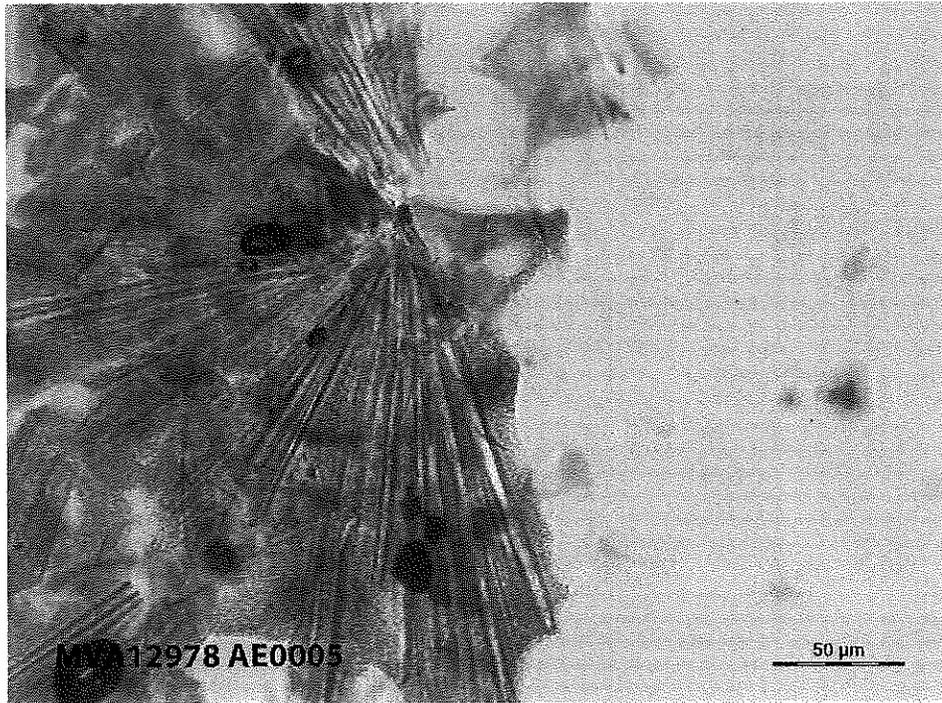
Figure 11. Fan-like acicular crystals in sample "Test 1 Water from Imps."

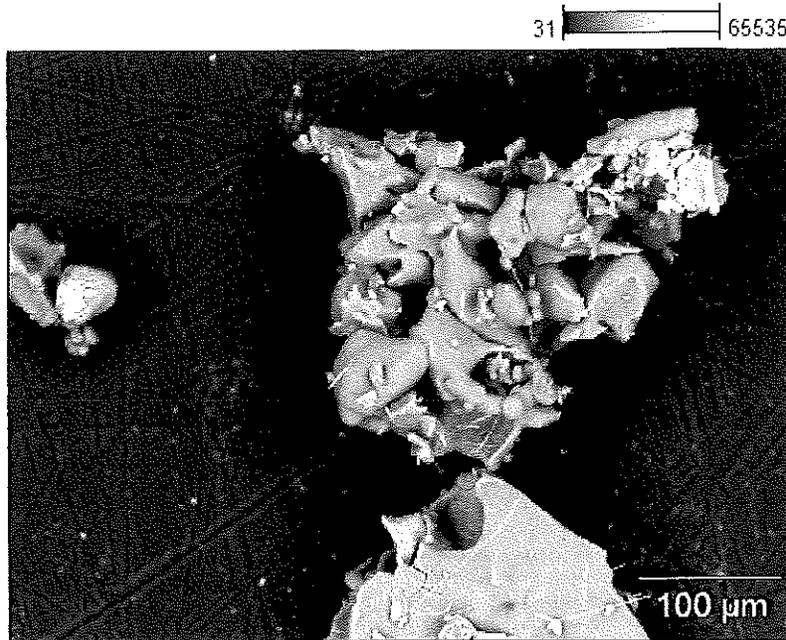
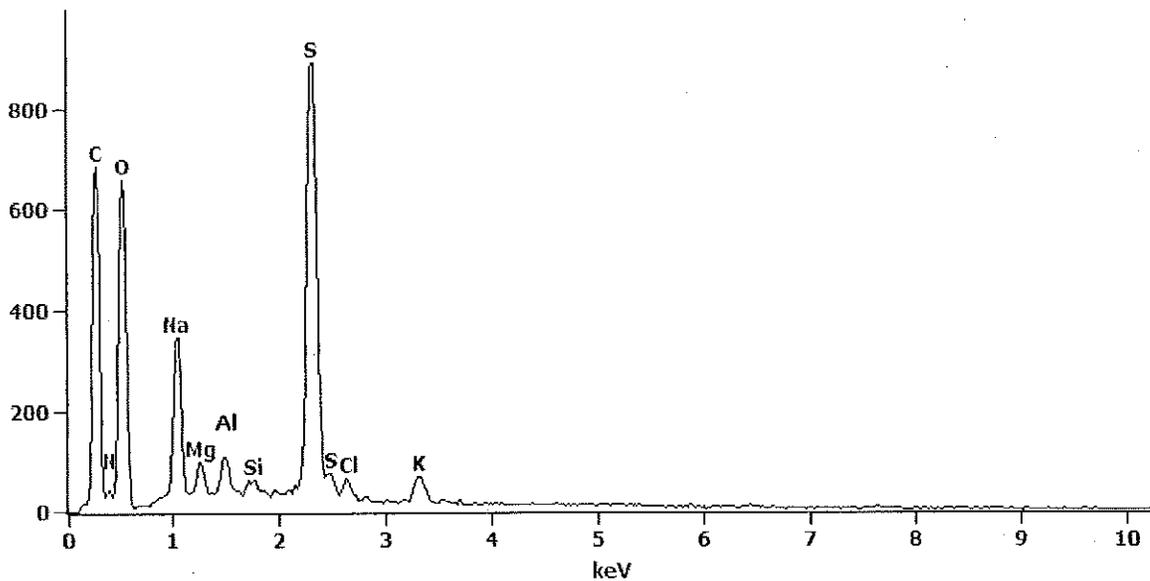
12978AE0005(1)

SEM/EDS analysis of the orange resinous material indicated that it is composed principally of carbon, nitrogen, oxygen, sodium and sulfur (Figures 12 through 14).

Figure 12. SEM image (above) and EDS spectrum (below) of a portion of the orange resinous material from sample "Test 1 Water from Imps." C = carbon, N = nitrogen, O = oxygen, Na = sodium, Mg = magnesium, Al = aluminum, Si = silicon, S = sulfur, Cl = chlorine, K = potassium.

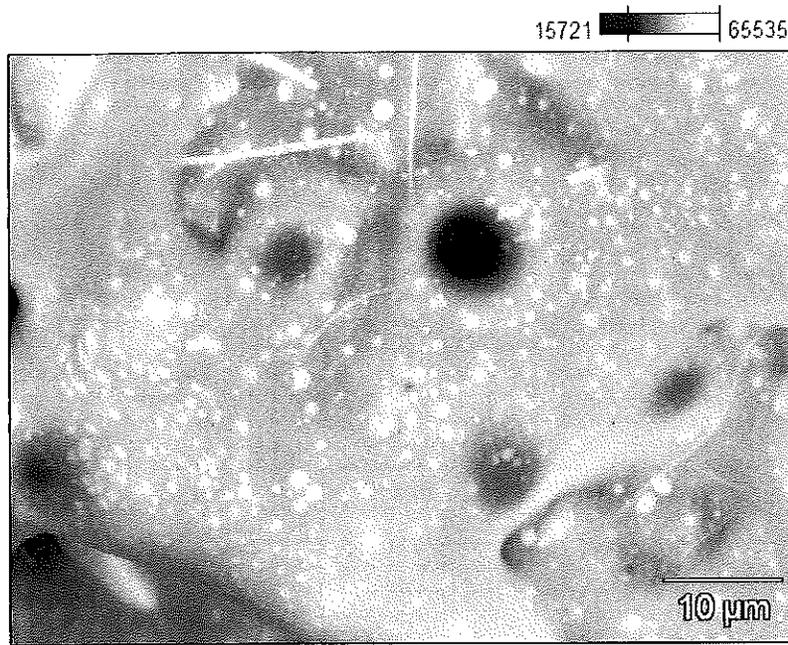
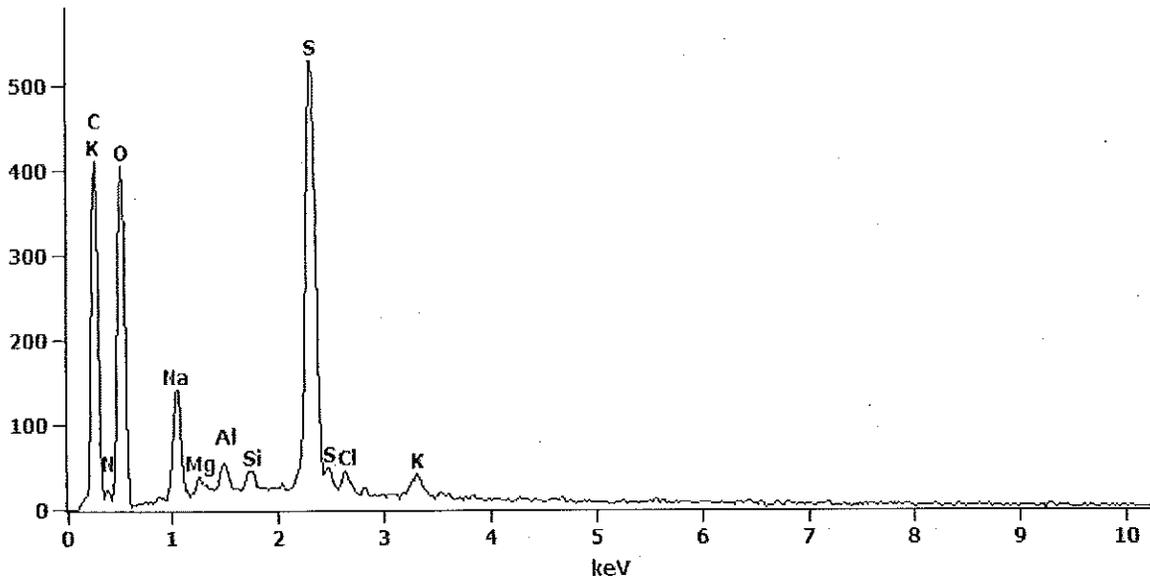
12978AE0006(2)

Figure 13. SEM image (above) and EDS spectrum (below) of a portion of the orange resinous material from sample "Test 2 Water from Imps."

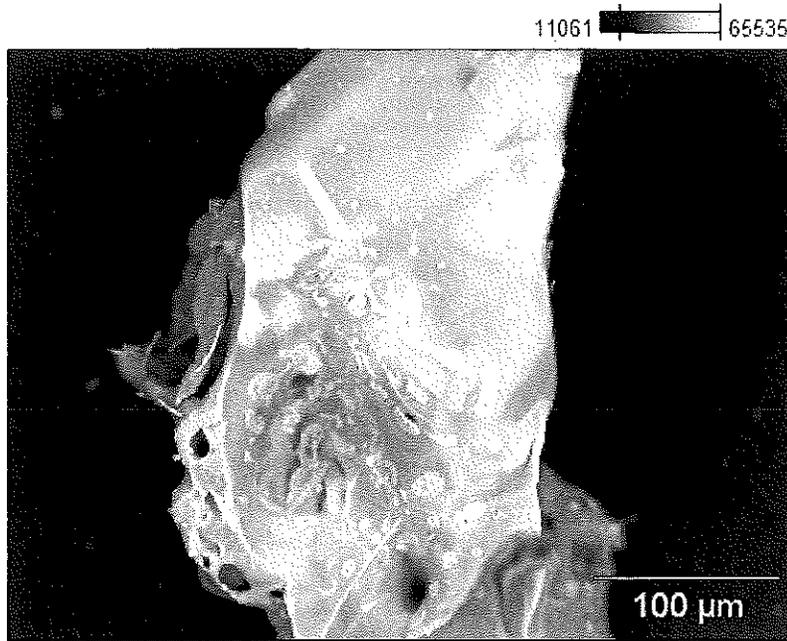
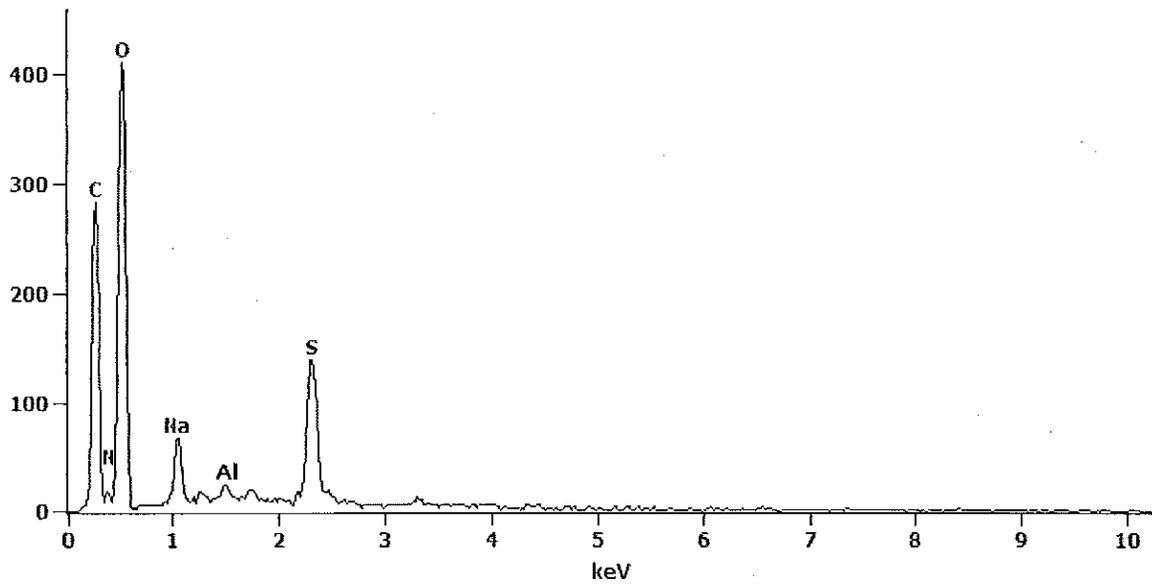
12978AE0007(1)

Figure 14. SEM image (above) and EDS spectrum (below) of a portion of the orange resinous material from sample "Test 3 Water from Imps."

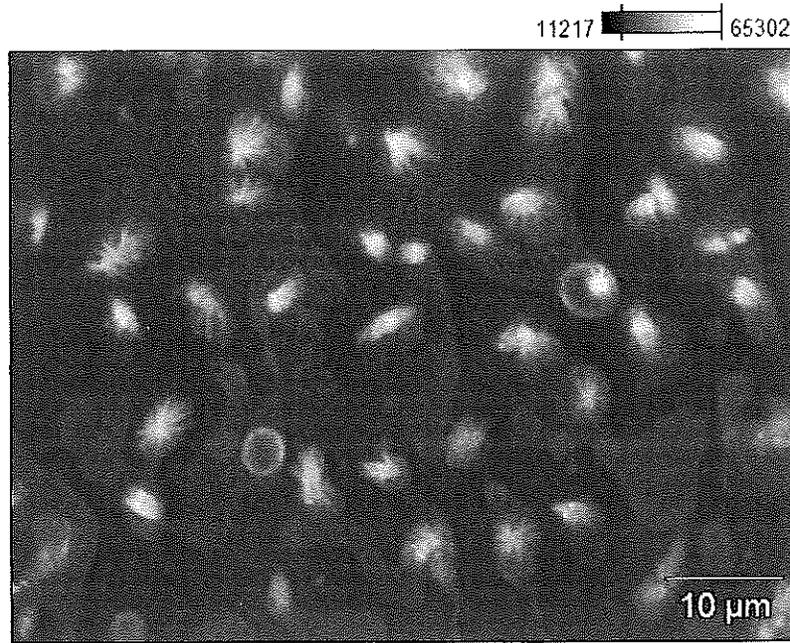
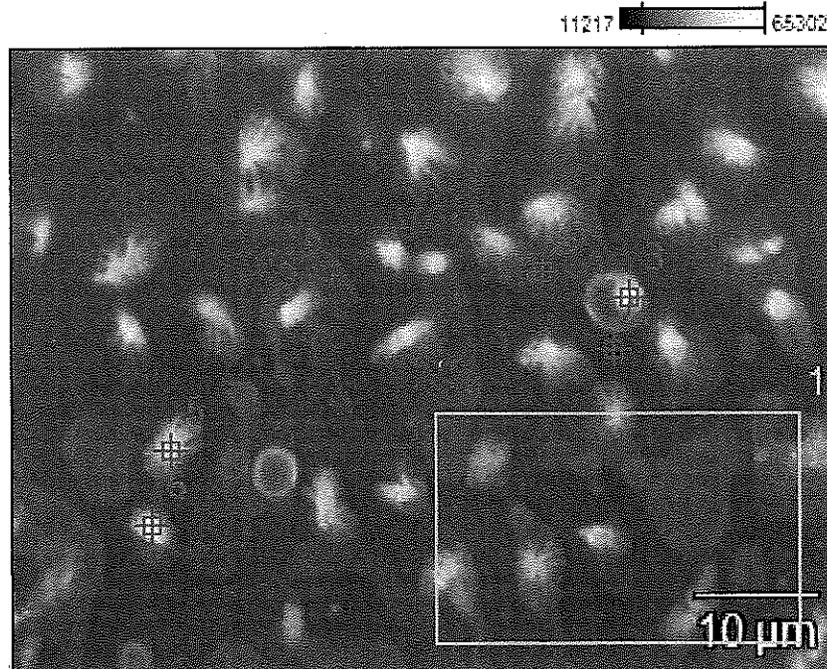
12978AE0005ext(3)

A portion of sample "Test 1 Water from Imps" was extracted with hexane and water. No hexane-soluble material was found. The orange residue was readily soluble in water, leaving a clear orange solution. Figures 15 through 22 present the SEM/EDS data obtained from the reprecipitated water-soluble fraction. These results indicate that this fraction is composed of sodium/calcium sulfate/sulfite(?) crystals (Figures 16, 19, 21 and 22) embedded in a matrix composed principally of carbon, nitrogen and oxygen (Figures 18 and 20). Iron is present at low levels and may account for the orange color. Analysis of the insoluble fraction indicates it is composed of a carbon/oxygen phase (with no nitrogen) (Figure 23) and gypsum (Figure 24).

Figure 15. SEM image of a portion of the water-soluble fraction of sample "Test 1 Water from Imps."

Figure 16. The same field of view shown in Figure 15, with the locations of individual EDS analyses indicated.

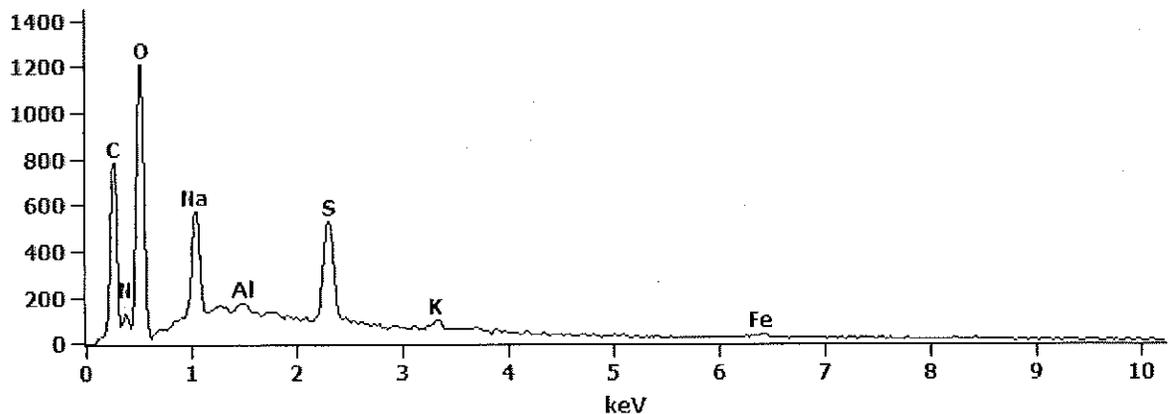
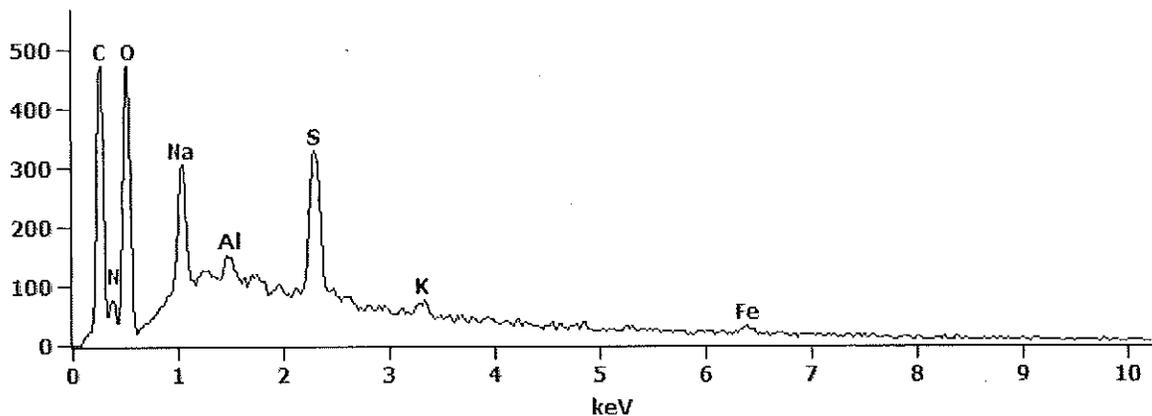
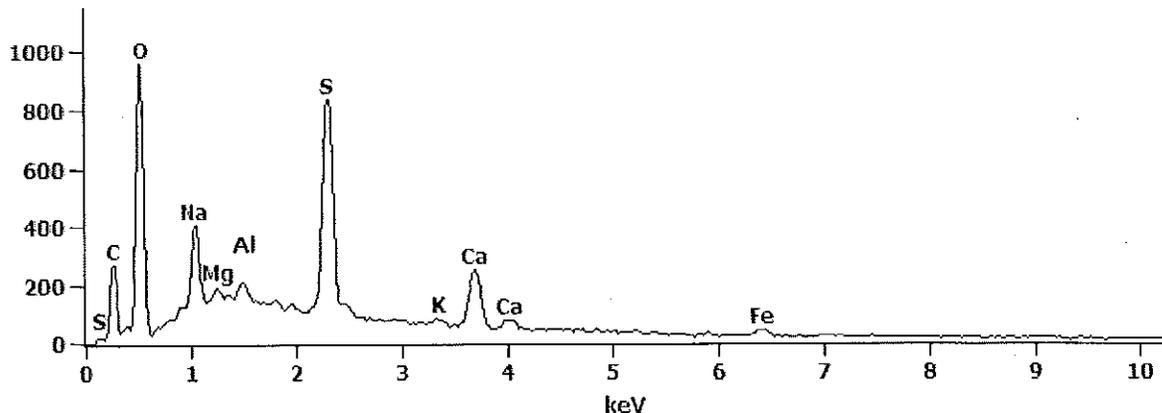
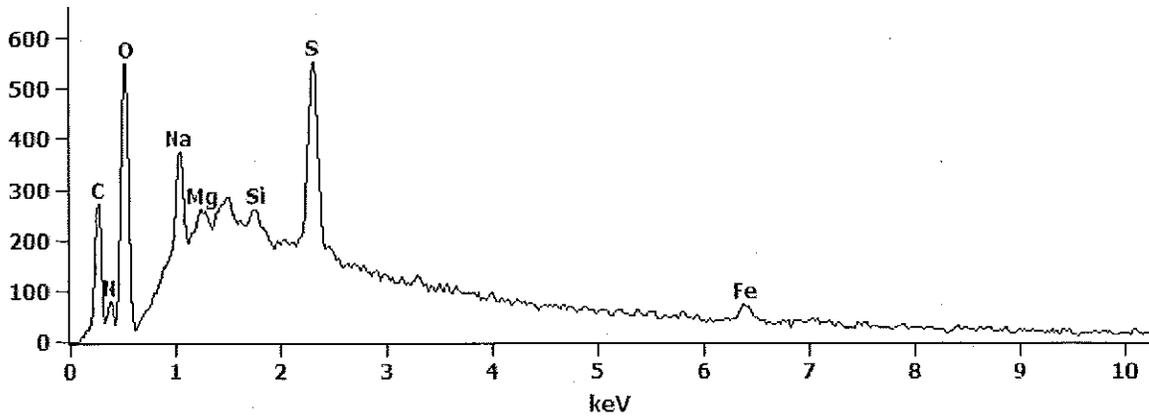
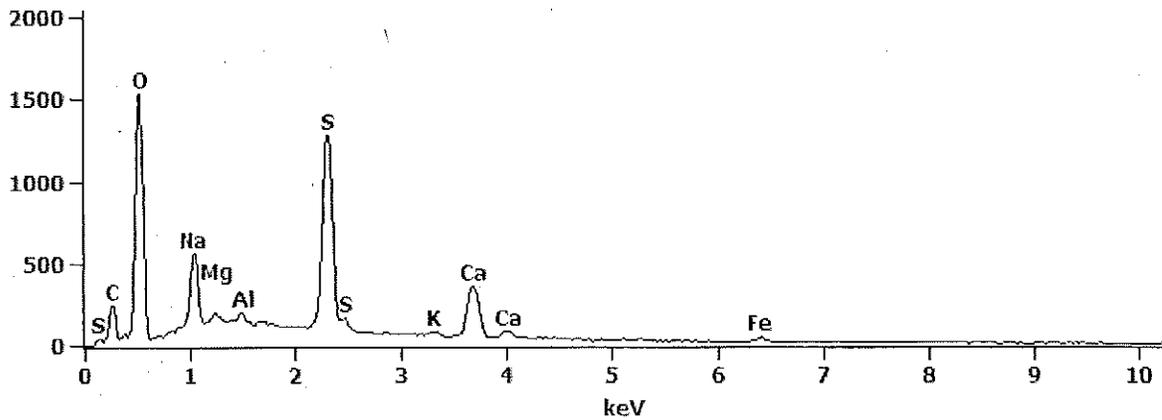
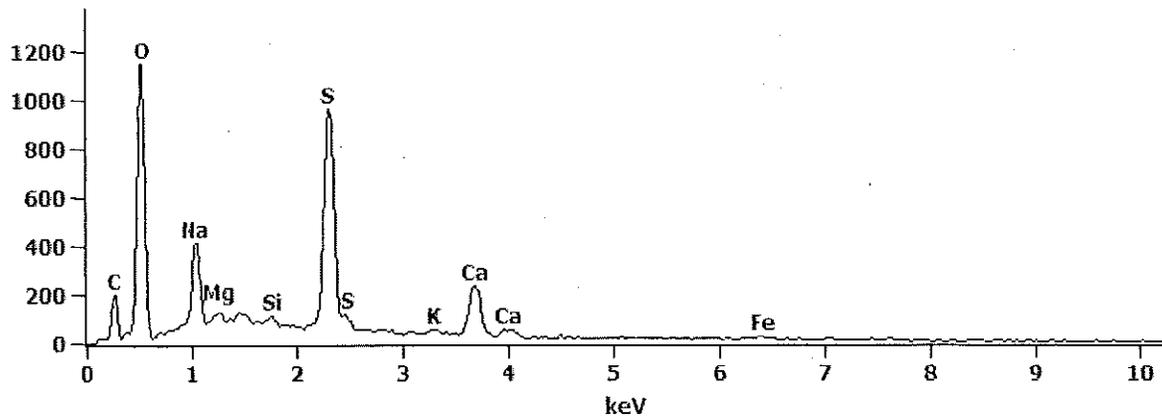
Figure 17. The EDS spectrum obtained from location 1 in Figure 16.

Figure 18. The EDS spectrum obtained from location 2 in Figure 16.

Figure 19. The EDS spectrum obtained from location 3 in Figure 16.

Figure 20. The EDS spectrum obtained from location 4 in Figure 16.

Figure 21. The EDS spectrum obtained from location 5 in Figure 16.

Figure 22. The EDS spectrum obtained from location 6 in Figure 16.

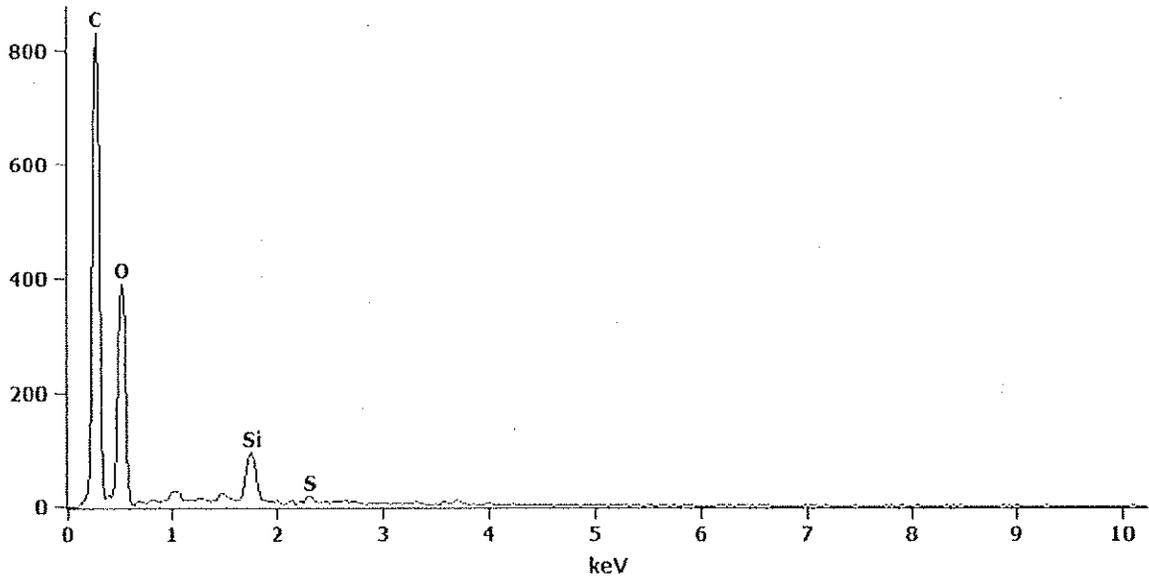
12978AE0005w(1)_pt2

Figure 23. EDS spectrum obtained from the water-insoluble residue of sample "Test 1 Water from Imps."

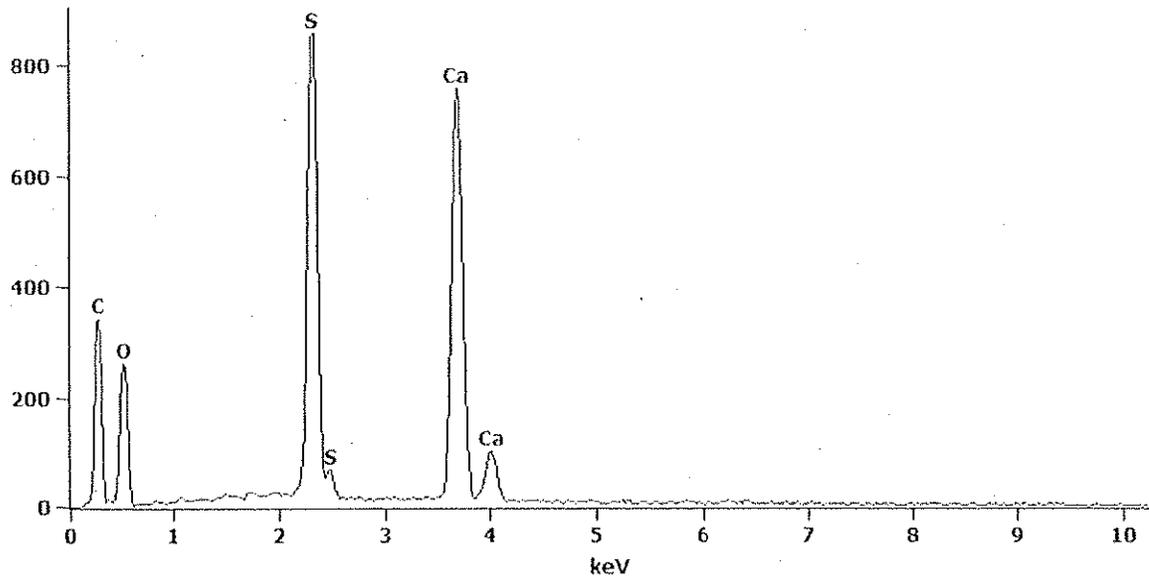
12978AE0005w(1)_pt6

Figure 24. EDS spectrum obtained from gypsum in the water-insoluble residue of sample "Test 1 Water from Imps."

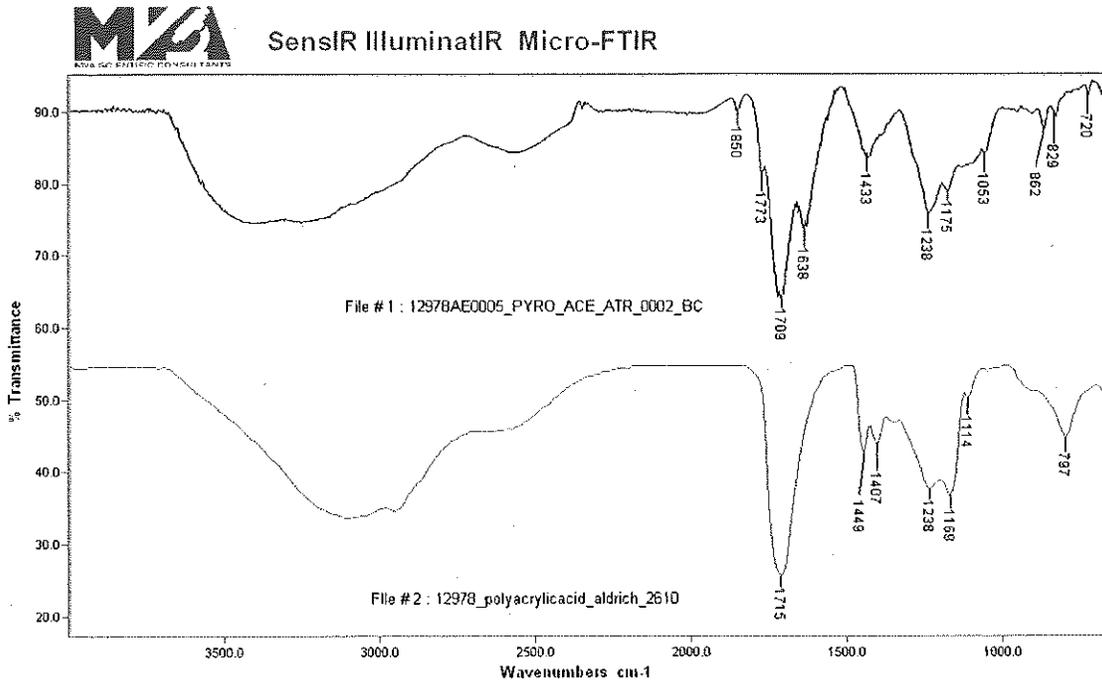
We were unable to obtain a useful infrared absorption spectrum from the bulk sample or the water-soluble residue. We therefore pyrolyzed a portion of sample "Test 1 Water from Imps" and obtained the absorption spectrum of the pyrolyzate. This spectrum is consistent with a polyacrylic acid or similar compound and is presented in Figure 25.

A polyacrylate is not expected as a significant combustion product of natural gas. Acrylates are commonly used in coatings (e.g., paints) and plastics.

Figure 25. The infrared absorption spectrum obtained from the pyrolyzate of sample "Test 1 Water from Imps" (upper trace) shown with a reference spectrum for polyacrylic acid.
