# DEPARTMENT OF ENVIRONMENTAL QUALITY AIR QUALITY DIVISION **ACTIVITY REPORT: Off-site Inspection**

B280657396		
FACILITY: DTE Electric Company - Superior Peaking Facility		SRN / ID: B2806
LOCATION: 6000 FIRST STREET, SUPERIOR TWP		DISTRICT: Jackson
CITY: SUPERIOR TWP		COUNTY: WASHTENAW
CONTACT: Stefanie Ledesma, Staff Environmental Engineer		ACTIVITY DATE: 03/23/2021
STAFF: Brian Carley	<b>COMPLIANCE STATUS:</b> Compliance	SOURCE CLASS: MAJOR
SUBJECT: Scheduled targeted inspection		
RESOLVED COMPLAINTS:

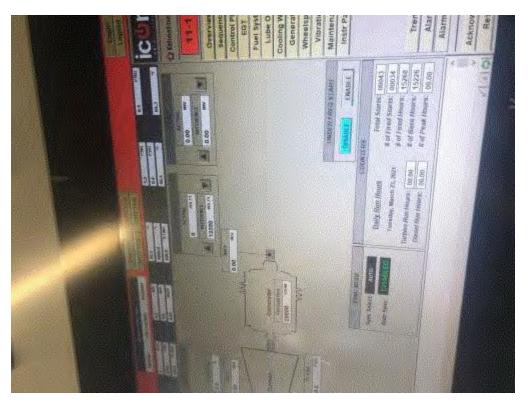
**Image 1(Unit 11-1) :** Control panel for Unit 11-1 which shows the hours meter for that unit. Photo taken by Stefanie Ledesma, DTE on March 23, 2021.

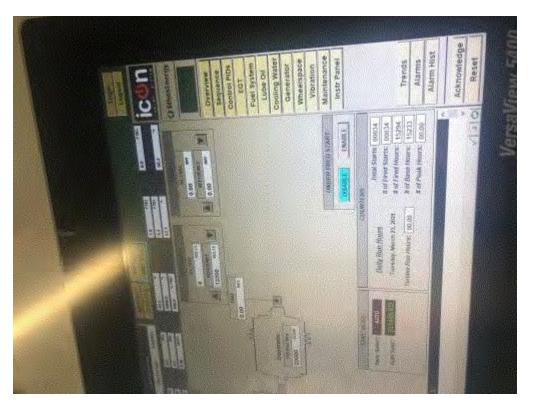
**Image 2(Unit 11-4) :** Control panel for Unit 11-4 which shows the hours meter for that unit. Photo taken by Stefanie Ledesma, DTE on March 23, 2021.

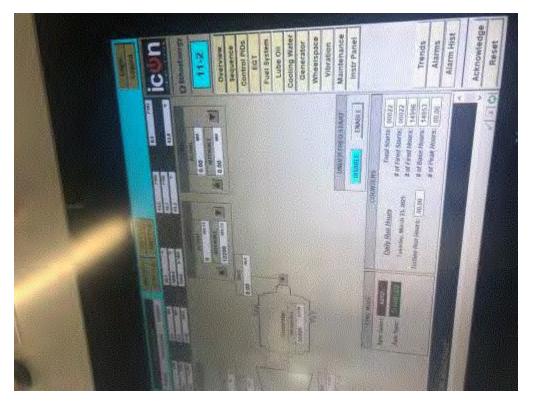
**Image 3(Unit 11-2) :** Control panel for Unit 11-2 which shows the hours meter for that unit. Photo taken by Stefanie Ledesma, DTE on March 23, 2021.

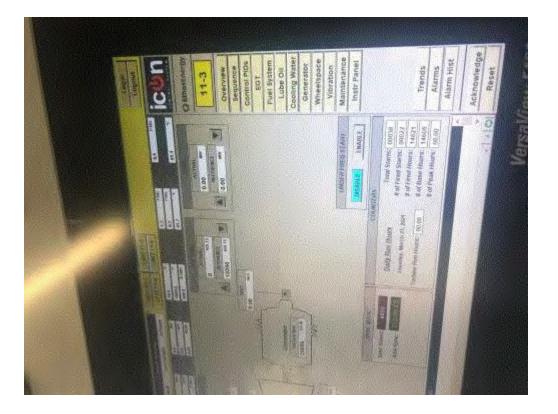
Image 4(Unit 11-3) : Control panel for Unit 11-3 which shows the hours meter for that unit. Photo taken by Stefanie Ledesma, DTE on March 23, 2021.
