DEPARTMENT OF ENVIRONMENTAL QUALITY  
AIR QUALITY DIVISION  
ACTIVITY REPORT: Scheduled Inspection

FACILITY: LBWL, Erickson Station		SRN / ID: B4001
LOCATION: 3725 South Canal Road, LANSING		DISTRICT: Lansing
CITY: LANSING		COUNTY: EATON
CONTACT: Susan Pemberton, Environmental Engineer		ACTIVITY DATE: 06/23/2016
STAFF: Michelle Luplow	COMPLIANCE STATUS: Non Compliance	SOURCE CLASS: MAJOR
SUBJECT: Scheduled compliance inspection to determine compliance with LBWL Erickson Station's MI-ROP-B4001-2015.		
RESOLVED COMPLAINTS:

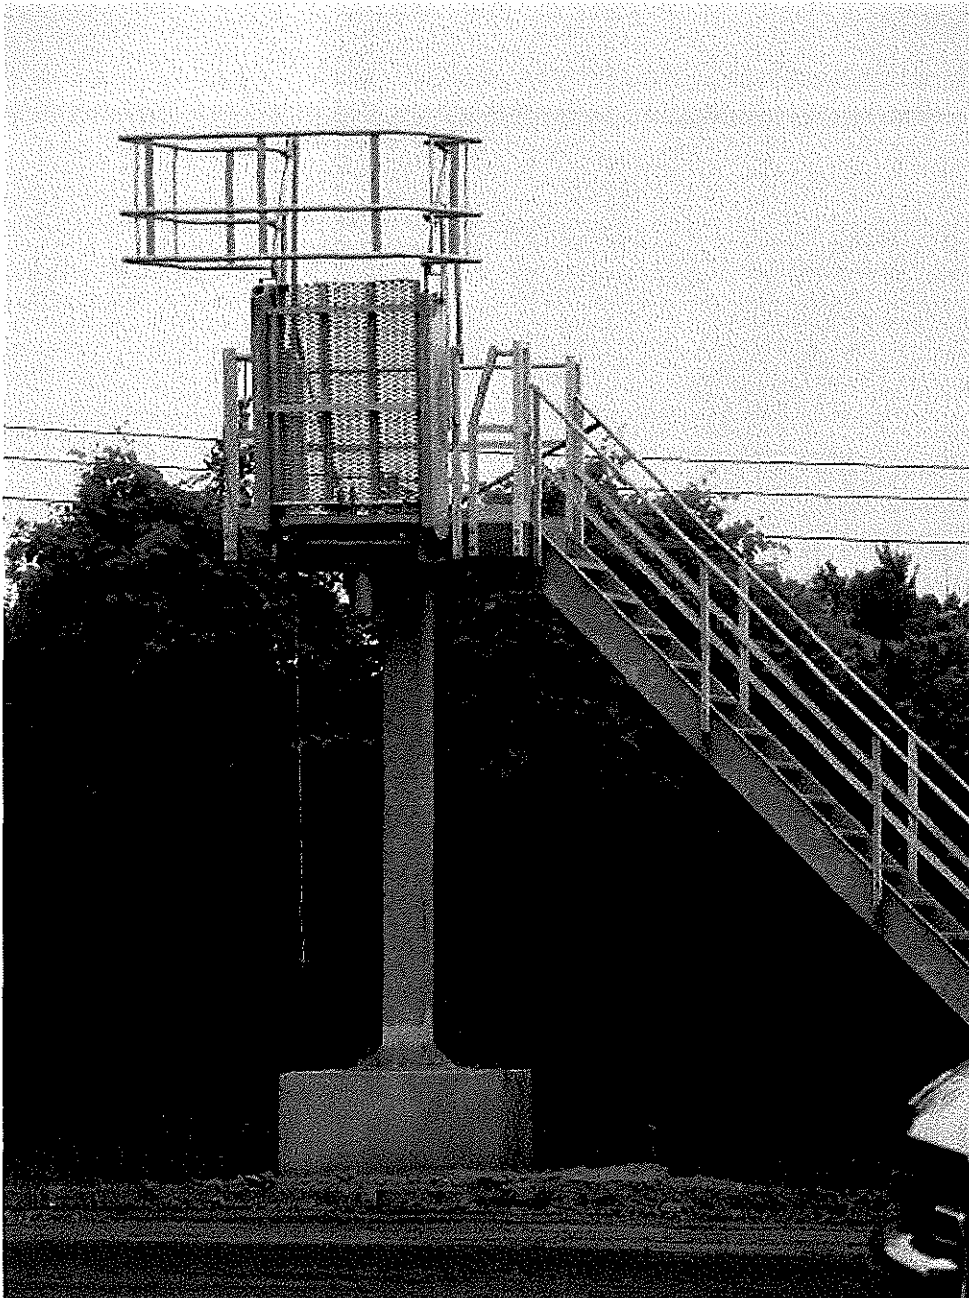
Once trucks are loaded with fly ash, the truck driver drives over to a platform (**photo attached**) where he climbs to the top of the truck to close the "lids" where fly ash loads into the truck. There is fugitive dust from this process (as witnessed during a 6/27/16 visit). K. Beson explained that the platform is required by OSHA.

**Image 1(FGASHHANDLING)** : Platform where loaded trucks park for truck driver to shut the "lids" where flyash is loaded into truck.

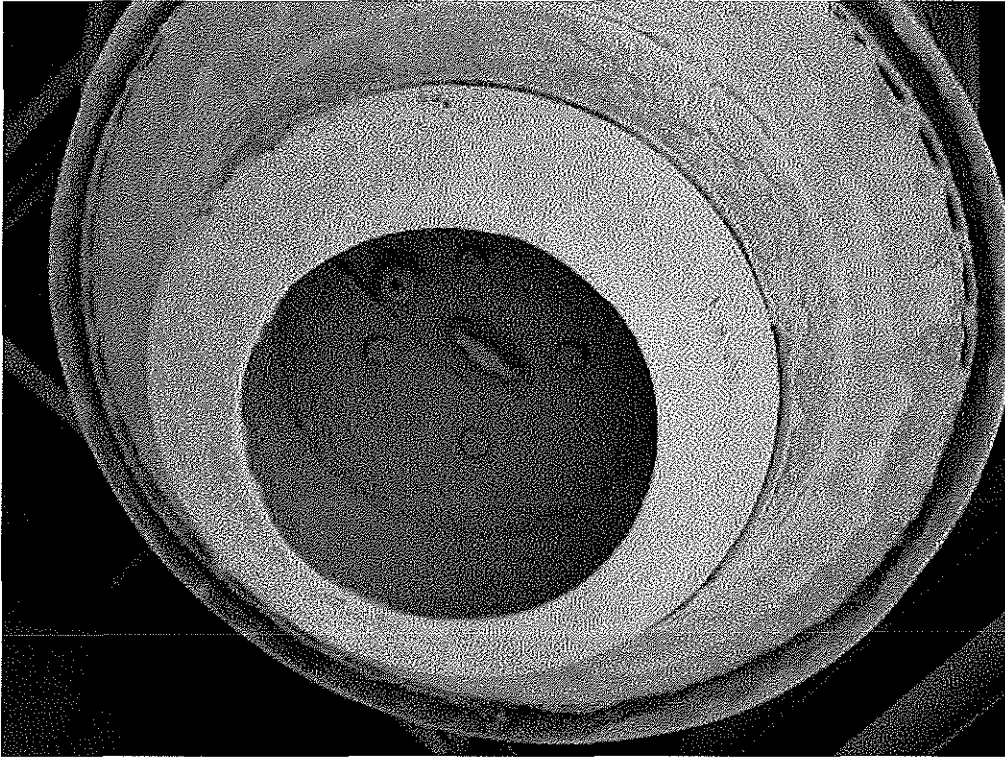
Another potential source of the fugitive fly ash that D. Allen pointed out during the June 2015 inspection was the loadout chute for the trucks. D. Allen pointed out that there were holes in the chute and in the seal that connects to the trucks for loadout of the fly ash. During the inspection D. Allen said that the new chute had already been ordered and would arrive in 4-5 weeks.

As follow-up to the June 2015 inspection, while onsite during the June 23, 2016 inspection, I took photos of the new door and loadout **chute (attached)**. Both appeared to be in good condition: there were no cracks or seal breakages that I could see. Additionally, K. Beson pointed out that the baghouse used for loadout control will be replaced within the next couple of weeks with a more efficiency baghouse that uses cartridges.

**Image 2(FGASHHANDLING)** : Fly ash loadout chute with new seals

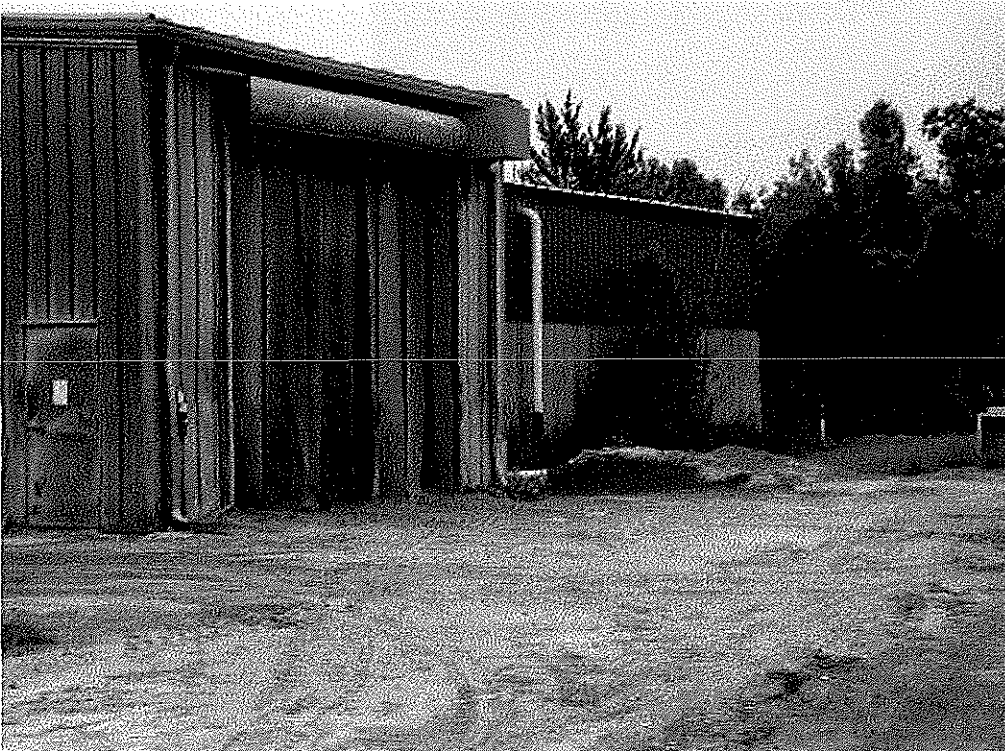
Because of the concerns with fly ash on the complainant's property I discussed with D. Allen the possible sources of the fly ash during the June 2015 inspection. D. Allen said that sometime either in February or March 2015 she noticed that fly ash was being emitted through the cracks in the seals of the Mass Storage building's vehicle entrance overhead doors. She said that she immediately had the system shut down, and kept it shut down until the baghouse was fixed, which she said involved replacing all the bags in the baghouse. She said that under normal operation the building is under vacuum, and when the baghouse malfunctioned it placed positive pressure on the system, forcing the fly ash out through the cracked seals on the door. D. Allen said that they have ordered new seals, door rollers, and a new door, all of which will be installed on the outside of the building so that visual inspection of the door and seals can be done more easily to detect any wear.

**Image 3(FGASHHANDLING)** : Repaired door with new seals, door rollers, new door. Front end loaders enter mass storage building through this entrance.

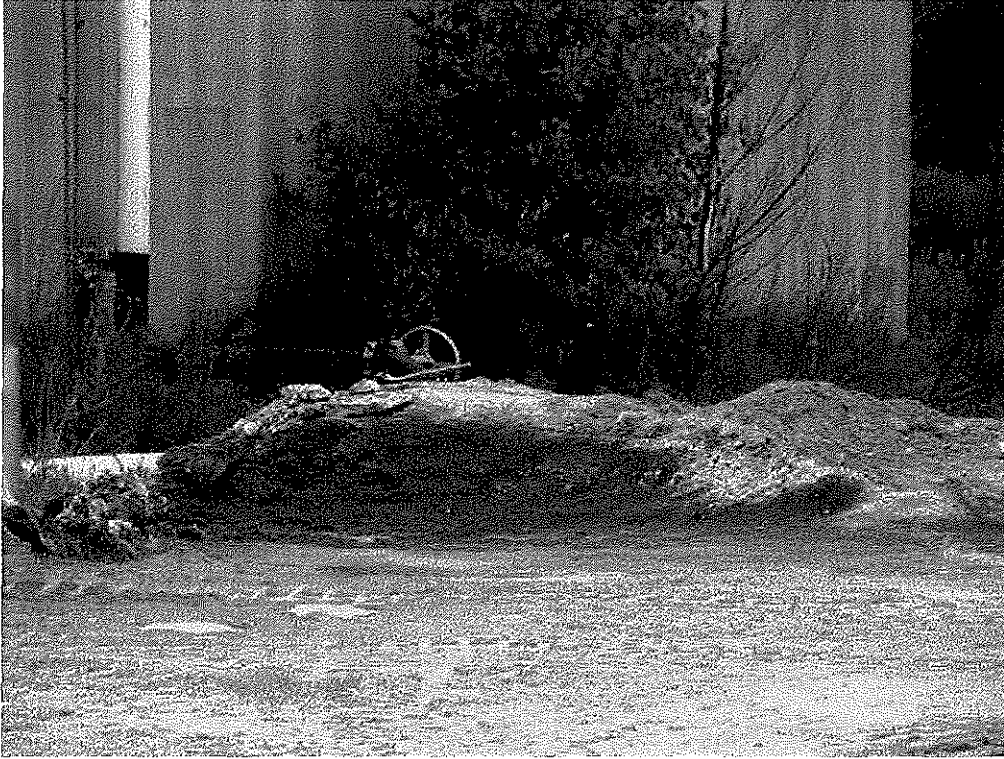
M. Nelson and Keith Beson showed B. Bukowski and I around the ash handling site. The new door to the main ash storage building was open, I did not see any opacity being emitted from the open door. M. Nelson explained that front-end loaders enter into the main ash storage building using this door. Once inside, the loaders push the fly ash over the grates located inside the building so that conveyors can carry the fly ash out of the storage building and into the storage silos or into the loadout silo. He said that any of the fly ash that becomes hardened and too compact to be pushed through the grates is pushed out of the main storage building and stored in a pile outside until a truck picks it up to be landfilled. He said that a truck comes once per week to pick up this pile of fly ash. **Attached is a photo of this pile.** The pile is not enclosed and is exposed to the elements.

The results of both sets of samples indicate high concentrations of fly ash in the outside storage piles and on the unpaved plant yard areas. Storage of fly ash outside without containment and fly ash being present throughout the plant yard is considered a violation of Rule 370 which requires that the collection and disposal of air contaminants be done in a manner to minimize the introduction of the contaminants to the outer air. Additionally, this is considered a violation of Rule 901: failure to meet Rule 370 has caused fly ash to be dispersed to the surrounding area, including the complainant's property, where fly ash has been found in each sample that has been taken since December 2014, from various locations and objects on his property. This is considered a Rule 901 violation. **A violation notice will be sent to address violations of Rule 370 and Rule 901.**

**Image 4(FGASHHANDLING)** : Fly ash pile being stored just outside the mass storage building.

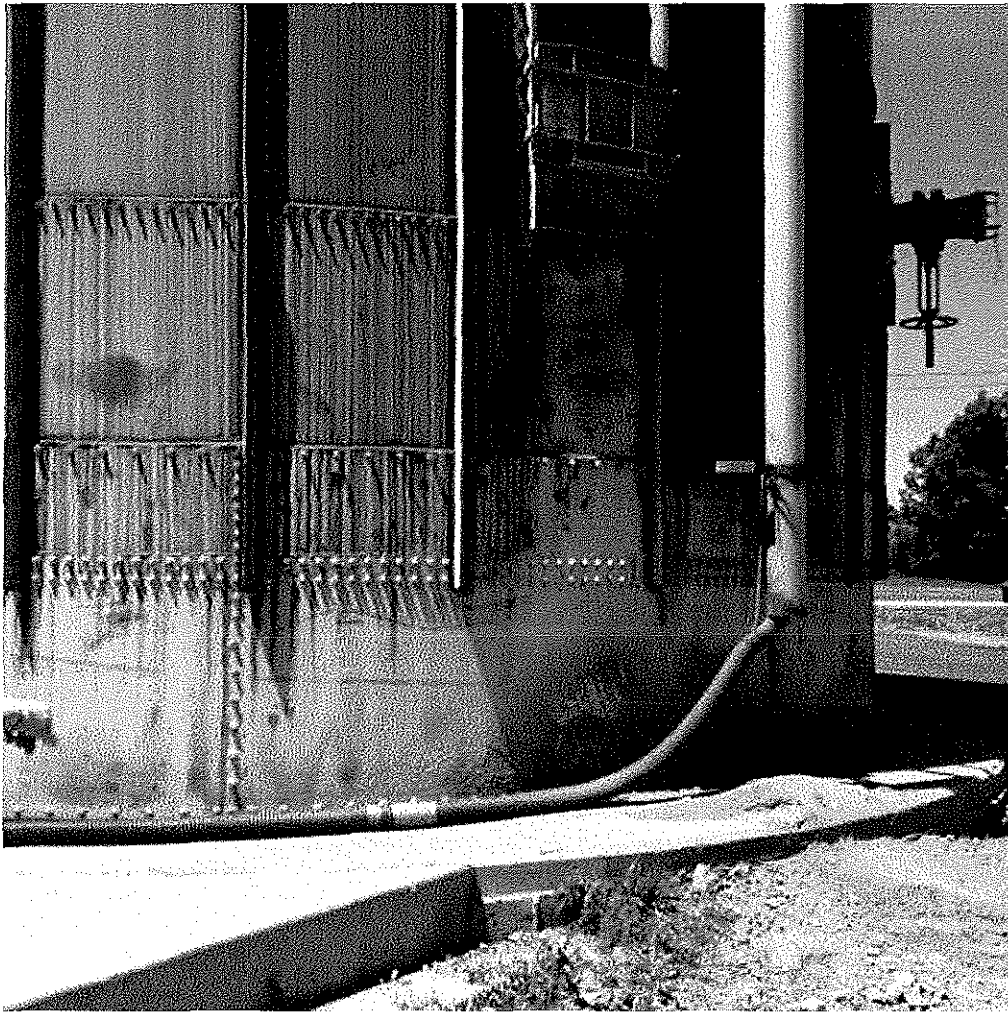
**Image 5(FGASHHANDLING)** : Storage silo with ventilation piping. Appears to be "leaking" fly ash onto cement pad.

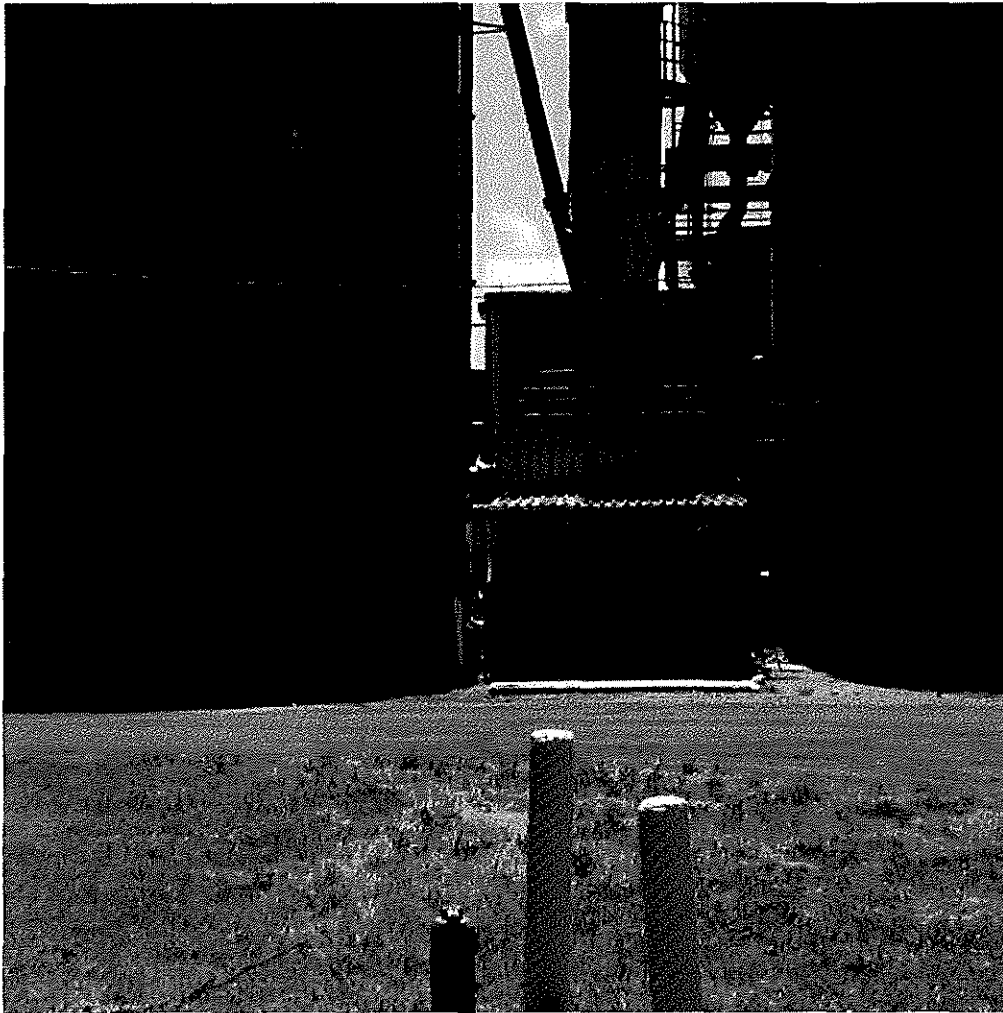
Upon arrival for the site visit at 1:40 pm on 6/27/16 when J. Brunner and I arrived to take samples around the plant yard, we noticed visible emissions from the exhaust of the loadout silo baghouse (**see attached photo for reference photo of baghouse with horizontal exhaust**). Each time the baghouse pulsed (which was about every 10 seconds) dust would come out of the exhaust. The magnahelic gauge for the baghouse did not fluctuate when the system pulsed/emitted particulate from the exhaust. The gauge read consistently at 0.8" H<sub>2</sub>O before, during, and after each pulse. It would be expected that some type of change in pressure drop would be observed during the pulses. Because the baghouse was operating outside of the normal operating range of 1-5" H<sub>2</sub>O (less than 1" H<sub>2</sub>O), it is a violation of Monitoring/Recordkeeping condition 1. Upon arrival at 10:14 a.m. on 6/30/16 for the site visit for sampling, I did not observe any opacity being exhausted from the baghouse exhaust vent at any time during operation. The pulses at this time were ~ 20 seconds apart.

Although records for 6/27/16 indicate that the loadout silo baghouse was operating within the 1-5" H<sub>2</sub>O operating limits, the <1" H<sub>2</sub>O I observed onsite indicated otherwise. In addition to operating outside of the operating limits and not recording the time, date, duration in minutes and results of the VE reading (it was reported as "None"), this is also a violation of Rule 910, for failure to maintain and operate in any air cleaning device in a satisfactory manner and in accordance with the Michigan Air Pollution Control rules and existing law. **In the violation notice I will include violations of SC VI.1 (Monitoring/Recordkeeping) and Rule 910 for this baghouse.**

**Image 6(FGASHHANDLING)** : Loadout silo baghouse exhaust without opacity

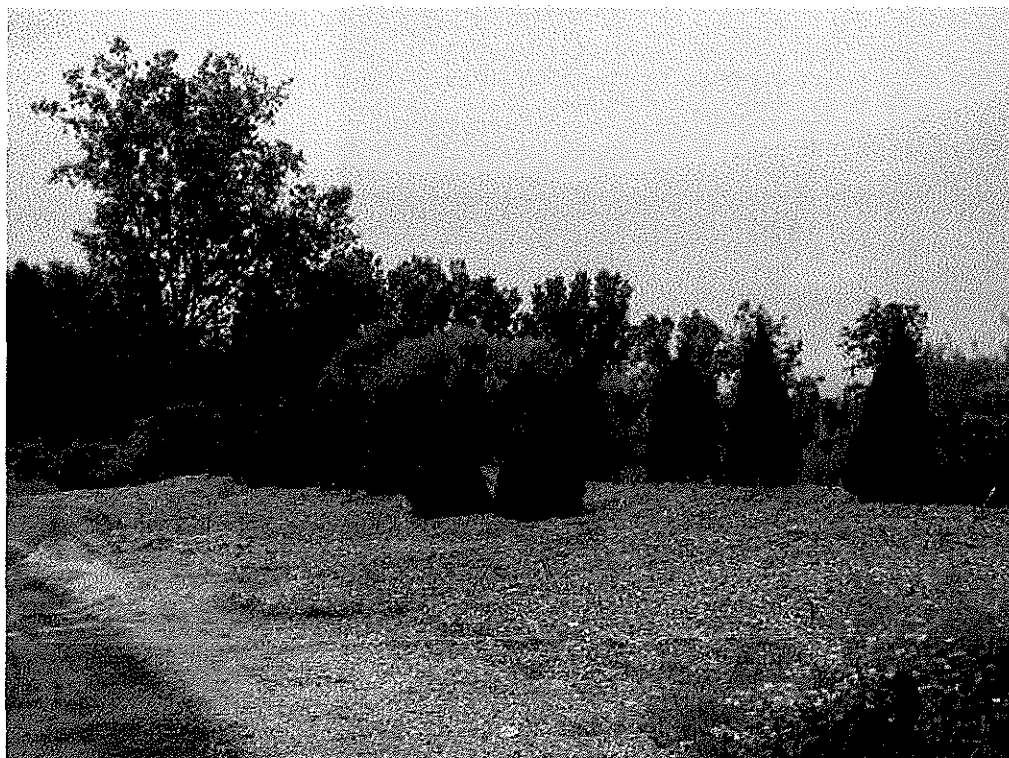
In addition to the berm, the LBWL has also planted trees between the coal pile and ash handling site to create a wind break (**see attached photo**). D. Allen said that the wind speeds can get up to 75 mph because the topography (buildings and flat land) surrounding the ash handling and coal pile creates a wind tunnel effect, in which she said there is really nothing to control the dust at those wind speeds, except potentially a wind break. Plans and photos of the final location of the trees were submitted in December 2015.

**Image 7(FGASHHANDLING)** : Trees planted between ash handling facility and coal pile to provide windbreak

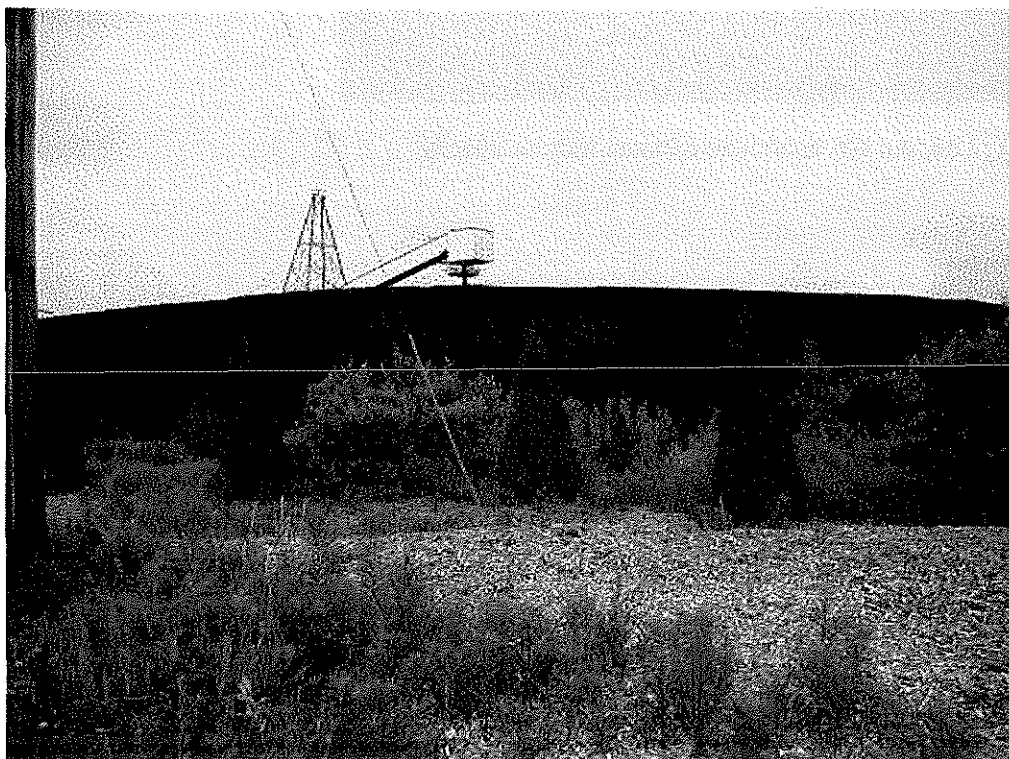
To mitigate fugitive dust from strong prevailing winds, D. Allen said that since May 10, 2015 they have been maintaining the pile at a lower height, while keeping the berm higher than the tip of the coal pile. As soon as they offload the coal onto the pile, the coal is graded to maintain that height. This berm is flush with the top of the coal pile, so that any fugitive dust being blown off the coal pile hits the berm, thus preventing it from moving off the LBWL property. We may discuss at a later date how the coal dust from the berm can also be controlled.

**Image 8(EU001)** : Coal berm

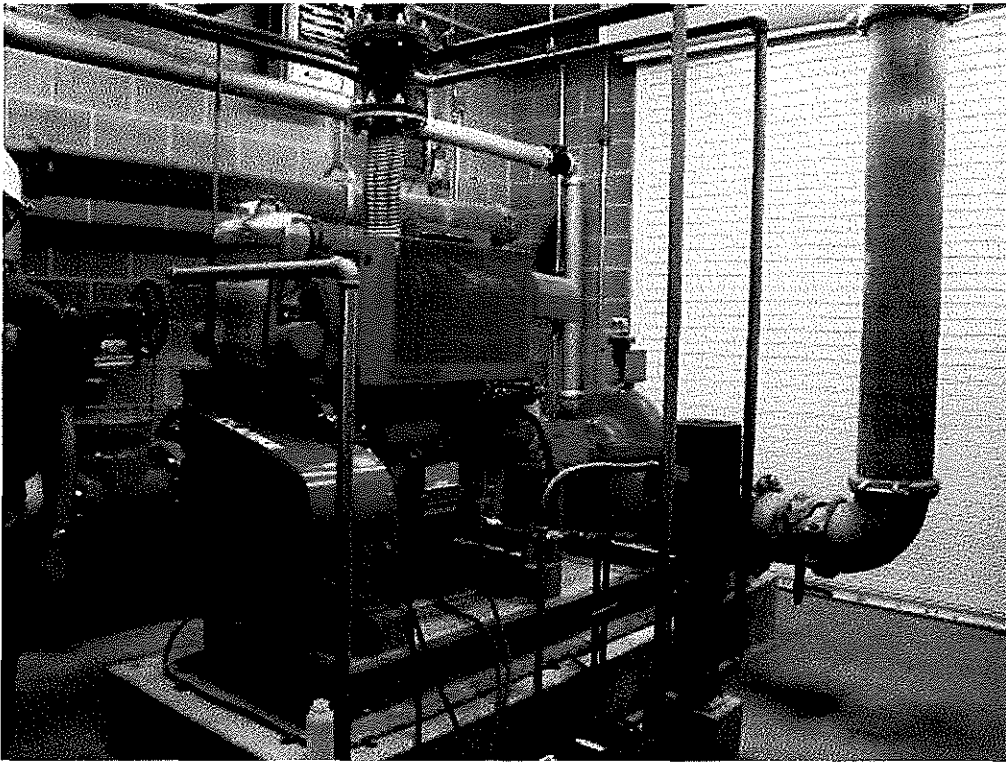
**Image 9(EUFPENGINE)** : Fire Pump Engine

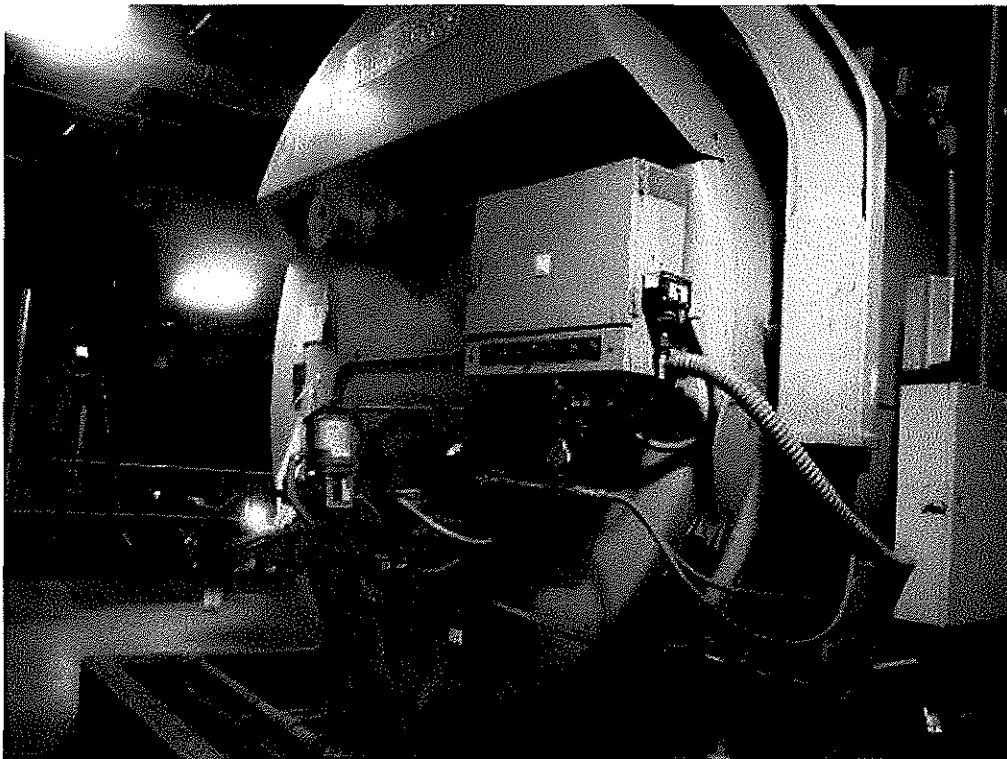
The auxiliary boiler is used to supply the plant heat when EU001 is not operating. The unit is ignited with liquefied petroleum gasoline (LPG), but can also run on fuel oil (see attachment for photo of unit).

**Image 10(EUAUXBLR)** : Auxiliary Boiler
