DEPARTMENT OF ENVIRONMENTAL QUALITY
AIR QUALITY DIVISION
ACTIVITY REPORT: Scheduled Inspection

FACILITY: LBWL, Erickson Station		SRN / ID: B4001
LOCATION: 3725 South Canal Road, LANSING		DISTRICT: Lansing
CITY: LANSING		COUNTY: EATON
CONTACT: Trista Gregorski, Engineer		ACTIVITY DATE: 08/24/2017
STAFF: Michelle Luplow	COMPLIANCE STATUS: Compliance	SOURCE CLASS: MAJOR
SUBJECT: Scheduled, announced inspection of the Erickson fly ash handling facility; scheduled, unannounced inspection of the Erickson Power Plant.		
RESOLVED COMPLAINTS:

Purpose: Conduct an unannounced, scheduled compliance inspection of the LBWL Erickson Station Power Plant, and an announced, scheduled compliance inspection of the LBWL Fly Ash Handling Facility located on Millett Highway. Compliance was determined with the Lansing Board of Water and Light's Renewable Operating Permit MI-ROP-B4001-2015. This also included follow-up inspection of items addressed in the LBWL's April 2017 updates to the Fugitive Dust Management Plan and Malfunction Abatement Plan in response to the 8/26/2016 violation notice. This inspection was a partial compliance evaluation (PCE), conducted as part of a full compliance evaluation (FC

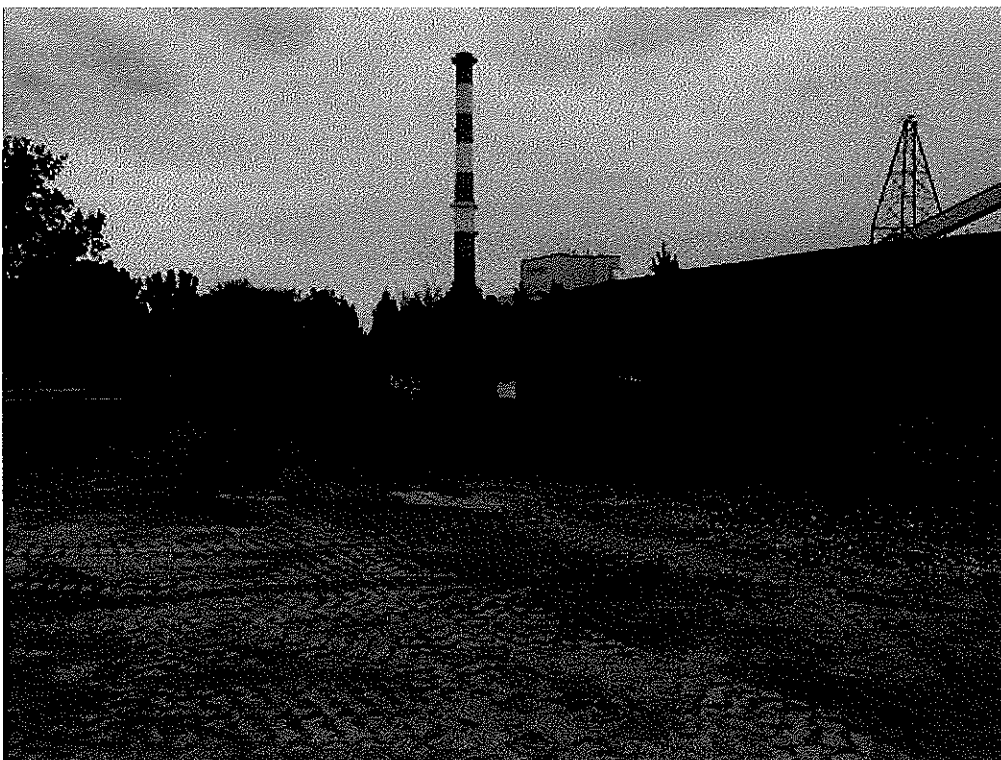
In response to the violation notice the LBWL has changed their practice of handling and disposing of the non-marketable fly ash. All non-marketable fly ash is wetted with a water/surfactant mix prior to removing it from the mass storage building. From the mass storage building, front end loaders will dump the fly ash into a landfill roll-off bin located outside the mass storage building. The bin's lid is then closed to prevent fugitive dust from being re-entrained into the ambient air. During the inspection, I noted that there was no lid on the bin. T. Gregorski explained that when the area recently had a wind storm, the lid was blown off the roll-off bin and LBWL staff were not able to find it. She explained that they will have a lid again when Granger brings a new roll-off bin the beginning of the week of August 28th. I observed the contents of the bin: the fly ash had all been crusted over and did not appear to be capable of being re-entrained into the ambient air at that time. I was therefore not concerned about fugitive emissions from this bin.

Image 1(Roll-off fly ash bin) : Roll-off which non-marketable, "chunky" fly ash is stored, prior to disposal.

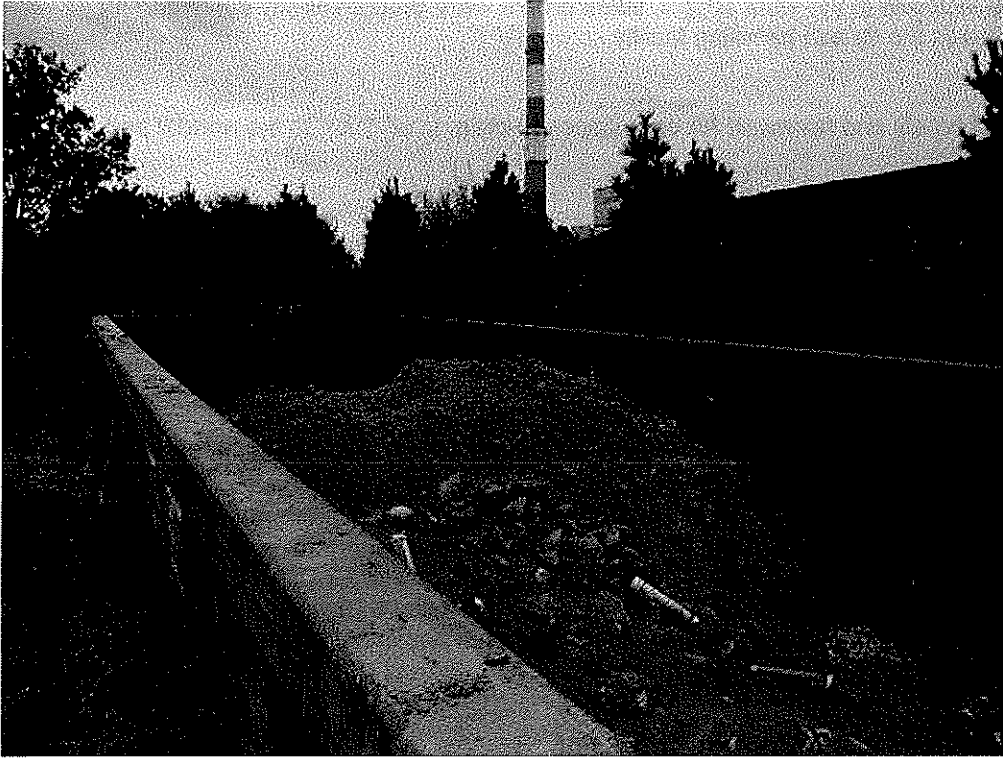
Image 2(Bin fly ash) : Note the fly ash has been crusted over.

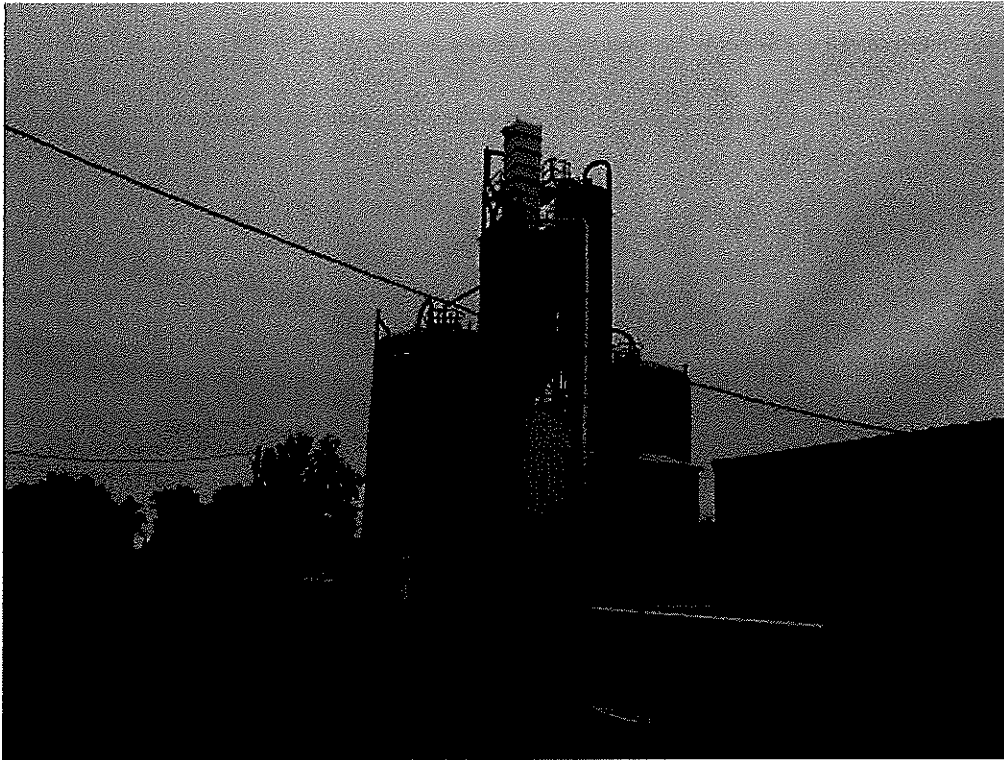
Image 3(Fly Ash Handling) : Entire facility

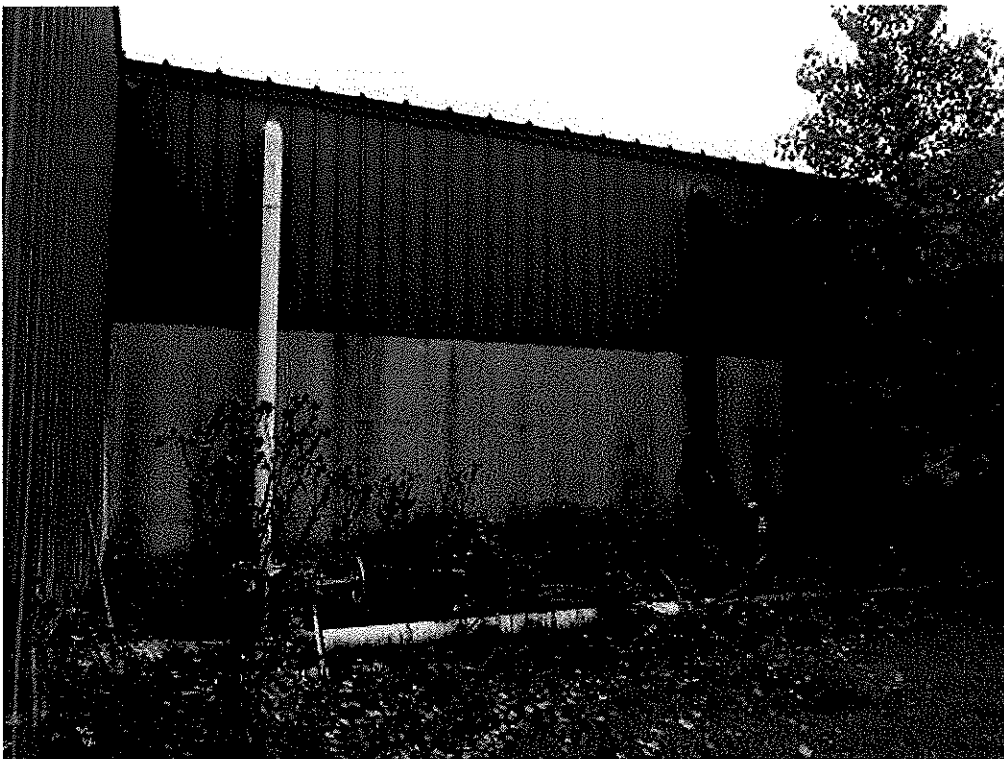
Image 4(Pneumatic Piping) : A portion of the pneumatic fly ash piping system entering the mass storage building

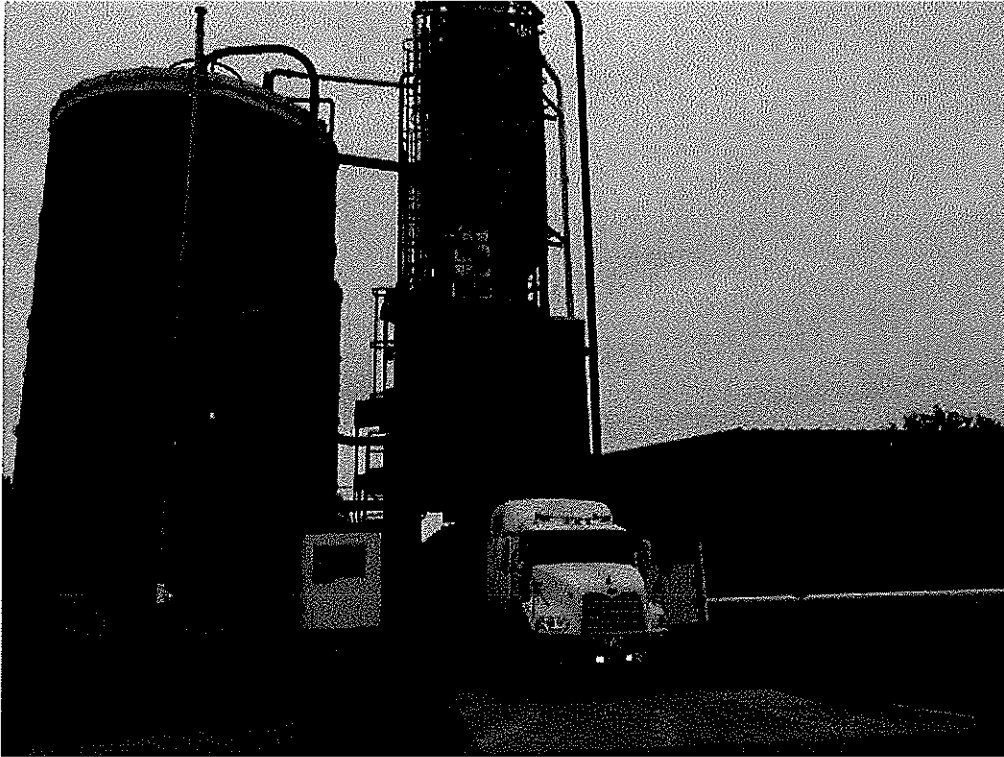
Fly ash was not being transported to the various silos during the inspection; however, we were able to witness commercial truck loadout of the fly ash. The loadout chute connects and seals directly to the truck prior to loading. During this process we witnessed no visible emissions from any of the pieces of equipment, baghouse exhaust or truck opening. The baghouse for the mass storage building, EUASHDC4 was the only baghouse operating during the inspection. Due to respiratory hazards from the fly ash in the mass storage building, K. Beson went into the mass storage building to obtain the pressure drop, which he reported to be 1 – 1.2 inches H₂O, within the appropriate operating range. LBWL also has a loadout spout for non-marketable fly ash: this is fly ash that was marketable, but because of an excess in fly ash inventory, is created non-marketable by mixing it with a surfactant before shipping it out as waste. The loadout spout from this type of ash is non-telescopic, and does not attach to vehicles. This could be a potential source of fugitive fly ash emissions, but we did not observe loadout of the nonmarketable fly ash the day of the inspection.

Image 5(Ash loadout) : Commercial Ash loadout - Note there are no VE's during this process.

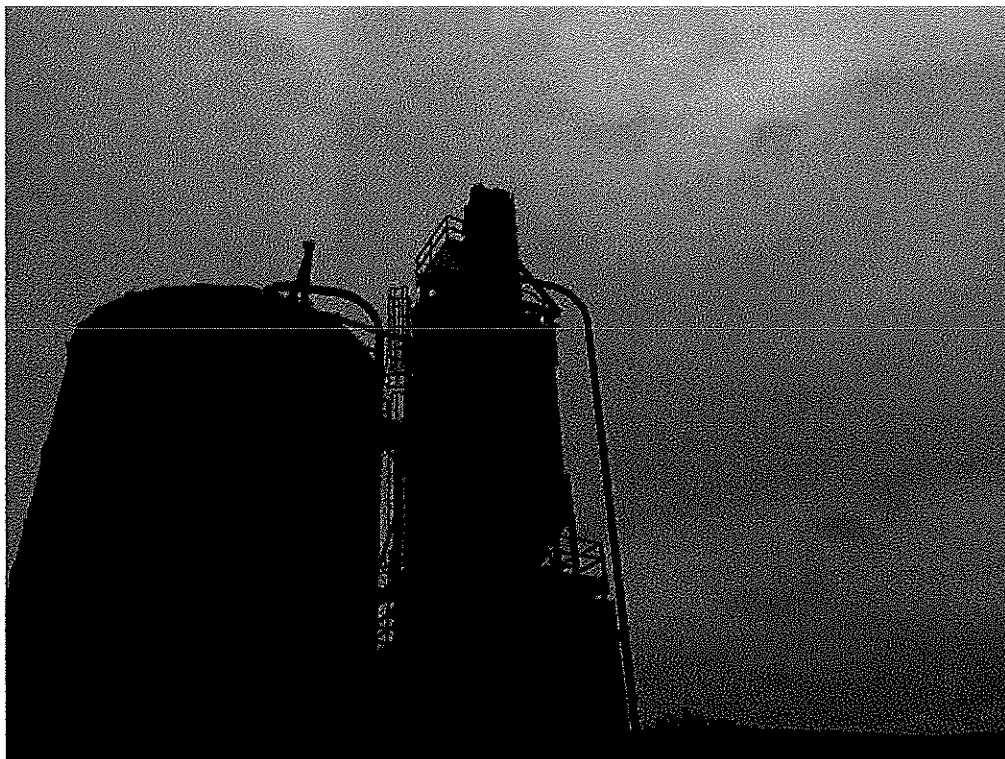
Image 6(EUASHDC2) : Photo of EUASHDC2 - loadout silo baghouse

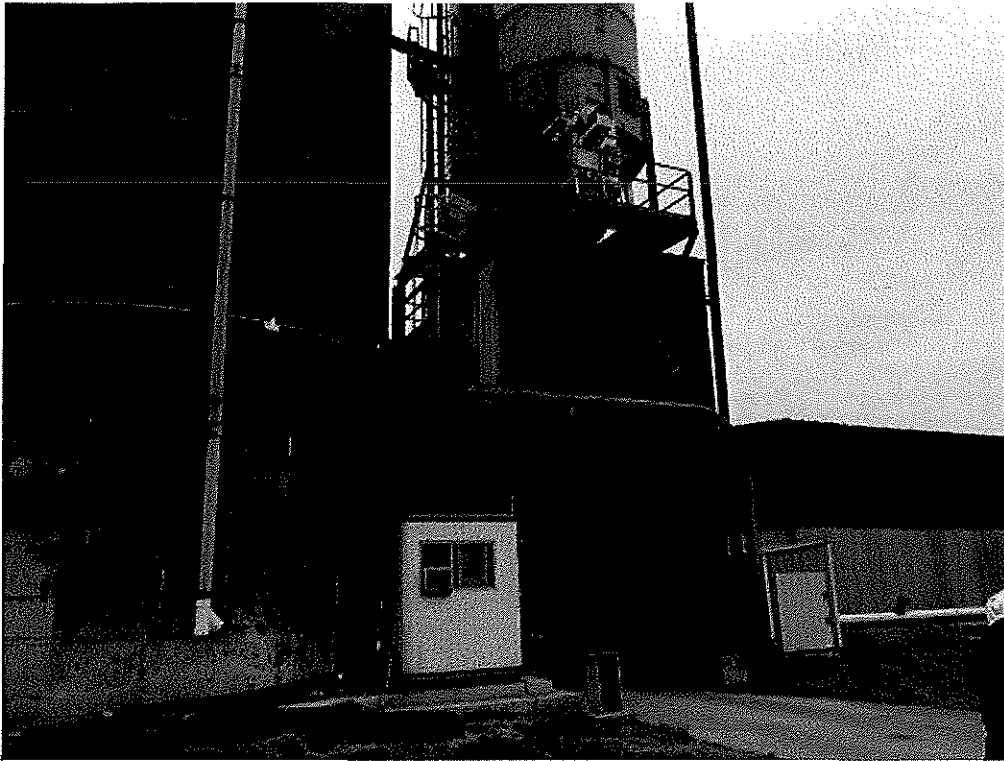
Image 7(EUASHDC3) : Truck loadout silo chute baghouse (small white unit located near the base of the silo)

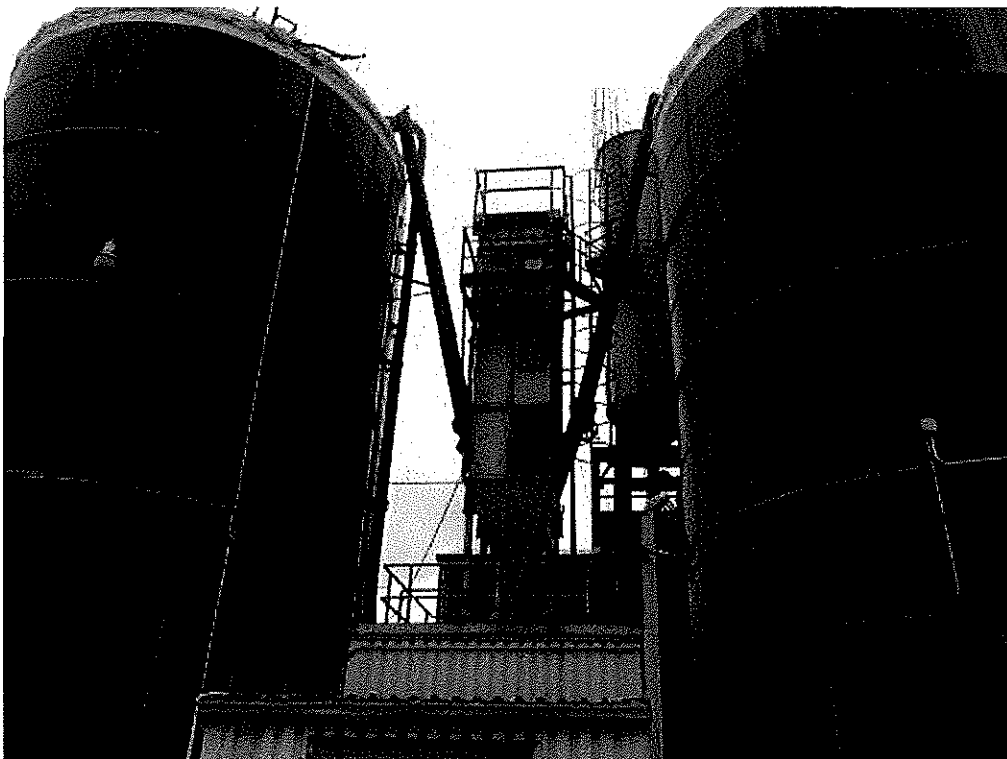
Image 8(EUASHDC1) : East and West storage silo baghouse (between the two blue silos)

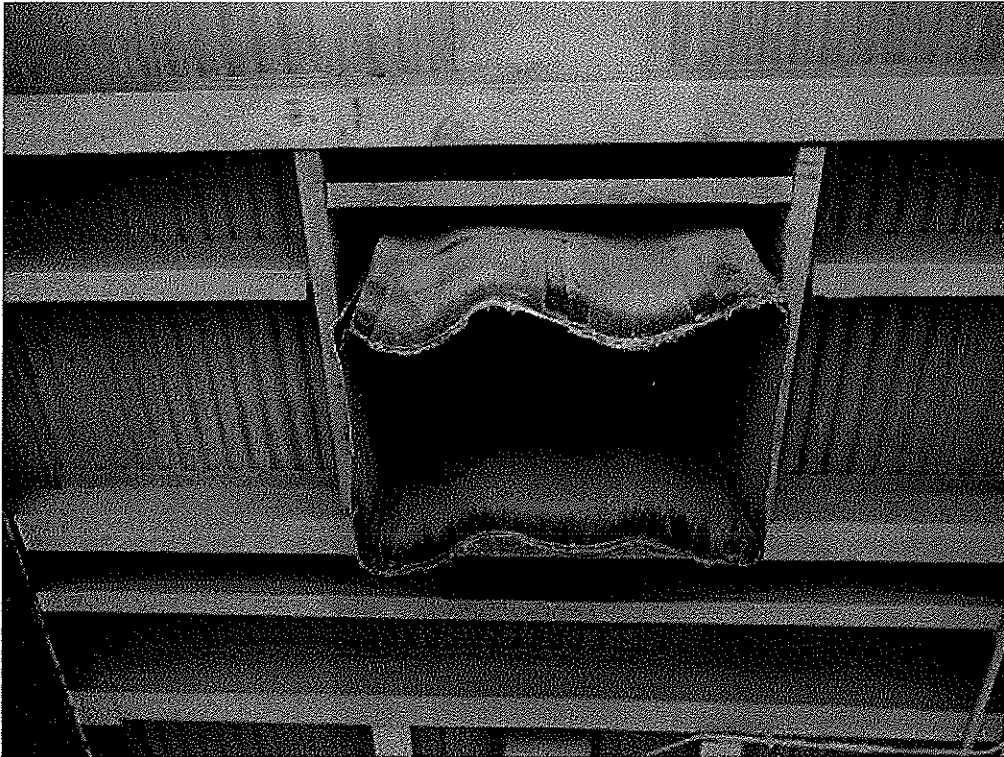
Image 9(Non-market Loadout) : Non-marketable fly ash loadout chute. Fly ash mixed with surfactant prior to loadout through chute.

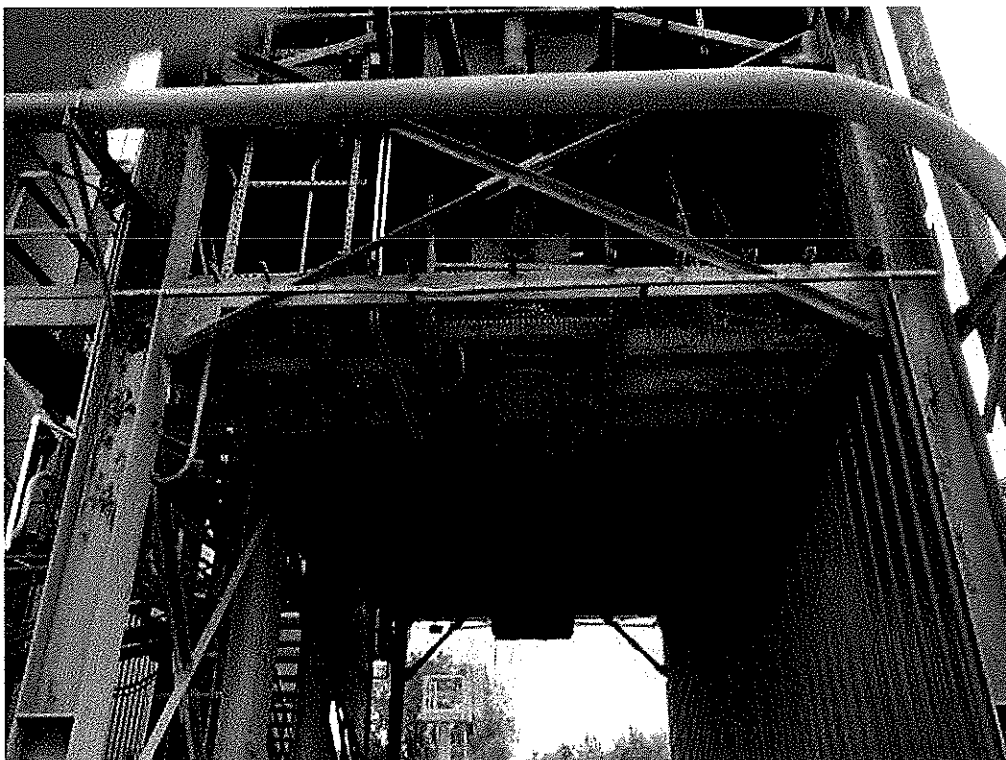
Image 10(Commercial ash Load) : Commercial ash loadout chute - telescopic

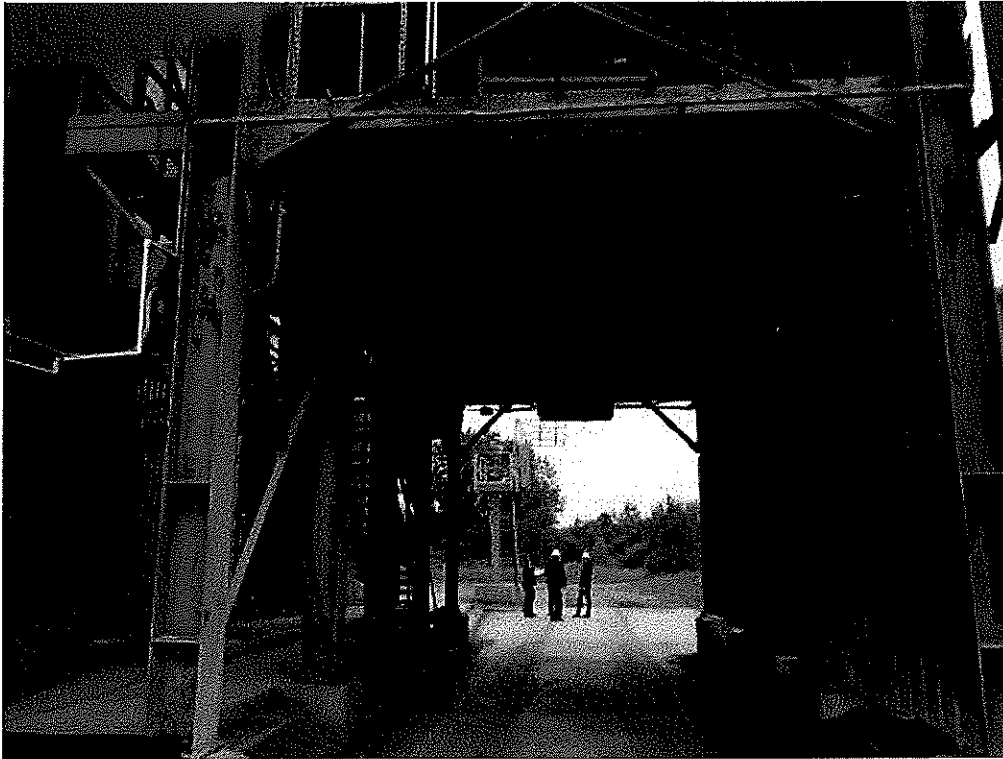
Housekeeping throughout the plant yard and in the truck loadout area has improved; however, I noted that there was some residual fly ash in the truck loadout area, as well as in the location of the unpaved plant yard where the fly ash pile had been, identified by its characteristic "poofing" when it's disturbed. I brought this to LBWL staff's attention. They said that they would work with the ash handling staff to determine the best way to proceed with ensuring that fugitive fly ash throughout the plant yard is minimized as best as possible on a daily basis. I explained to LBWL staff my concern that strong winds could easily pick up the fly ash that is present on the ground and potentially allow it to leave the property. Efforts therefore, should then be focused on minimizing fugitive fly ash at all times. The main plant roads appeared well-watered.

Image 11(Loadout Bay) : Entirety of loadout bay - for both commercial and nonmarketable ash
