**DEPARTMENT OF ENVIRONMENTAL QUALITY  
AIR QUALITY DIVISION  
ACTIVITY REPORT: Self Initiated Inspection**

B426033900

FACILITY: L'ANSE WARDEN ELECTRIC COMPANY LLC		SRN / ID: B4260
LOCATION: 157 S MAIN STREET, LANSE		DISTRICT: Upper Peninsula
CITY: LANSE		COUNTY: BARAGA
CONTACT: Chris Anderson , Operations Manager		ACTIVITY DATE: 03/21/2016
STAFF: Ed Lancaster	COMPLIANCE STATUS: Non Compliance	SOURCE CLASS: MAJOR
SUBJECT: I received an e-mail with photos from the Ketola's, on Sunday at approximately 9:00 PM, showing that one of the bottom incline conveyor tarps at LWEC had torn loose, prompting my decision to inspect the facility the next morning.		
RESOLVED COMPLAINTS:

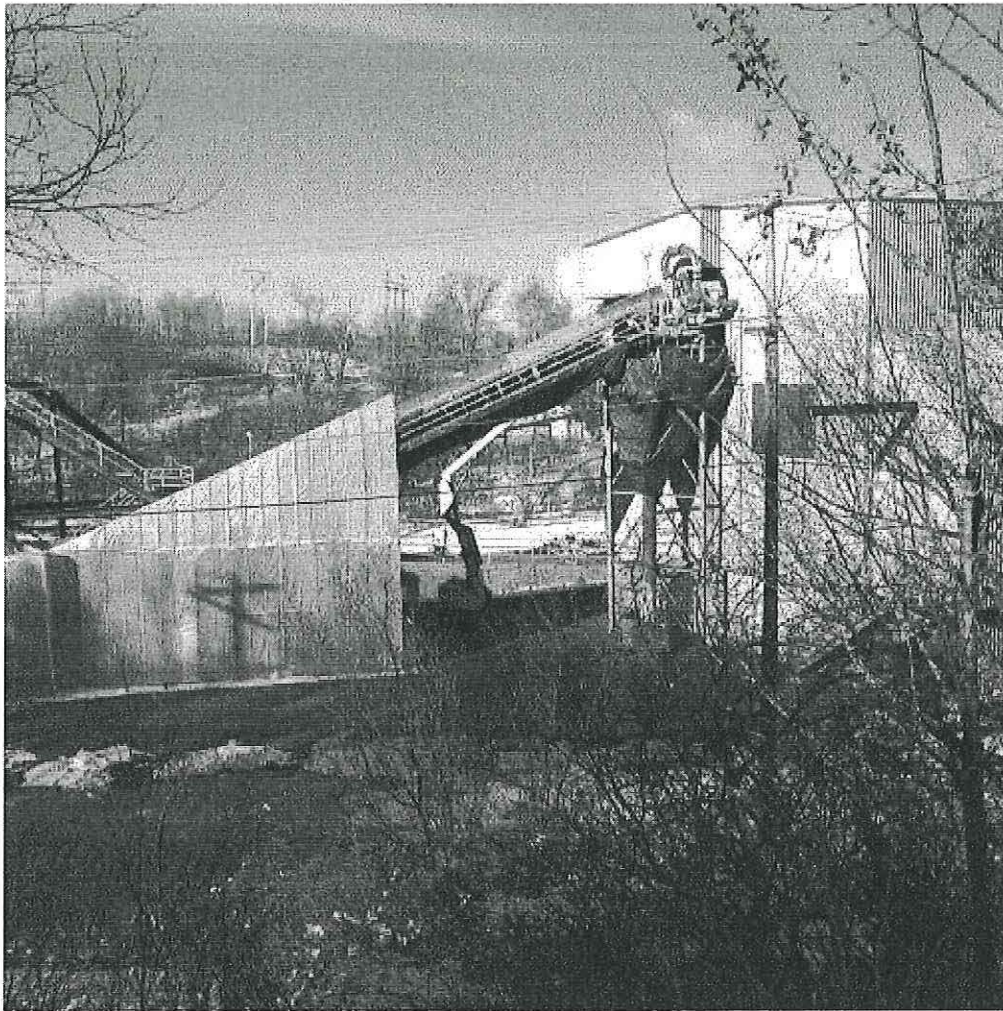
**Image 1(Photo 1)** : LWEC incline conveyor. Photo taken on March 21, 2016.

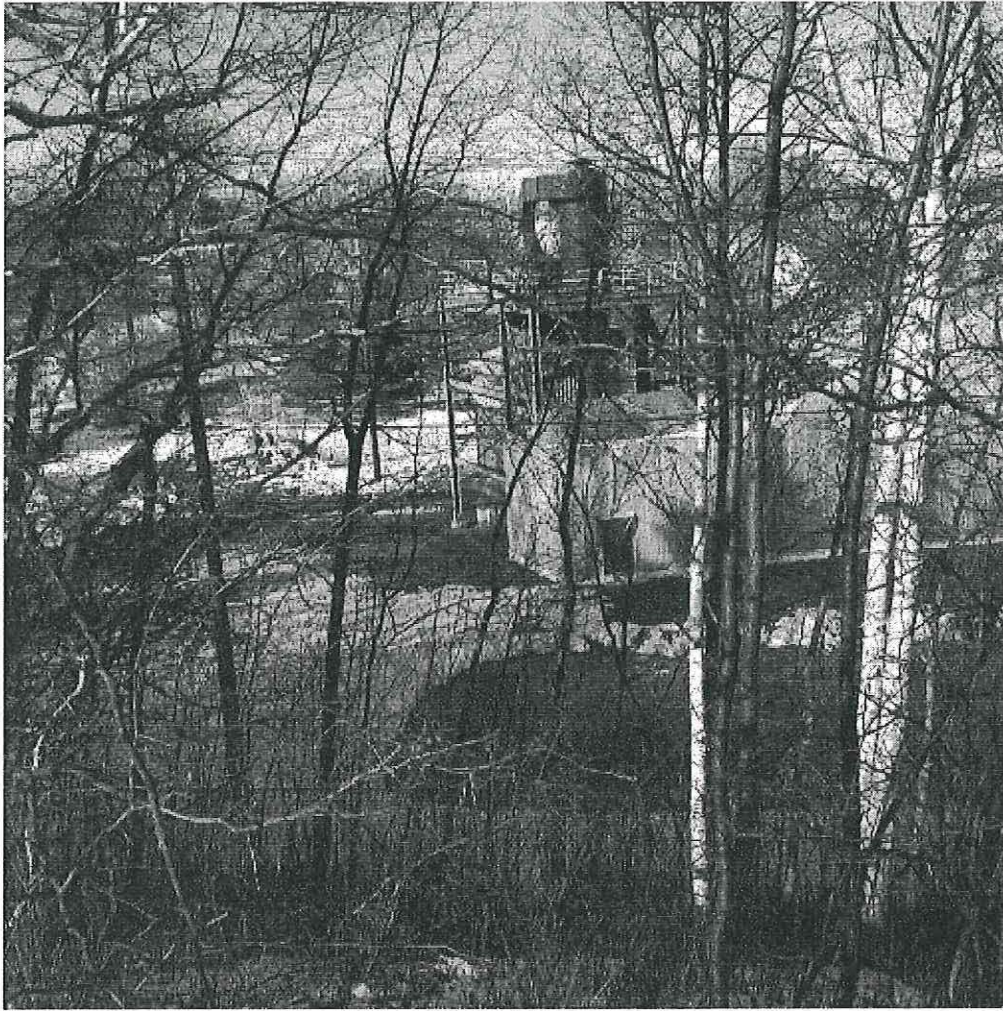
**Image 2(Photo 2)** : LWEC fuel receiving hopper. Note build-up of dust on hopper structure. Photo taken on March 21, 2016.

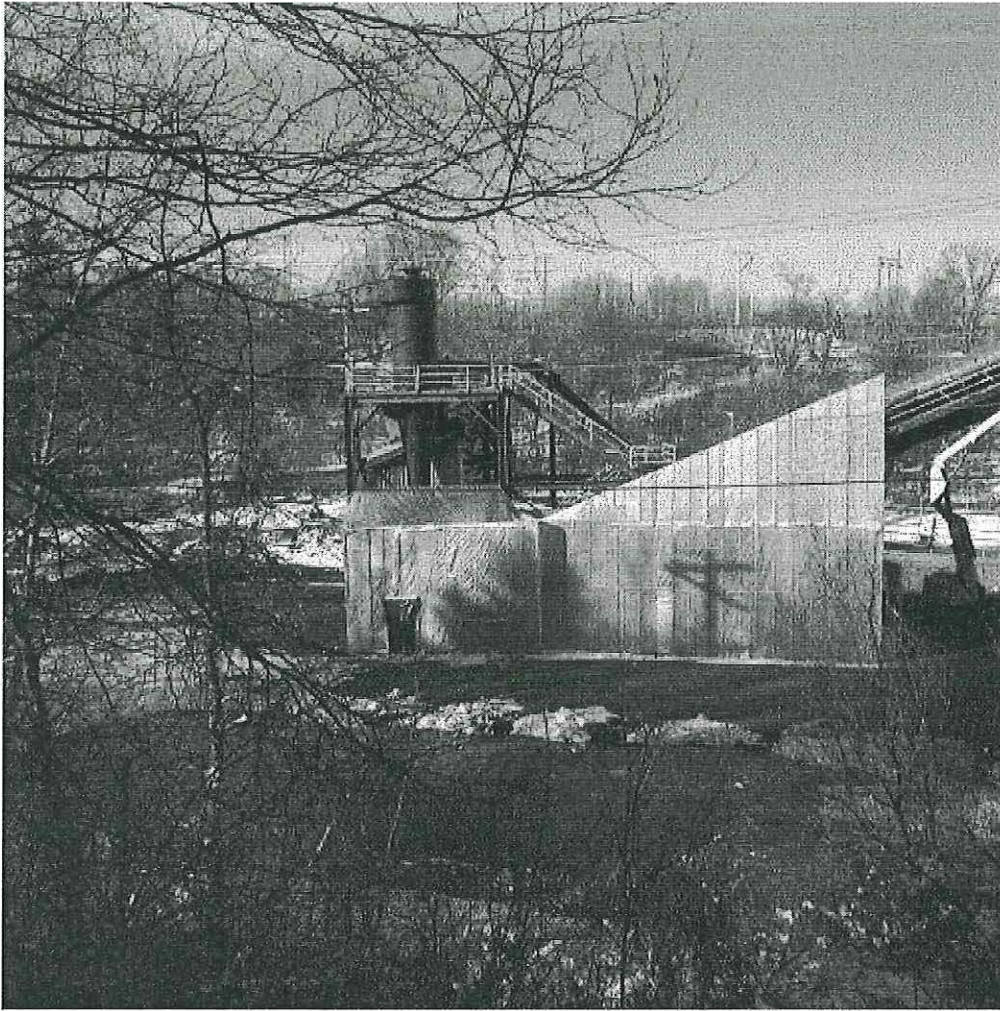
**Image 3(Photo 3) :** LWEC fuel receiving hopper and incline conveyor. Photo taken on March 21, 2016.

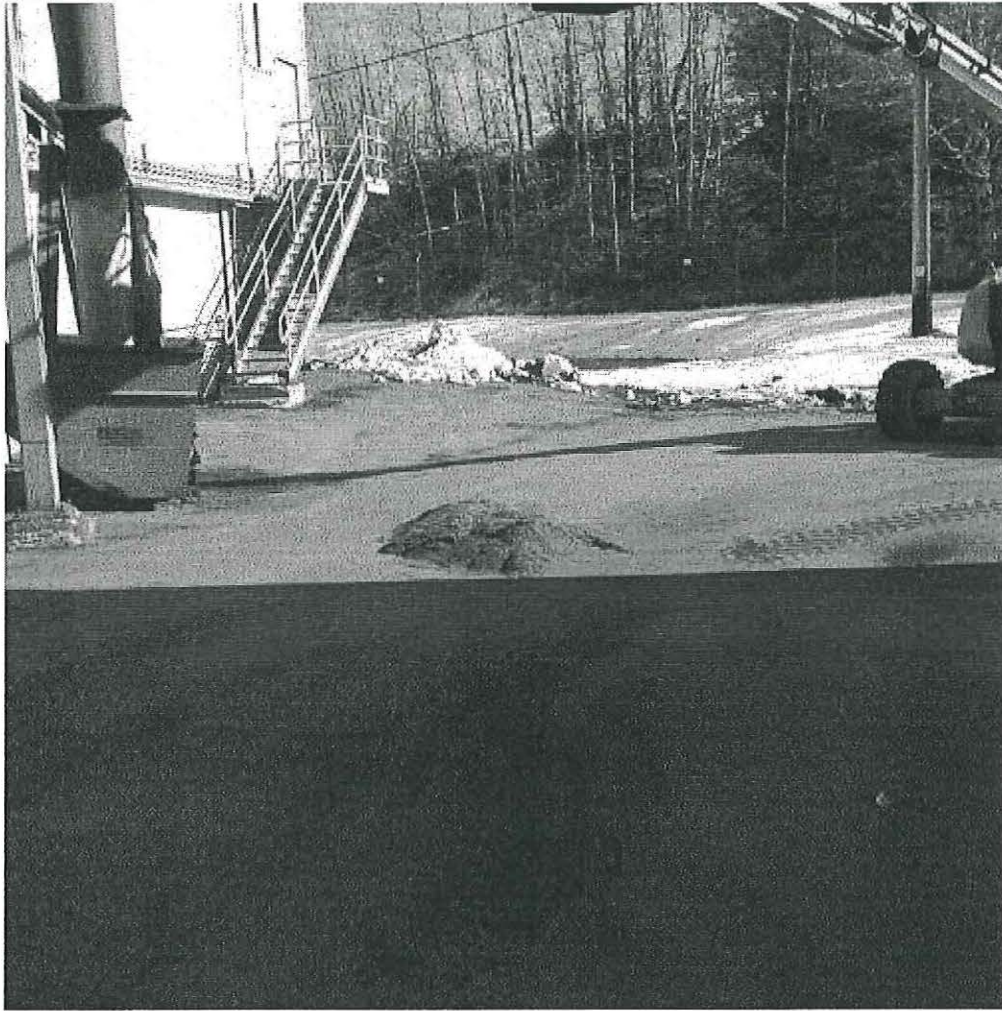
Mr. Anderson and I then walked out to the incline conveyor, where I observed the pile of fugitive dust, less than half a cubic yard (see photos). The tarp had been replaced, and Mr. Anderson reported his crew was installing an additional brush on the return of the incline conveyor to help in removing the dust. We observed two workers shoveling the dust into a front-end loader. Mr. Anderson said the material would be placed in the ash building and hauled to the landfill. We then walked over to the ash building and I photographed the fall-out material that was recently added to the ash (see photos).

**Image 4(Photo 4)** : Dust pile from failed tarp beneath LWEC fuel incline conveyor. Photo taken on March 21, 2016.

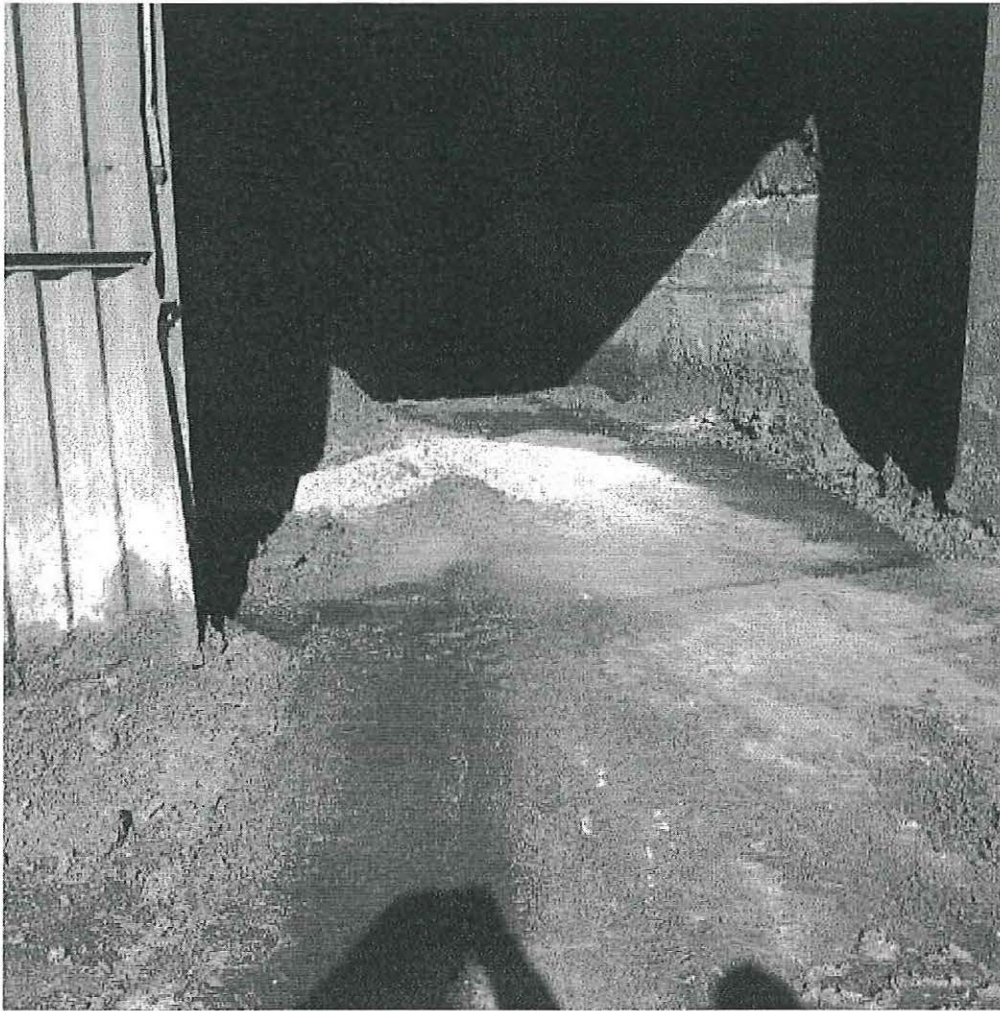
**Image 5(Photo 5) :** Fugitive dust pile from failed tarp relocated to ash building. Photo taken March 21, 2016.
