DEPARTMENT OF ENVIRONMENTAL QUALITY
AIR QUALITY DIVISION
ACTIVITY REPORT: Scheduled Inspection

FACILITY: Gerdau MacSteel Monroe		SRN / ID: B7061
LOCATION: 3000 E FRONT STREET, MONROE		DISTRICT: Jackson
CITY: MONROE		COUNTY: MONROE
CONTACT: Craig Metzger , Environmental Manager - Monroe Mill		ACTIVITY DATE: 06/12/2014
STAFF: Sersena White	COMPLIANCE STATUS: Compliance	SOURCE CLASS: MAJOR
SUBJECT: Scheduled targeted inspection with AQD Permit staff accompanying to observe processes involved in a permit to install revision.		
RESOLVED COMPLAINTS:

Company Name: Gerdau Special Steel North America – Monroe Mill

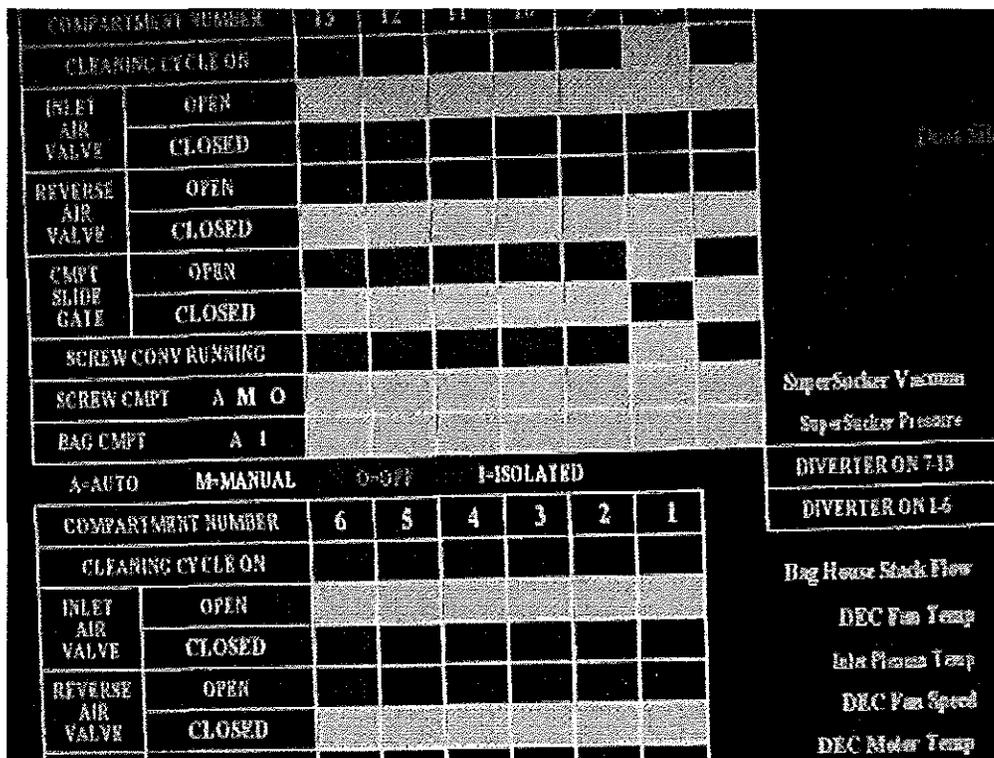
From the scrap yard we went into the baghouse control room, where we observed the control panel used to monitor the operation of the baghouse fans and the Direct Evacuation Fan in the control room. (Photo DSC00064 & 66)

Image 1(DSC00064) : Photo of screen image in baghouse control room where fan information is monitored and displayed.

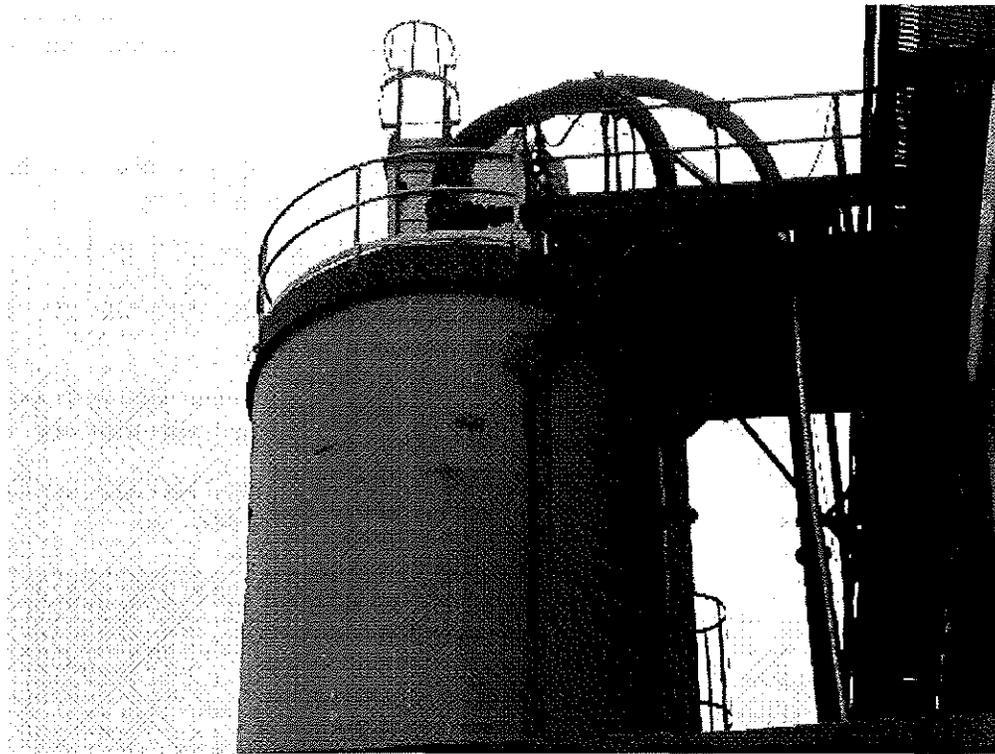
We then observed the EAF Dust silo and load out area where Craig explained that fugitive emissions resulting from truck loading is controlled by a timer after the loading of the truck is finished to ensure no fugitive dust escapes to the ambient air. The collected fugitives are returned to the baghouse. (Photo DSC00070)

Image 2(DSC00070) : Photo of baghouse dust silo with bin vent to control fugitive emissions during truck loading.

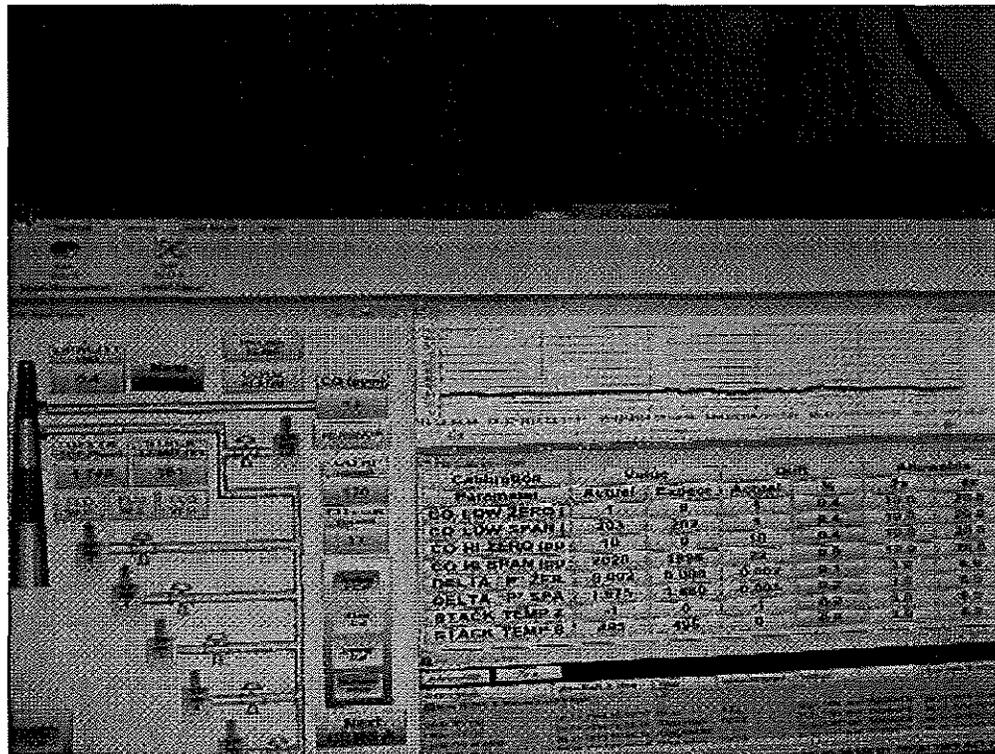
Image 3(DSC00067) : CO CEMS data monitor display

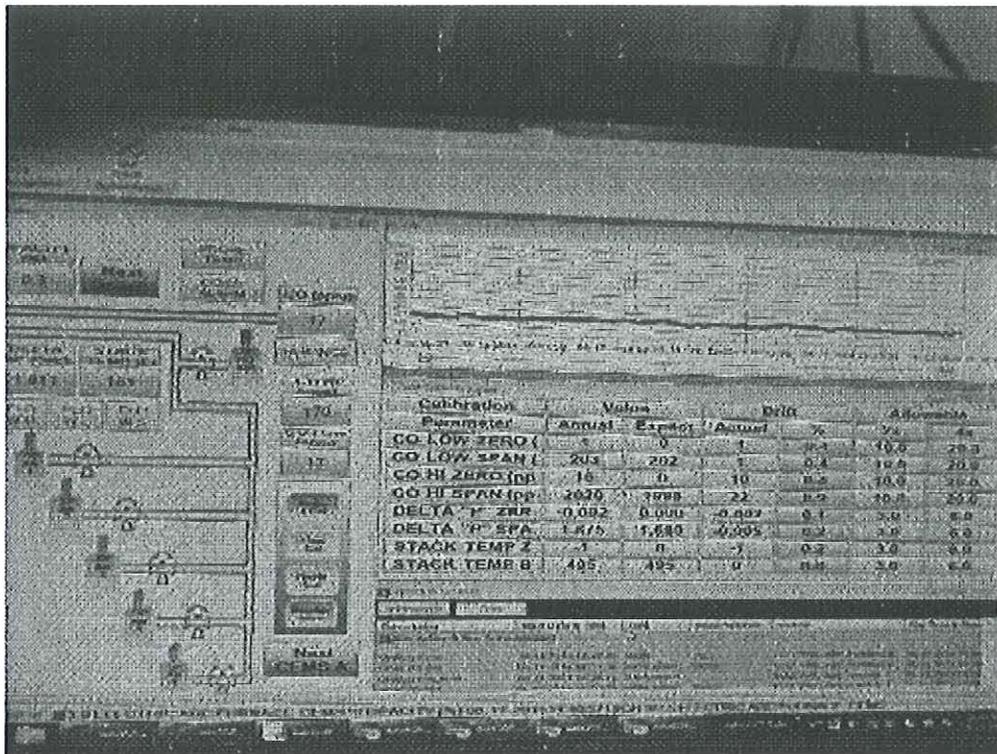
Image 4(DSC00068) : CO and Opacity Data monitor display

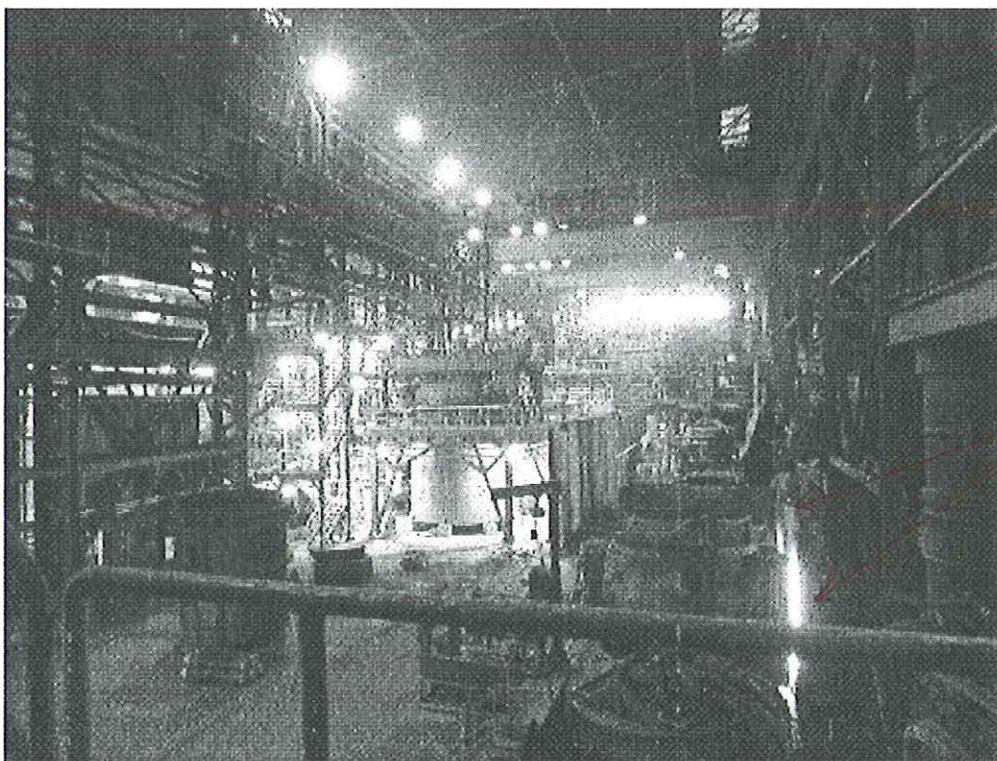
Image 5(DSC00072) : Photo of ladle preheating stations

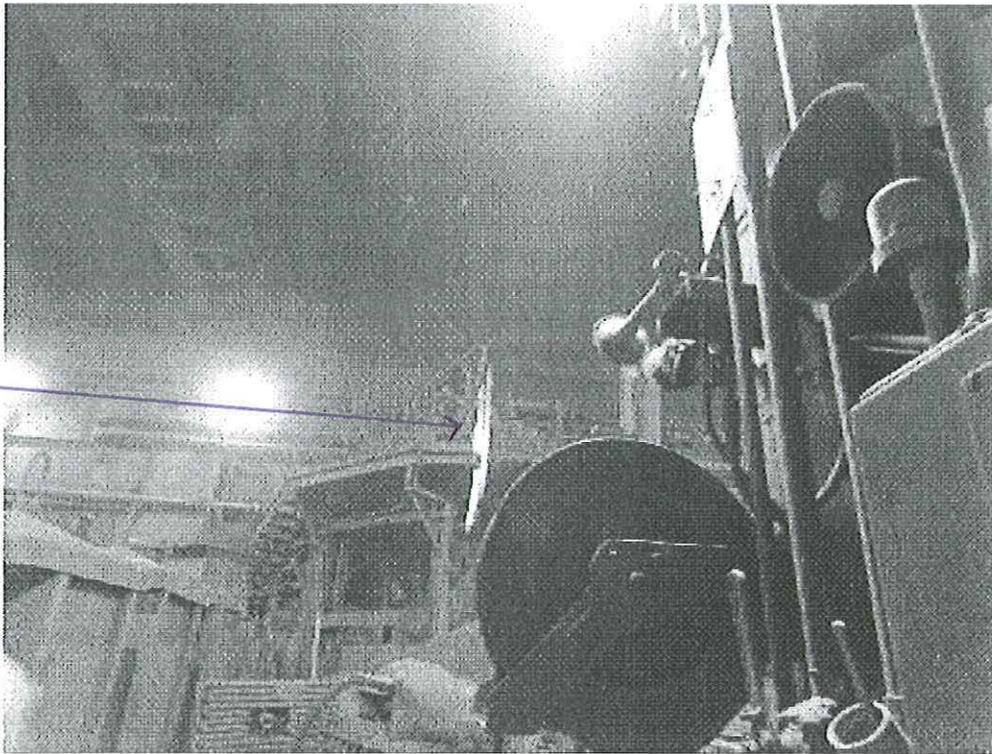
DEC
GAP

After leaving the baghouse we went to control room where Continuous Emission Monitoring System (CEMS) monitor Data Acquisition Handling System (DAHS) are located and observed the monitors displaying CO and Opacity data (Photos DSC00067-68). After leaving the CEMS control room we went to the Electric Arc Furnace pulpit. On the way there we observed the ladle preheat stations (Photo DSC00072), where there are currently two in use and another one will be added later according to Craig. We could also see the Vacuum Tank Degassers in the background (on the left). While we were in the EAF pulpit we were able to observe an initial charge and the replacement of an electrode. The molten metal from the EAF is gravity fed into a ladle below. The EAF is slightly tilted to facilitate unloading and provide clearance of the DEC duct from the EAF (Photo DSC00081).

Image 6(DSC00081) : Photo of DEC duct capture of emissions from EAF

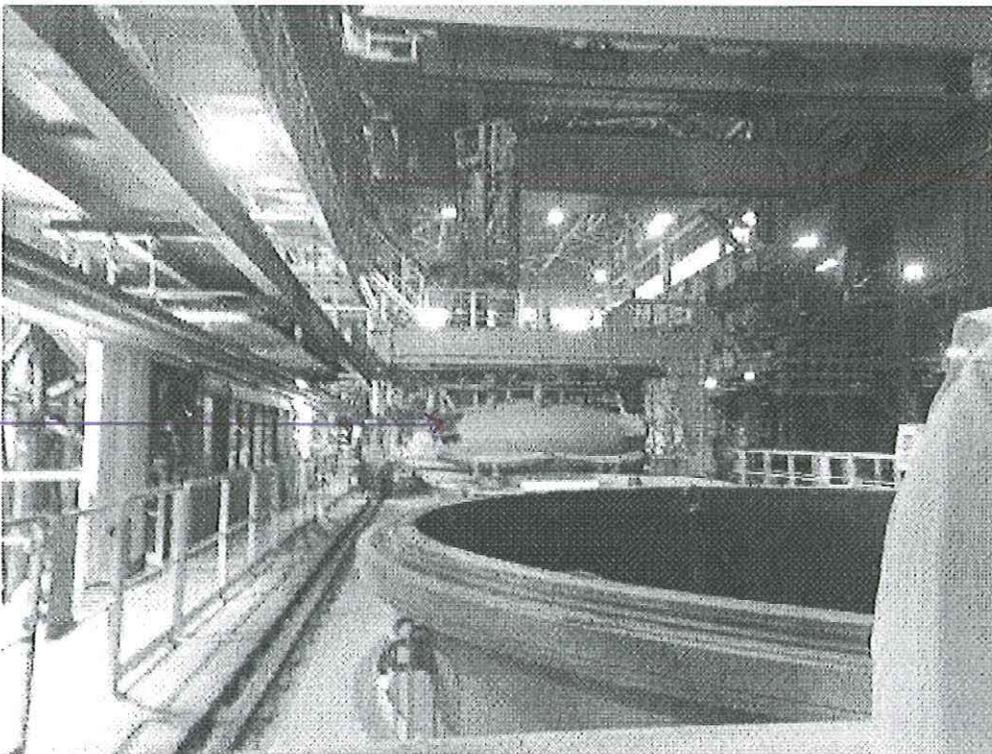
VTD
w/ HOOD

After we left the EAF pulpit we went to the VTD area, where there was one (Photo DSC00082) of two in operation. The VTD has a control room with computers and monitors to display real time operating parameters and a visual image of inside the VTD. A ladle with the molten metal is lowered into one of the two vessels. A hood is placed over the VTD to retain as much heat as possible. Argon gas is injected from below to produce stirring and alloys are added by feeding rod according to the heat (metal) specification by the customer. There is no heat applied during this stage of the process and stirring is generated by bubbling in the argon gas. Maintaining the temperature of the heat is critical in order for the caster to turn the molten metal into billets. A couple of photos were taken of the dry pump cleaning baghouse used to clean the air used for the vacuums in this process. It was originally planned to be located inside the building, but evidently there was not enough room. (Photos DSC00091-92)

Image 7(DSC00082) : Photo of both VTD with hood in place on the one in use

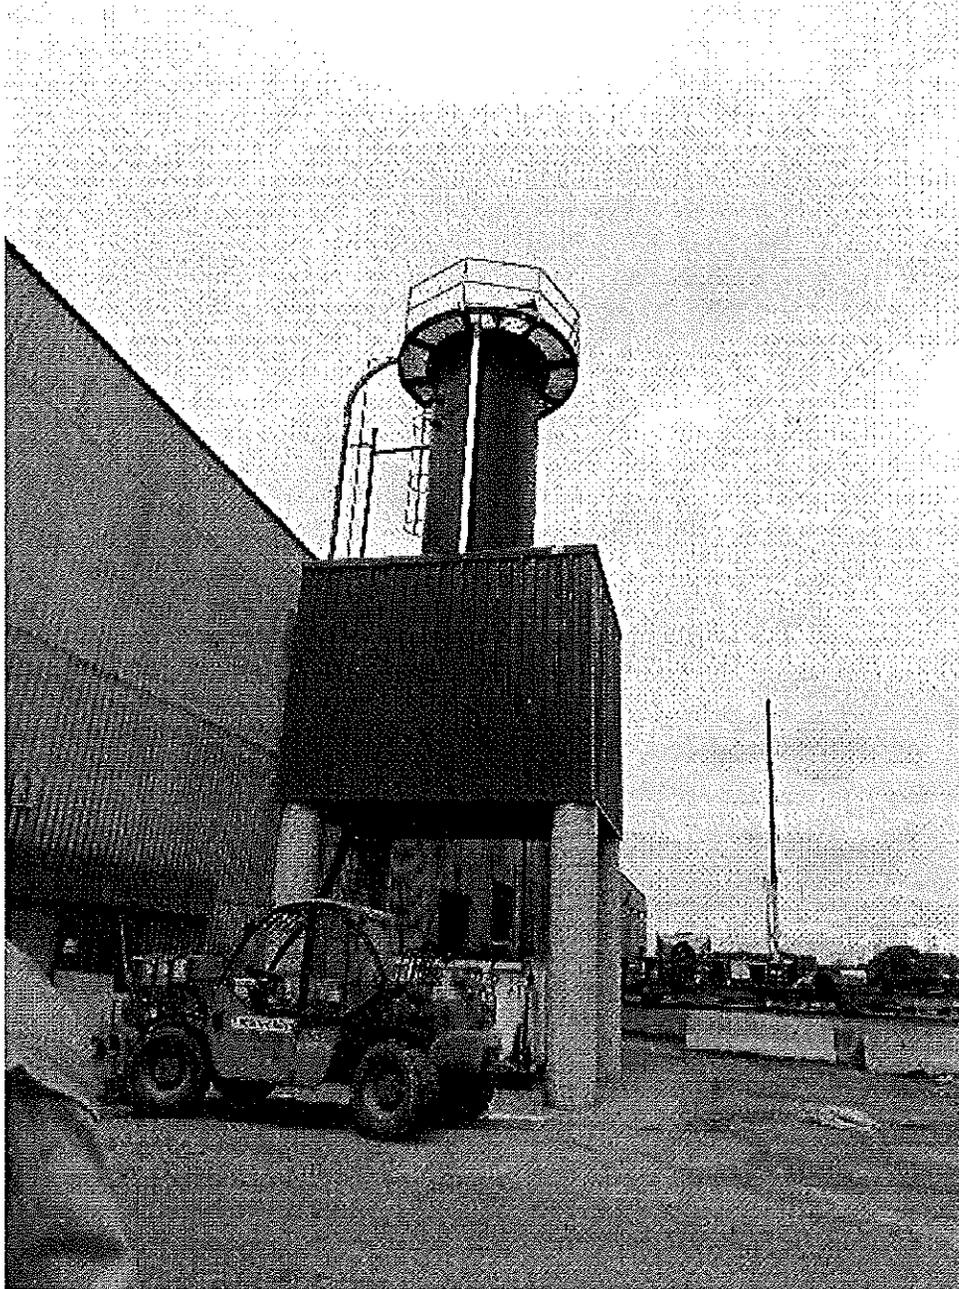
Image 8(DSC00091) : Photo of dust collection system for vacuum system serving the twin VTD's

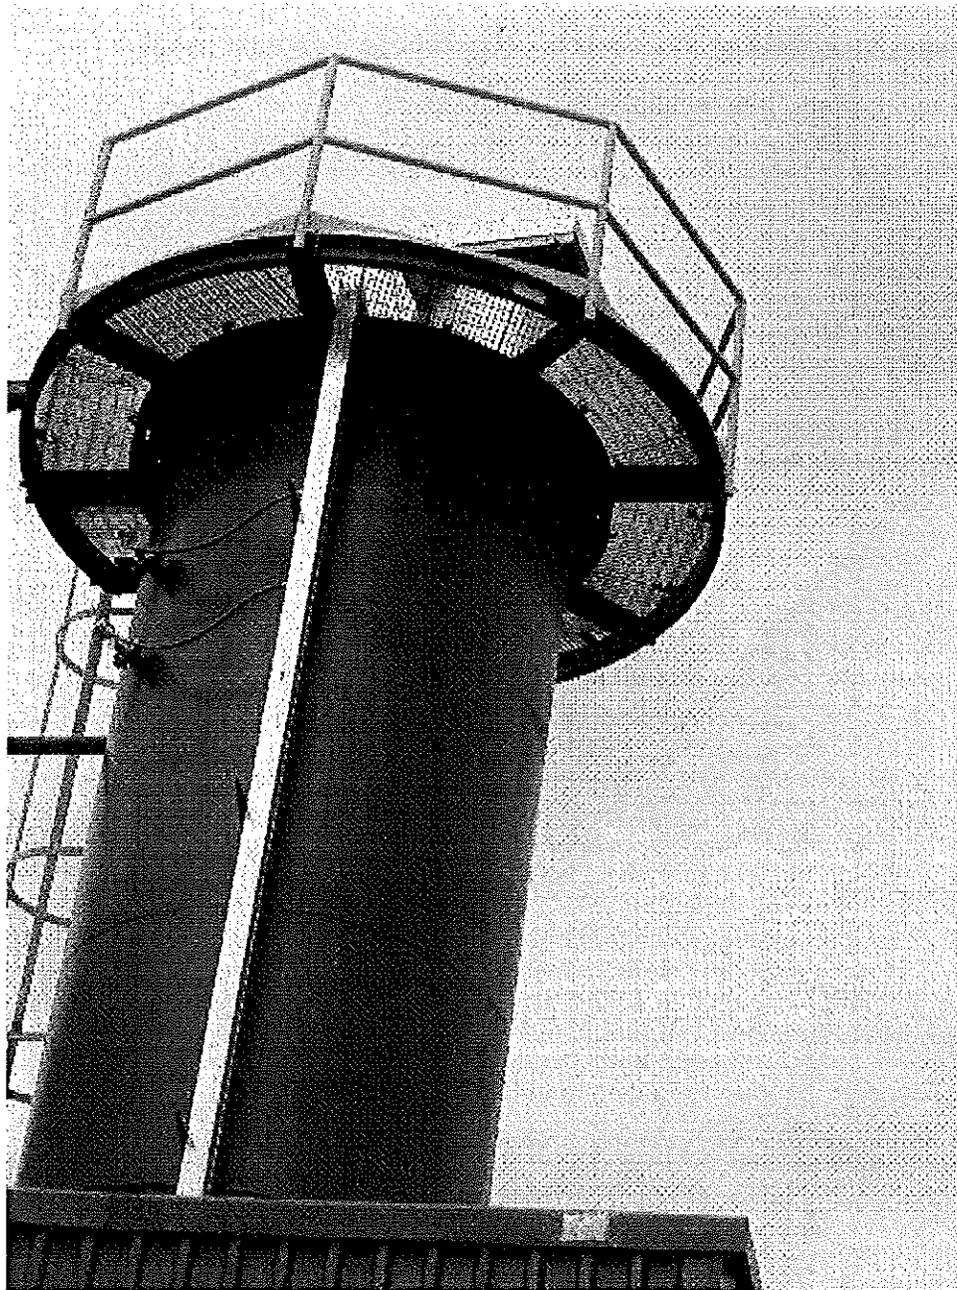
Image 9(DSC00092) : Another view of the dust collection system for the vacuum pumps serving the VTD's

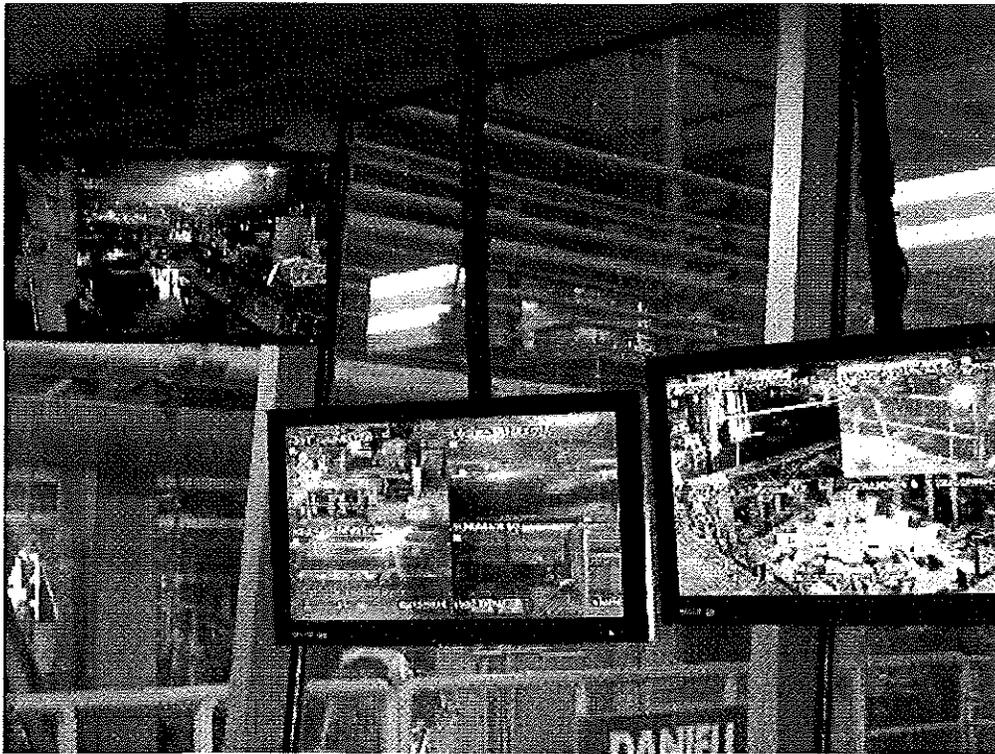
Image 10(DSC00086) : Photo of monitoring inside the Caster control room.

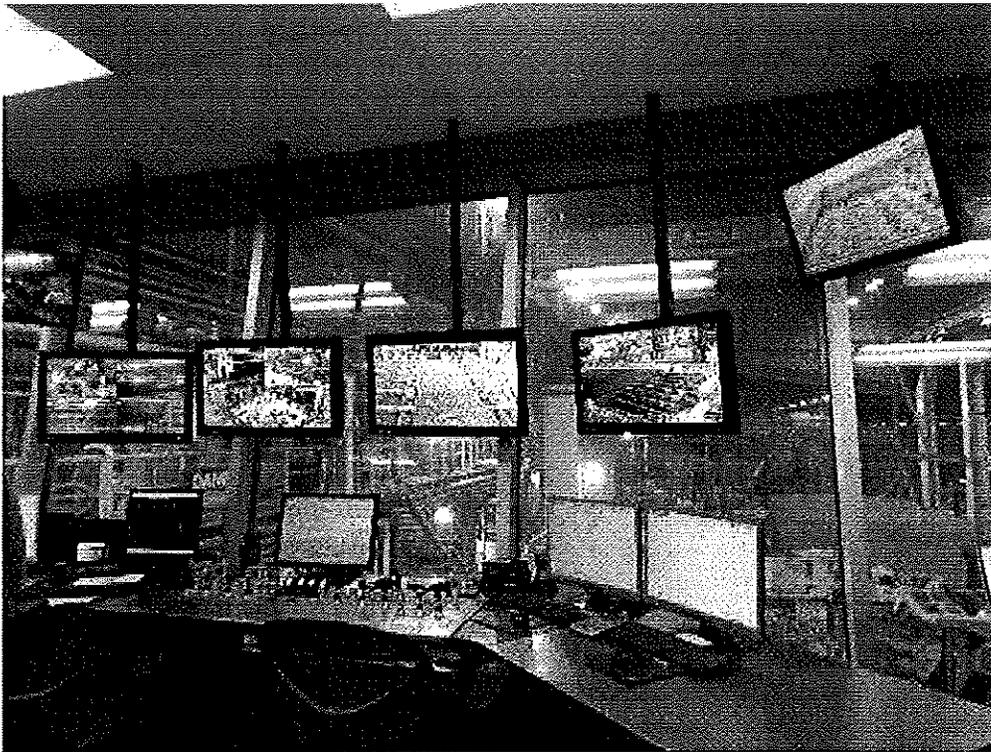
Image 11(DSC00087) : Another view of monitoring inside the Caster control room.

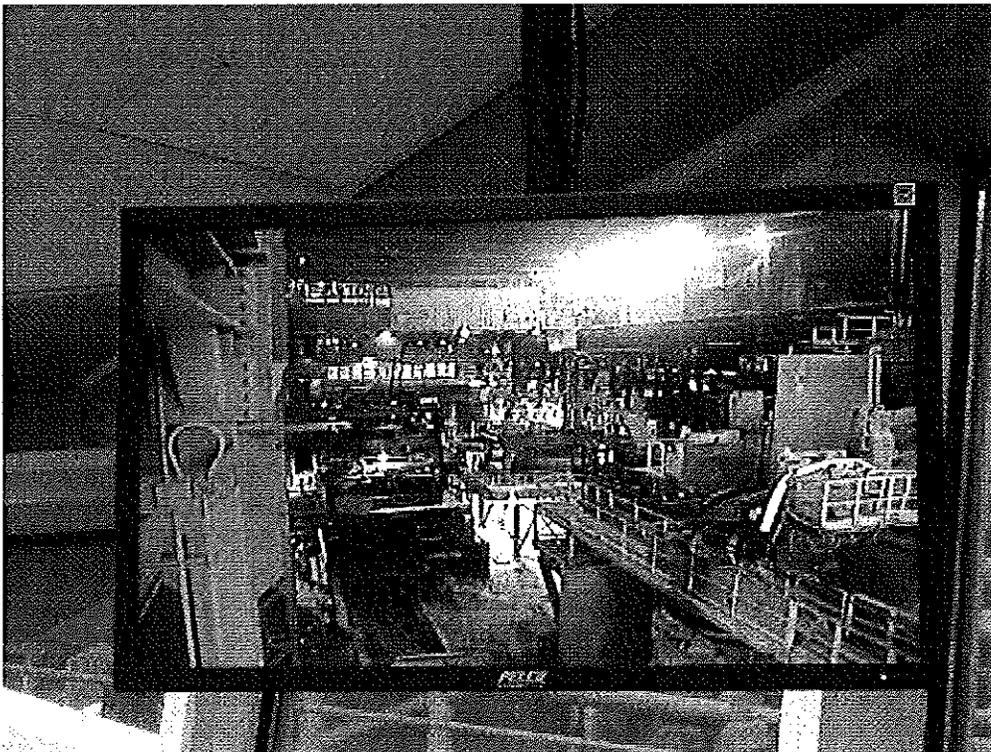
Image 12(DSC00088) : Photo of another view where the new billet reheat furnace will be located from inside the Caster control room

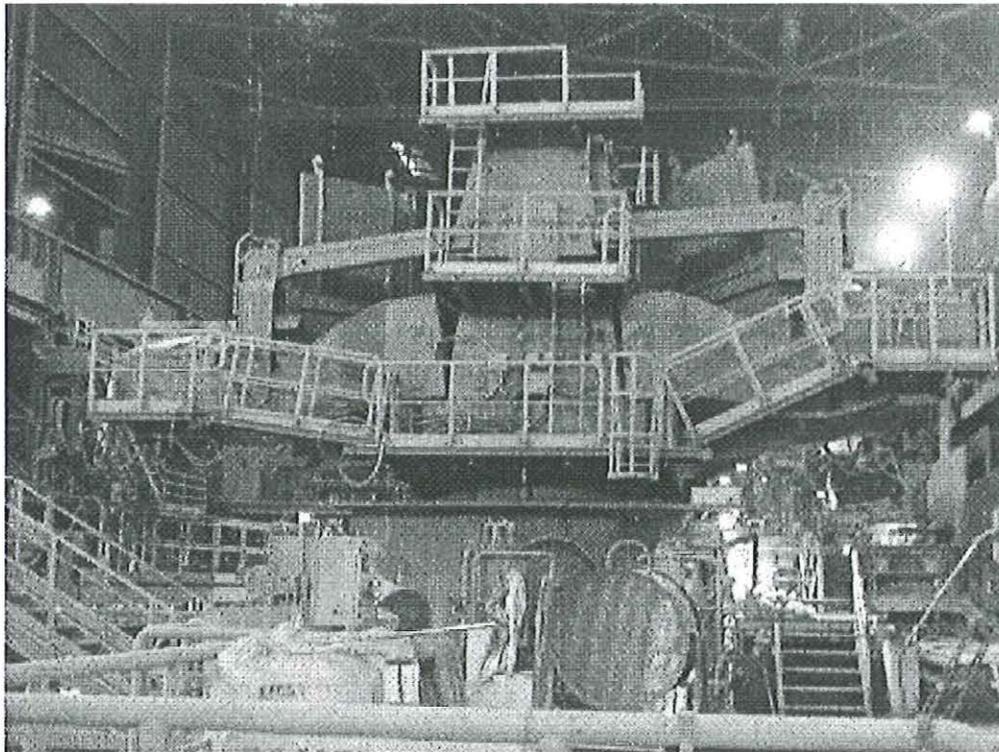
Image 13(DSC00089) : Photo of Caster with twin turrets which rotate to receive molten metal to be cast into billets

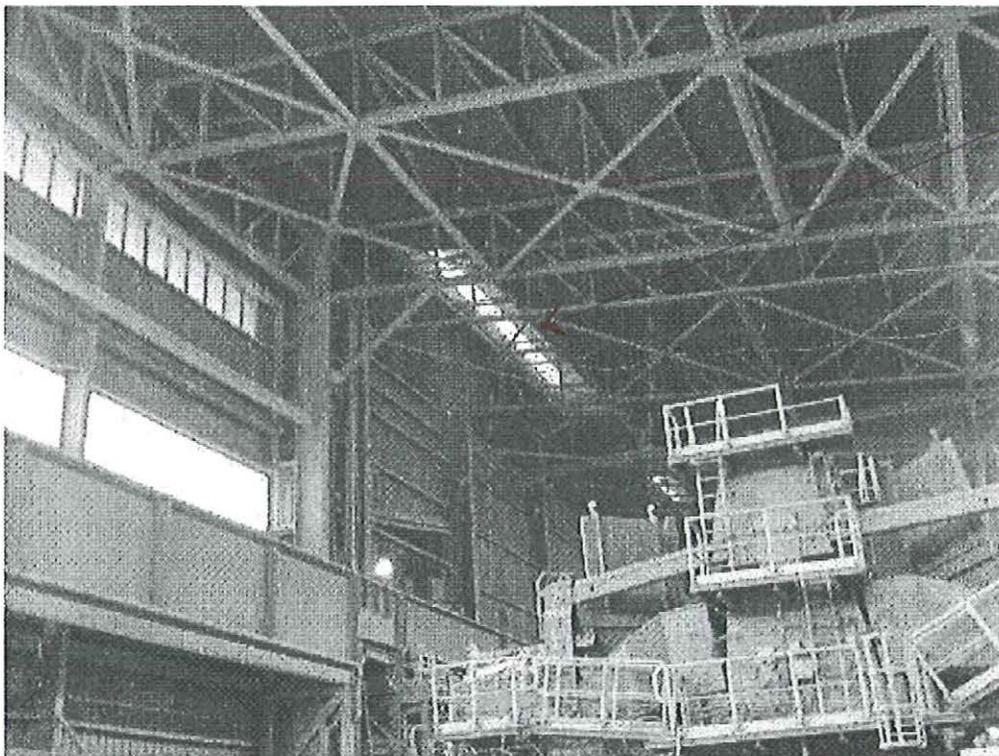
Image 14(DSC00090) : Photo of roof vent in top left area above the caster that will be closed off to reduce fugitive emissions

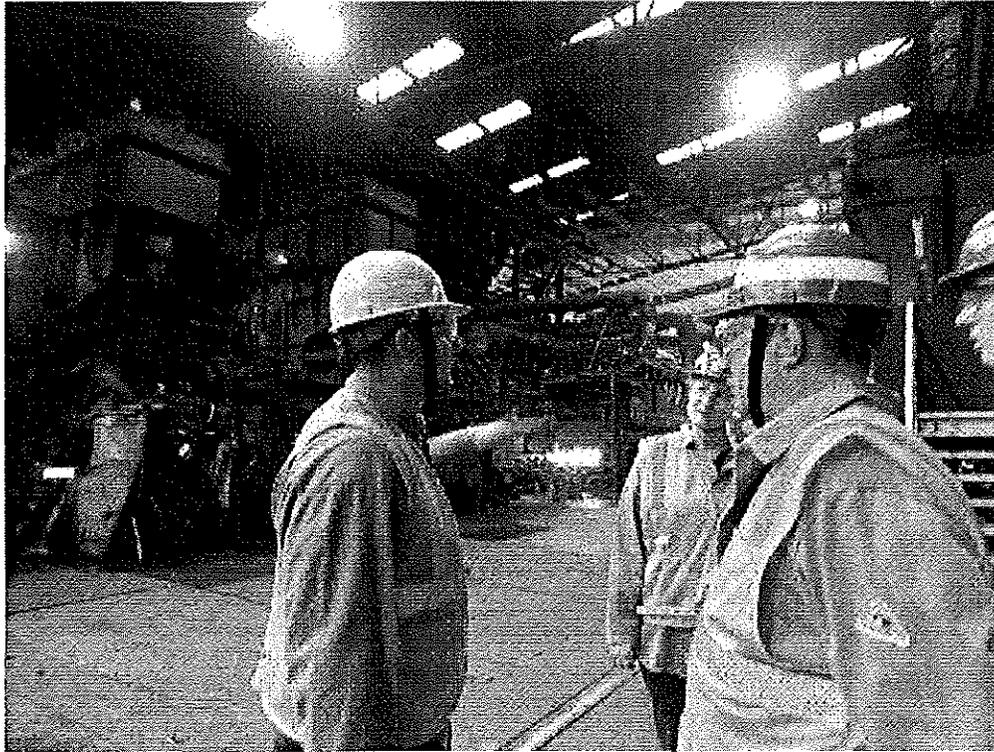
Image 15(DSC00093) : Photo of a reheated billet exiting the billet reheat furnace

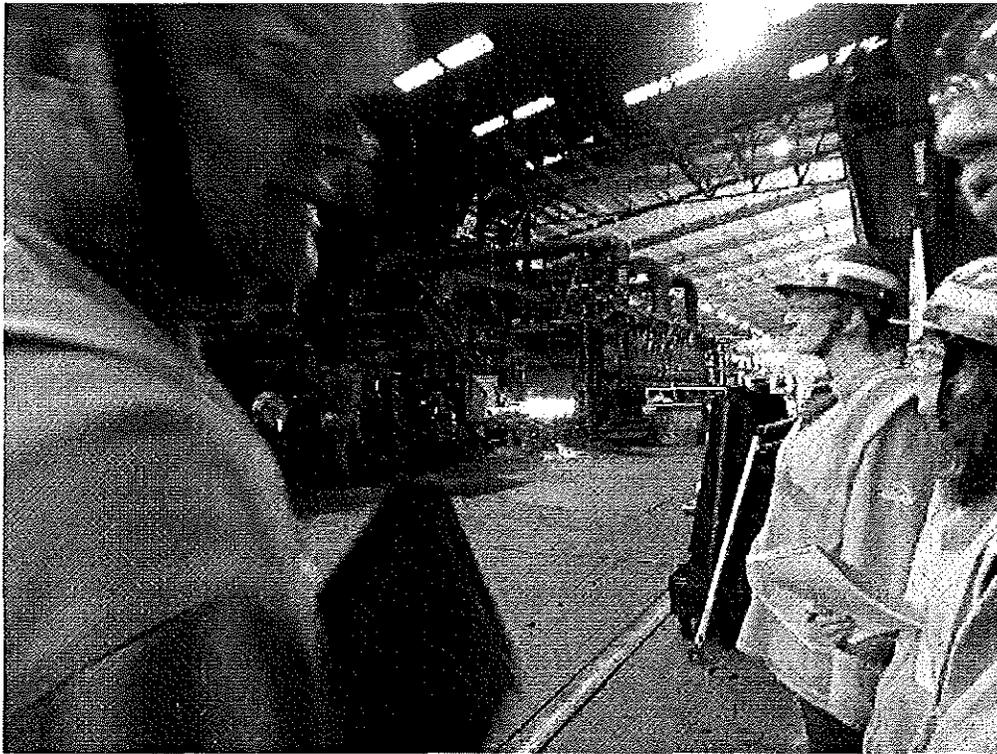
Image 16(DSC00094) : Photo of reheated billet moving from the reheat furnace on it's way to the rolling mill stands

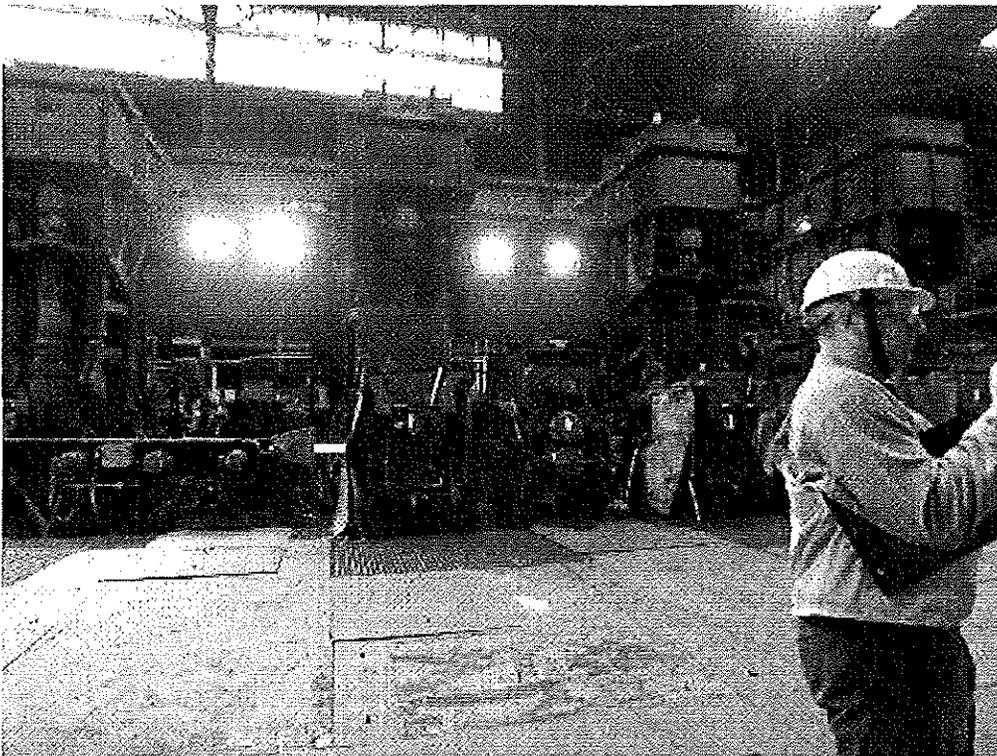
Image 17(DSC00095) : Photo of billet beginning to be reshaped after passing through one milling stand (Left side of photo red hot piece)

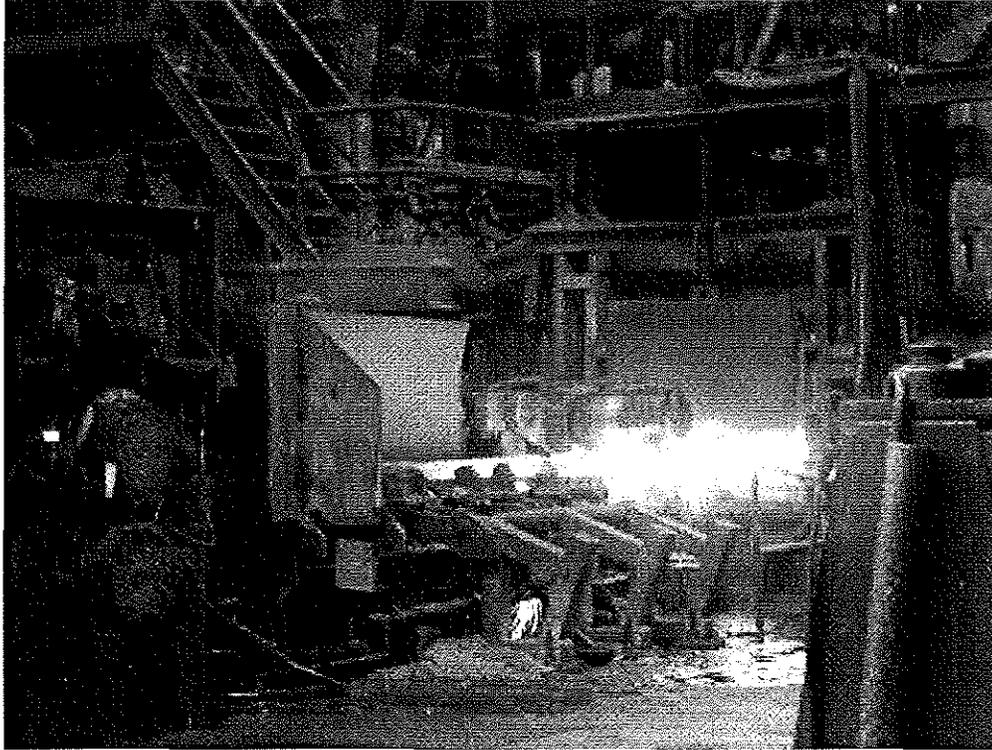
Image 18(DSC00096) : Photo of reheated billet beginning the milling process

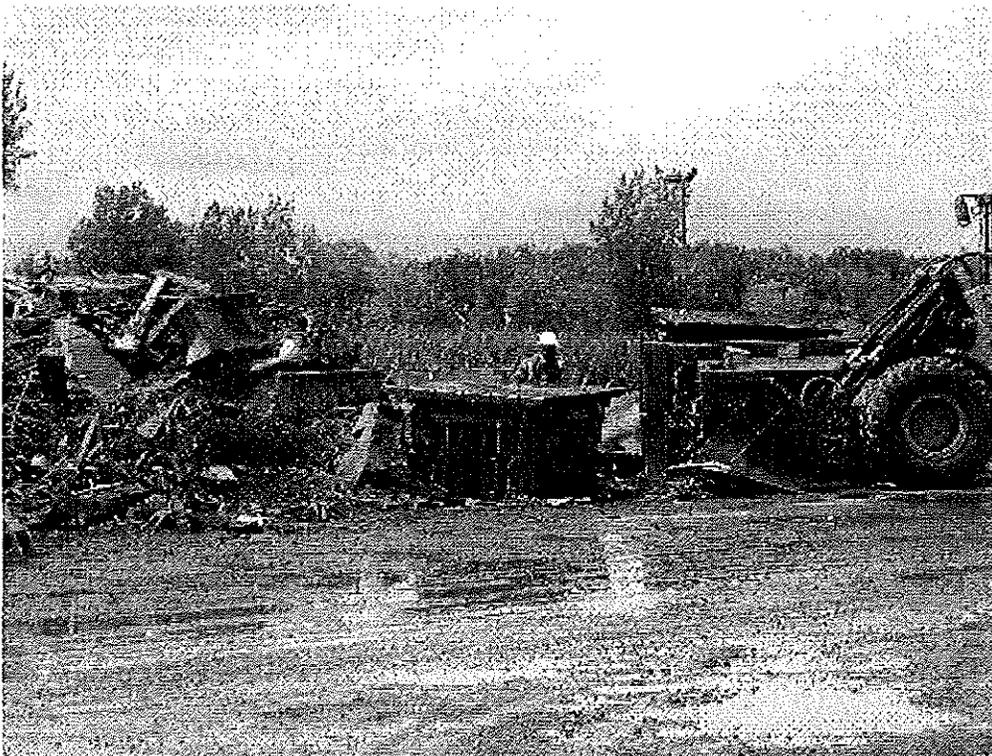
After leaving the bundler area we went to observe the scrap yard torch cutting operation (Photo DSC00098). There is only one torch cutter and that person removes all of the hoses from the piece that will be

cut up using a propane torch. The particular piece that was being prepared for cutting was an automotive die. According to Craig, Gerdau applies the general condition for opacity to this process, which they can comply with due to the fact that the torch cutting process is intermittent.

Image 19(DSC00098) : Photo of scrap yard torch cutter operator removing hoses from the piece that will be cut

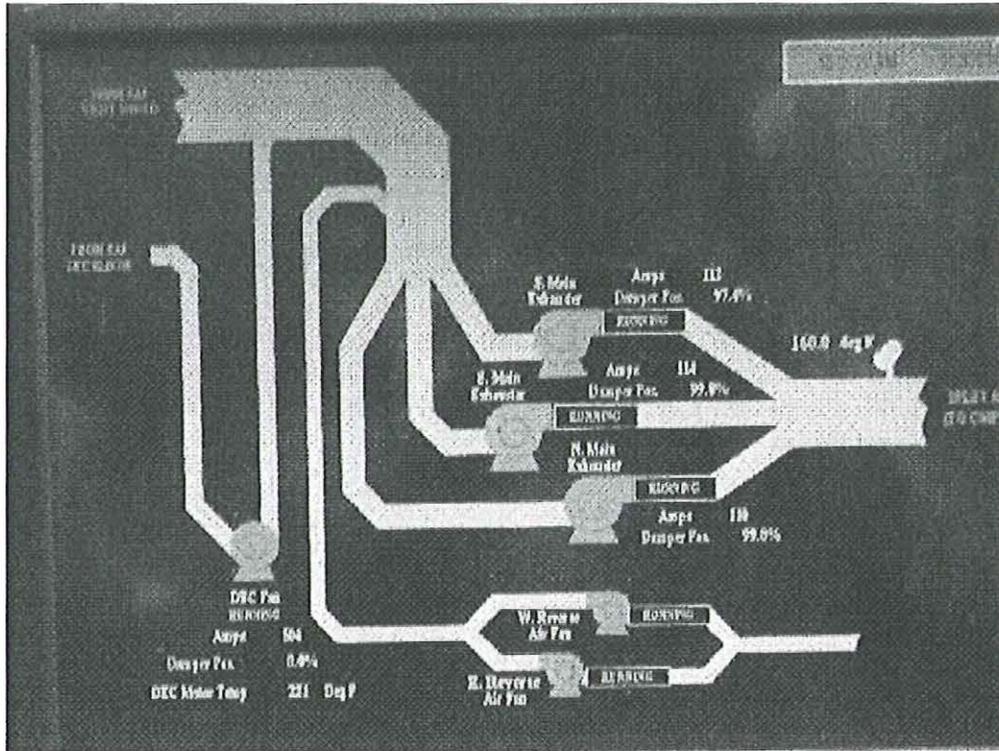
Image 20(DSC00066) : Photo of fan operating status in baghouse control room
