**DEPARTMENT OF ENVIRONMENTAL QUALITY
AIR QUALITY DIVISION
ACTIVITY REPORT: Scheduled Inspection**

FACILITY: CARGILL, INC.		SRN / ID: M3654
LOCATION: 110 SHERWOOD STREET, DECATUR		DISTRICT: Kalamazoo
CITY: DECATUR		COUNTY: VAN BUREN
CONTACT: Mike Borrie , Plant Manager		ACTIVITY DATE: 10/27/2014
STAFF: Dorothy Bohn	COMPLIANCE STATUS: Compliance	SOURCE CLASS: MINOR
SUBJECT:		
RESOLVED COMPLAINTS:

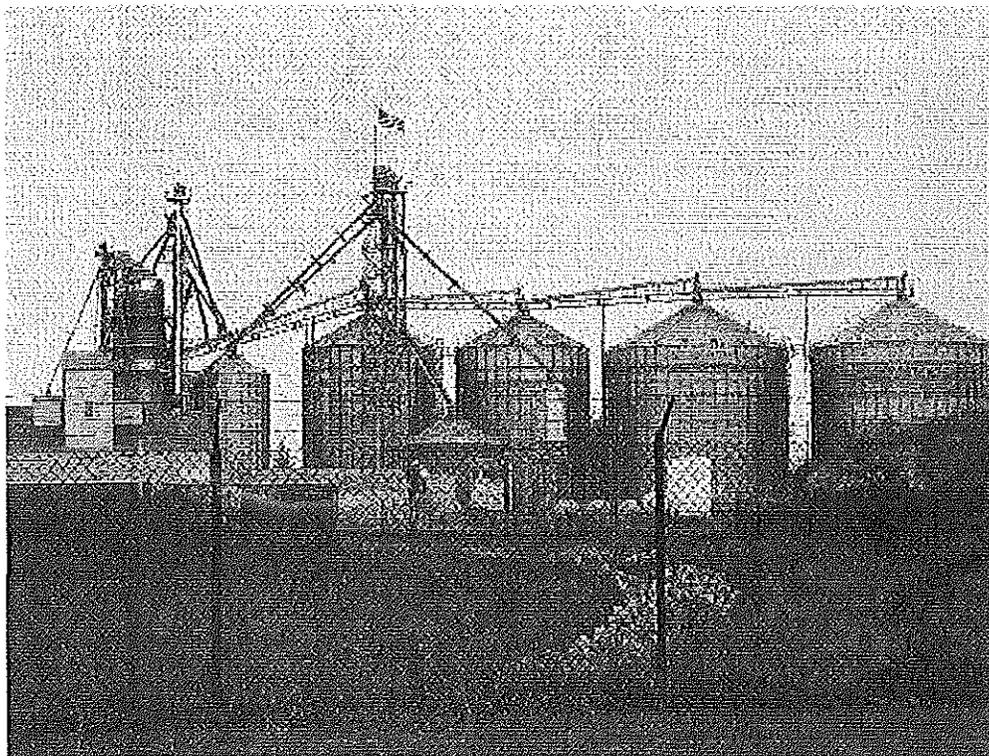
Image 1(Looking NW) : From Bronson St. - can see small tanks which are part of EU LiquidFert., silos and the corn dryer that are on the NW side of the RR tracks.

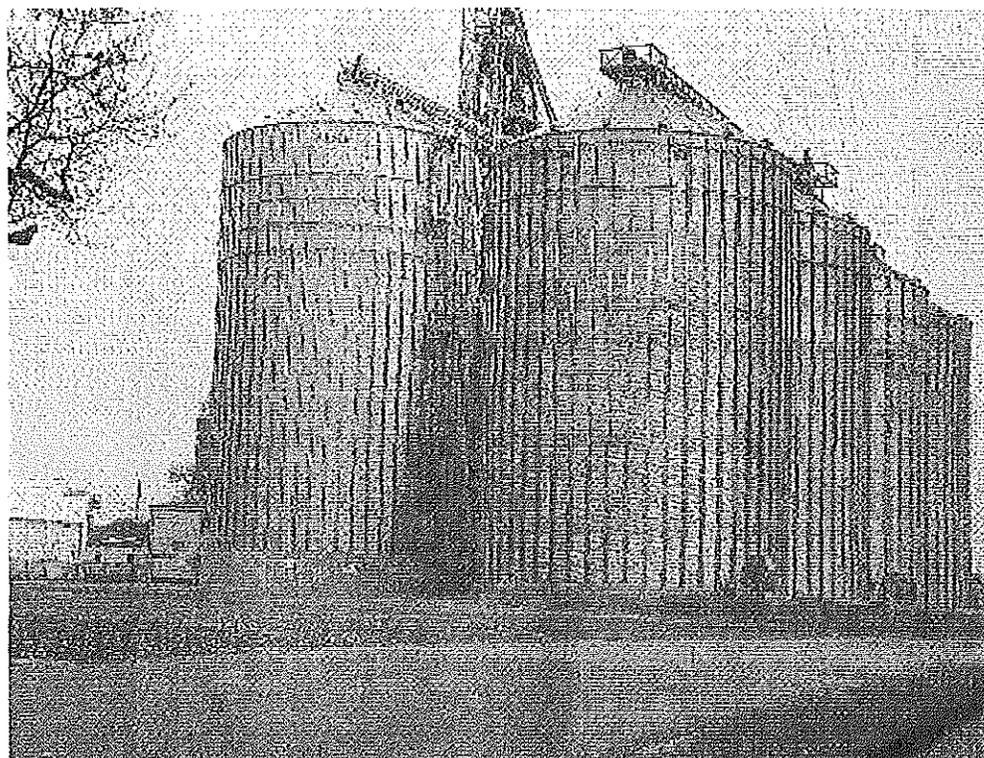
Image 2(Looking N) : from near Williams St and Beers St. The silos on the SE side of the tracks.

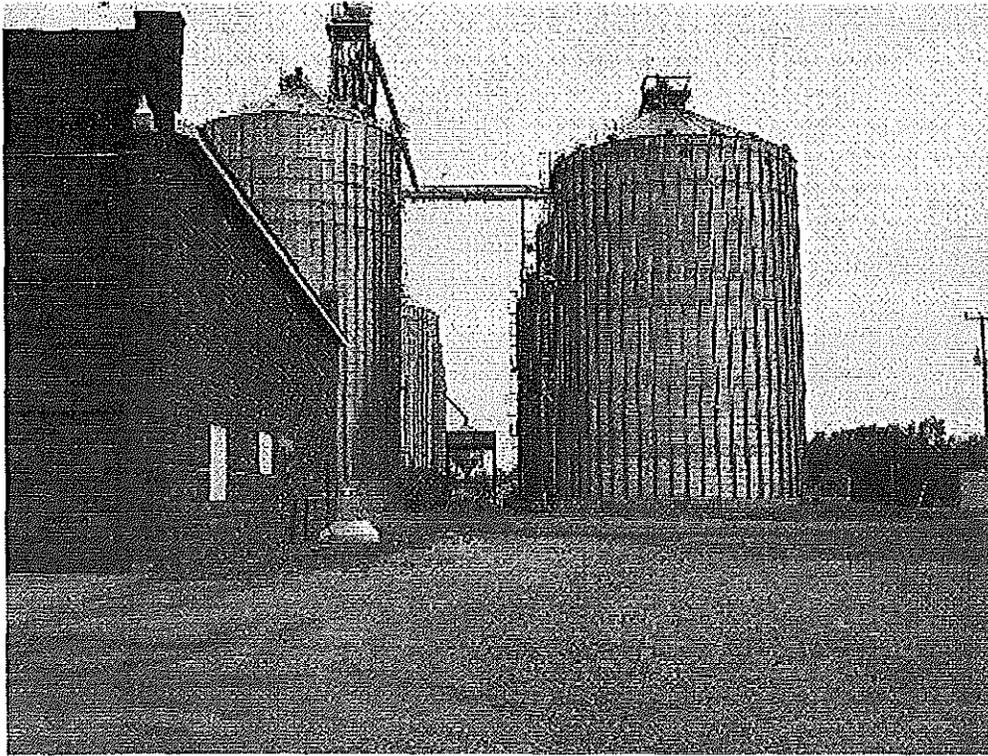
Image 3(SR1) : South Receiving pit in the middle of the silos. Looking NE from Williams St. Brown brick building is for storage.

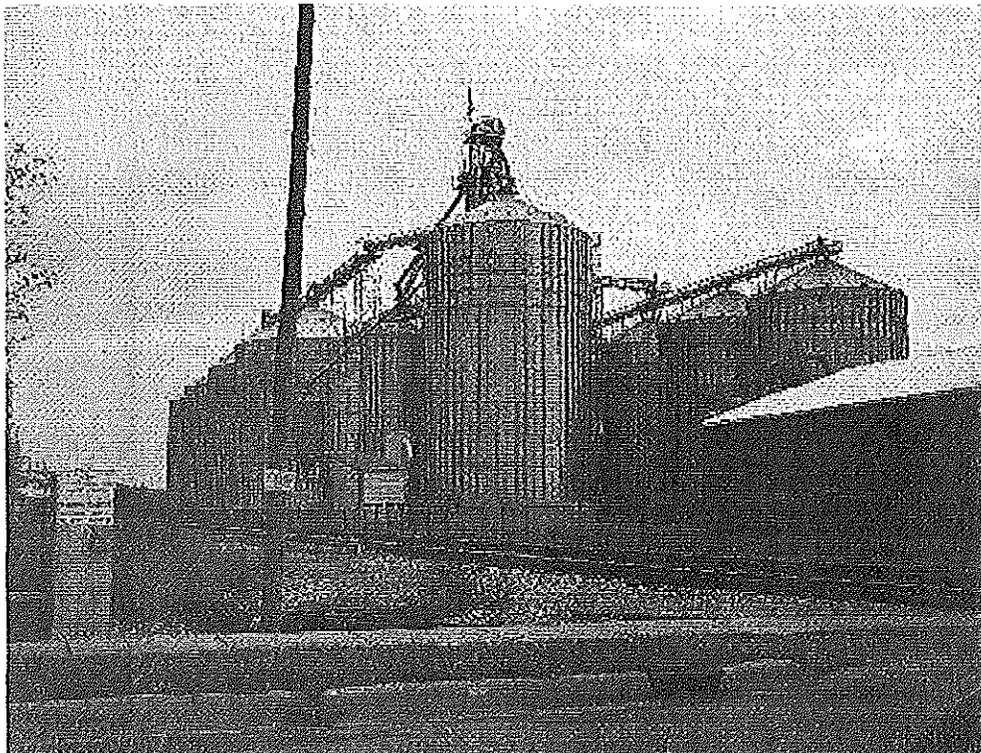
Image 4(South plant) : Looking NE from Williams St. Truck loadout and receiving pit.
