DEPARTMENT OF ENVIRONMENTAL QUALITY  
AIR QUALITY DIVISION  
ACTIVITY REPORT: Self Initiated Inspection

N132854204

FACILITY: Rec Boat Holdings LLC - Cruiser Plant		SRN / ID: N1328
LOCATION: 609 13 TH. St., CADILLAC		DISTRICT: Gaylord
CITY: CADILLAC		COUNTY: WEXFORD
CONTACT: Trent Burch , Environmental/Safety Compliance		ACTIVITY DATE: 07/09/2020
STAFF: Sharon LeBlanc	COMPLIANCE STATUS: Non Compliance	SOURCE CLASS: MAJOR
SUBJECT: Site visit to check condition of Wyse joints on stacks. Maintenance work is required on central stack. sgl		
RESOLVED COMPLAINTS:

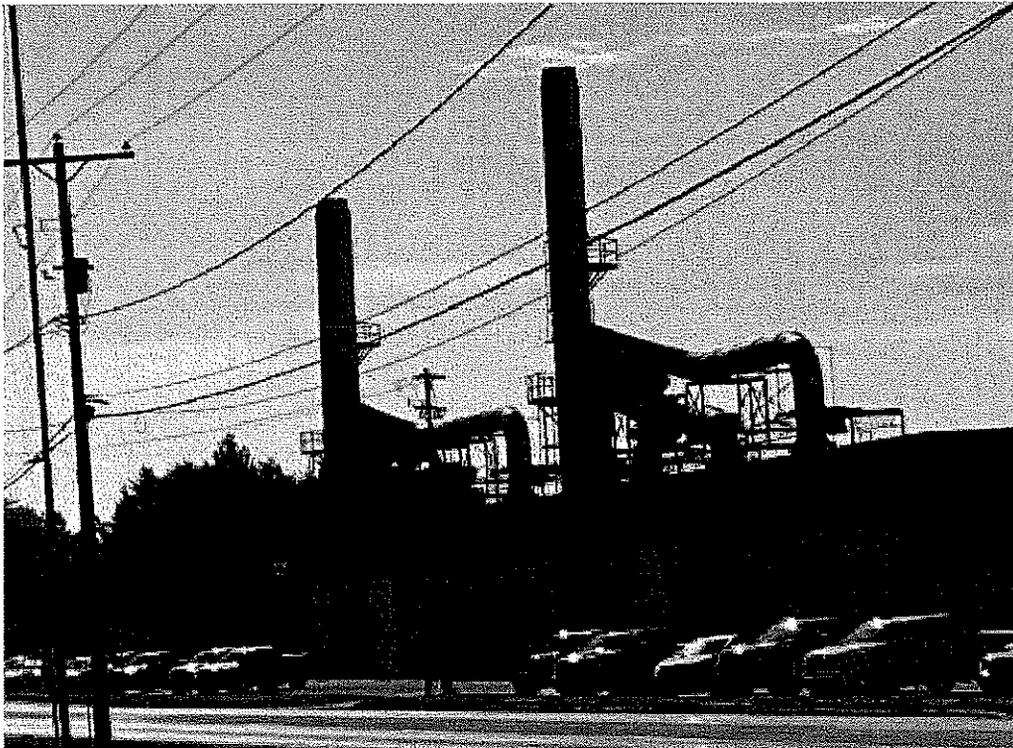
An initial drive by along 13th street in front of the building indicated that there were dark spots and rust at multiple spots along the two eastern most stacks. Observations made from the parking lot below the two eastern stacks identified locations where it appeared that the metallic (foil?) exterior coating of a rubber band used at stack joins was peeling, and exposing the black rubber. At at least one location on the center stack it appeared that the black rubber had torn, but that the tear did not extend to the point of a leak, however at a lower wyse joint it was clear that the damage to the rubber at that location had resulted in a hole that needed immediate attention. Mr. Trent indicated that a work order would be prepared for the required work, and that if the banding was instock that the repairs would be made yet this week. If the material was not in stock it would be ordered and installed as soon as possible.

**Image 1(view from west) :** View of two eastern most stacks and wyse joints from across 13th street.

Mr. Burch is to follow up with a tentative schedule for the repairs, and pictures of the repaired locations.

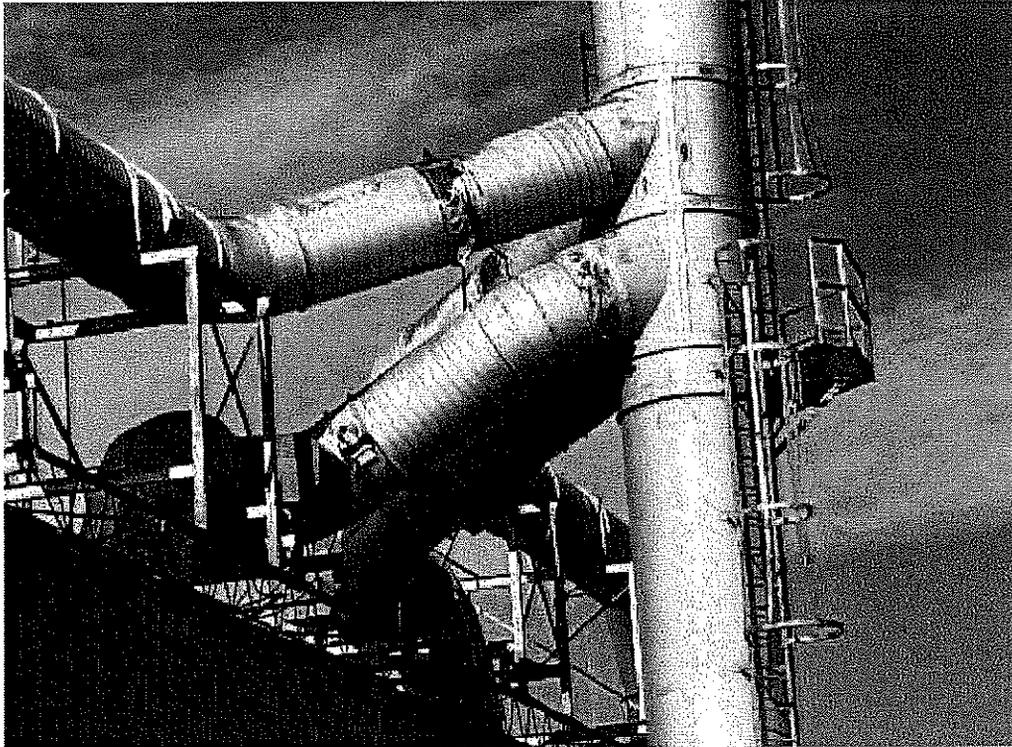
**Image 2(central stack)** : view of stack and wyse joints for central stack. Note the metallic coating of rubber banding at joints is coming off.
