**DEPARTMENT OF ENVIRONMENTAL QUALITY
AIR QUALITY DIVISION
ACTIVITY REPORT: Self Initiated Inspection**

N158644168

FACILITY: TUSCOLA ENERGY - NIXON FARMS		SRN / ID: N1586
LOCATION: 7611 BAY CITY FORESTVILLE RD, AKRON		DISTRICT: Saginaw Bay
CITY: AKRON		COUNTY: TUSCOLA
CONTACT: Jeff Adler, President		ACTIVITY DATE: 04/13/2018
STAFF: Matthew Karl	COMPLIANCE STATUS: Non Compliance	SOURCE CLASS: MINOR
SUBJECT: Unannounced site visit of Nixon Farms to determine compliance with PTI No. 20-12A and Michigan Air Pollution Control Rules.		
RESOLVED COMPLAINTS:

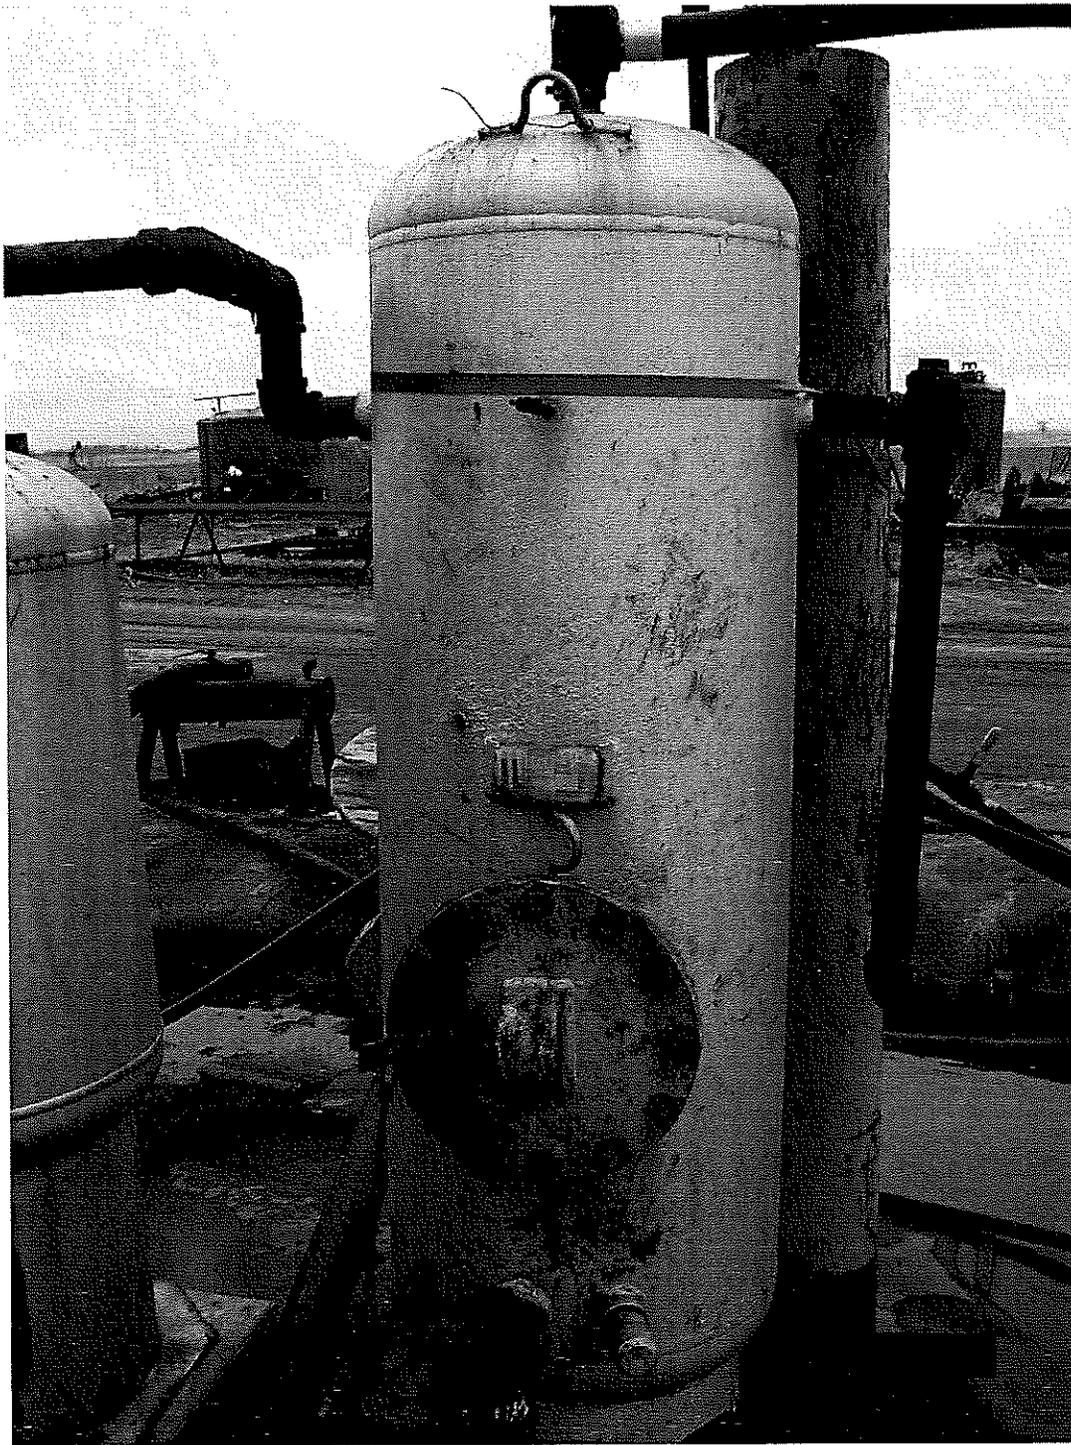
First, the separator tank EUNIXON4SEP had a leak at one of the connecting pipes (Attachment A, Figure 1, 2). At 15:08, the H2S meter we brought on site detected H2S concentrations of 82 ppm near the separator. A previous AQD VN was sent about a separator H2S leak at this facility on 11/7/2016. The leaking sour gas is a violation of PTI 20-12A FGOILPRODUCTION SC IV.1. A violation notice letter will follow.

Figure 1 EUNIXON4SEP separator tank for the Nixon 4-23 sour well. Piping near bottom-center-left had a hole and was leaking H₂S at 82 ppm.

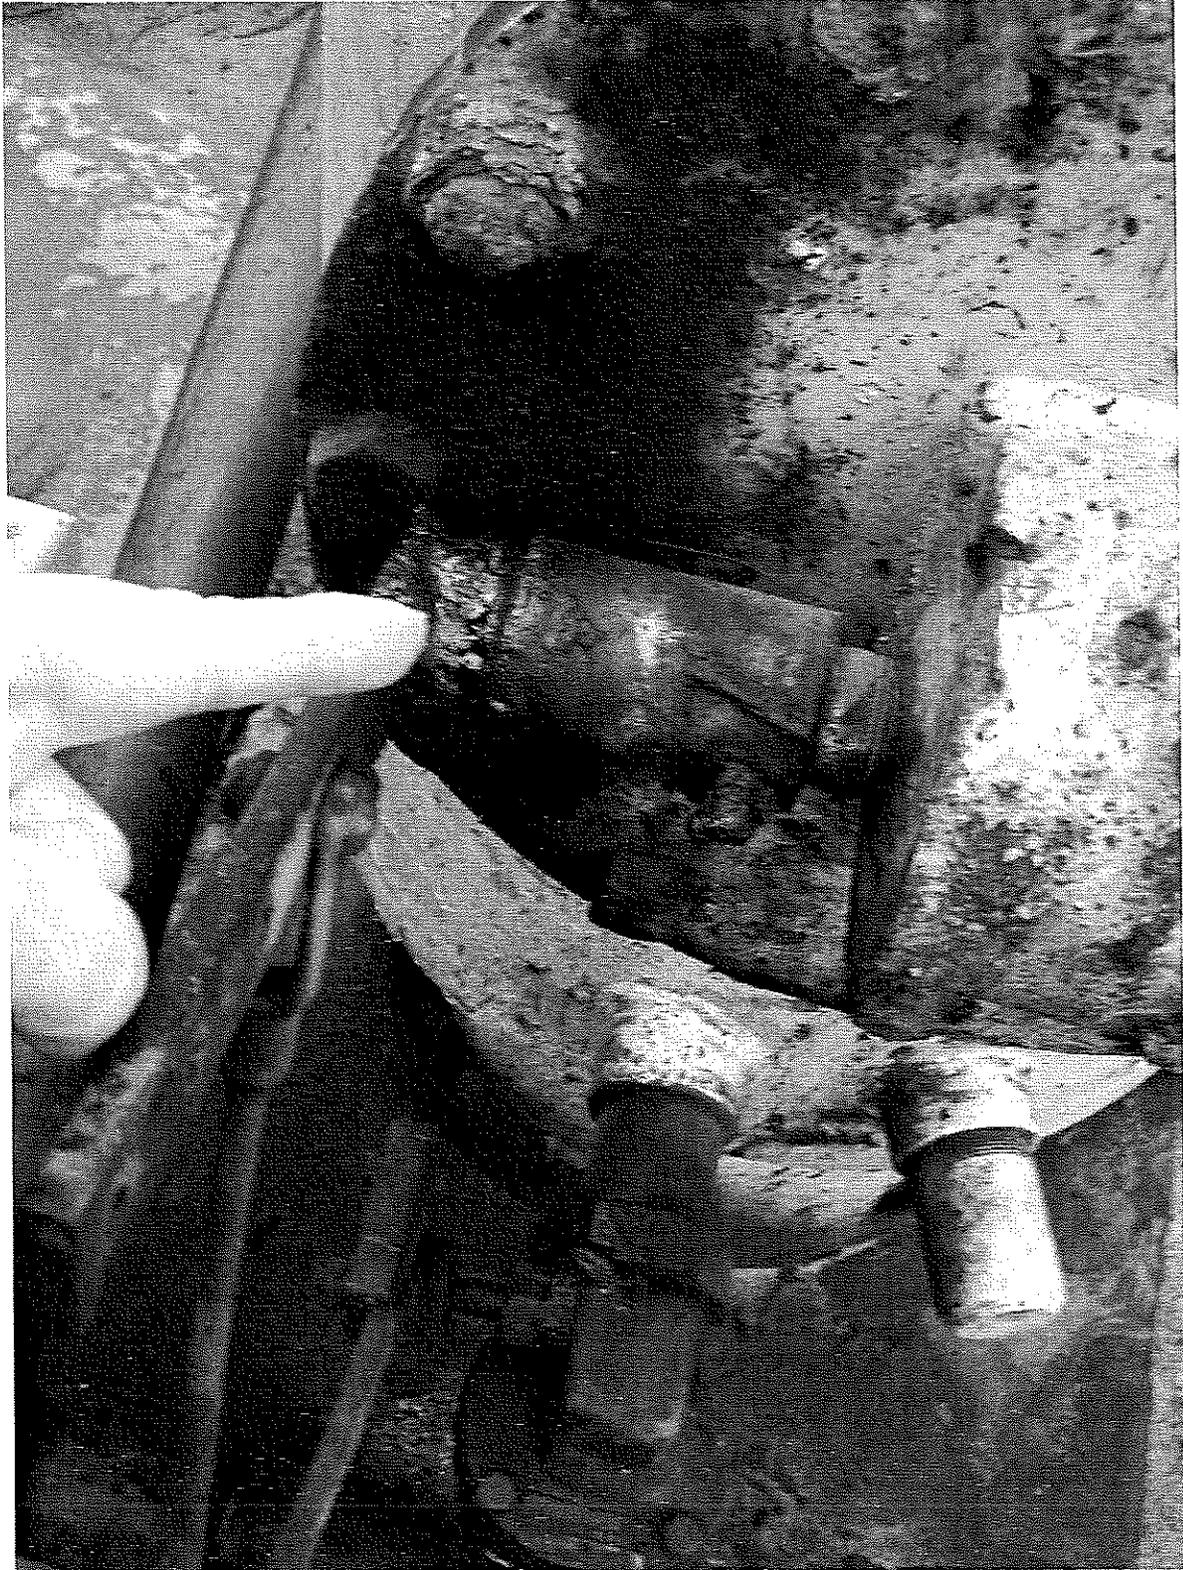
Figure 2 Closeup of EUNIXON4SEP separator tank for the Nixon 4-23 sour well. The hole in the piping is indicated at the end of the finger included for scale. H₂S reading 82 ppm.

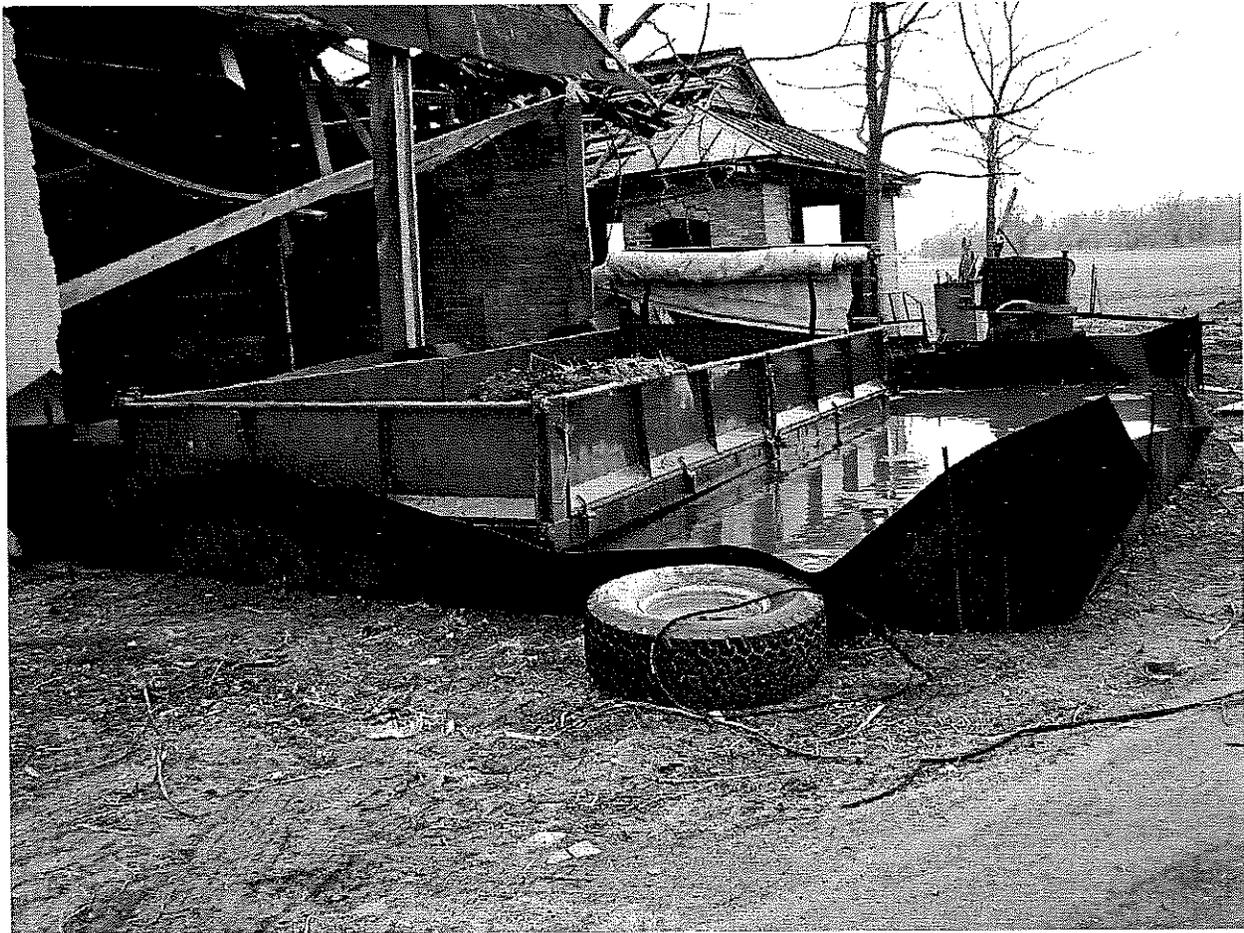
Also, it was noted that there was a red dumpster with what appeared to be contaminated soil located near the front of the site. The secondary containment around the red dumpster was filled with water and appeared to be in danger of failing (Attachment A, Figures 3, 4).

Figure 3 Red dumpster with what appeared to be contaminated soil. Photo taken over concerns about the integrity of the secondary containment that is filled with water.

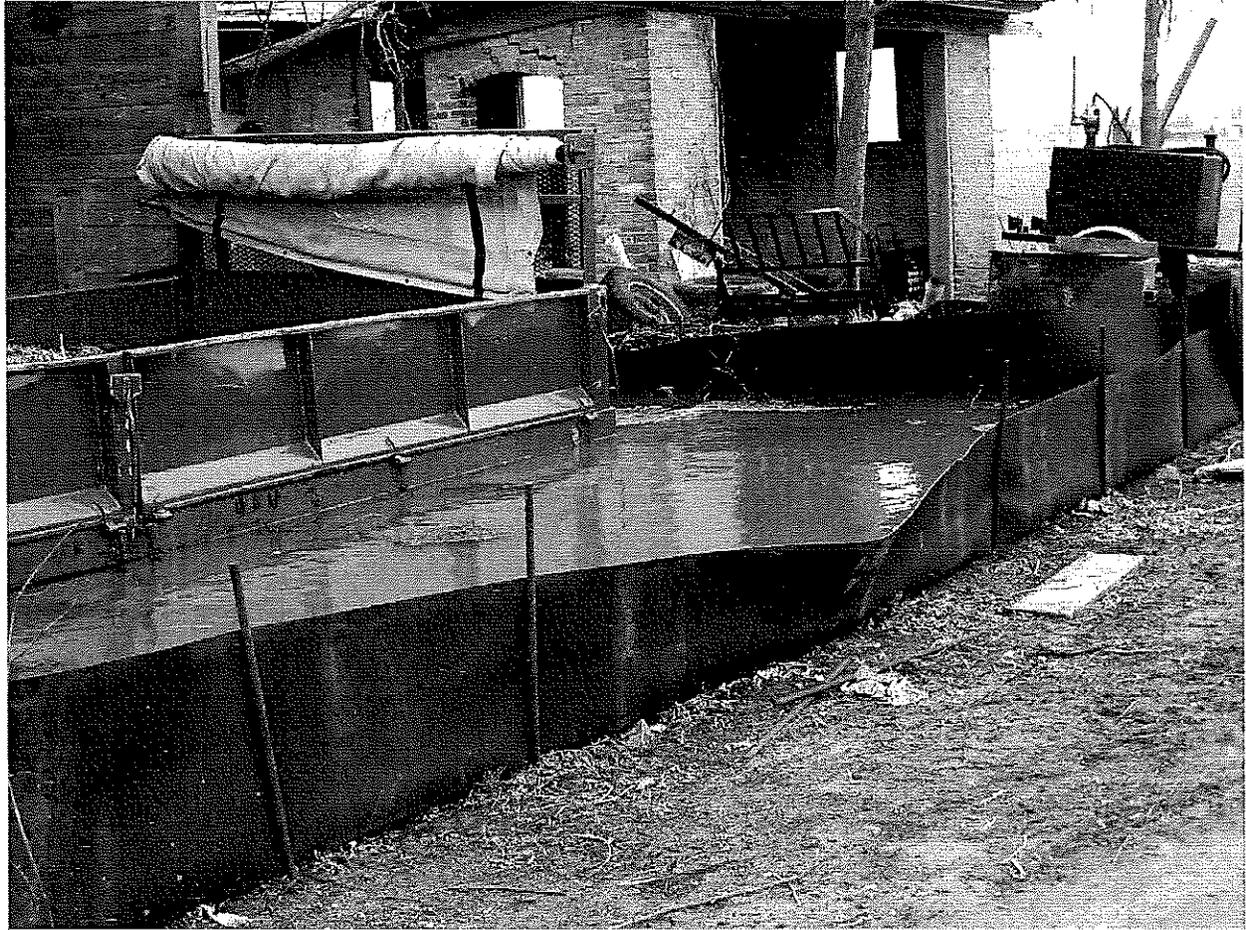
Figure 4 Red dumpster with what appeared to be contaminated soil. Photo taken over concerns about the integrity of the secondary containment that is filled with water.
