**DEPARTMENT OF ENVIRONMENTAL QUALITY  
AIR QUALITY DIVISION  
ACTIVITY REPORT: Scheduled Inspection**

| FACILITY: Lapeer Plating & Plastics, Inc. | | SRN / ID: N1863 |
| SUBJECT: Inspection of permitted equipment. EU-CHROMEPLATE32: scrubber in-op, dynes/cm measurements out of compliance 7 days during March and April; EU-CHROMEETCH: 3 magnehelic gauges out of compliance ranges, leak at entry of scrubber; FG-COATING: no pressure test caps for HPLV. | | |

**Inspection Report****N1863- Lapeer Plating and Plastics**

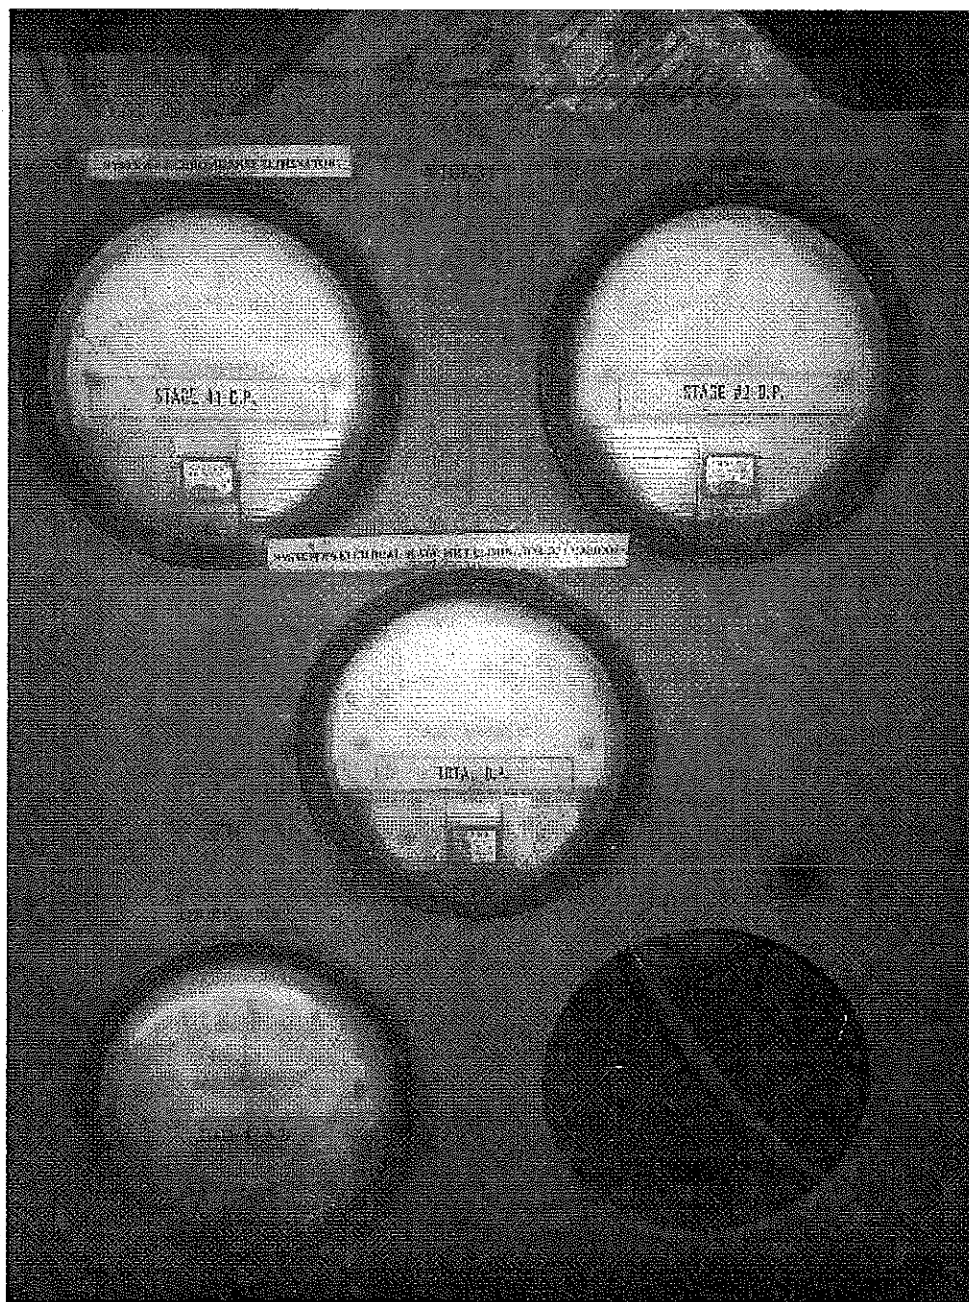
1. System 1 Chrome Mist Eliminator "Stage #1 D.P." Magnehelic gauge reading of 0.0, compliance range 1.0-3.0
2. System #5 Etch Dual Stage, Stage 1 Magnehelic gauge reading of 0.0, compliance range 1.0-3.0
3. System #5 Etch Dual Stage, Total DP Combined Magnehelic gauge reading of 0.15, compliance range 1.5-3.5

**Image 1(Multi Mag. Panel) :** System#1 Chrome Mist Eliminator, System#3 Pre-plate Wet Scrubber, System#4 Nitric Wet Scrubber, and System#5 Etch Dual Stage- Total DP Combined

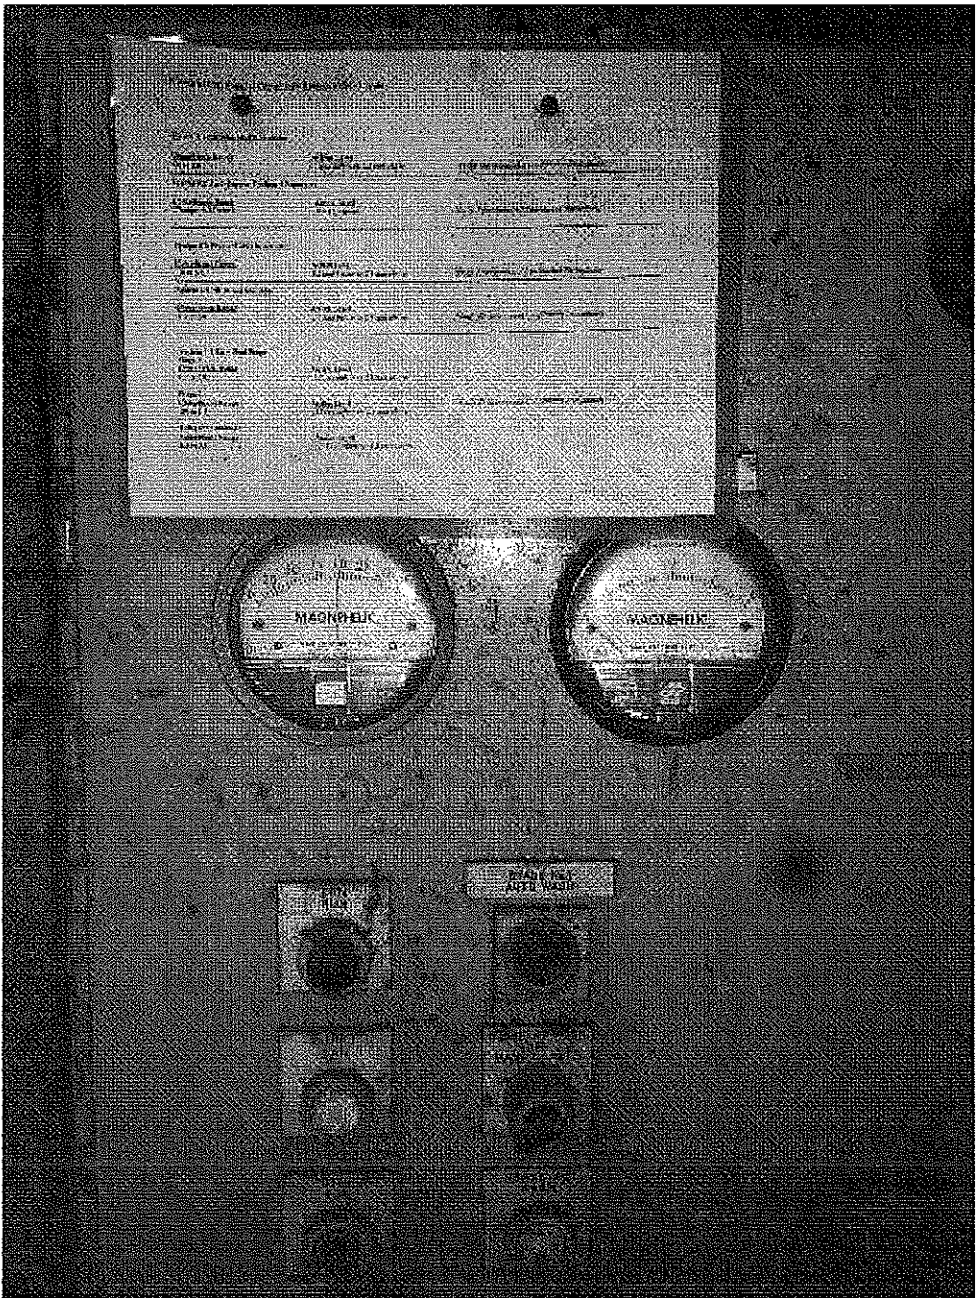
1. System 1 Chrome Mist Eliminator "Stage #1 D.P." Magnehelic gauge reading of 0.0 out of compliance range
2. System #5 Etch Dual Stage, Stage 1 Magnehelic gauge reading of 0.0 out of compliance range

3. System #5 Etch Dual Stage, Total DP Combined Magnehelic gauge reading of 0.15
4. Packed Bed / CMP scrubber Maintenance records unavailable for inspection
5. Evidence of leak in duct at entry point of Packed Bed / CMP scrubber

**Image 2(Etch Panel)** : System#5 Etch Dual Stage Stage 1 (left) and Stage 2 (right).

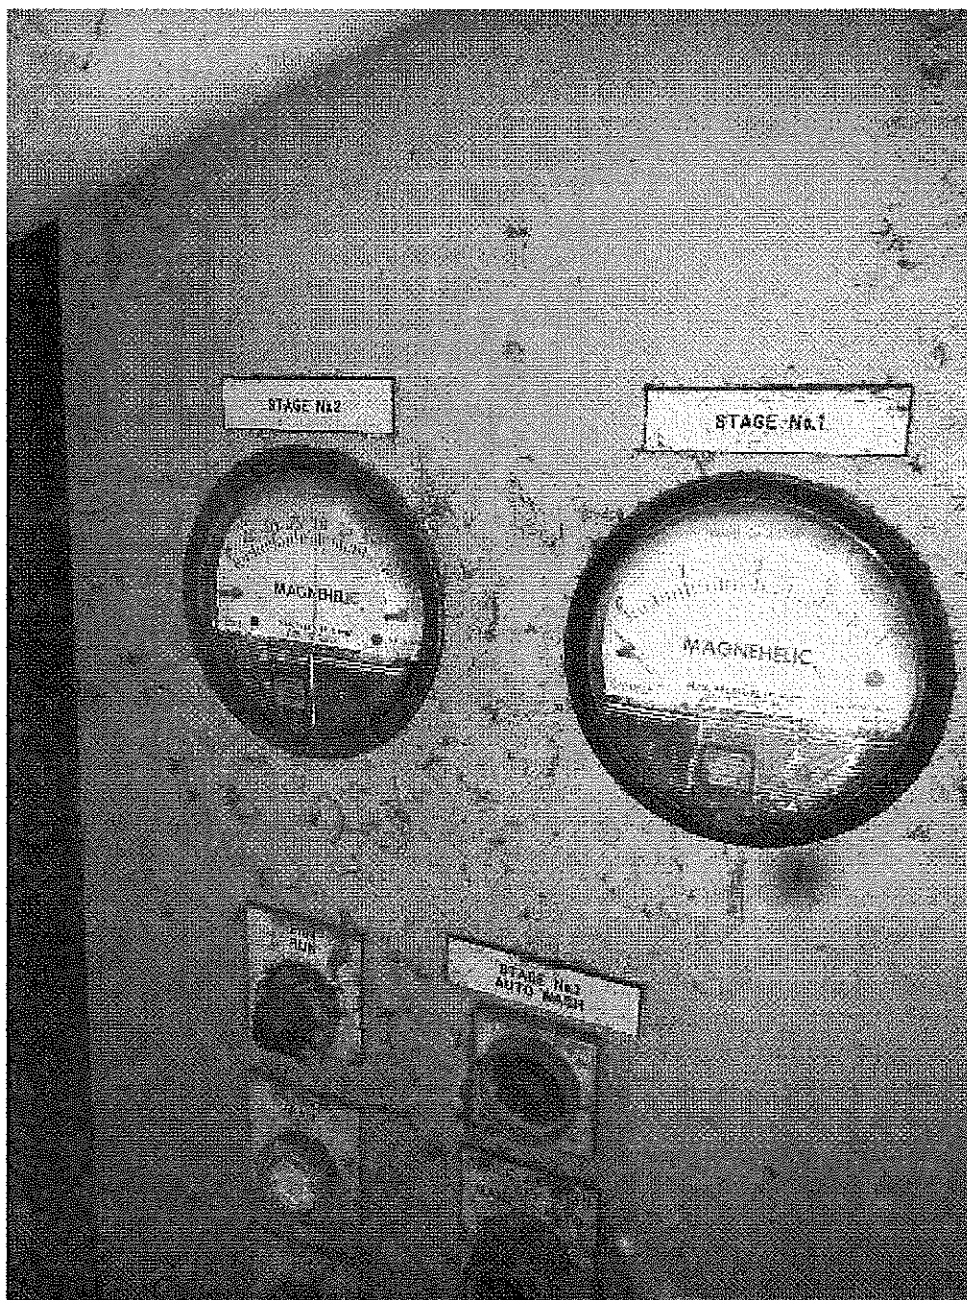
Image 3(Etch panel2) : labels visible

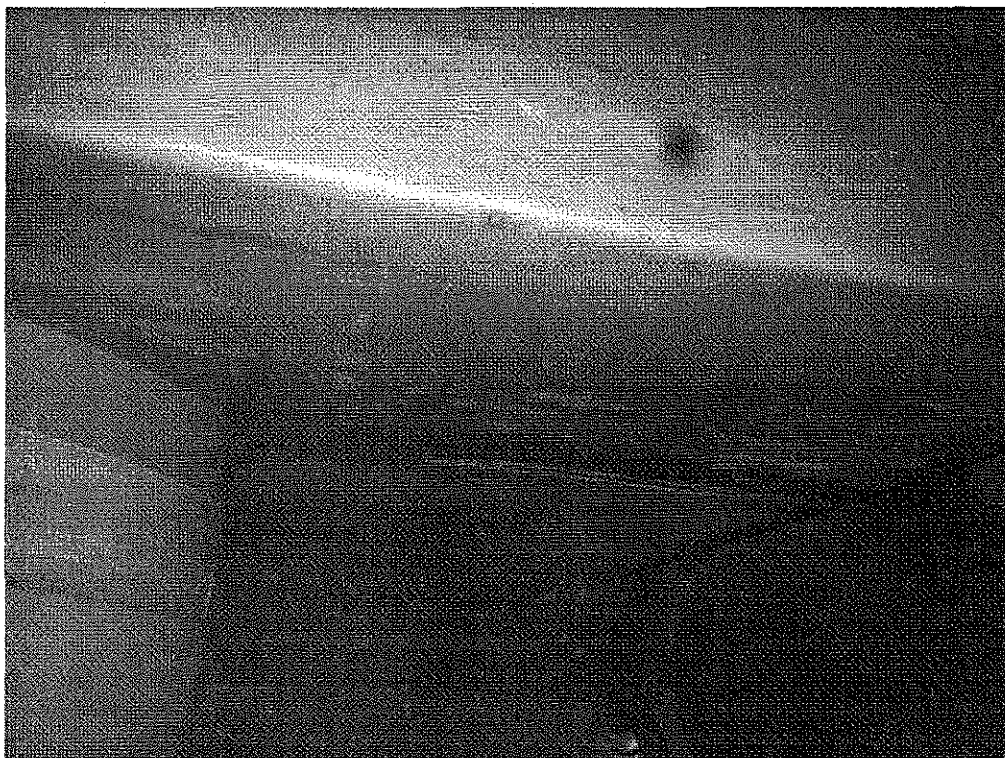
**Image 4(Etch Scrubber leak) :** Etch Scrubber leak at ductwork entrance

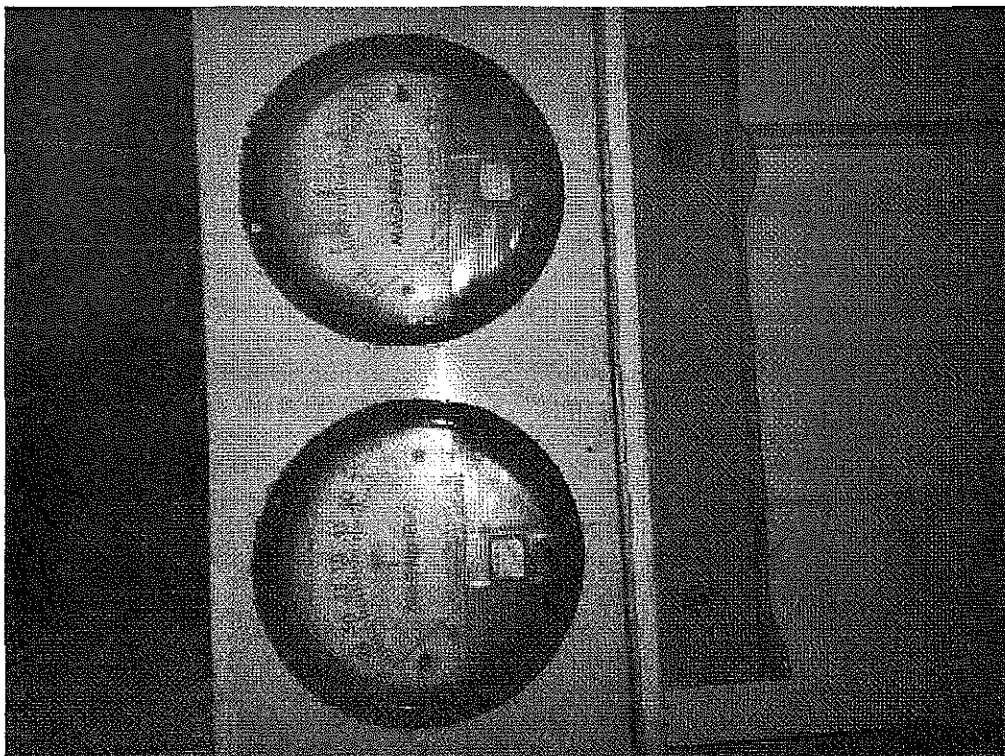
1. Composite Mesh Pad (CMP) Scrubber inoperative
2. CMP Scrubber Maintenance records unavailable for inspection
3. Surface tension measurements above 33 dynes/cm

Once complete with the paint line, we went back to the chrome area to the EU-CHROMEPLATE32 scrubber area. While looking at the magnehelic gauges, we found both to be reading 0.0. I climbed onto the roof of the lab to check the ductwork and confirm the gauges were properly hooked up, Ken went up with me. We found that they were connected; I could not feel any vibration in the ductwork to confirm the fan was operational. We climbed back down and tried to approach the fan (post scrubber). We found that the exhaust fan was not operational. At this time Tim Colters (maintenance) arrived. When asked, he informed us that the fan had been down for about two weeks. We requested again to see the maintenance records, but Tim stated he had just left an important meeting and had to get back to the meeting. We requested copies to be sent to us asap. Tim stated he had the replacement fan on-hand, yet was busy and the earliest he could install it would be about 2 weeks. We walked over to where the fan was located and confirmed it was on hand. Sam Daniel joined us at this point. Brian and I were asked how long they had to repair it and I replied as soon as possible.

**Image 5(EU-CHROMEPLATE32 Mag) :** No indication of DP, scrubber and exhaust fan in-op
