DEPARTMENT OF ENVIRONMENTAL QUALITY
AIR QUALITY DIVISION
ACTIVITY REPORT: Scheduled Inspection

N187247771

FACILITY: Southern Lithoplate Inc.		SRN / ID: N1872
LOCATION: 4150 Danvers Court SE, KENTWOOD		DISTRICT: Grand Rapids
CITY: KENTWOOD		COUNTY: KENT
CONTACT: Cory Kirkbride ,		ACTIVITY DATE: 01/09/2019
STAFF: April Lazzaro	COMPLIANCE STATUS: Non Compliance	SOURCE CLASS: MINOR
SUBJECT: Unannounced, scheduled inspection.		
RESOLVED COMPLAINTS:

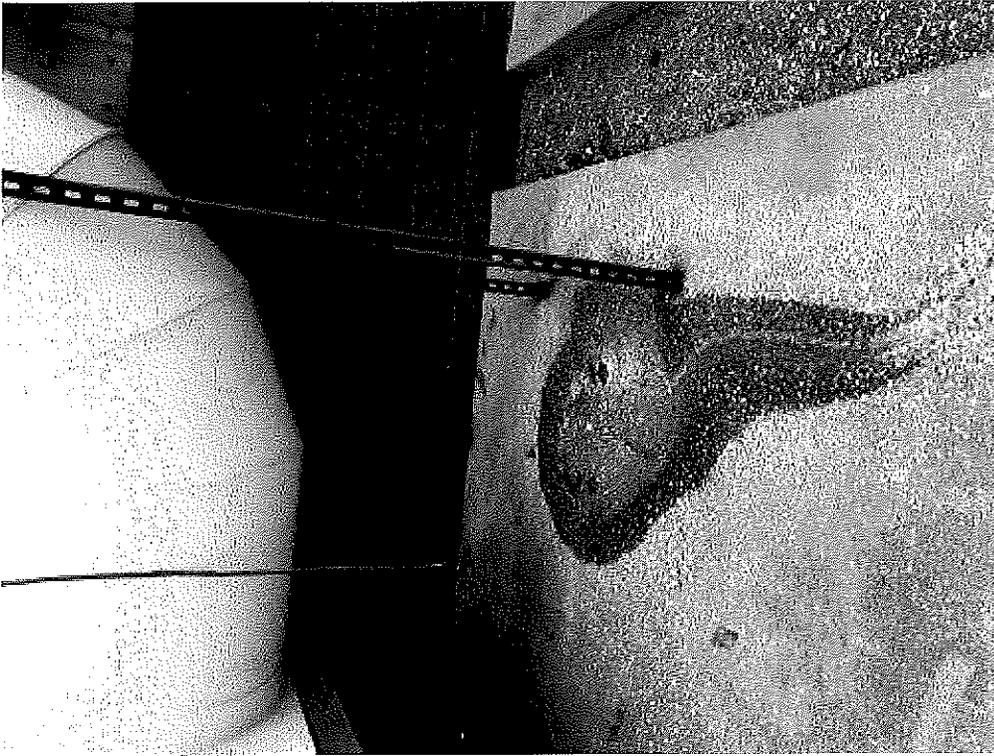
During the inspection, I did not observe any improper disposal practices at the facility. The Malfunction Abatement Plan is dated March 25, 2011 and AQD staff will request that the document be updated. Currently, the facility is not conducting all of the proper maintenance activities as specified in the plan. Specifically, the requirements for monitoring the scrubber are not being documented as frequently as the plan specifies. During the inspection, I identified that the scrubber inlet ductwork had been leaking acid water onto the concrete pad below. This was evidenced by the destruction of a portion of the concrete that was visibly wet as the acid water was continuously dripping down. This is process moisture condensing prior to the control device. I pointed out that a storm drain was nearby as well. The leak and damage were pointed out to Mr. Kirkbride who took immediate action to address the problem. He called a contractor who came the next day to repair the leak in the stack. (see attached email and photos)

Image 1(Scrubber leak) : Leak of acid water from inlet duct, pre-control.

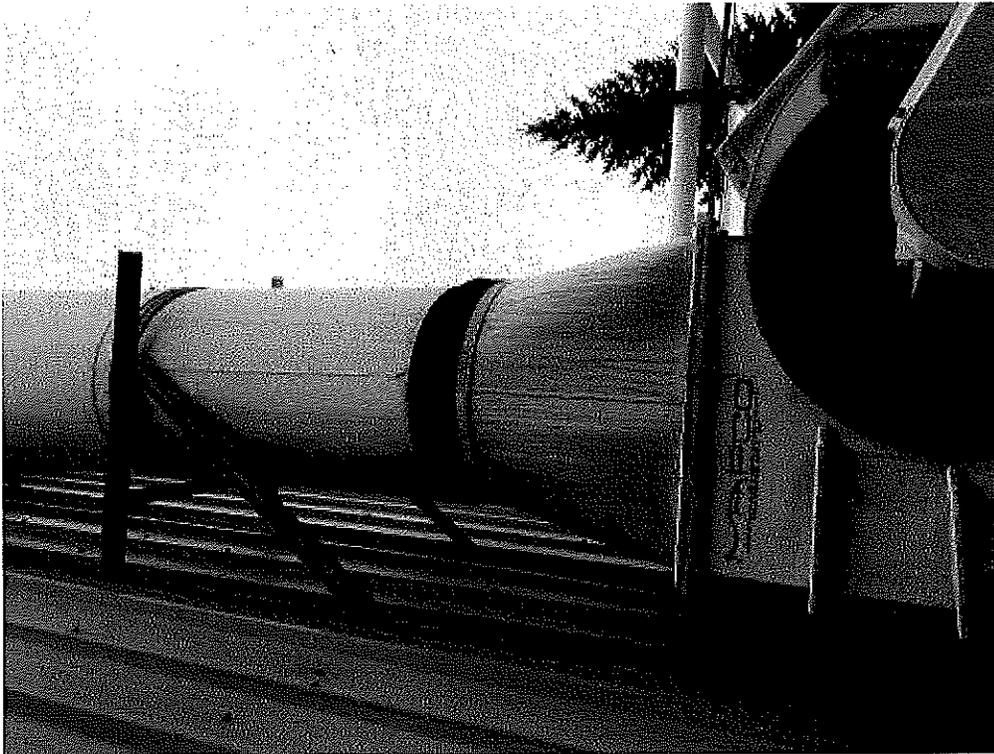
Image 2(Scrubber stack) : Scrubber stack.
