DEPARTMENT OF ENVIRONMENTAL QUALITY
AIR QUALITY DIVISION
ACTIVITY REPORT: Scheduled Inspection

| FACILITY: FINISHING SERVICES INC | | SRN / ID: N2474 |
| SUBJECT: Unannounced compliance inspection of a small electroless plating facility. | | |

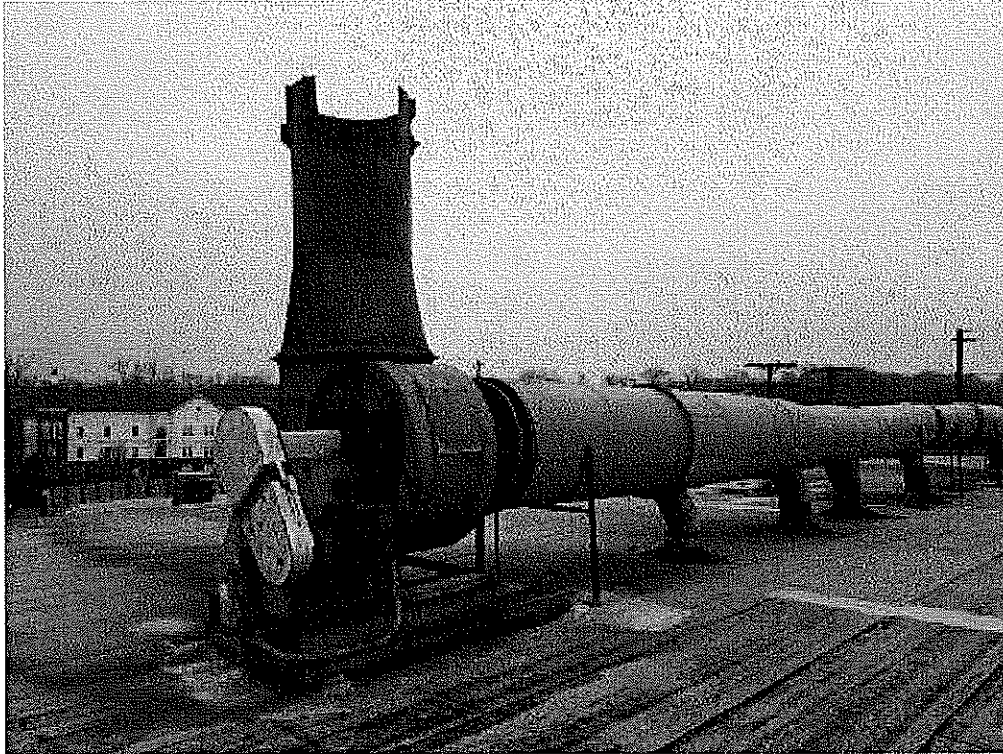
MM first gave me a tour of the roof which is easily accessed from a stair case inside the building. No odors or smoke was noted on the roof. We first observed the phosphate exhaust system on the roof. The exhaust stack from this process had been damaged by ice and the exhaust fan was very loud with an apparent bearing problem. MM noted the damaged stack and said that they would be making repairs to both the stack and fan shortly.

Phosphate Line. It was active. It has phosphate and HCL tanks with slotted vent style ventilation located on the side of the tanks. Much of the steam raising from the tanks was not going into the ventilation system but simply going up in the roof area. The faulty fan on the roof is likely cause. The HCL tanks were at 25 % concentration.

Image 1(Phosphate) : Phosphate line exhaust stack and fan. Note damaged stack. Fan in very poor condition.

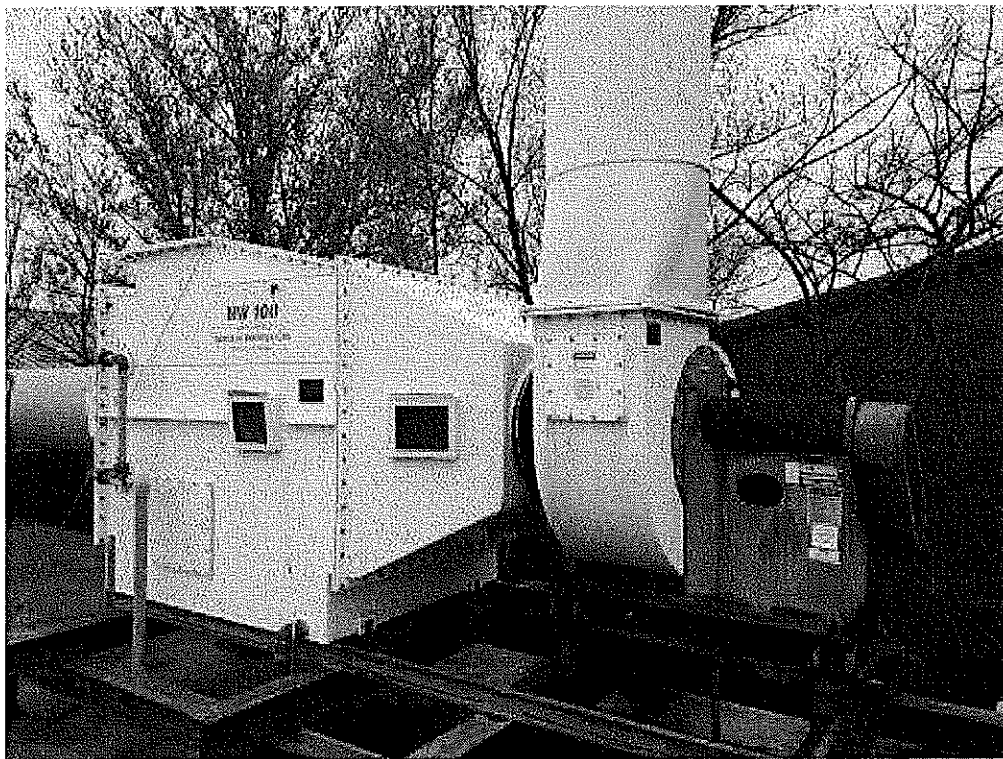
Next, we looked at a packed bed scrubber (8496 cfm, recirculation rate 38 gallons per minute, water make up rate of 1.9 gallon per minute.) manufactured by Midwest Air Products. This scrubber controls emissions from EUSYSTEM1. It was operating. No opacity or steam coming from the stack. No leaks and appeared to be in excellent condition. Water could be seen flowing through the transparent panels. See attached photo.

Image 2(Number 1 Scrubber) : Number 1 Scrubber. (Older)

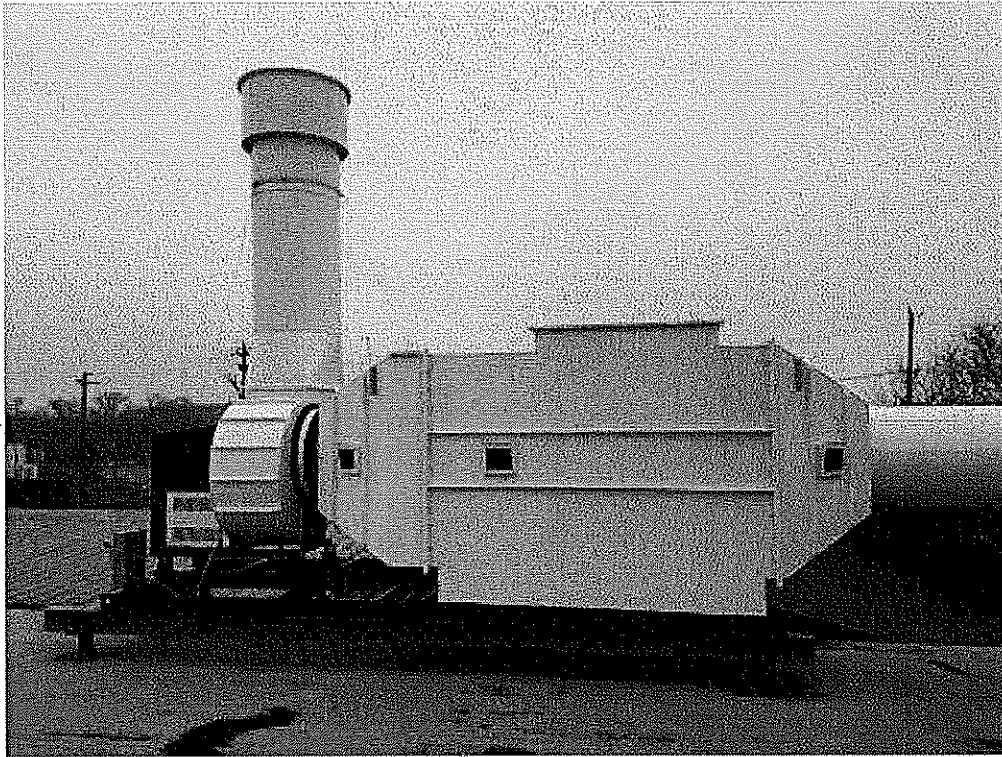
Next, we looked at another packed bed scrubber (19,850 cfm). This is the new one. This scrubber controls emission from EUSYSTEM2 and appears similar in appearance to the other one. It was operating. No opacity or steam coming from the stack. No leaks and appeared to be in excellent condition. Water could be seen flowing through the transparent panels. See attached photo.

Image 3(Number 2 Scrubber) : Number 2 Scrubber. (Newer)

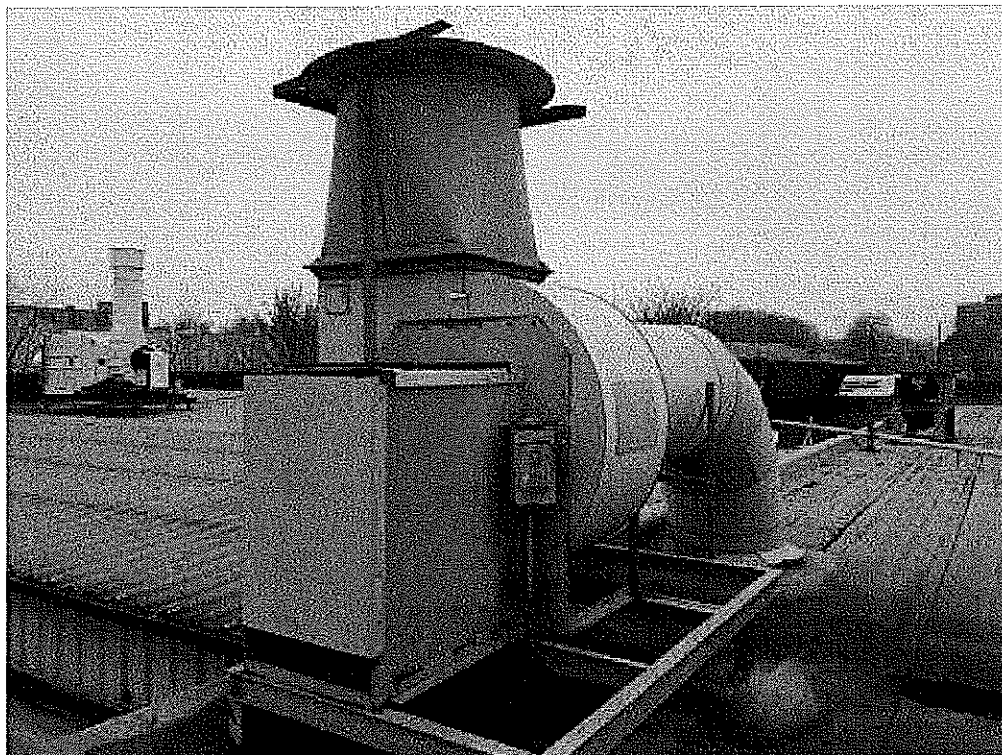
Finally, we looked at the stack exhaust from a tin/zinc coating line. Nothing remarkable. See attached photo.

Image 4(Tin Plating Exhaust) : Tin plating line exhaust.

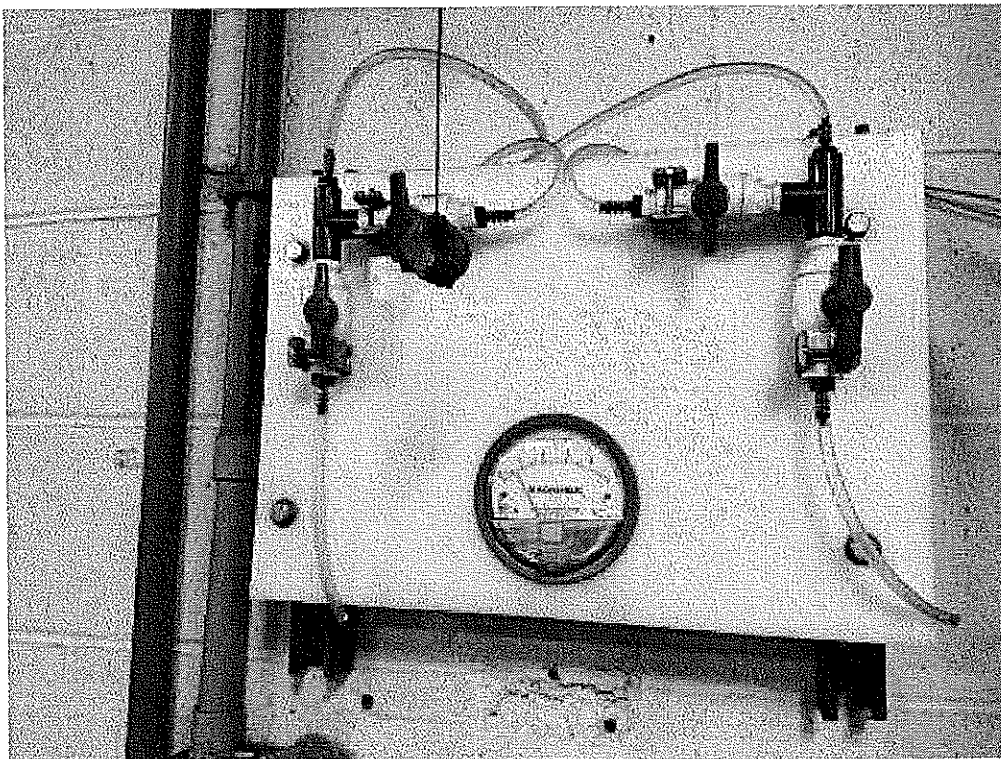
EUSYSTEM1. It was active. Noted some ammonia smell adjacent to a 1% concentration ammonia tank. Noted the pressure drop of the associated packed bed scrubber was reading 0.7" of water. The recirculation water was a little foamy. See attached photo.

Image 5(Pressure Drop 1) : Pressure drop for the scrubber controlling line 1 nickel.

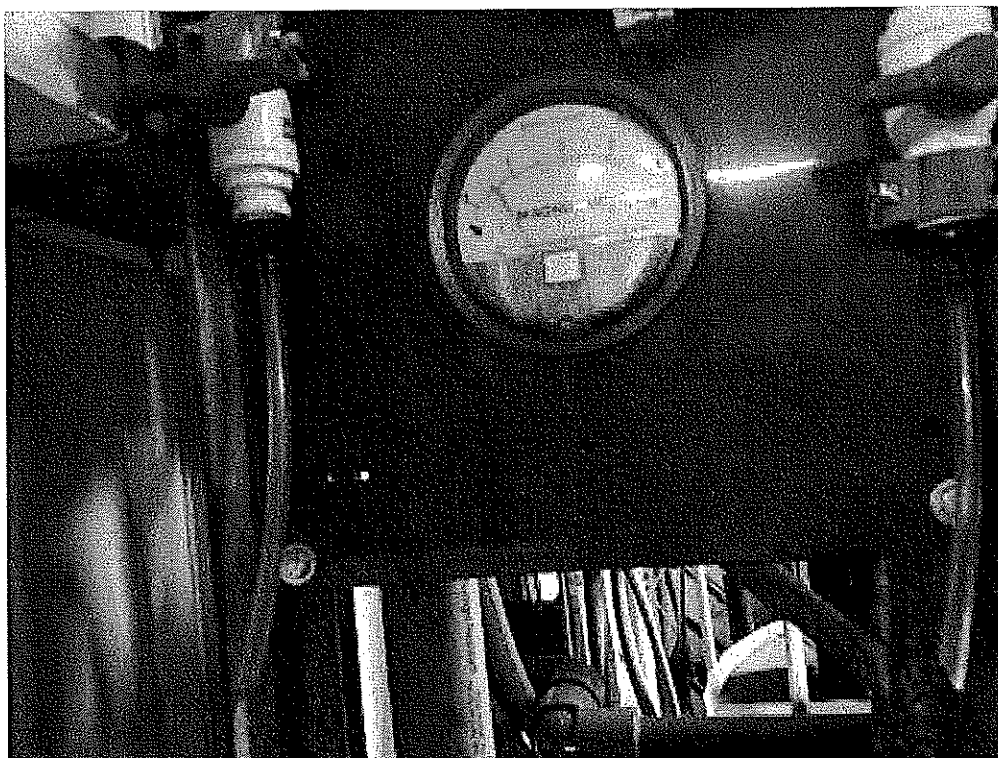
EUSYSTEM2. It was idle but tanks were full. No odors. Noted the pressure drop of the associated packed bed scrubber was reading 0.6" of water. The recirculation water was very foamy; so much so that it was spilled out the tank. See attached photo.

Image 6(Pressure Drop 2) : Pressure drop for scrubber controlling the new nickel plating line.

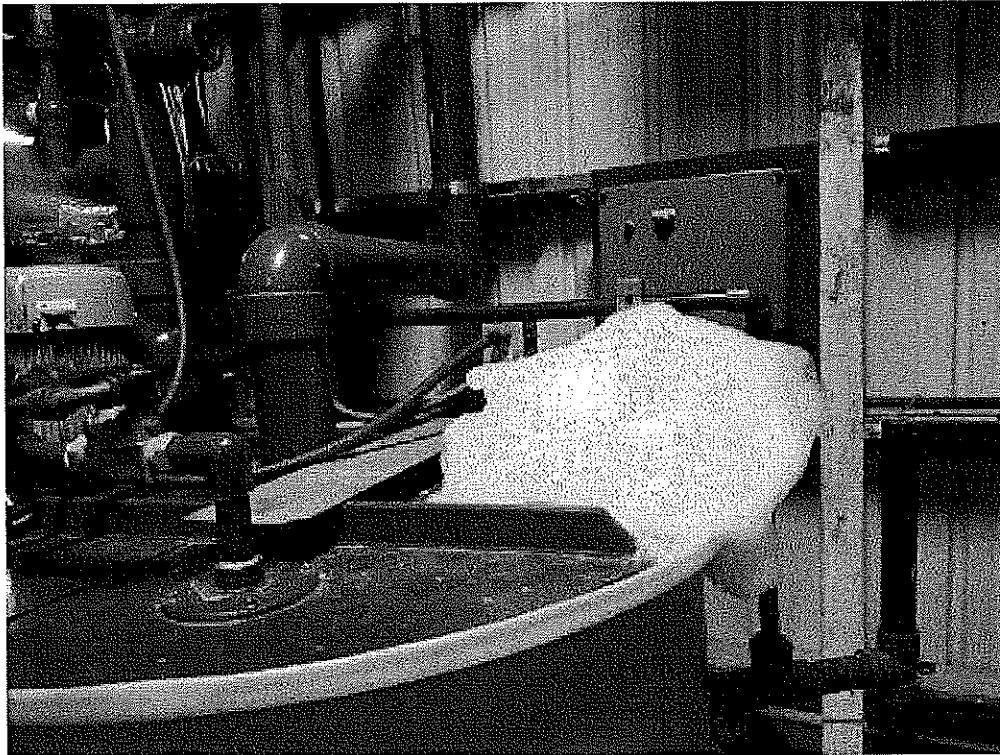
Image 7(Foam recirculation) : Foam coming from the scrubber water recirculation tank for the newer nickel line.
