DEPARTMENT OF ENVIRONMENTAL QUALITY
AIR QUALITY DIVISION
ACTIVITY REPORT: Self Initiated Inspection

FACILITY: ELECTRO CHEMICAL FINISHING		SRN / ID: N2787
LOCATION: 2610 REMICO S W, WYOMING		DISTRICT: Grand Rapids
CITY: WYOMING		COUNTY: KENT
CONTACT: Steve Hulst , Quality Manager/EHS Manager		ACTIVITY DATE: 11/23/2015
STAFF: April Lazzaro	COMPLIANCE STATUS: Non Compliance	SOURCE CLASS: MINOR
SUBJECT: Unannounced partial compliance evaluation.		
RESOLVED COMPLAINTS:

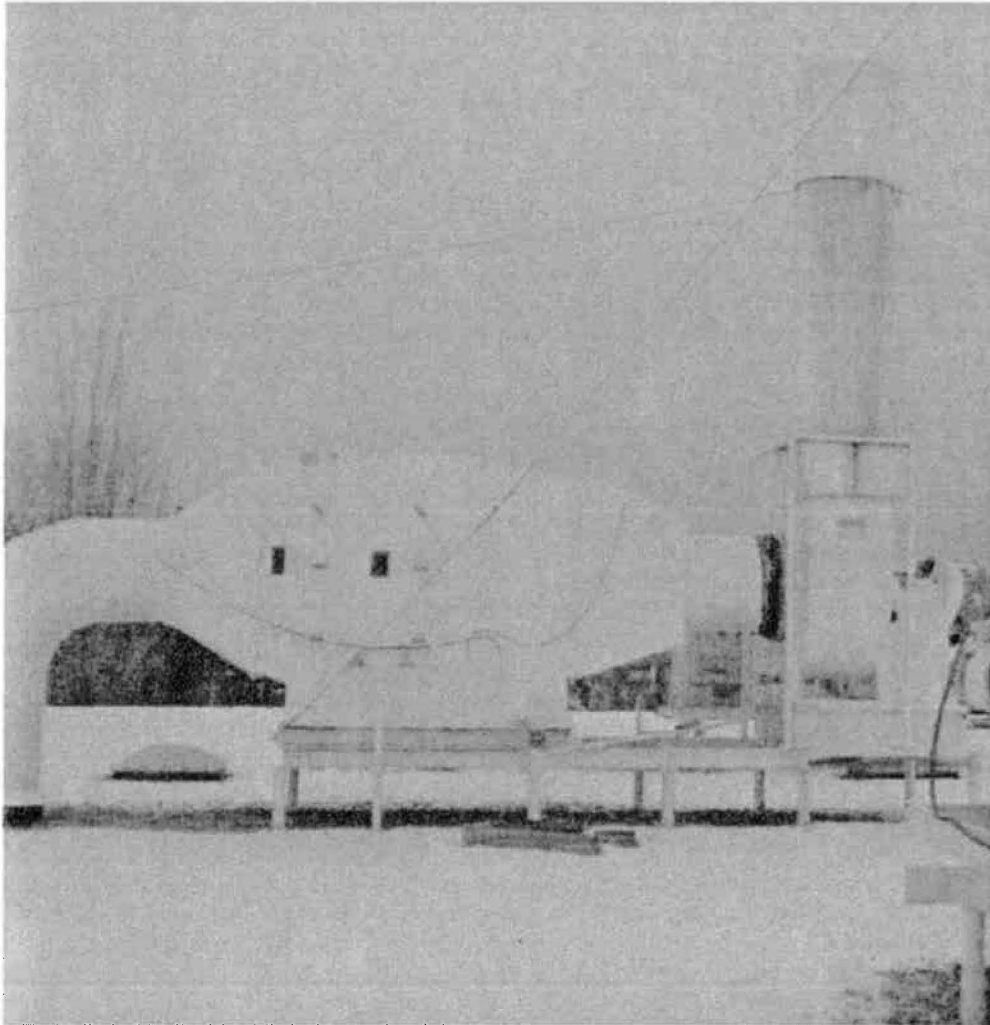
I looked up at the B Line scrubber stack to see green staining going down the sides. (all scrubbers were painted before the stack test in early August 2015) I stated to Mr. Hulst, that I wanted to do a walk around of the B Line scrubber. As I approached, I noted dark green staining at the fan casing that was actively in a drip pattern. (see attached photo) As I continued to walk around the unit, it became clear that the scrubber was leaking scrubber water onto the roof, based on the patch of accumulated yellowish ice that had formed. (see attached photos) A closer look to the area of the leak indicated that the seal is very corroded and had failed. (see attached photos of corrosion) This is in the same general area of a pin point leak identified during the August 18, 2015 stack test. The identification of the leak by me, and the repair of it by the company is detailed in the stack test report.

Image 1(B Line scrubber) : Green stack stainage

A violation notice will be sent for the B Line scrubber for failure to maintain and operate an air-cleaning device in a satisfactory manner as required in Rule 336.1910. A Rule 278a request will be made for the replacement of the

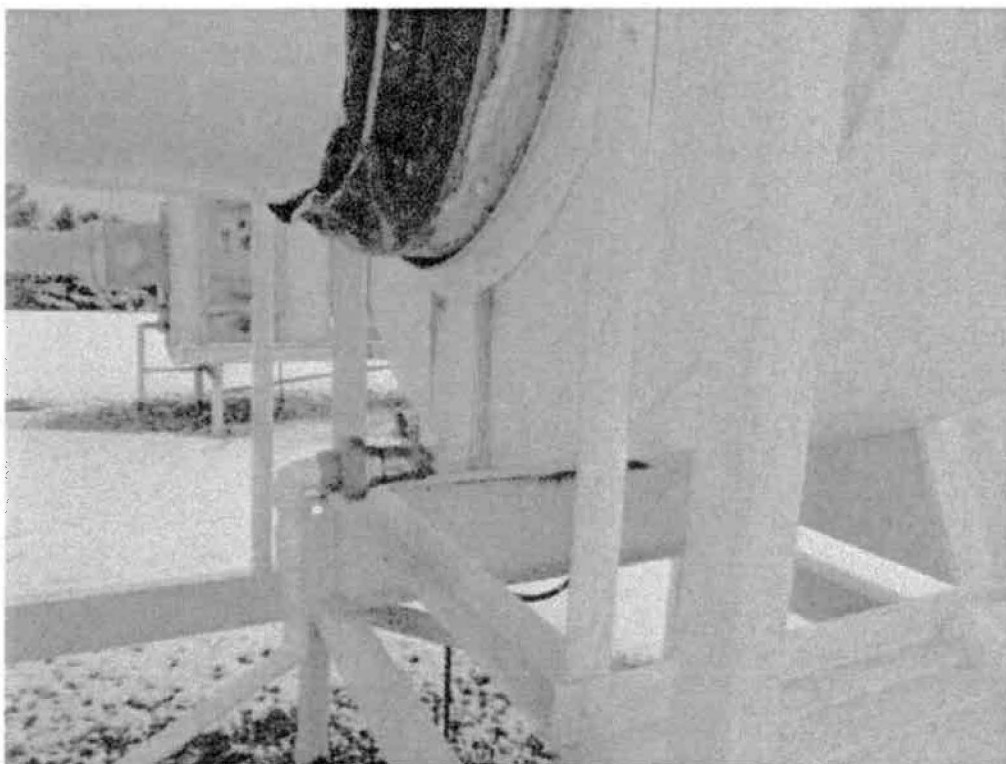
Image 2(B Line Scrubber) : Green drippage from fan at outlet of scrubber.

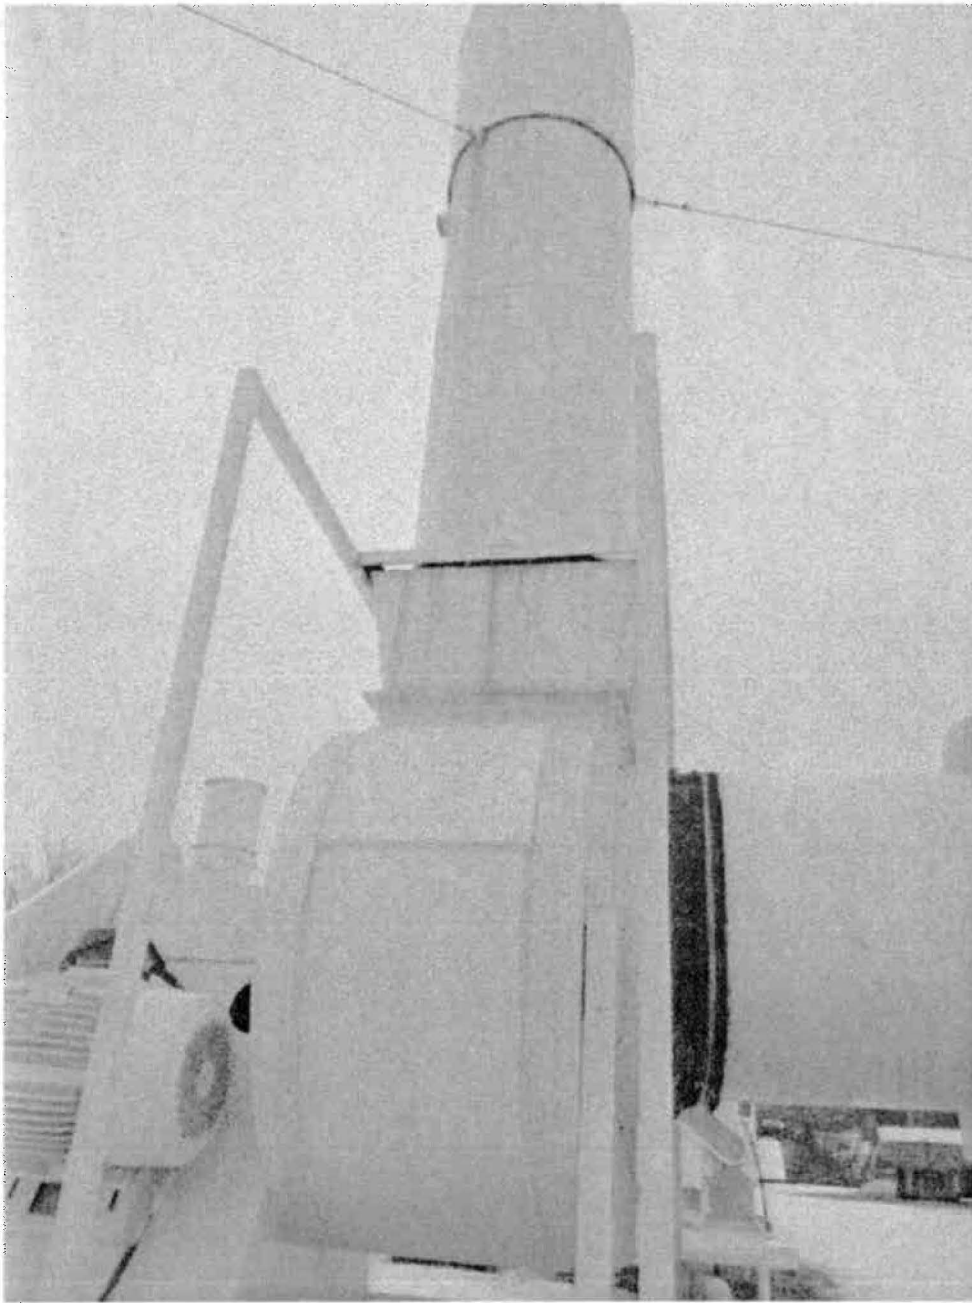
Image 3(B Line Scrubber) : Other side of stack.

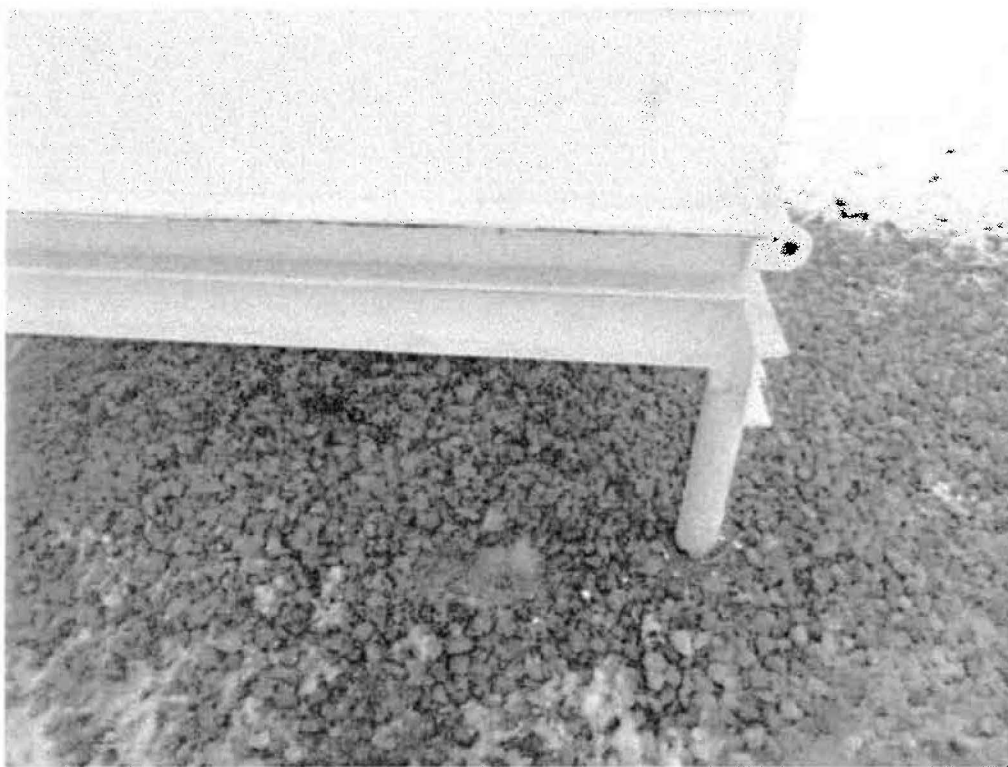
Image 4(B Line Scrubber) : Leak at base, corrosion at seam.

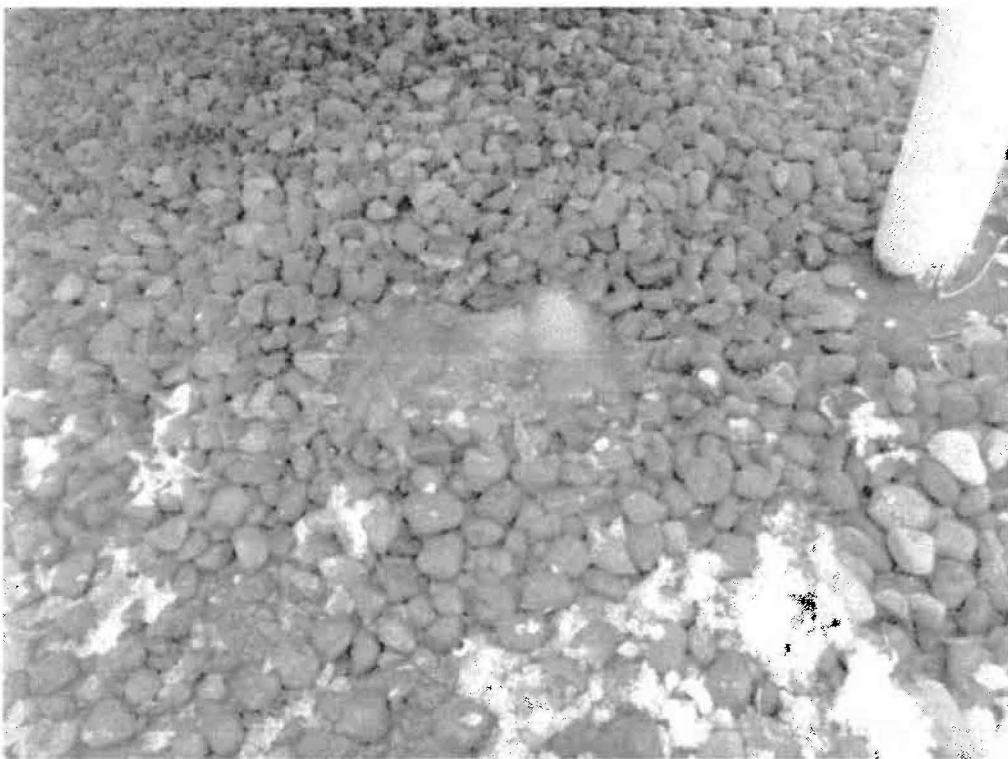
Image 5(B Line Scrubber) : Leak in the form of ice below unit. Broken icicles are present.

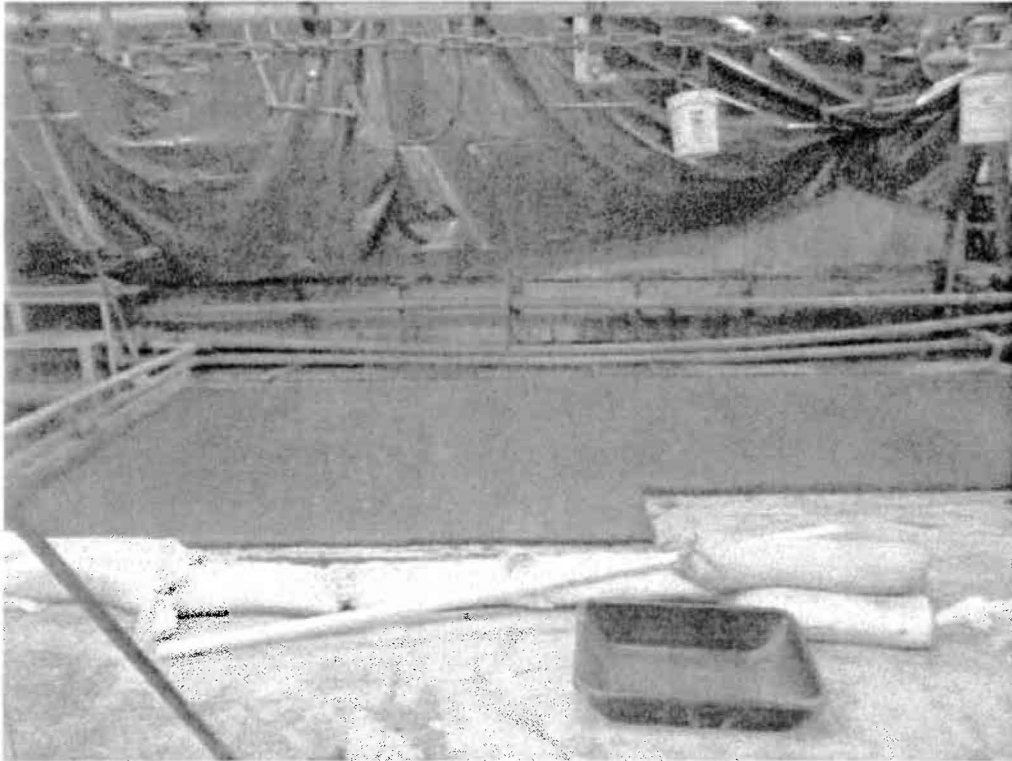
Image 6(Nitric Acid Strip) : Location in plant of former nitric acid strip line tanks (2) that are being replaced.

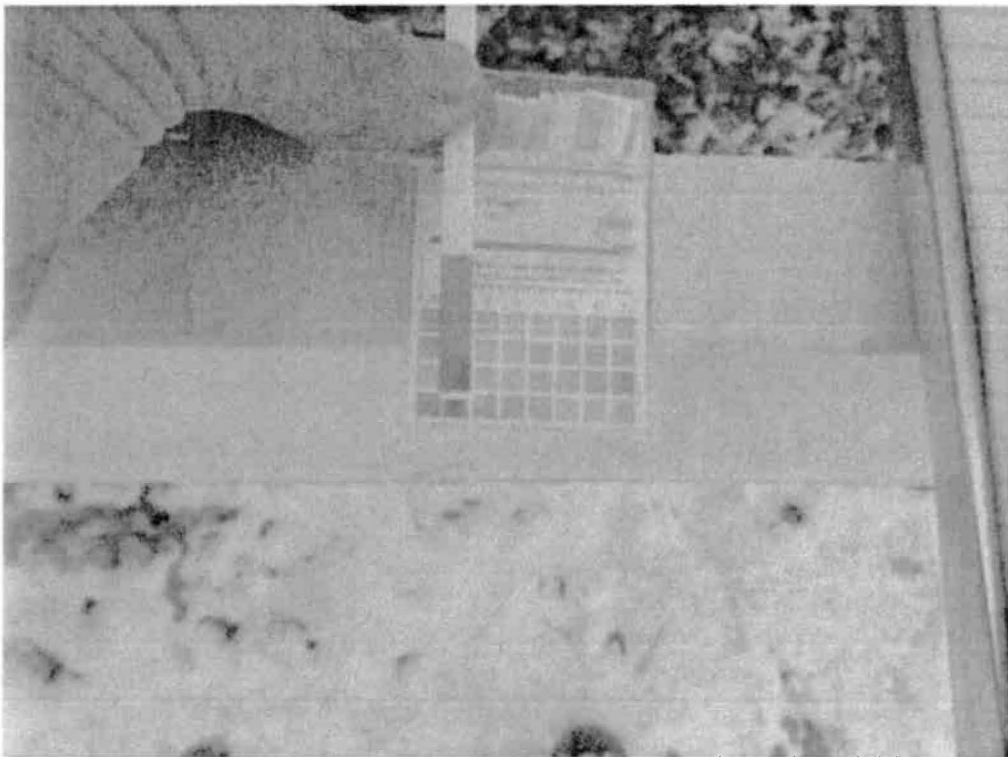
Image 7(Nitric Acid Strip) : Evidence that nitric acid strip line scrubber has been emitting acid. pH paper shows acid level.

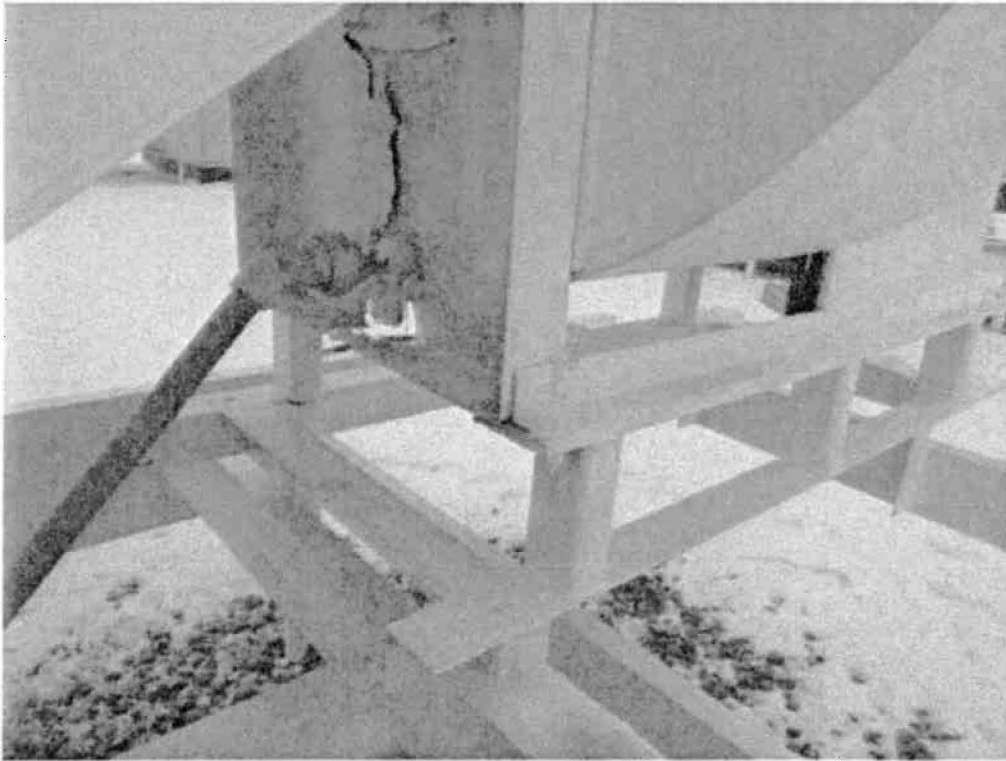
Image 8(Nitric Acid Strip) : Evidence of ongoing non-compliance of scrubber. AQD has not approved the SEP for replacement of this unit.
