DEPARTMENT OF ENVIRONMENTAL QUALITY
AIR QUALITY DIVISION
ACTIVITY REPORT: Scheduled Inspection

FACILITY: Camshaft Machine Co		SRN / ID: N5012
LOCATION: 717 Woodworth Rd, JACKSON		DISTRICT: Jackson
CITY: JACKSON		COUNTY: JACKSON
CONTACT:		ACTIVITY DATE: 10/28/2016
STAFF: Mike Kovalchick	COMPLIANCE STATUS: Non Compliance	SOURCE CLASS: Minor
SUBJECT: Unannounced compliance inspection		
RESOLVED COMPLAINTS:

Minor Source Inspection**Facility Contact**

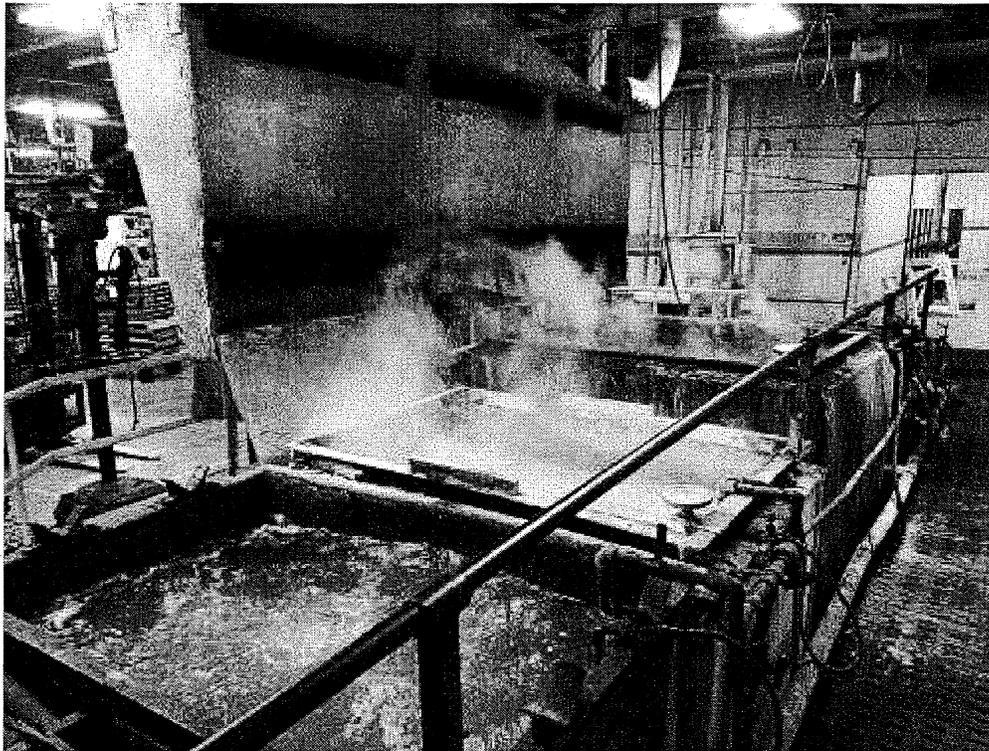
The focus was on the manganese phosphate etching line. Attachment (2) is complete description of the line and how it is operated. The temperature of the tanks was at 190 degrees F. The overall condition of the tanks was poor. (JW indicated that they will need to replace them soon.) The steamy emissions from the tanks were be drawn off and exhausted out the roof. See attached photos for pictures of the etching line.

Image 1(Etch Tank Line) : Etch Tank Line and exhaust system

Based upon the facility inspection, review of the records, and review of applicable requirements, while the Company is in substantial compliance, it is not in compliance with the requirement to have an air permit for the manganese phosphate etching line. A Violation Notice (VN) will be sent to the Company that will outline the violation and request a corrective action program that includes the submittal of air permit application.

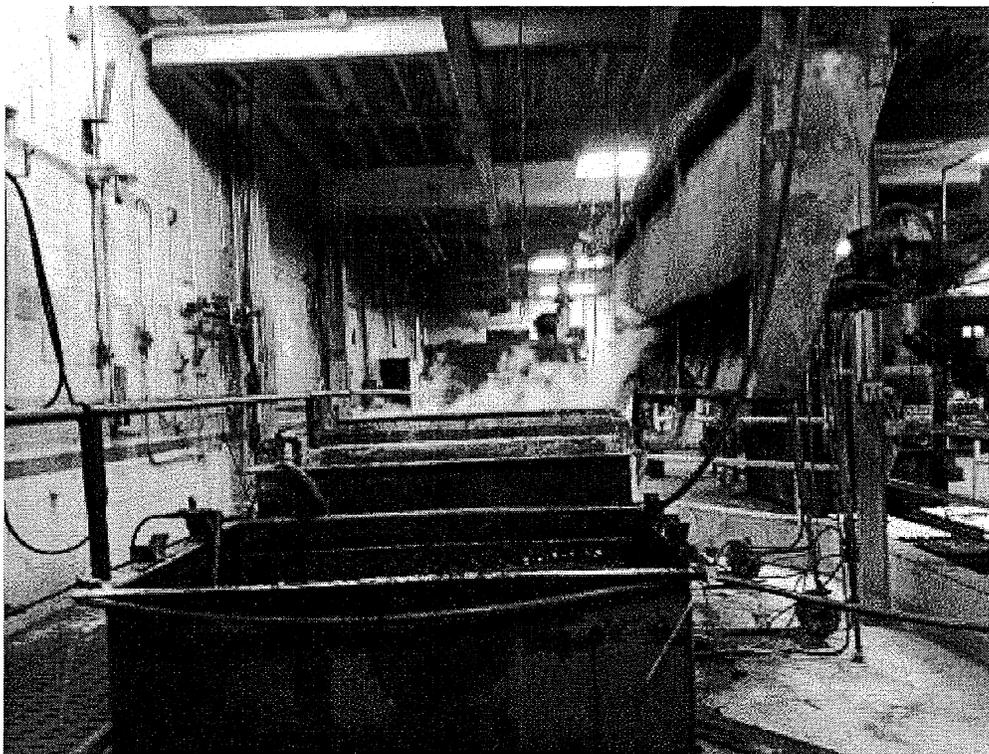
Image 2(Etch tank line) : Etch tank line

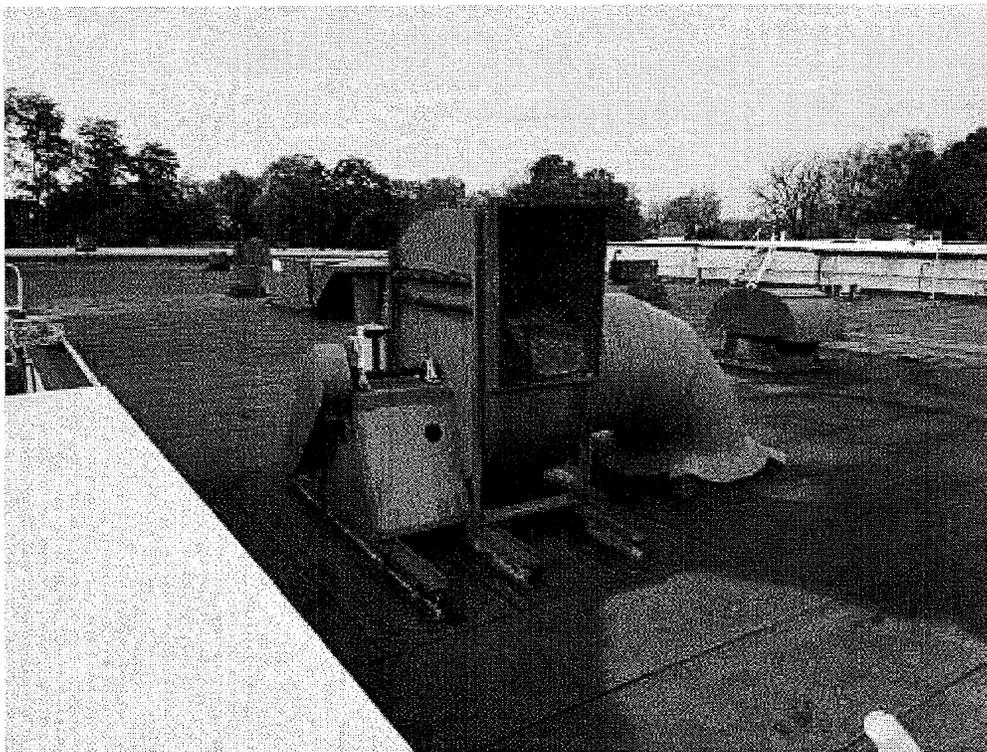
A roof inspection was conducted (Roof was accessed via stairs inside the plant.) Ventilation duct and exhaust from the etching line was in satisfactory condition although it was being exhausted in a horizontal direction. See attached photo of etching line exhaust. One notable observation was large areas of what appeared to be cast iron fallout on the roof. See attached photo showing discolored water on roof. It was not clear where the fallout was coming from. The old facility has numerous general roof vents and many stacks that are no longer connected to processes in the facility. I informed JW that particulate fallout would be a problem if it impacted any of the surrounding homes near the plant.

Image 3(Roof Exhaust) : Roof exhaust from etch tank line

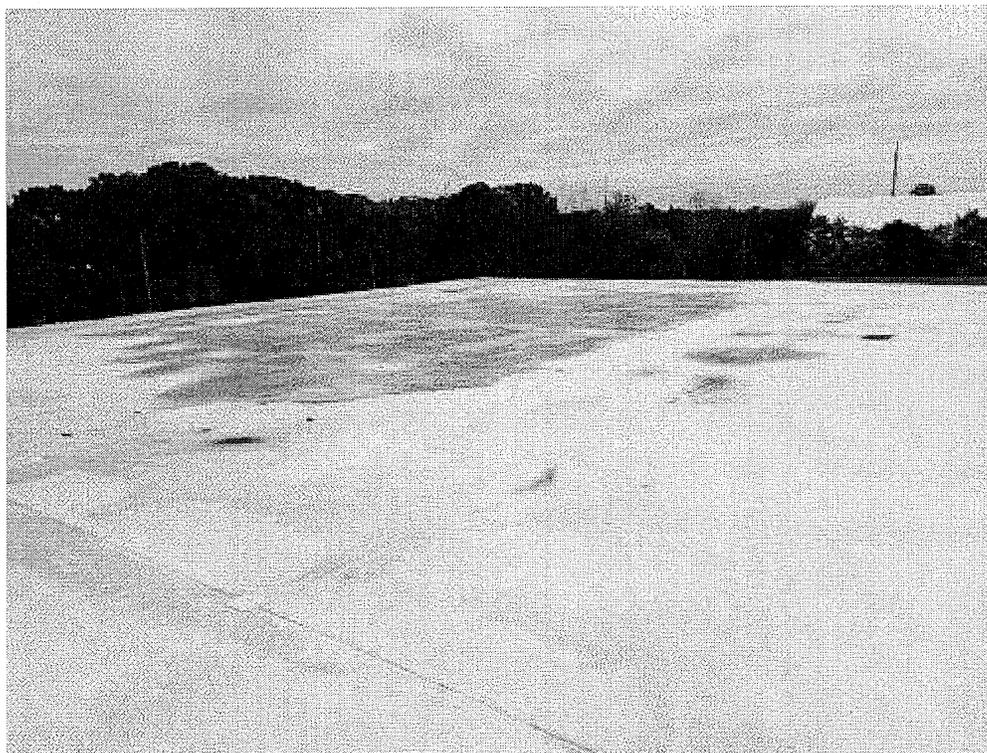
Image 4(Roof fallout) : Evidence of fallout on roof. Note discolored pools of water that look like oxidized cast iron.

I held a brief post-inspection meeting with JW. I reviewed my findings that the Company appeared to be in compliance. I noted that I was somewhat concerned by the apparent iron oxide fallout that was seen on part of the roof and recommended that JW investigate the matter. I thanked JW for his time and cooperation, and departed the facility at approximately 11:00 AM.
