DEPARTMENT OF ENVIRONMENTAL QUALITY
AIR QUALITY DIVISION
ACTIVITY REPORT: Scheduled Inspection

N652028863

FACILITY: ELECTRO CHEMICAL FINISHING		SRN / ID: N6520
LOCATION: 379 44TH ST SW, WYOMING		DISTRICT: Grand Rapids
CITY: WYOMING		COUNTY: KENT
CONTACT: Steve Hulst, Quality Manager/EHS Manager		ACTIVITY DATE: 03/13/2015
STAFF: April Lazzaro	COMPLIANCE STATUS: Non Compliance	SOURCE CLASS: MINOR
SUBJECT: Unannounced, scheduled inspection.		
RESOLVED COMPLAINTS:

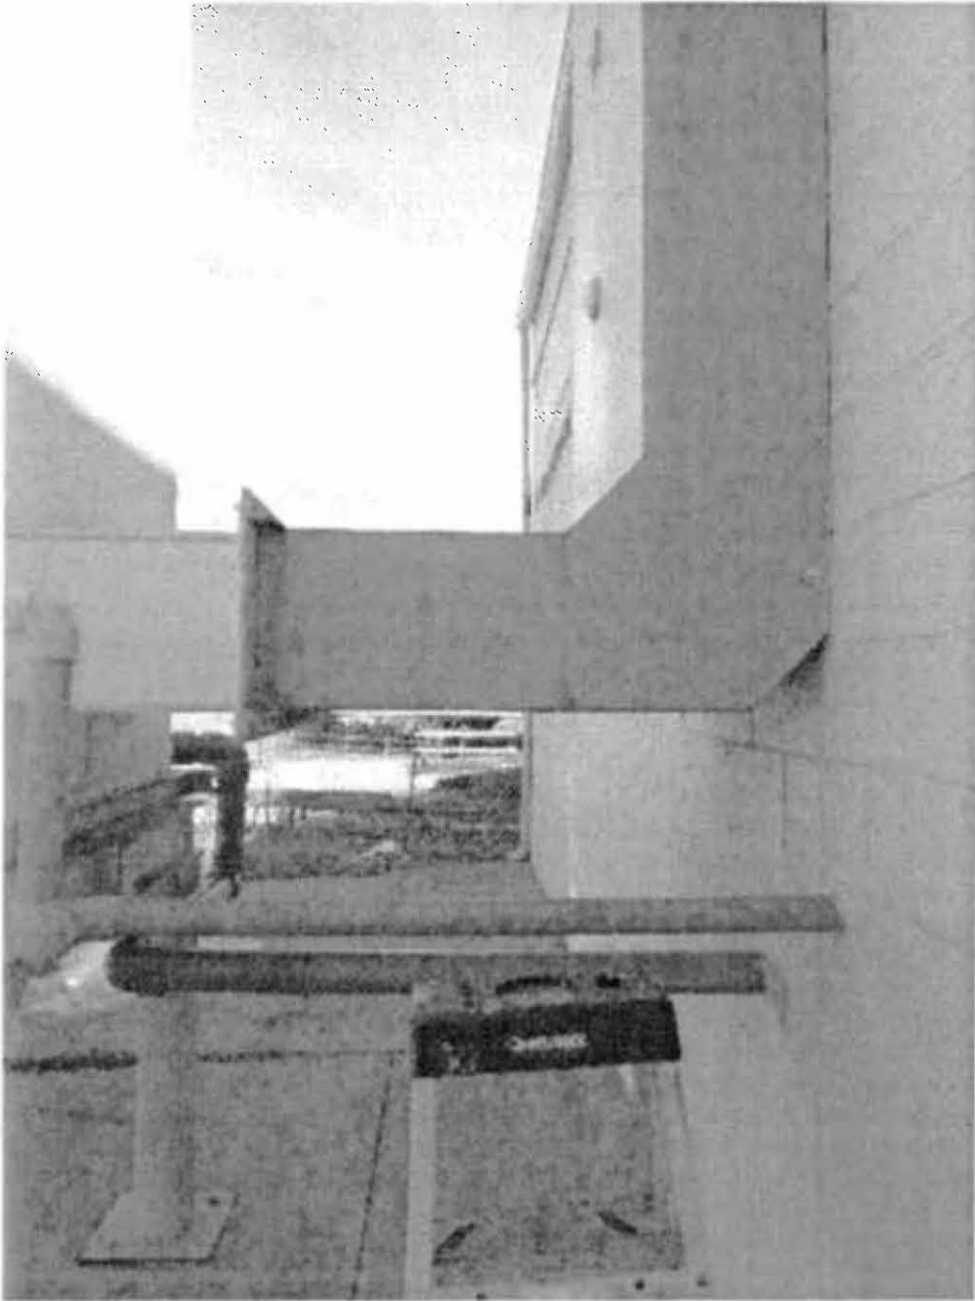
Mr. Hulst and Mr. Keeney escorted me outside to conduct a visual inspection of the control devices. The north scrubber was operating, and I noted that there was green corrosion on the duct work, and evidence that it was dripping onto the cement below. (see attached photo) Mr. Hulst stated that during their self-inspection, a hole in the scrubber ductwork, pre-control was found. He provided me with a ladder to see it because it was at the top of the duct, over my line of sight. An airflow check via a piece of paper identified that the air was blowing out of the corroded duct- and therefore was not being controlled by the scrubber. These two deficiencies are violations of Rule 910 as identified in PTI No. 288-98. Additionally the facility was not implementing the required O&M Plan for the chrome tank that is required by the permit. The facility has utilized the surface tension monitoring to demonstrate compliance with the Chrome NESHAP, and the scrubbers were required to comply with Michigan's air toxics rules. Mr. Hulst was able to provide copies of the Ongoing Compliance Reports for 2013 and 2014 which are attached. These are required to be maintained onsite and provided upon request. They were provided timely.

Image 1(ECF NS) : ECF North Scrubber ductwork

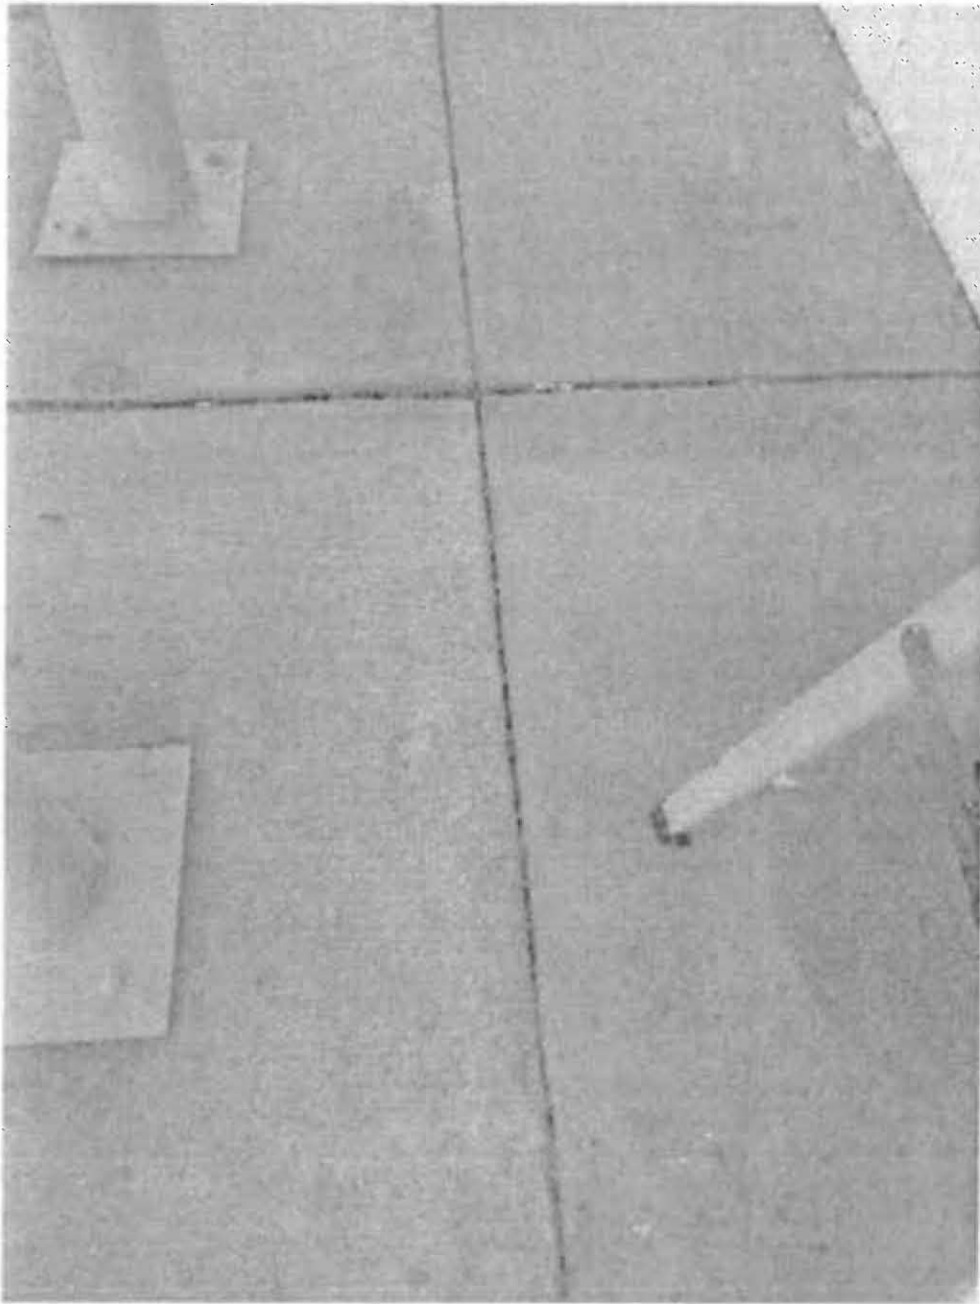
Image 2(ECF NS) : North Scrubber drips from ductwork.

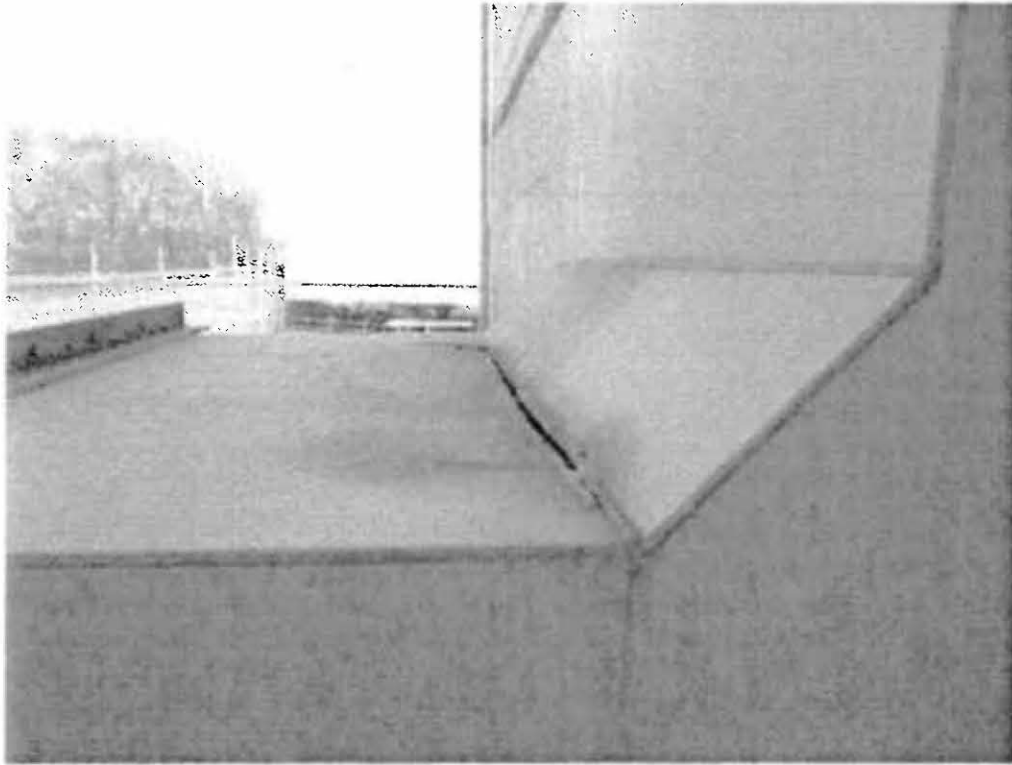
Image 3(ECF NS) : North scrubber breach in ductwork- pre-control emissions.

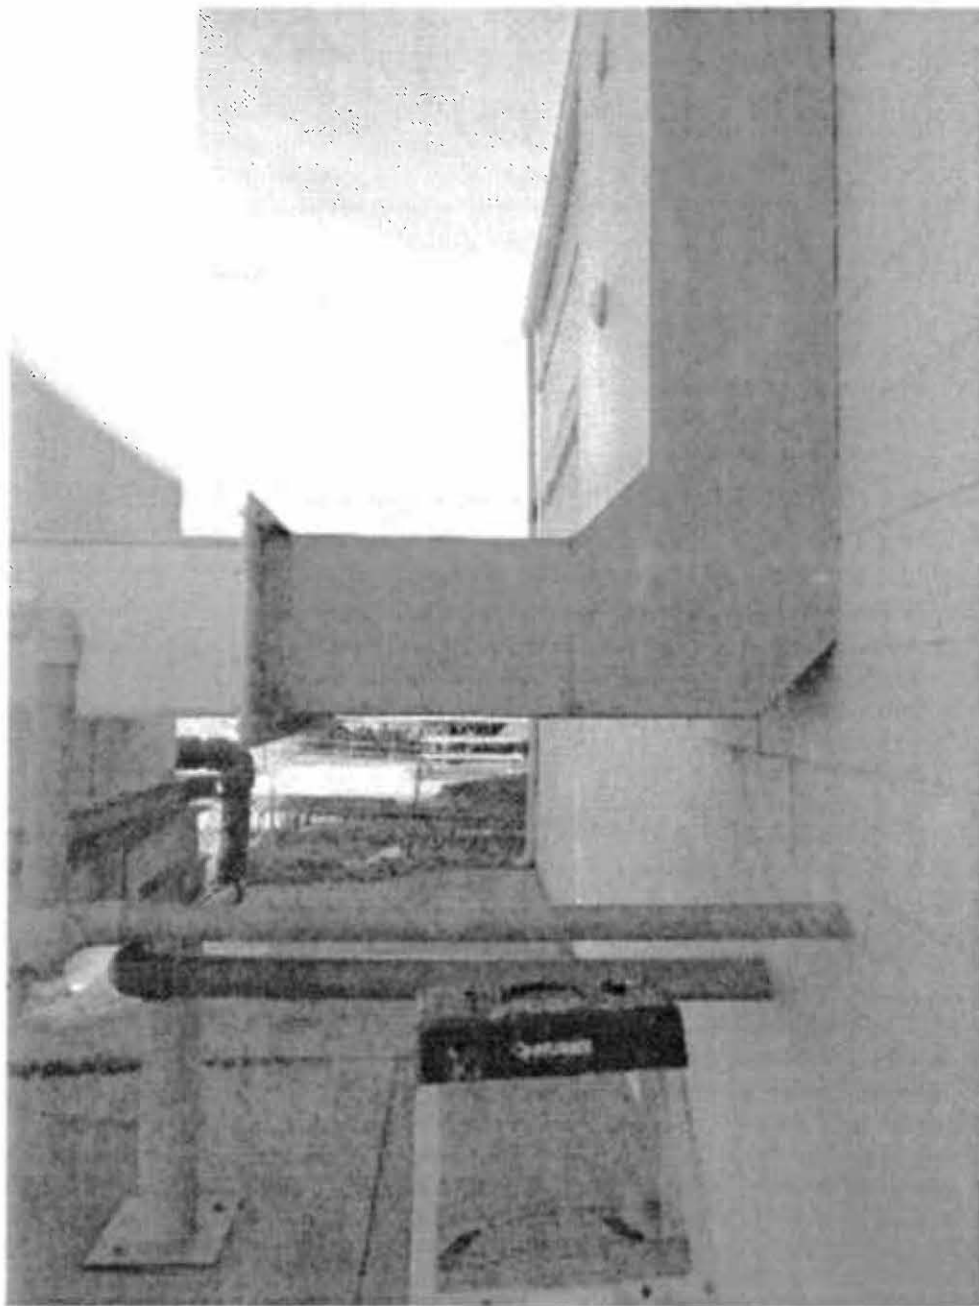
Image 6 (ECF NS) : Overview of North Scrubber ductwork. Corrosion not seen unless accessed by a ladder.
