DEPARTMENT OF ENVIRONMENTAL QUALITY
AIR QUALITY DIVISION
ACTIVITY REPORT: Self Initiated Inspection

Facility: Payne & Dolan Portable Crusher PC#5 (N6605)

Inspection Date: 7/23/3014

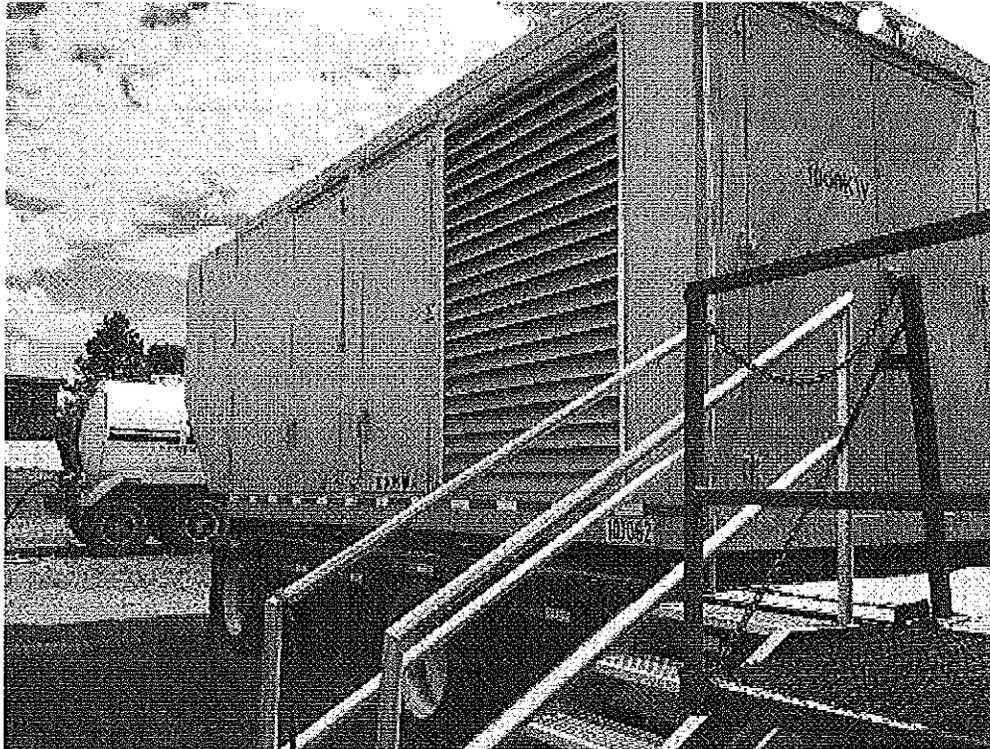
Image 13(7/23/14) : #107062 -- 1000KW generator

It should be noted that generator #107062 is listed as 750KW and generator #145113 is listed as a 60KW generator on the most recent equipment list (8/21/12) in the file. The generators themselves have stickers affixed stating 1000KW and 75KW, respectively.

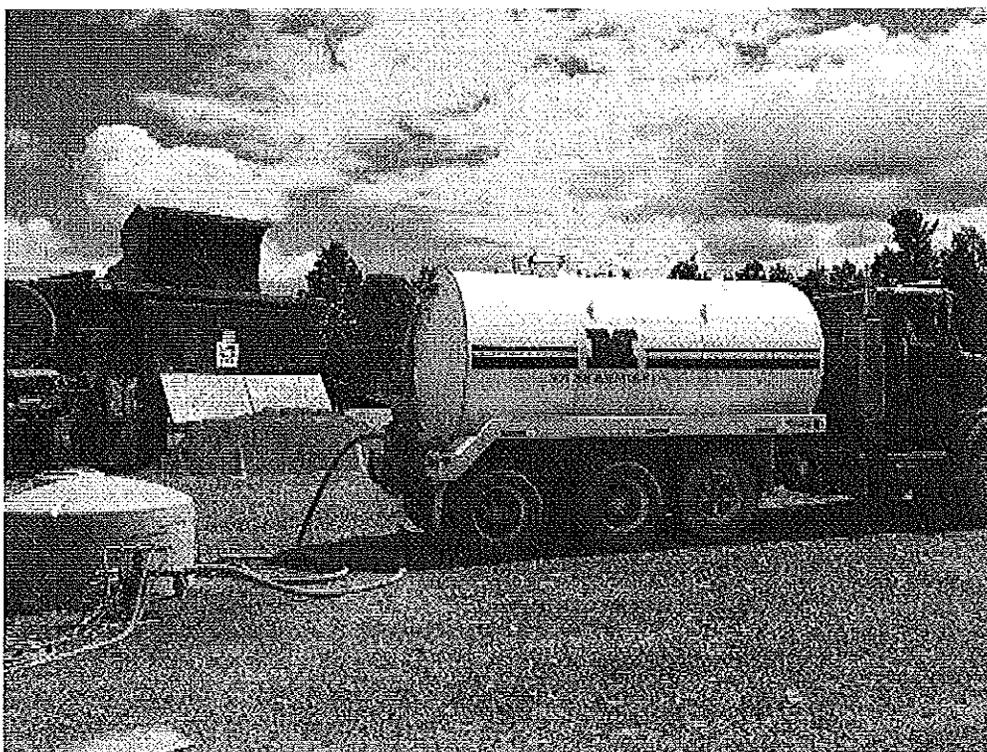
Two power generators were on site, a single 1000KW generator and a single 75KW generator. A water truck was on site which was being drained into a secondary water tank during operations. Pumps draw water from the secondary tank for the spray bars, etc. The stand-alone secondary tank allows the water truck to disengage from the water system while the secondary tank maintains supply to the pumps. This method of setup enables the water truck to travel to refill at Stager Lake without having to shut down crushing operations due to a lack of water for fugitive dust control.

Image 15(7/23/14) : Water truck and secondary tank.
