DEPARTMENT OF ENVIRONMENTAL QUALITY  
AIR QUALITY DIVISION  
ACTIVITY REPORT: Scheduled Inspection

N696823924

<b>FACILITY:</b> Valley Enterprises Inc		<b>SRN / ID:</b> N6968
<b>LOCATION:</b> 2147 Lepppek Rd, UBLY		<b>DISTRICT:</b> Saginaw Bay
<b>CITY:</b> UBLY		<b>COUNTY:</b> HURON
<b>CONTACT:</b> Michelle Gunderman , Coorporate Safety Coordinator		<b>ACTIVITY DATE:</b> 12/17/2013
<b>STAFF:</b> Gina McCann	<b>COMPLIANCE STATUS:</b> Compliance	<b>SOURCE CLASS:</b> MINOR
<b>SUBJECT:</b> Visited facility to inspect stack changes made to bring facility back into compliance. glm		
<b>RESOLVED COMPLAINTS:</b>

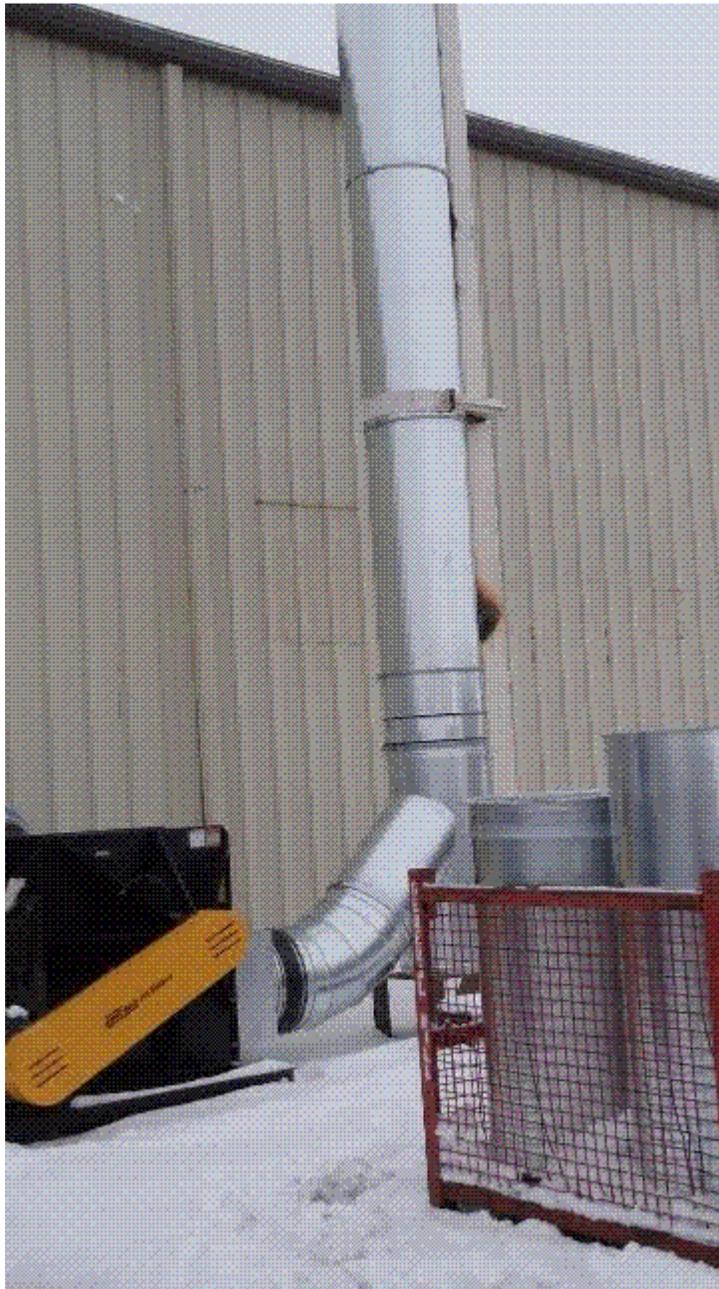
**Image 1(BP01)** : Exhaust for Bay 1 (BP01), installed over the weekend of 12/14/2013-12/15/2013.
