**DEPARTMENT OF ENVIRONMENTAL QUALITY
AIR QUALITY DIVISION
ACTIVITY REPORT: Complaint Investigation**

| FACILITY: Formtech Industries LLC Fraser | | SRN / ID: N7263 |
| SUBJECT: Investigation of fugitive dust and fallout. | | |

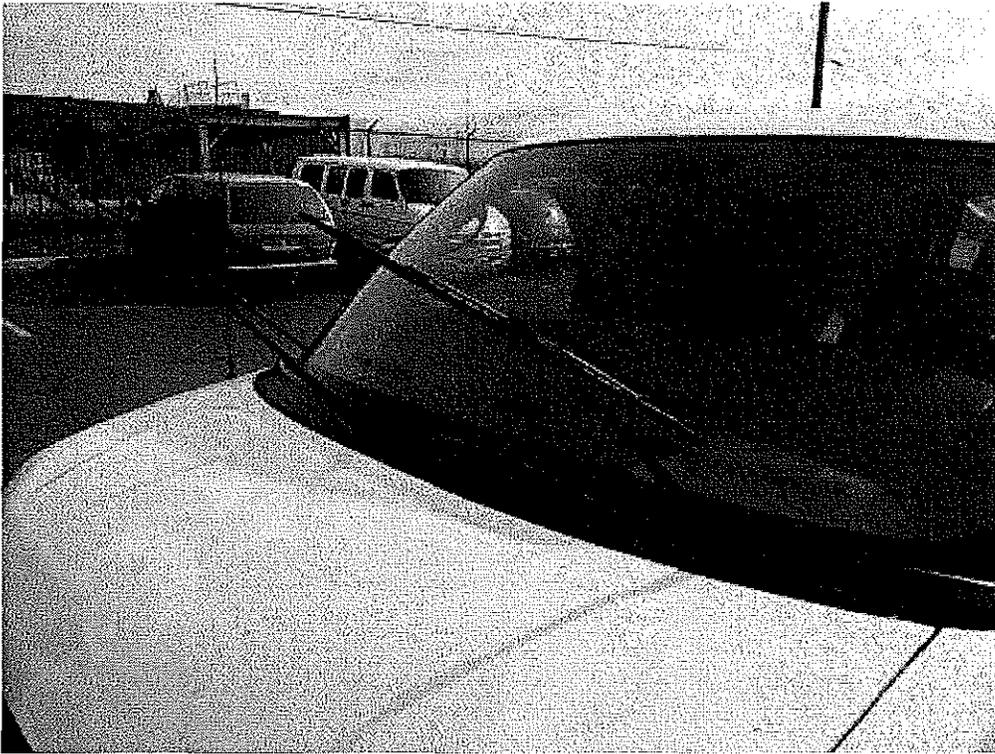
Image 1(Van) : Particles are imbedded into the paint.

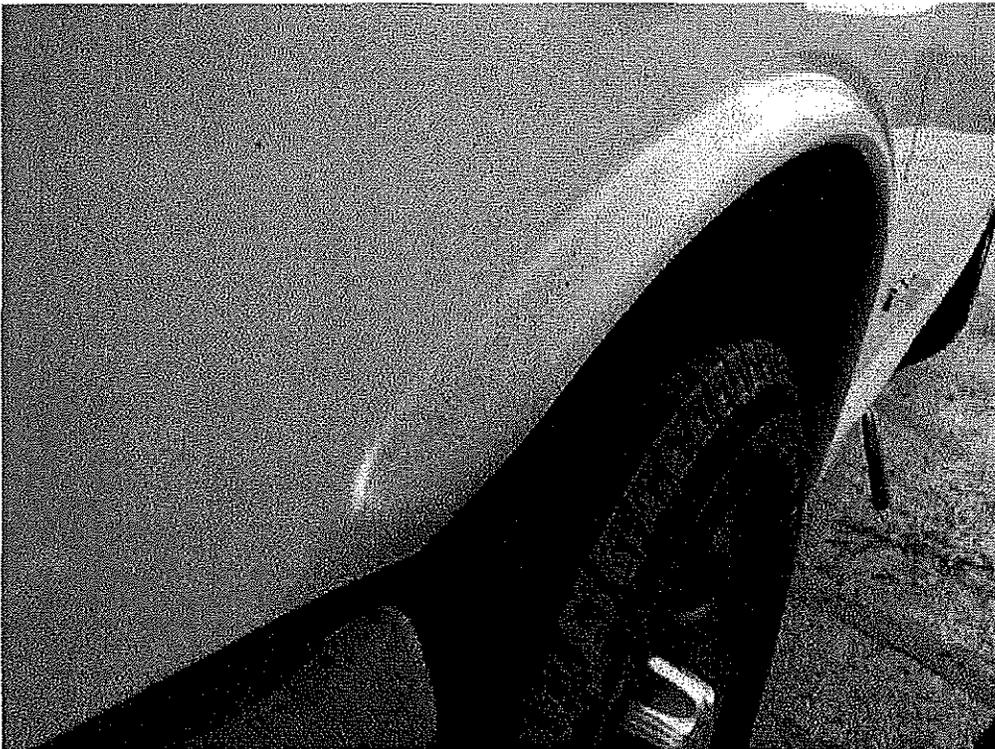
Image 2(Van 2) : Particles imbedded on the wheel and bumper area.

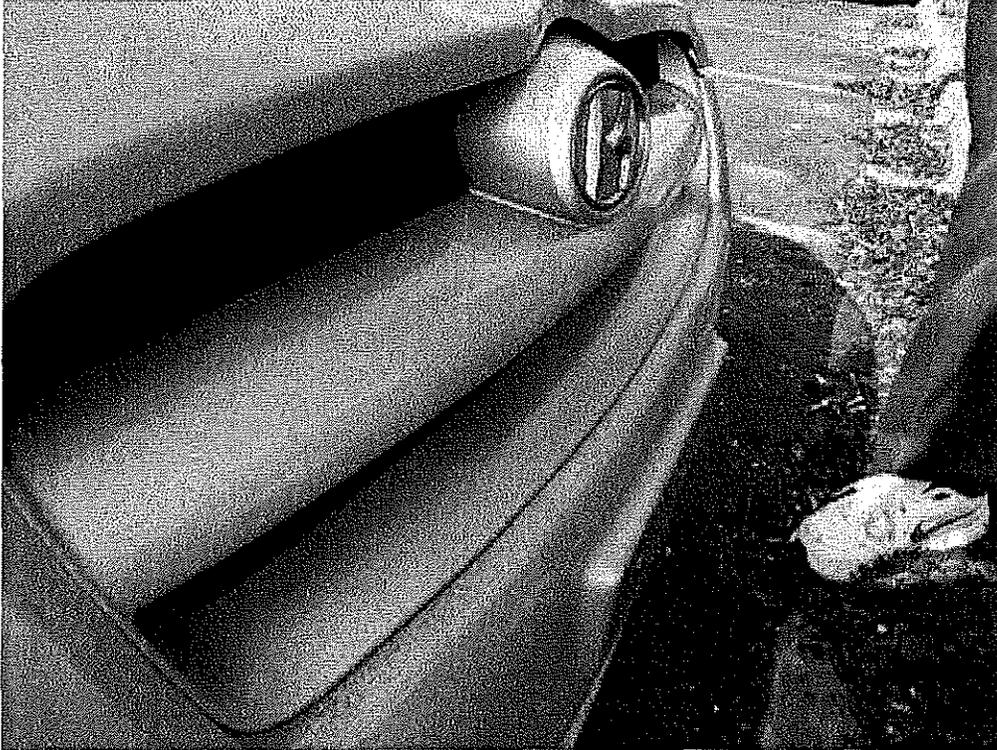
Image 3(Vehicle) : Rust like material built up on plastic.

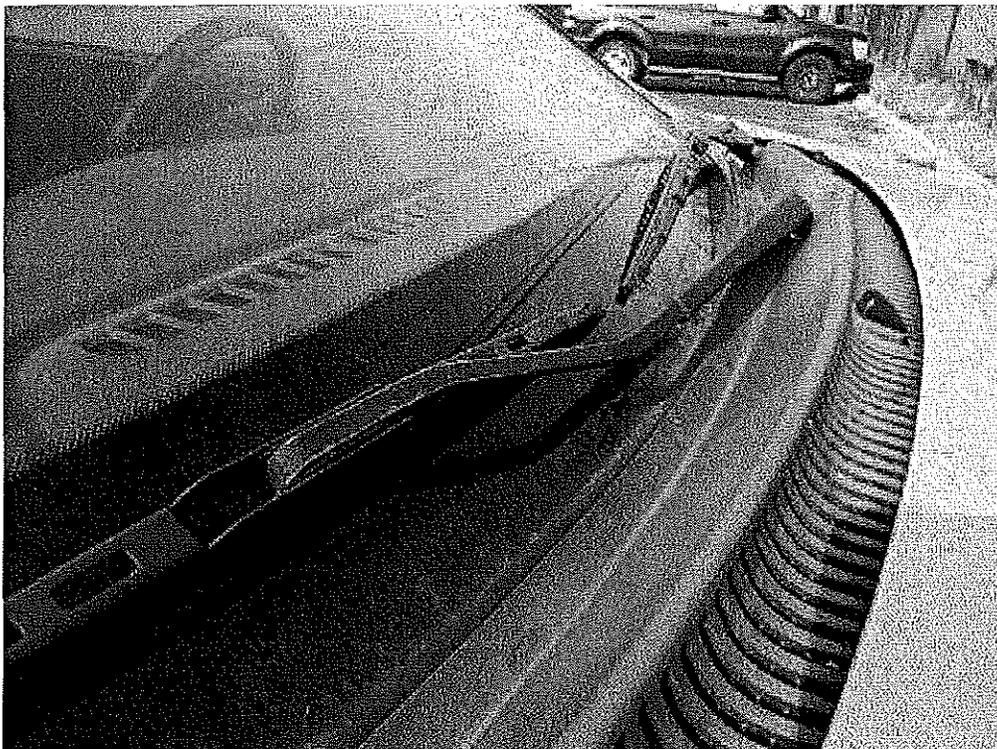
Image 4(Windshield) : Rust like material built up on glass. The material had crusted onto the glass.

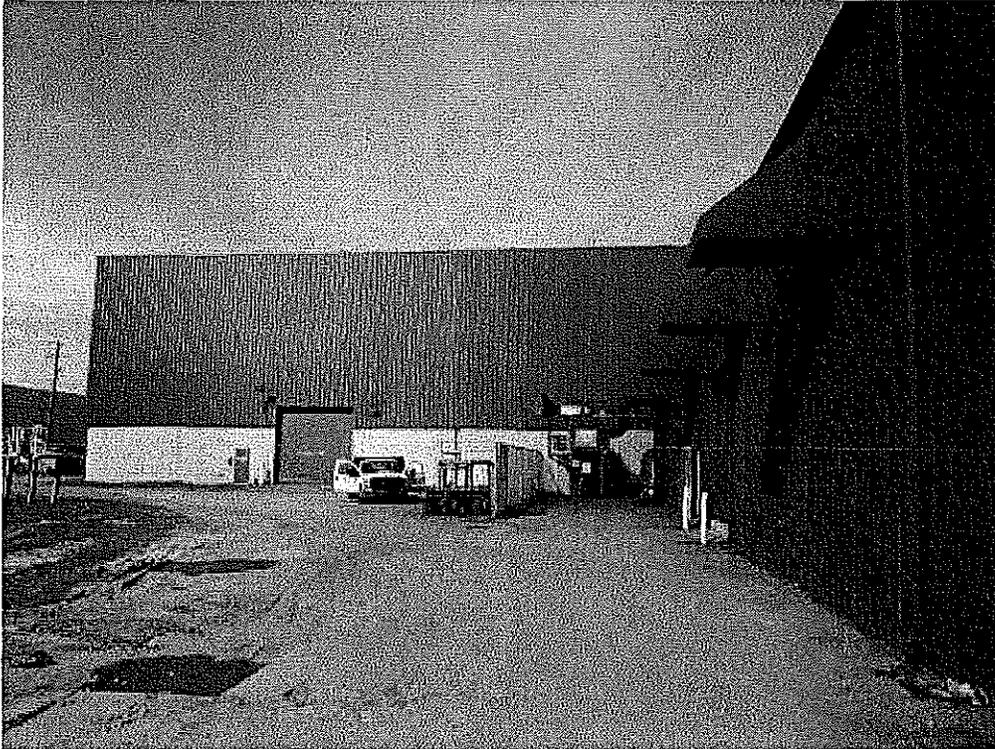
Image 5(Bag house area) : Formtech's bag house. Rust like soil contamination is present.

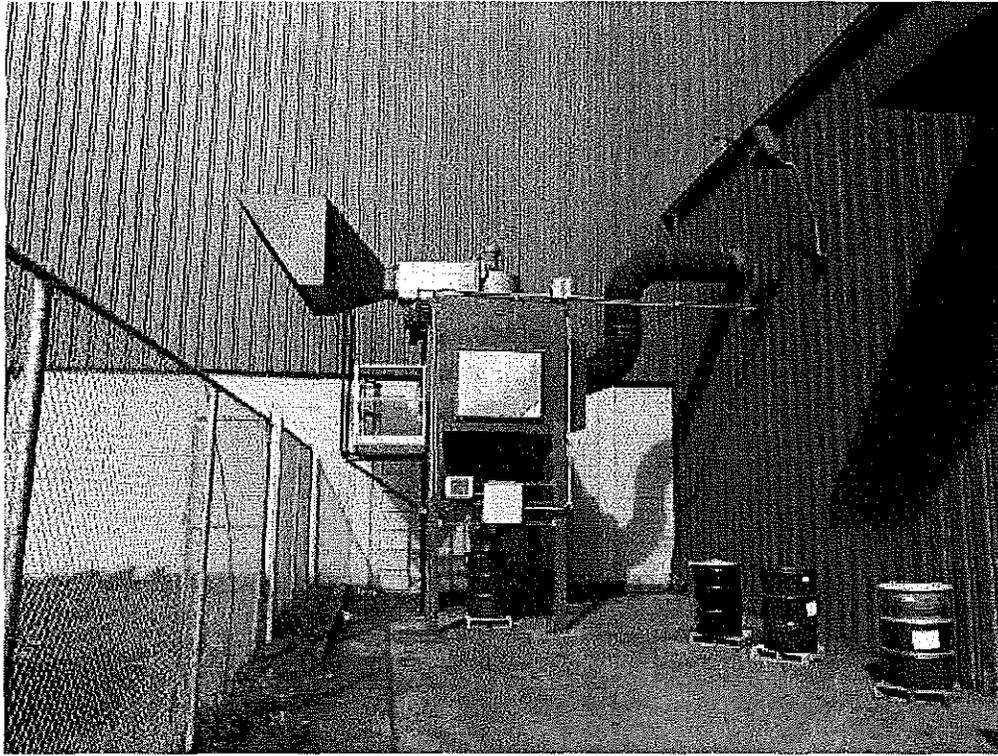
Formtech is in violation of rule 336.1910 for operating their air-cleaning device while not properly maintain the filters and or properly emptying storage barrels. Formtech is also in violation of rule 336.1901 based upon the lab sample results, for samples taken on 4/16/16.

Image 6(Baghouse) : Close-up view of effected pollution control device.

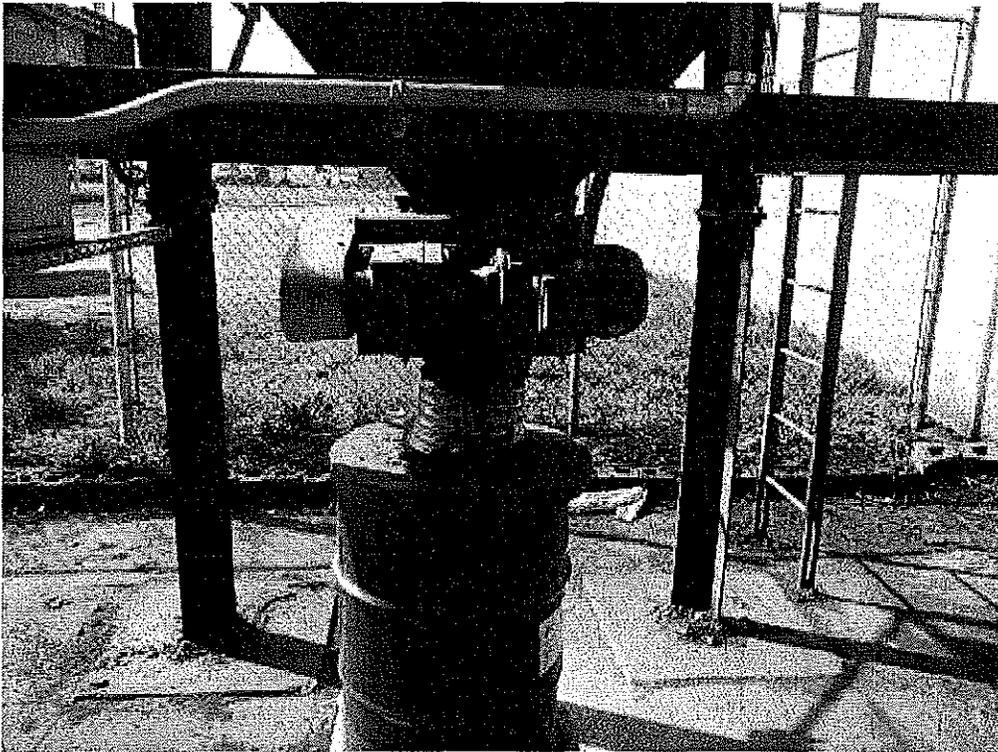
Image 7(Dust Collection) : Comparative analysis sample location.

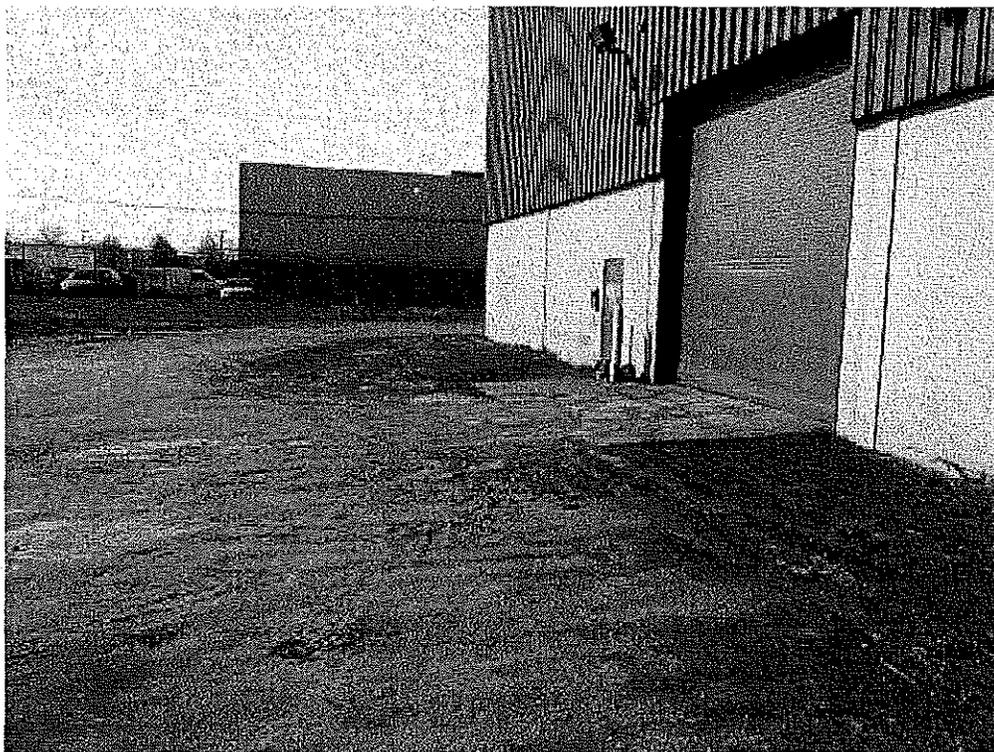
Image 9(Soil Contamination) : Rust like material in soil. BMT's parking lot is located in the back of the picture.
