DEPARTMENT OF ENVIRONMENTAL QUALITY AIR QUALITY DIVISION

ACTIVITY REPORT: Self Initiated Inspection

FACILITY: Portable Crusher PTI#32-07

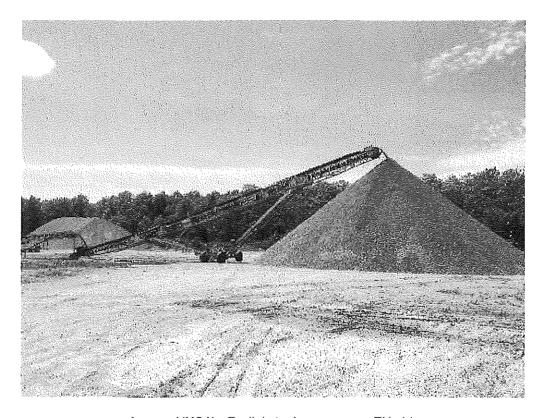
Image 1(NS1): Radial stacker conveyor EU_14

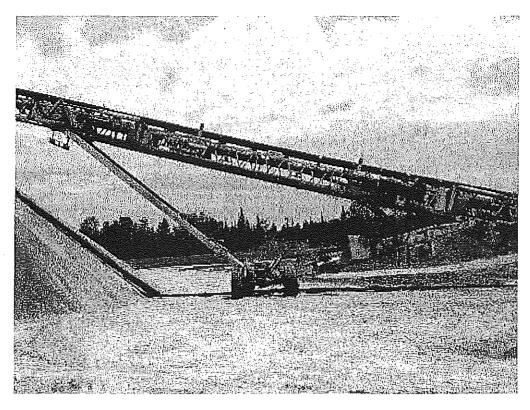
Image 2(NS2): Radial stacker conveyor EU_14

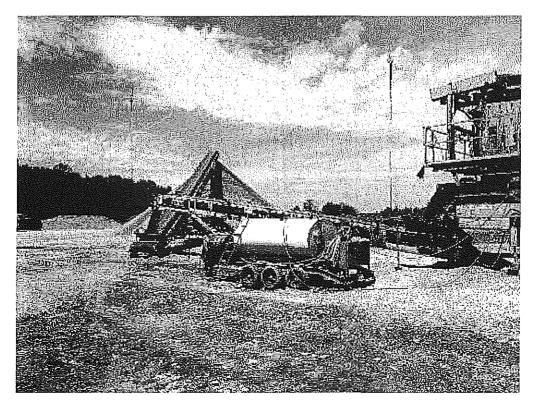
<u>Image 3(NS3)</u>: 1000 gallon water tank/trailer. Conveyor EU_2 is behind the water tank.

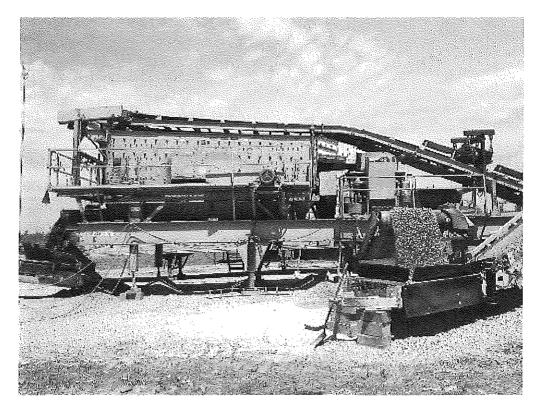
Image 4(NS4) : Cone Crusher EU_C

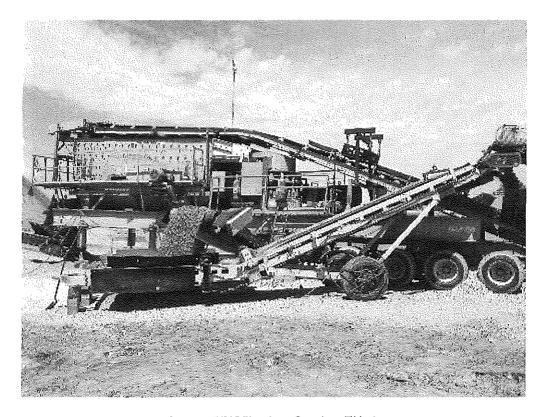
Image 5(NS5) : Jaw Crusher EU_A

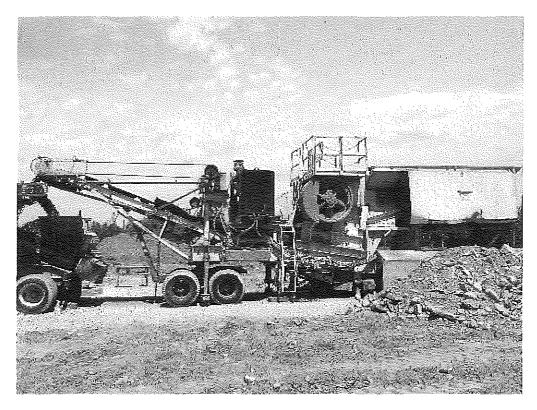
Image 6(NS6): Screen and conveyors
