DEPARTMENT OF ENVIRONMENTAL QUALITY
AIR QUALITY DIVISION
ACTIVITY REPORT: Self Initiated Inspection

FACILITY: BOND CRUSHED CONCRETE		SRN / ID: N8155
LOCATION: 3740 PATTERSON RD, BAY CITY		DISTRICT: Saginaw Bay
CITY: BAY CITY		COUNTY: BAY
CONTACT: Allan Bond , Owner		ACTIVITY DATE: 06/25/2015
STAFF: Benjamin Witkopp	COMPLIANCE STATUS: Non Compliance	SOURCE CLASS: MINOR
SUBJECT: Dual purpose - follow up on reported asbestos presence and conduct inspection since last one was in 2009.		
RESOLVED COMPLAINTS:

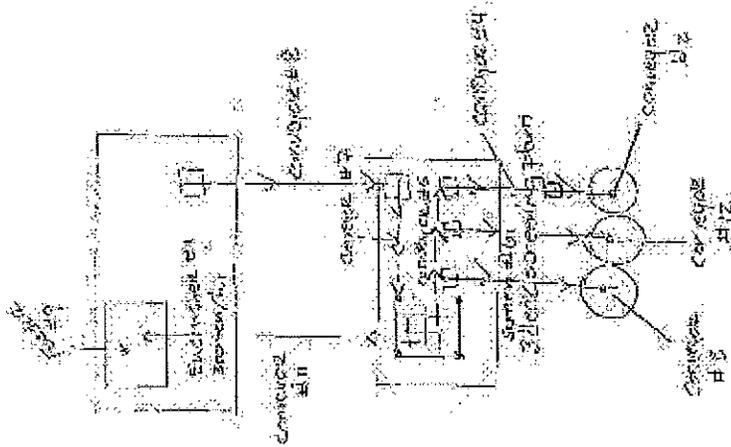
The facility is owned by AI Bond. It is basically a crushing operation subject to New Source performance Standard OOO. It is covered by air use permit 338-08. The crusher was not in operation at the time of the visit. The site has already undergone the testing required by the NSPS. The on site facility contact was Deborah. There was no processing occurring at the time of the visit. The crusher / screener / conveyor set up was checked. The equipment was identified by number and she was in the process of upgrading the readability and making sure the IDs were visible from all sides. A home made conveyor had been added to the set up and was noted as being ID 12. It was added in 2012. The additional conveyor was not permitted at the time of installation thereby resulting in a Rule 201 violation. Sharon made a sketch of the set up and it is attached.

Image 1(Crusher Layout) : Diagram of the crusher operation layout as of 6-25-15

We discussed the need for modification of the existing permit with AI and Deborah and informed them a violation notice would be sent.
