DEPARTMENT OF ENVIRONMENTAL QUALITY  
AIR QUALITY DIVISION  
ACTIVITY REPORT: Scheduled Inspection

FACILITY: WOODWORTH INC		SRN / ID: N8325
LOCATION: 4201 PIER NORTH BLVD, FLINT		DISTRICT: Lansing
CITY: FLINT		COUNTY: GENESEE
CONTACT: Robert (Bob) Lixey , General Manager		ACTIVITY DATE: 06/24/2016
STAFF: Nathaniel Hude	COMPLIANCE STATUS: Compliance	SOURCE CLASS: MINOR
SUBJECT: Scheduled, unannounced inspection.		
RESOLVED COMPLAINTS:

**Inspection Report**

N8325- Woodworth, Inc. (WWI)  
4201 Pier North Blvd  
Flint, MI 48504

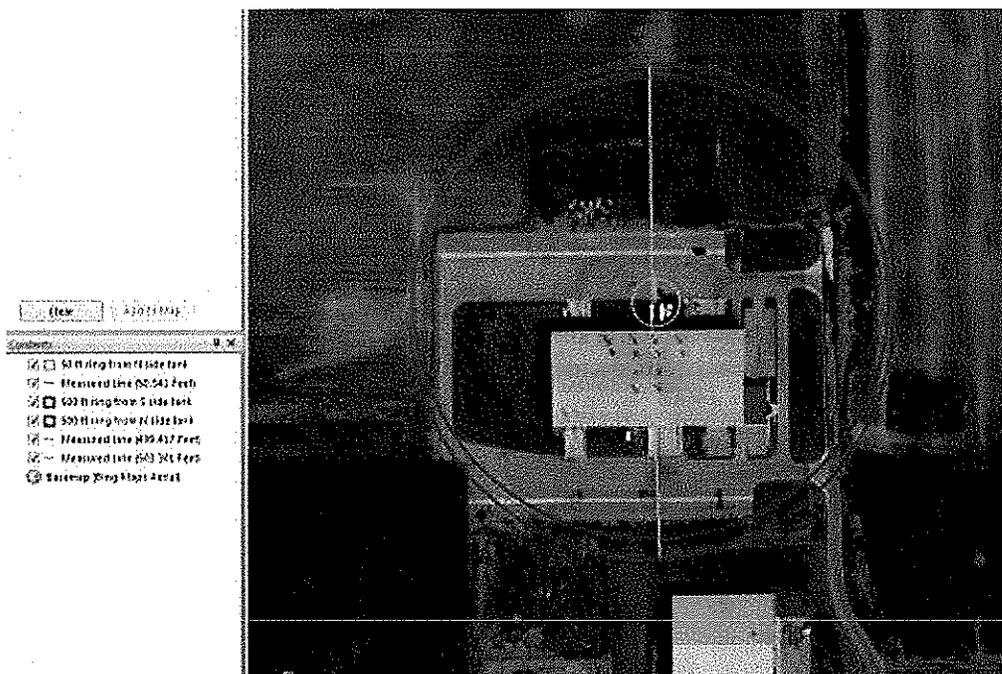
**Image 3(AA Distance GIS Map) :** ArcGIS Distances for Anhydrous Ammonia permit requirements
